RE: BYLAW NO. 559 – DISPOSITION OF PORT NEVILLE WHARF FACILITY

January 20, 2022 | Revision A

Marine Facility Condition Assessment of the Port Neville Wharf

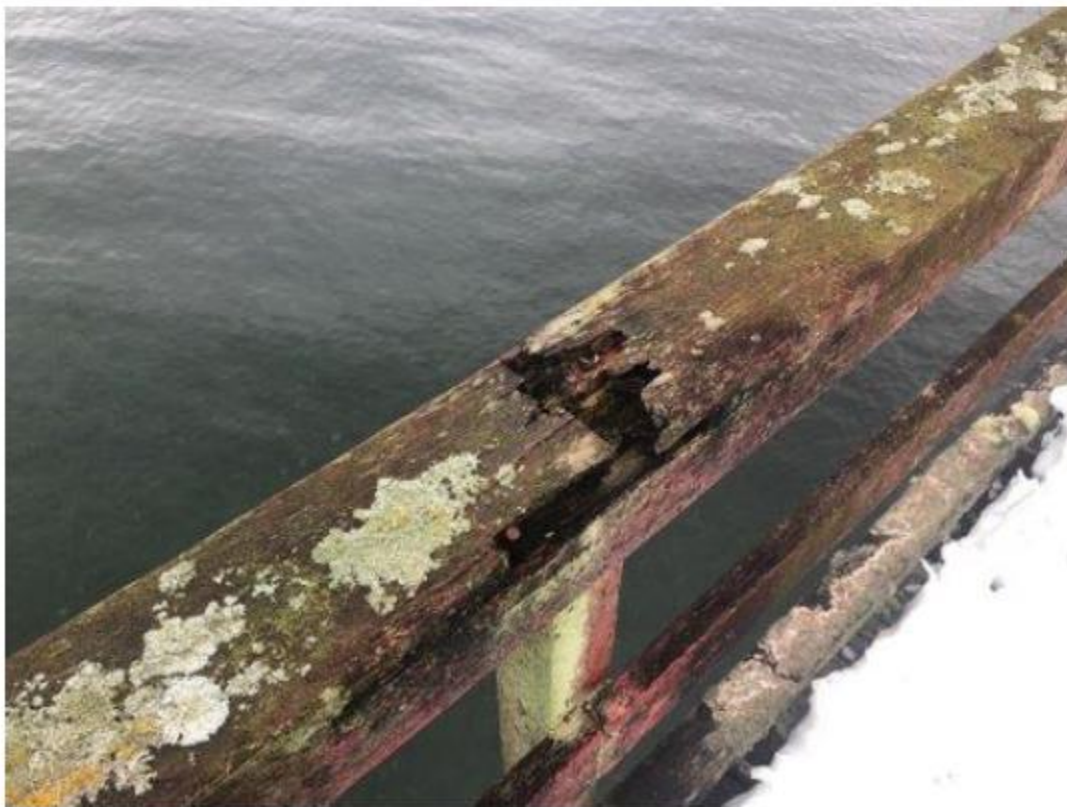
Photo 8 – Handrail deterioration between piles 11A and 12A

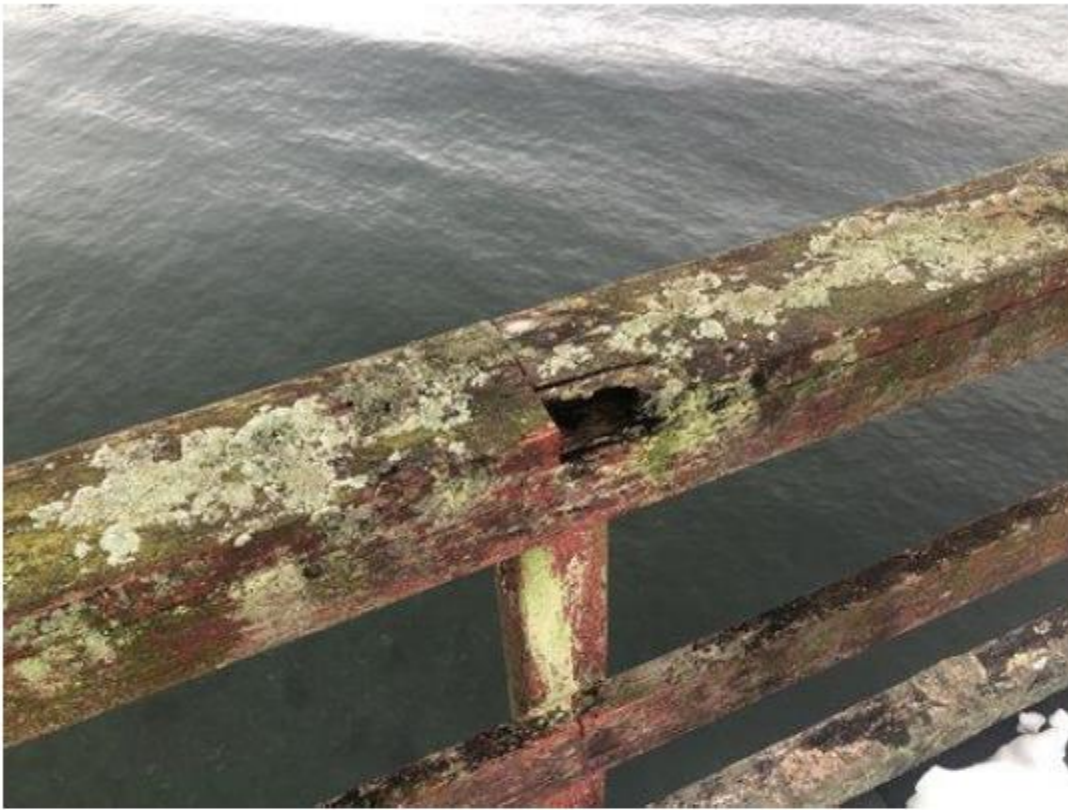
- Between piles 12A and 13A (Photo 9)
- Identified during the second inspection on December 7th, 2021, the top rail connection directly above pile 14B has deteriorated and is only connected on one end (Photo 10). *It is recommended that the bull rails and handrail posts be fully replaced and secured in places with deterioration and/or missing bolts. Consideration should be given to painting the handrails to extend the service life of the existing timber. Consideration should also be given to a full phased replacement of the topsides over the next 2-4 years.*

Photo 9 – Handrail deterioration between piles 12A and 13A

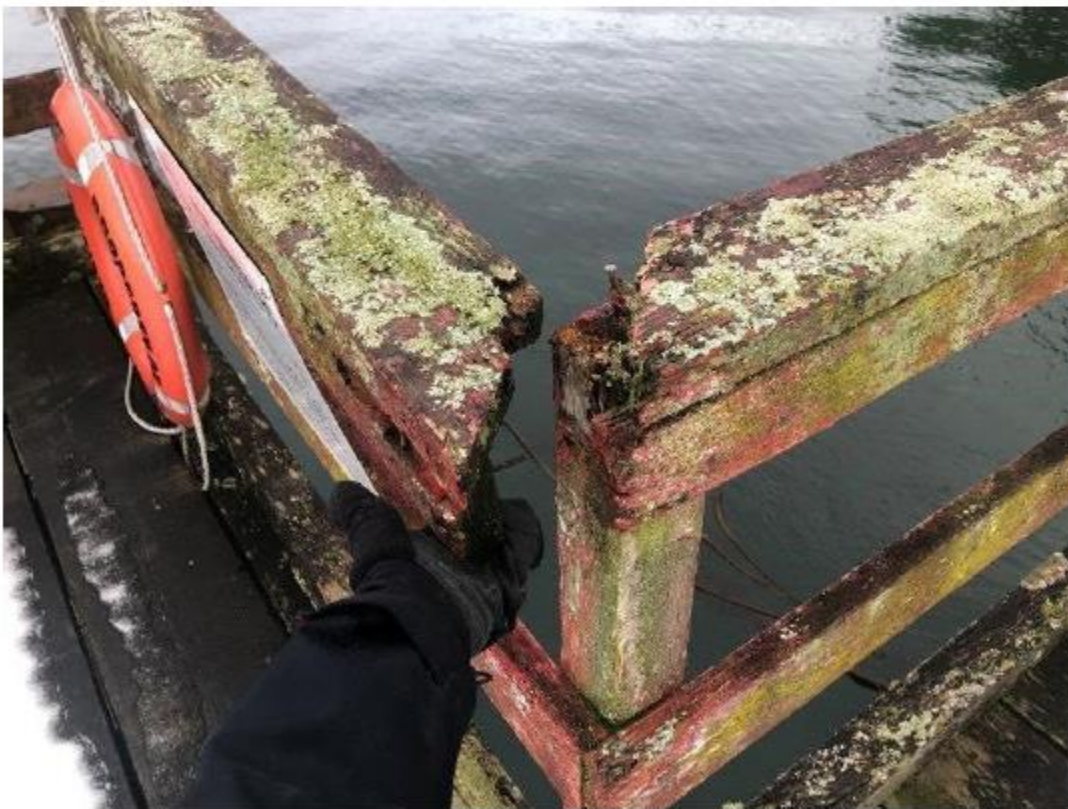
Photo 10 – Handrail deterioration between piles 14B and 14C

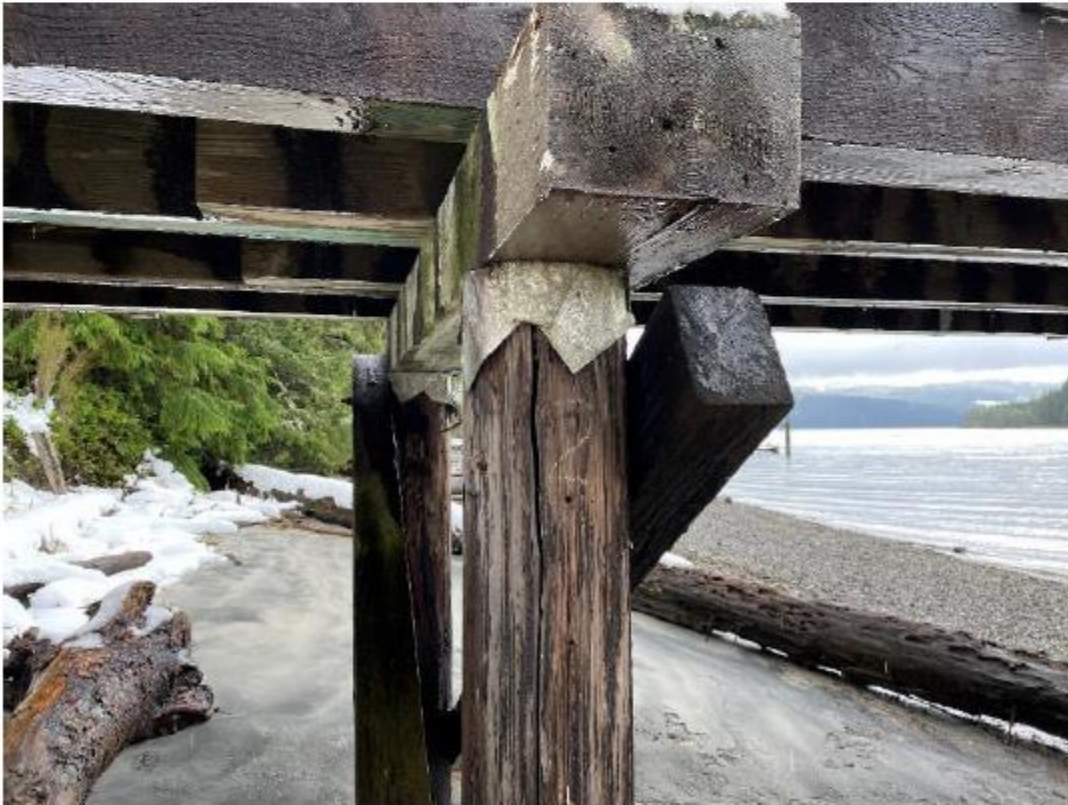
Photo 16 – Split in Pile 3B

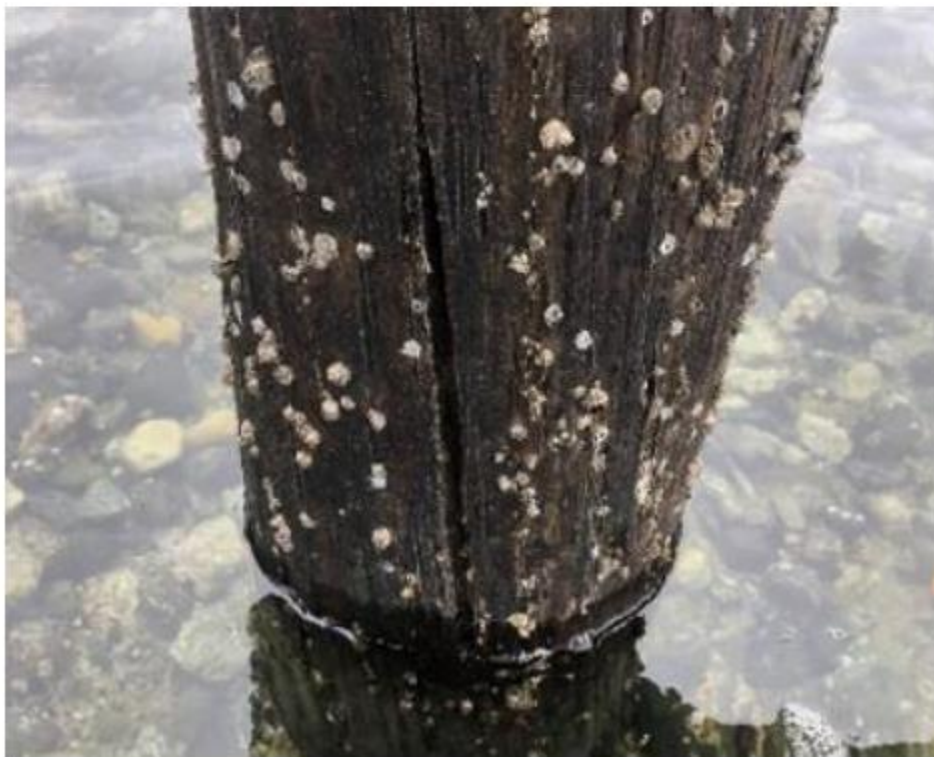
Photo 18 – Split in Pile 5A

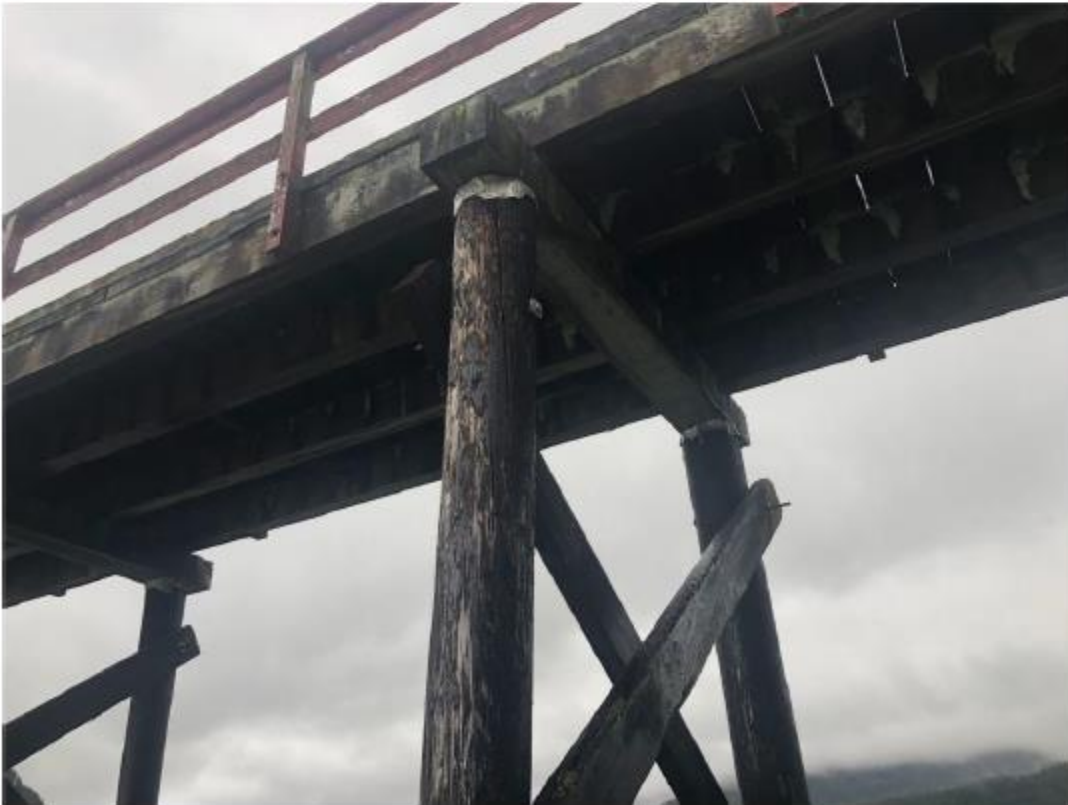
Pile 8A	Moderate splitting at the top of the pile. (Photo 20)	Monitor.
Pile 9A	Large open bolt hole at the top of the pile, likely from a previous cross-brace bolted connection. (Photo 21)	Monitor.
Pile 10A	Moderate splitting at the top of the pile. (Photo 22)	Monitor.
Pile 12A	Large open bolt hole at the top of the pile, likely from a previous cross-brace bolted connection. (Photo 23)	Monitor.
Pile 15B	Moss growing out of the top, indicating that there is fungal decay in the interior of the pile in this location. (Photo 24)	Monitor.

Photo 22 – Small split in Pile 10A

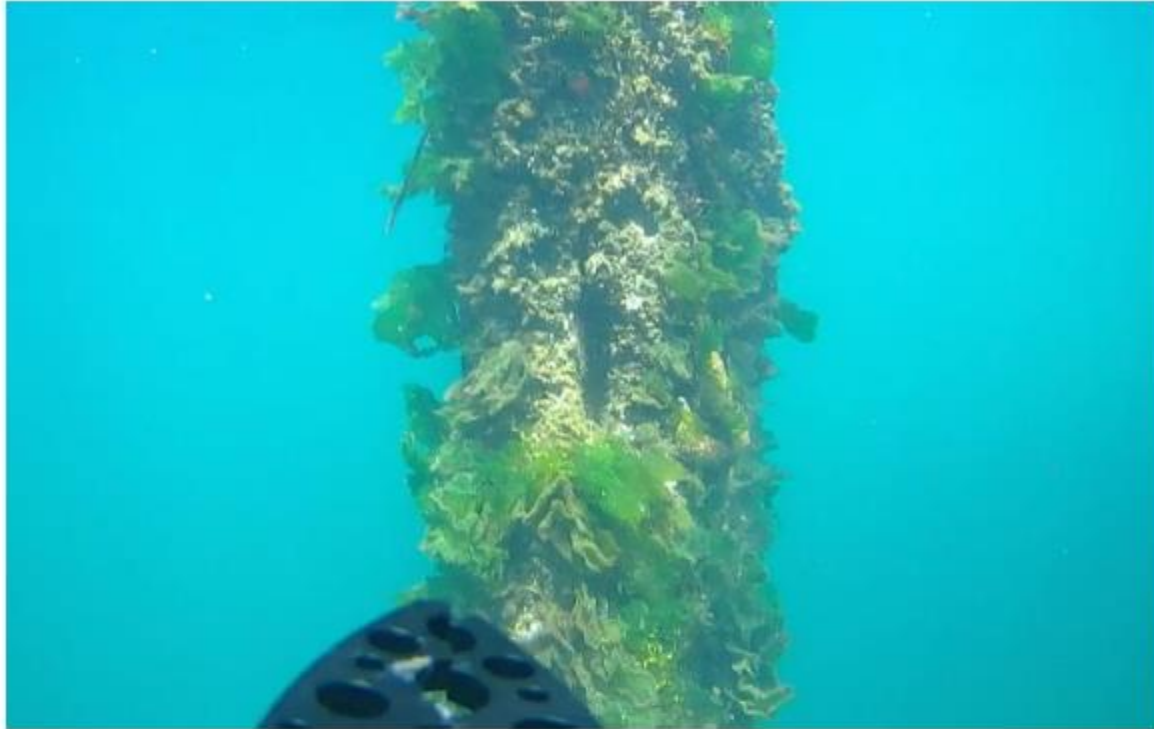
- Fender Pile 10B has a marine borer cavity in the lower intertidal zone with 25% cross-sectional loss (CSL) (Photo 25).
- Fender pile 14A has a large marine borer cavity with 50% CSL, and likely severe cross section loss due to fungal decay (Photos 26 & 27). Marine growth appears to be coming out of the pile.
- Fender pile 15C has a large marine borer cavity with 50% CSL, and likely severe cross section loss due to fungal decay (Photo 28).

Photo 27 – Underwater image of marine borer cavity of fender pile 14A

McElhanney understands that the fender piles are not longer used for vessel moorage and repairs are not considered necessary at this time as the fender piles are not structurally important to the pier.

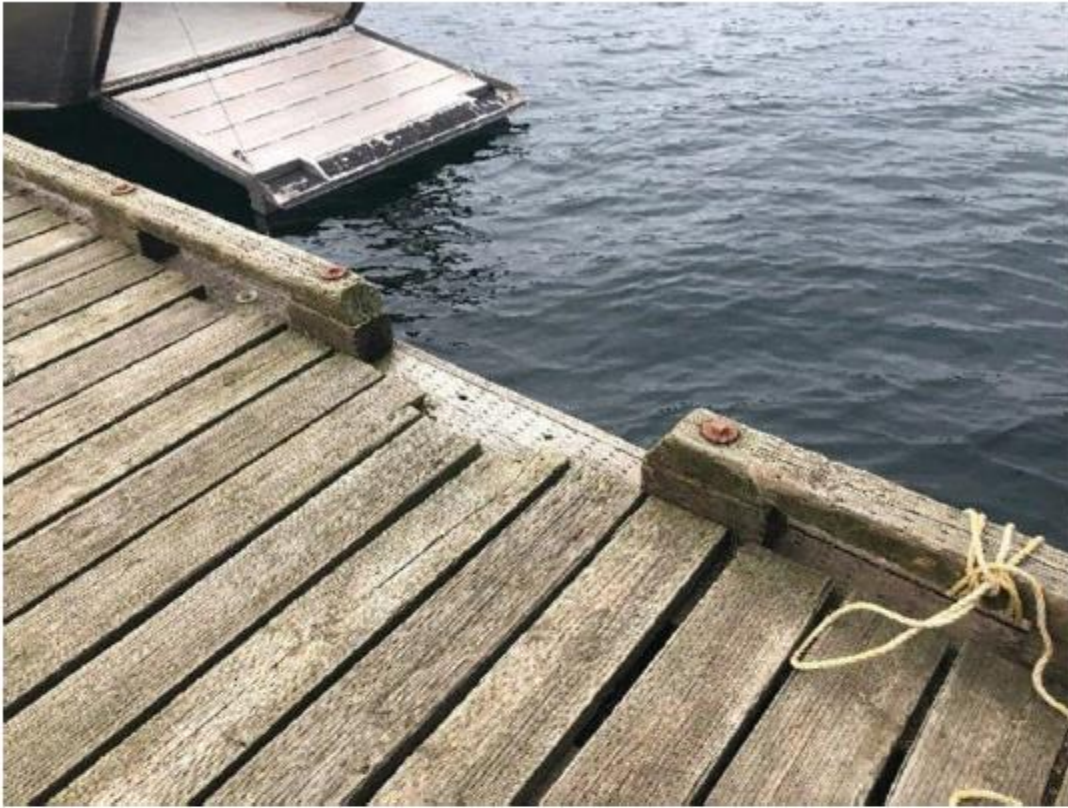
Photo 39 – Missing Bull rail on Float A

Consideration should be given to replacing Floats A and B along with the mooring system rather than continue regular minor maintenance/repairs.

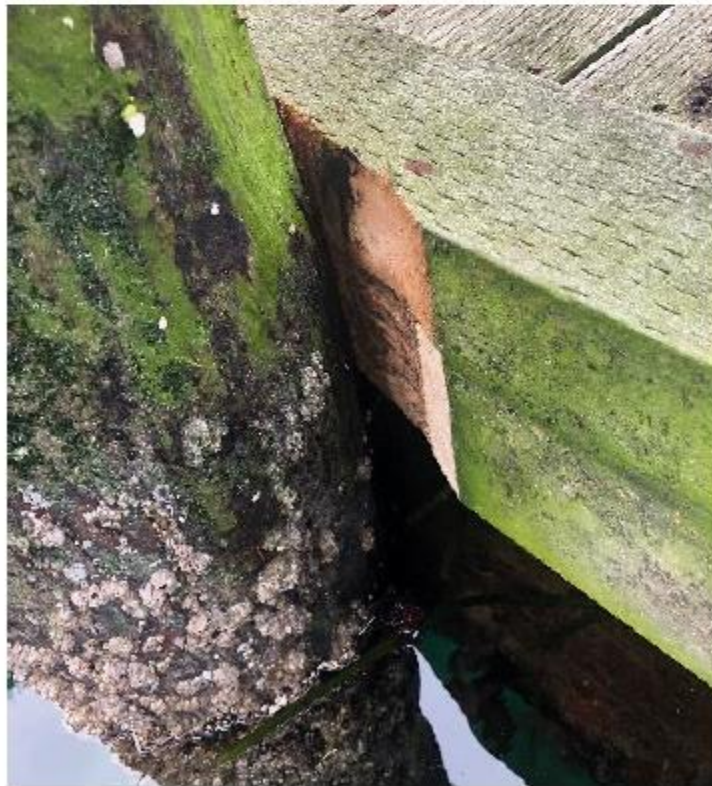
Photo 42 – Wearing to Float A from South Mooring Piles

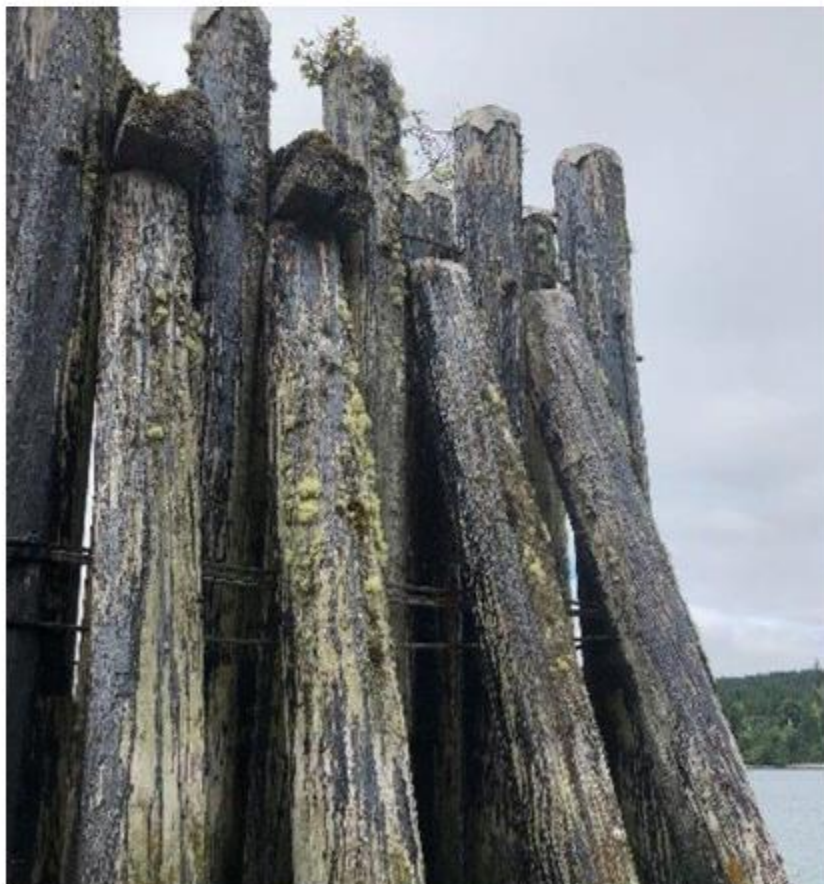
Photo 44 – North Mooring Dolphin

The timber mooring dolphins are in very poor condition. There is severe cross section loss due to internal fungal decay and marine borer cavity, as well as mechanical damage due to wearing of the floats.

- The north dolphin has vegetation growth near the tops of some of the piles. The timber blocking near the tops of the piles is deteriorating, and the cable wraps are loose (Photo 44)
- The south dolphin has significant vegetation growth near the tops of the piles. There is also severe cross section loss due to internal fungal decay and marine borer cavity in the intertidal zone, specifically on the front facing piles. The timber blocking is in poor condition, and the cable wraps are loose, but remain in place (Photo 45).

McElhanney understands that the mooring dolphins are no longer in service. To mitigate the risk of timber members contacting the dock, it is recommended that the timber dolphins be entirely removed and disposed of.
