Marine Facility Condition Assessment of the Owen Bay Wharf

August 24th, 2022 | Revision 0

Submitted to: Strathcona Regional District (SRD)
Prepared by McElhanney Ltd.

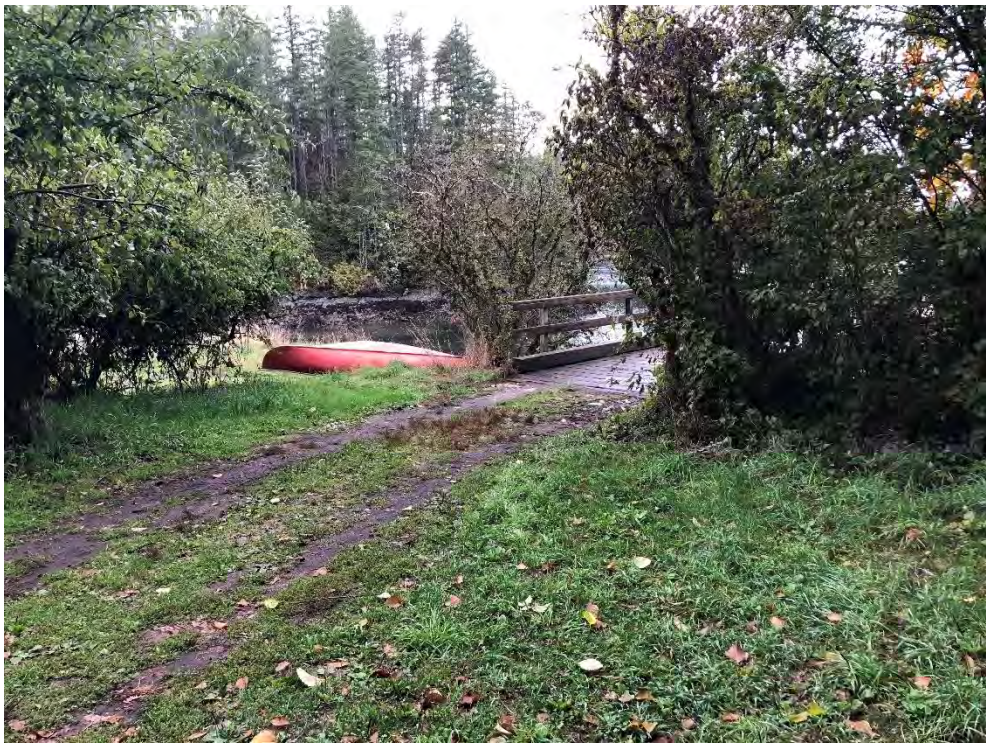
The approach is in generally good condition (Photo 2). There are no signs of settlement in this area, and the slope around the abutment appears stable. No load rating sign has been posted.

Photo 2 - Approach area

Repairs are not considered necessary at this time; however ongoing monitoring of the approach is recommended. Consideration should also be given to posting a load rating sign and extending safety barriers to the approach area.

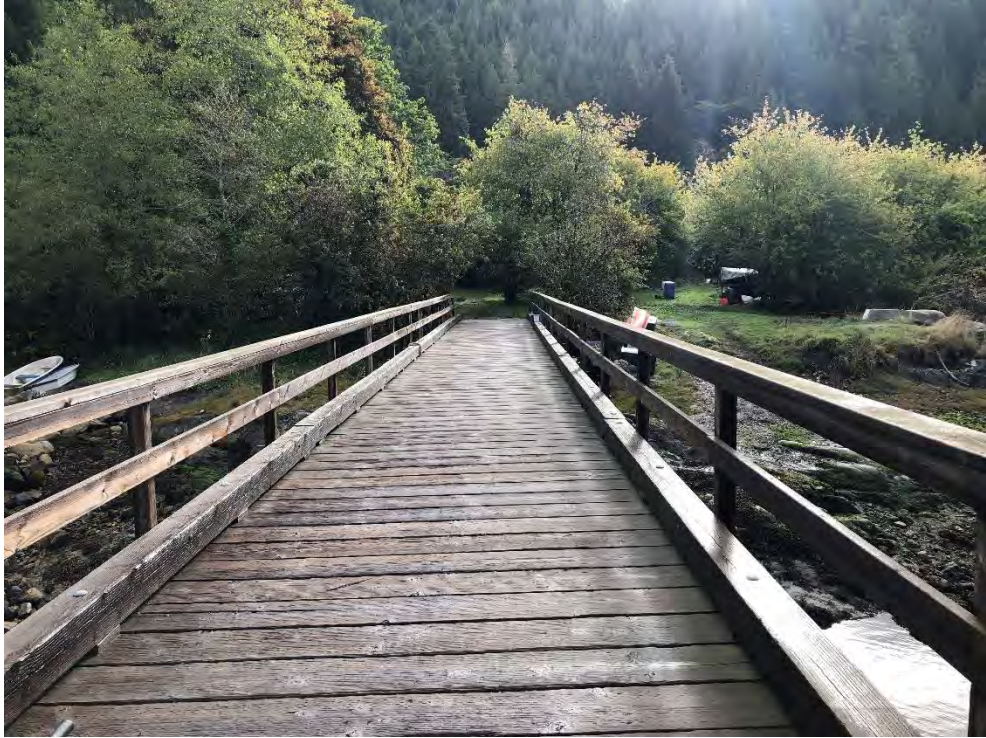
The topsides are generally in fair to good condition with moderate widespread weathering and fungal decay (Photo 3 and Photo 4). Inspection findings are as follows:

- The timber handrails are well secured and in good condition. They were replaced approx. 10 years ago according to previous reference drawings provided by the SRD.
- The timber deck planks have widespread minor weathering and fungal decay, however, are in fair to good condition. The deck planks appear generally well secured, with some missing/loose nails.

Photo 3 - Topsides of the Wharf Structure

Installation of an anti-slip grating to improve the safety during wet weather conditions is recommended. Consideration can be given to replacing and adding more nails to the decking. Ongoing monitoring of the condition of the topsides is recommended.

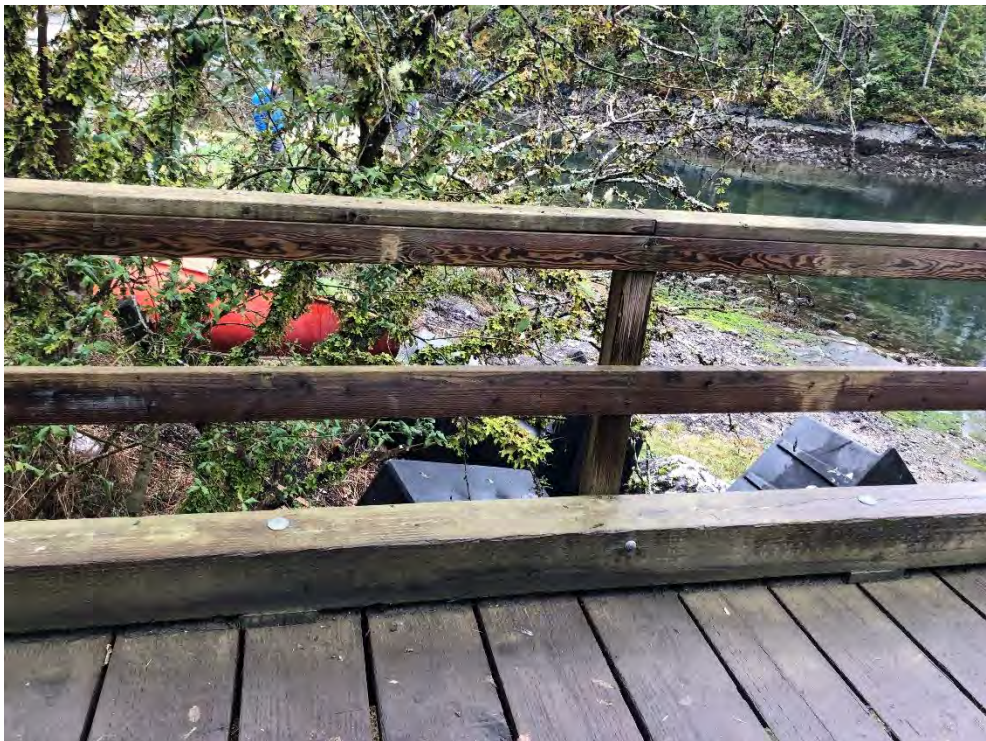
Photo 4 - General View of the Handrails

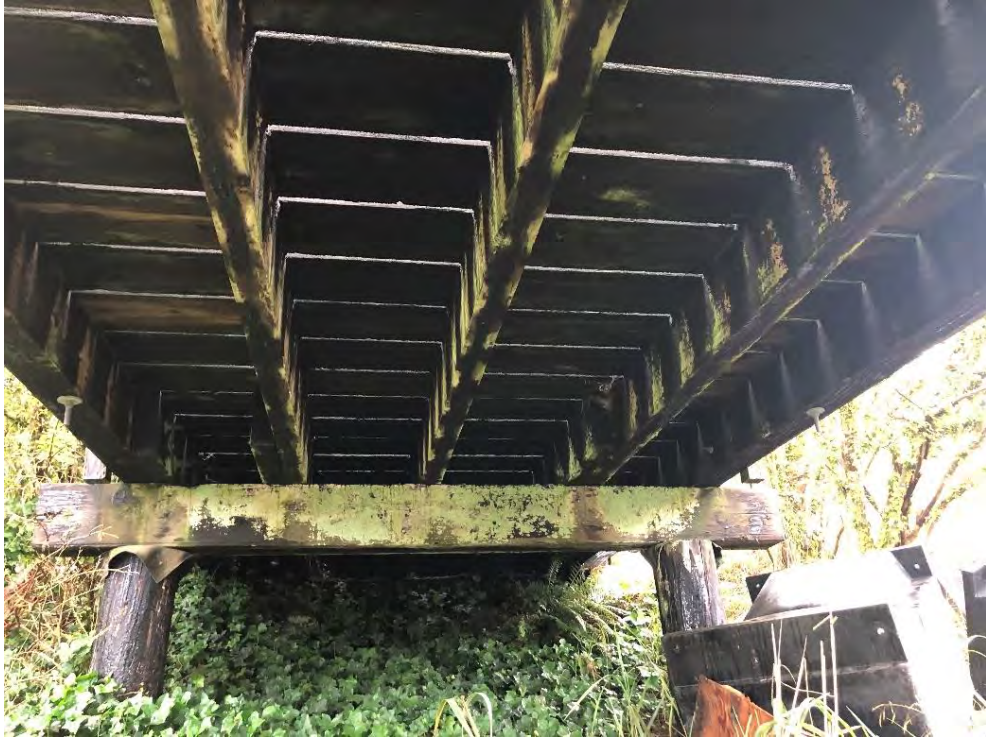
The treated timber stringers are generally in good condition, with green algae growth (Photo 5). The stringers appear well secured between the decking and the pile caps, and there is no evidence of significant splitting or structural deterioration. The ends of the stringers, where the end grain is present, does not show significant evidence of moisture or fungal decay.

Photo 5 - General view of the Stringers

Repairs are not considered necessary at this time; however ongoing monitoring of the stringers is recommended.

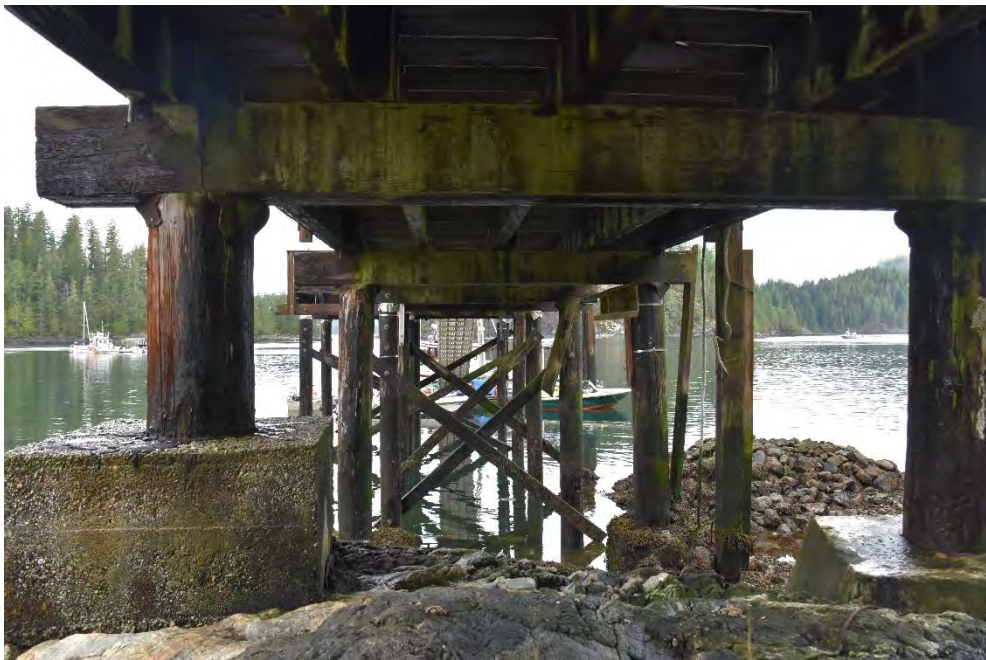
The treated timber pile caps are generally in fair to good condition with minor widespread weathering and green algae growth (Photo 6 and Photo 7). The pile caps appear well secured, and are typically aligned well over the piles, with no obvious evidence of shifting or displacement. Inspection findings are as follows:

Photo 6 - General view of the Pile Cap Bents

Pile caps at Bent Nos. 8 and 9 should be monitored for potential fungal decay where the through-bolts are. Replacements of the pile caps at Bent Nos. 5 and 6 should be considered. Ongoing monitoring of the remaining pile caps is recommended.

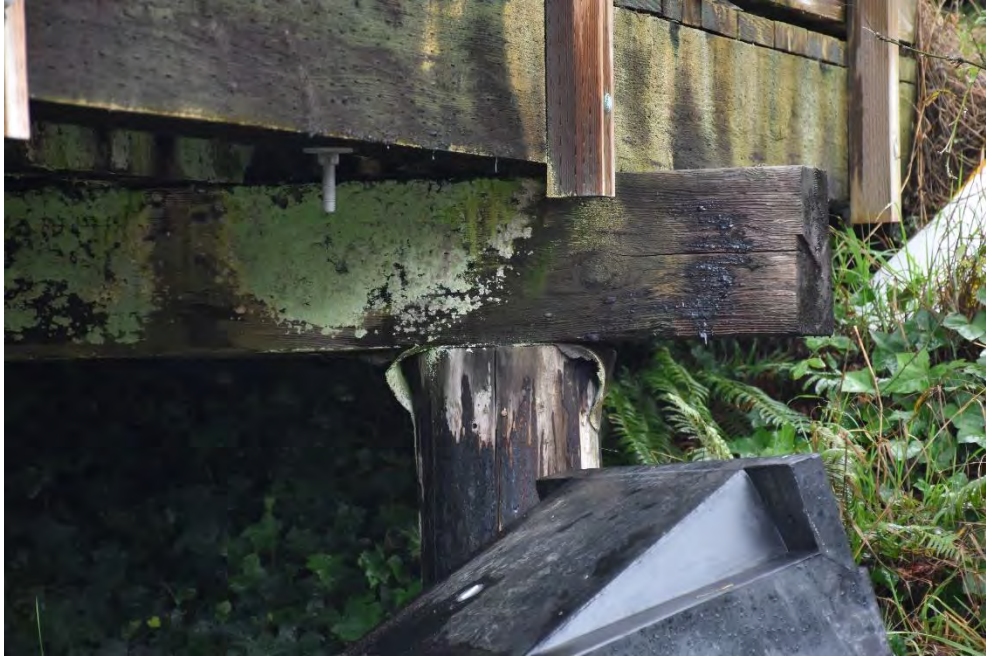
Photo 7 - Weathering and green algae growth on Pile Caps

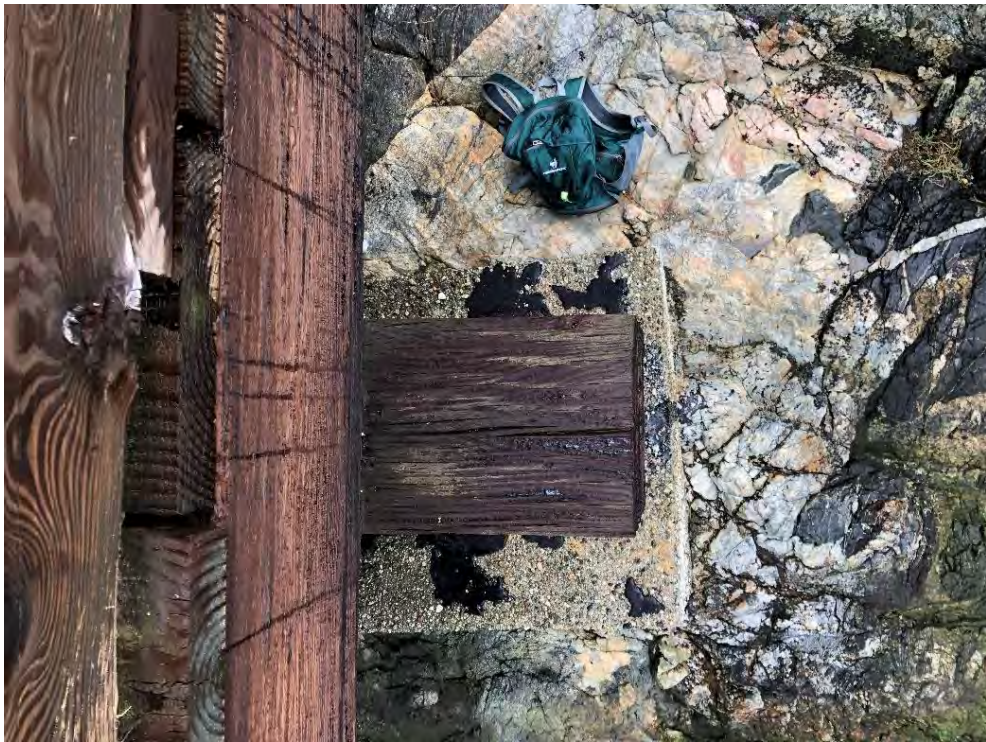
- The pile cap at Bent No. 4 has minor splitting at the end grain and top of the member on the south end (Photo 8).
- The pile cap at Bent No. 5 has severe splitting at the south end of the member (Photo 9).
- The pile cap at Bent No. 6 shows signs of deterioration at the end grain at the north end, as well as moderate to severe splitting at the south end (Photo 10 and Photo 11).
- The pile cap at Bent No. 8 has minor to moderate splitting at the north end (Photo 12).
- The through bolts from the bull rails directly above the pile caps at bents 8 and 9 connect to the pile caps (Photo 13).

Photo 8 - Minor splitting of the Pile cap at Bent 4

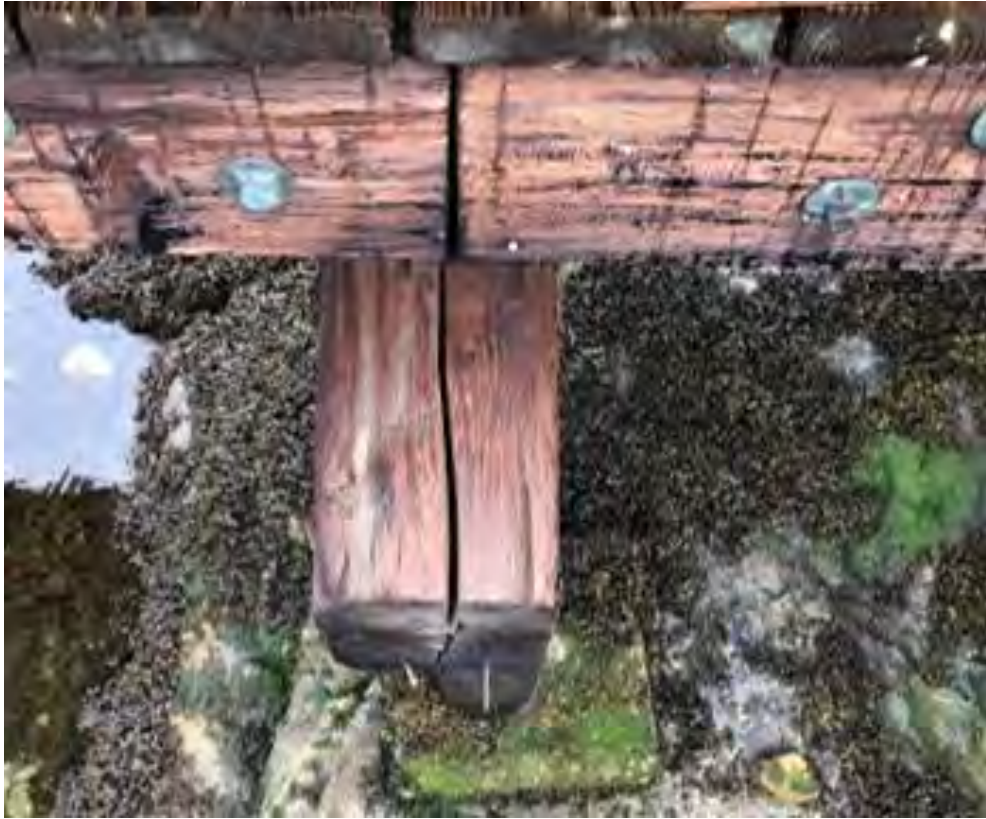
Photo 9 - Severe splitting of the Pile cap at Bent 5

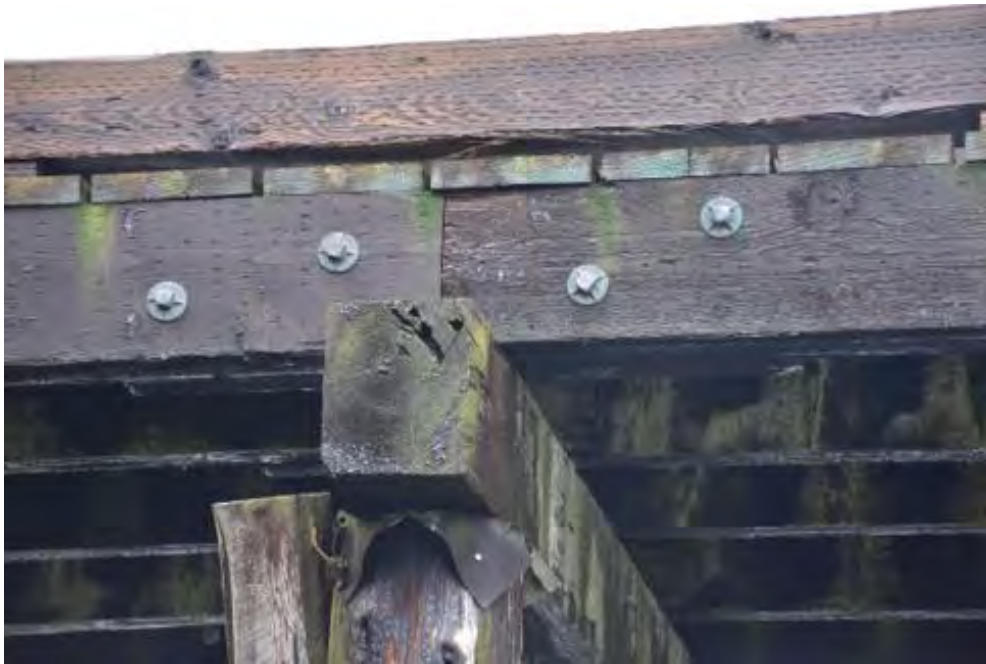
Photo 10 - Deterioration of the Pile Cap at Bent 6

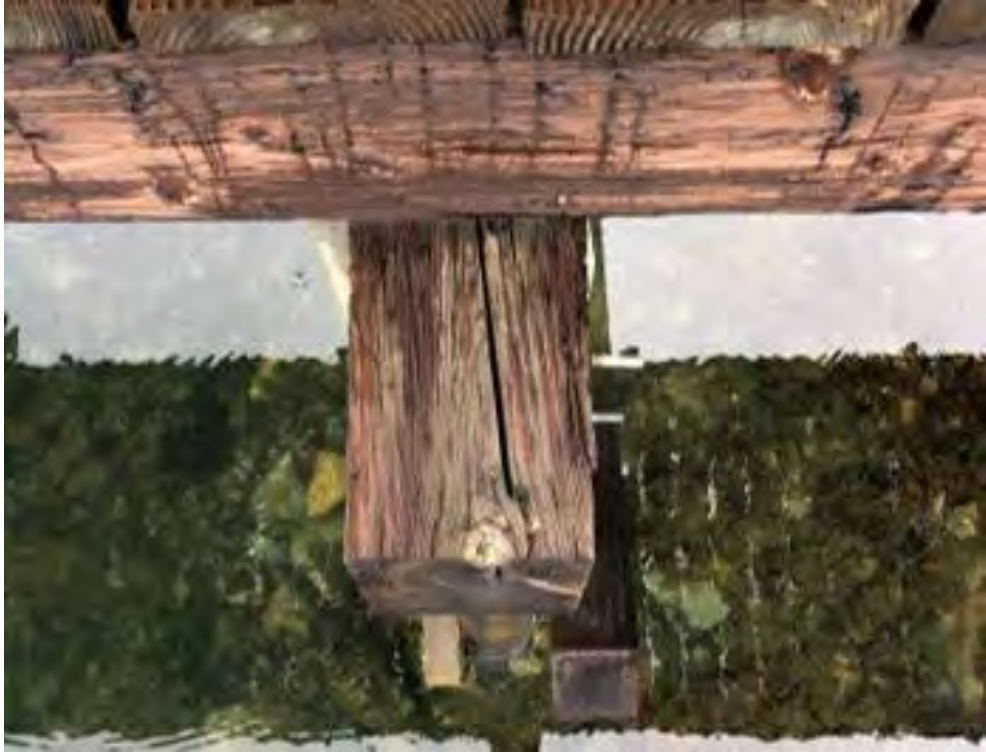
Photo 11 - Moderate to Severe splitting of the Pile cap at Bent 6

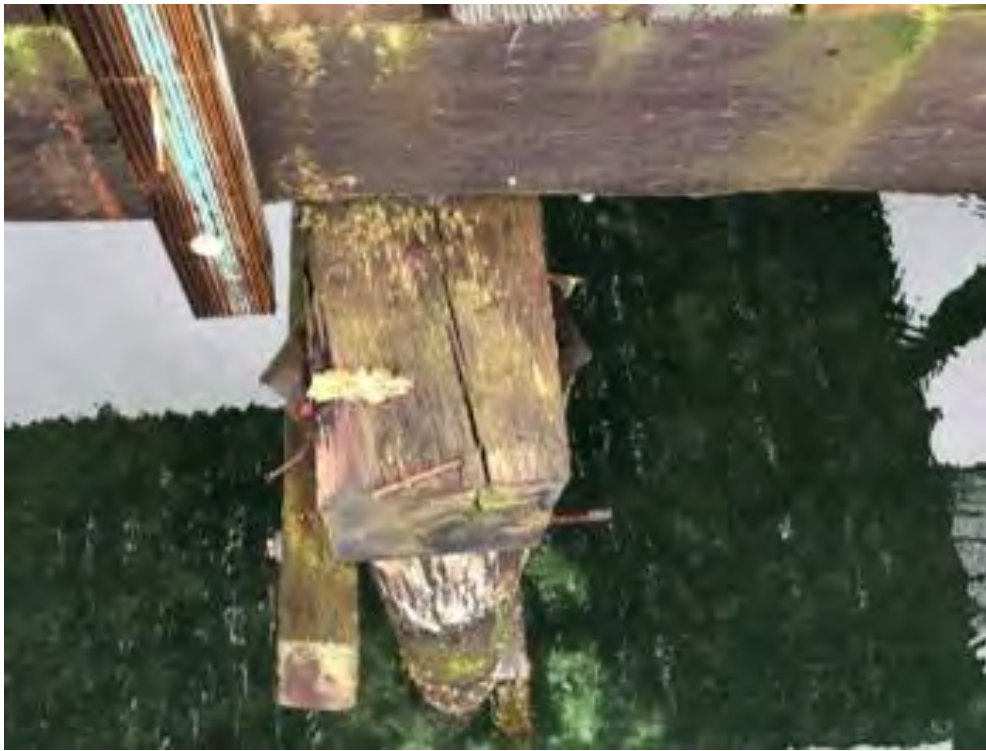
Photo 12 - Minor to moderate splitting of the Pile cap at Bent 8

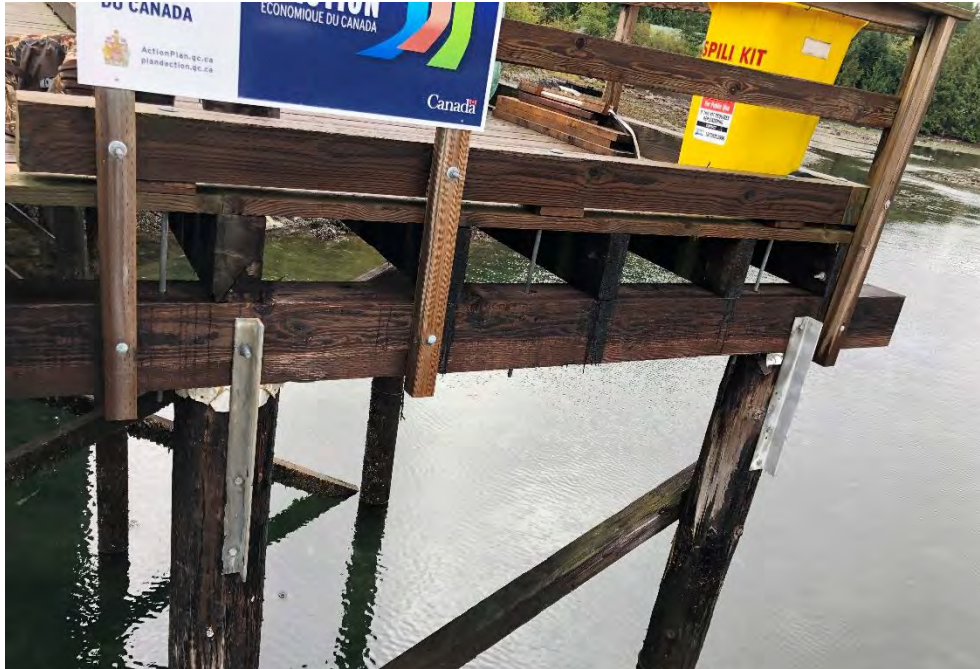
Photo 13 - Through bolts in the Pile Cap at Bent 9

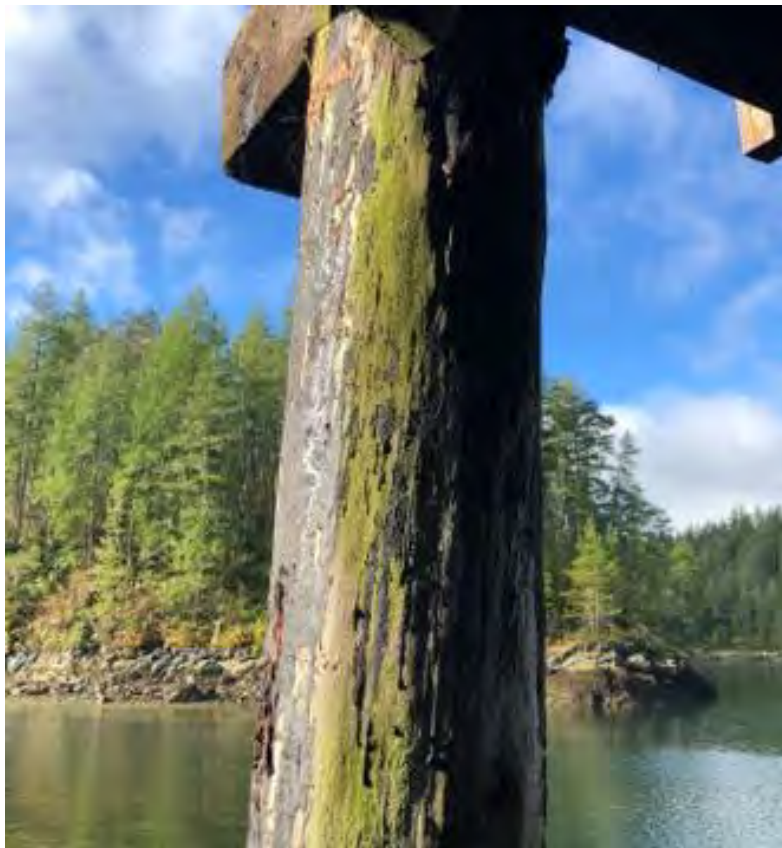
The timber piles are generally in fair condition, with some minor damage to isolated piles, and widespread minor weathering and green algae growth (Photo 14 and Photo 15 **Error! Reference source not found.**). Inspection findings are as follows:

Photo 14 - Typical weathering and green algae growth on piles

The missing and deteriorated capping should be replaced to prevent further damage to the tops of the piles. Pile 4B should be continually monitored and banded to prevent further splitting. Ongoing monitoring of the piles and footings and areas of damage is recommended. It is anticipated that the piles identified with splitting will have established internal fungal decay in the next 5-10 years and may be considered for replacement.

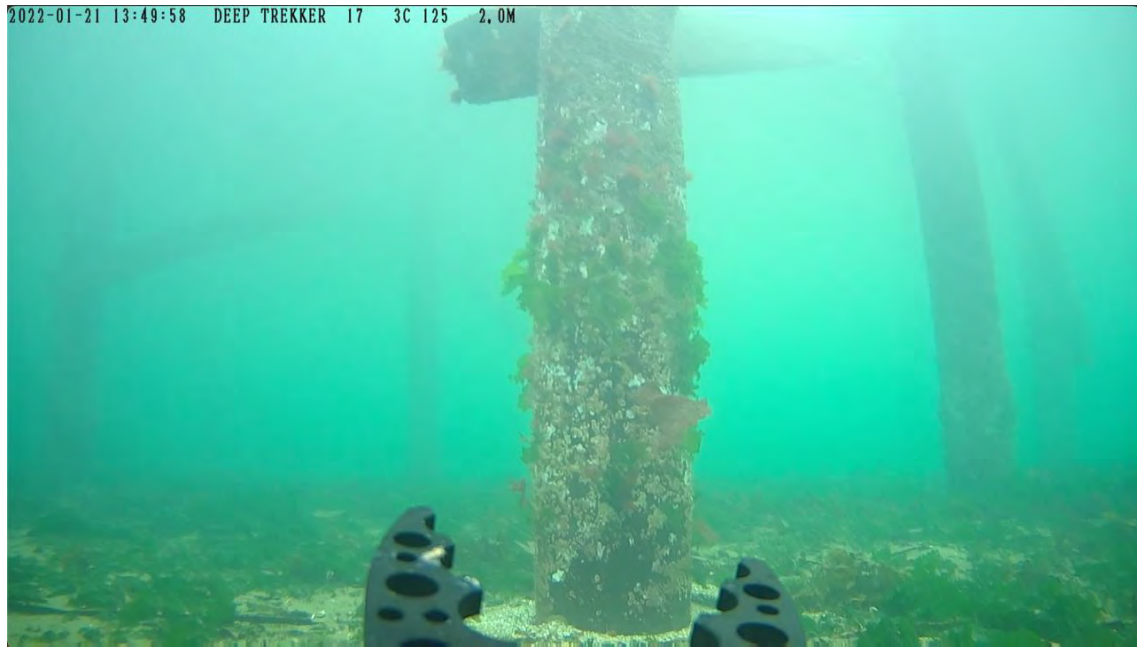
Photo 15 - Typical condition of underwater piles

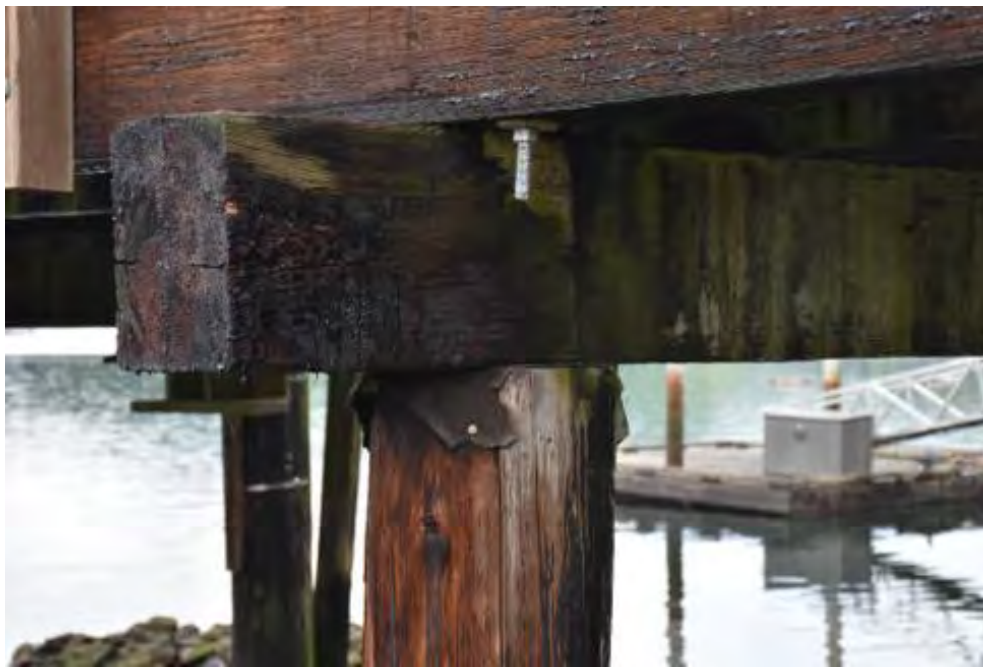
- The existing capping over all piles (excluding piles 3A, 3B, 7A, 7B, 8B, 8C, 9A, 9B, and 9C) is deteriorated or missing, with some biological growth where this occurs (Photo 16).
- The piles are supported on concrete footings which are in fair to good condition. There are minor signs of scouring, and minor signs of undermining at bents 2 and 3.
- Pile No. 4B has a minor split down the length of the pile (Photo 17).
- Pile No. 5A has split at the top of the pile. It has been banded in 2 locations to prevent further splitting (Photo 18).
- Pile No. 6B has split at the top of the pile. It has been banded in 2 locations to prevent further splitting.

Photo 16 - Typical deteriorated capping on piles

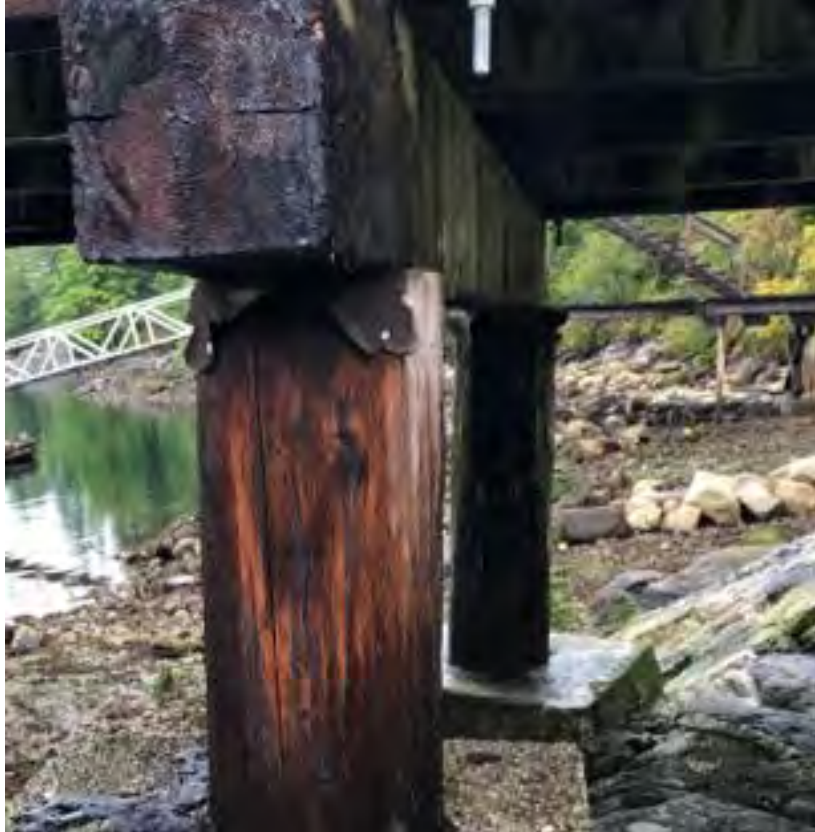
Photo 17 - Minor splitting on Pile 4B

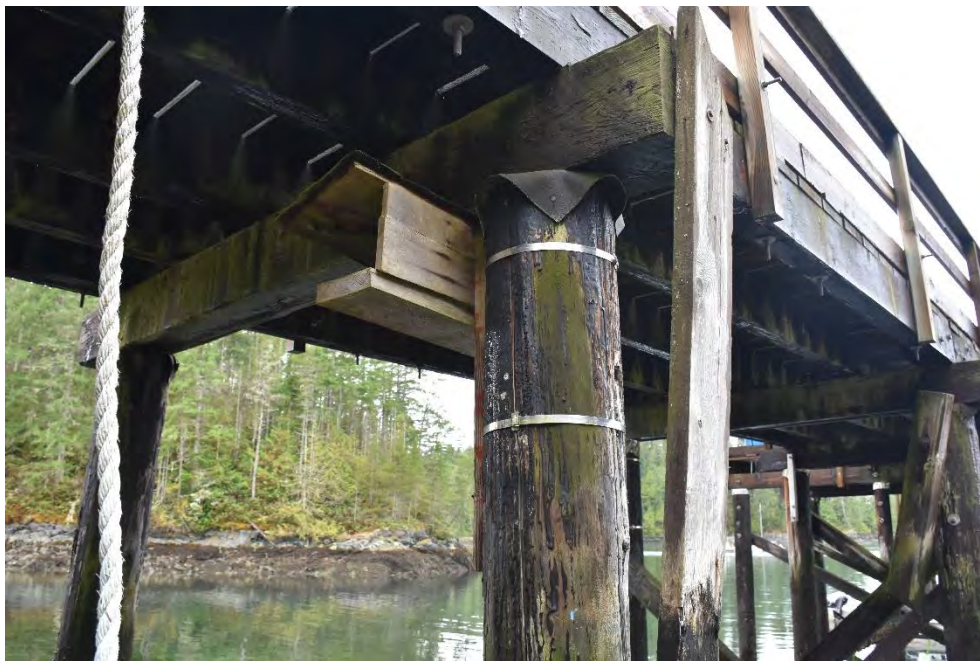
Photo 18 - Pile 5A with typical existing banded repair

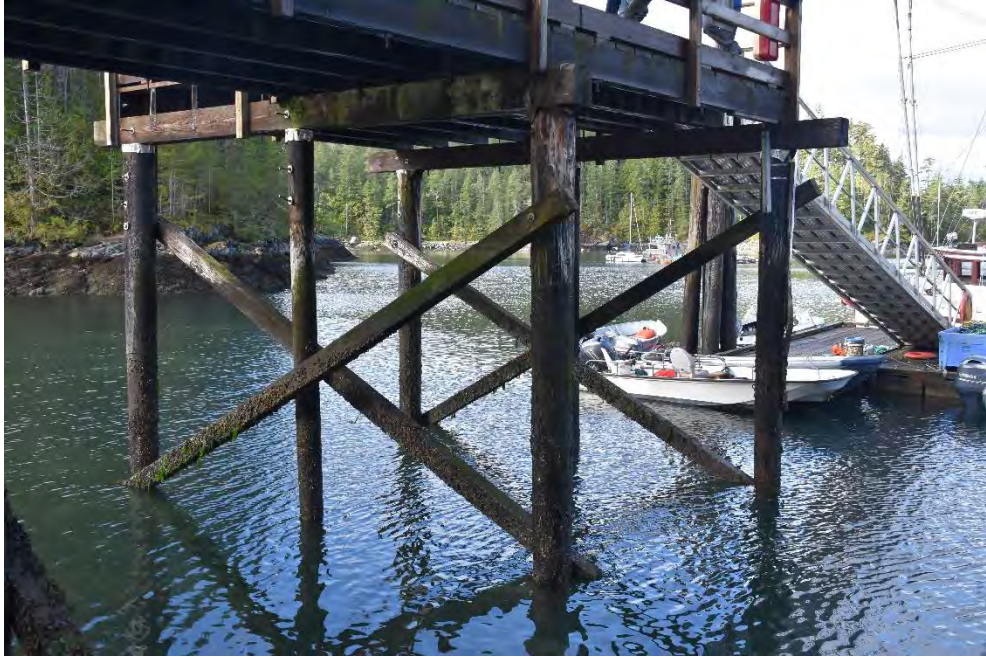
The timber cross bracing is generally in good condition (Photo 19 and Photo 20). There is widespread weathering, however the cross braces show no obvious sign of deterioration and are well secured to the piles.

Photo 19 - General view of Cross Bracing

Repairs are not considered necessary at this time; however ongoing monitoring of the cross bracing is recommended.

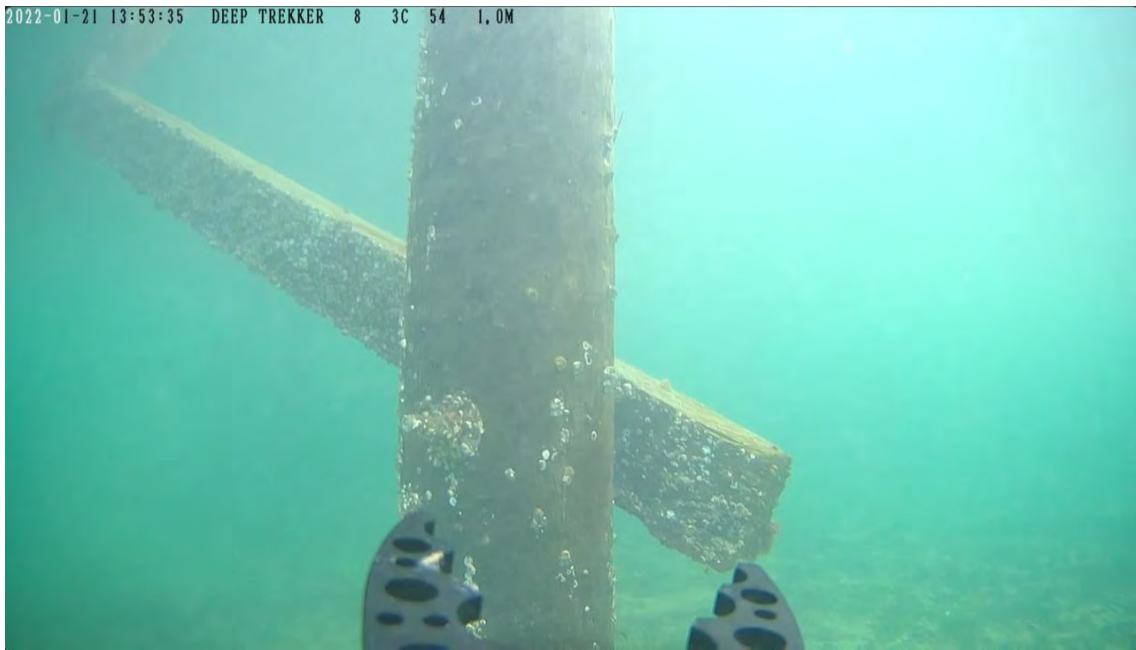
Photo 20 - Typical condition of underwater cross-bracing

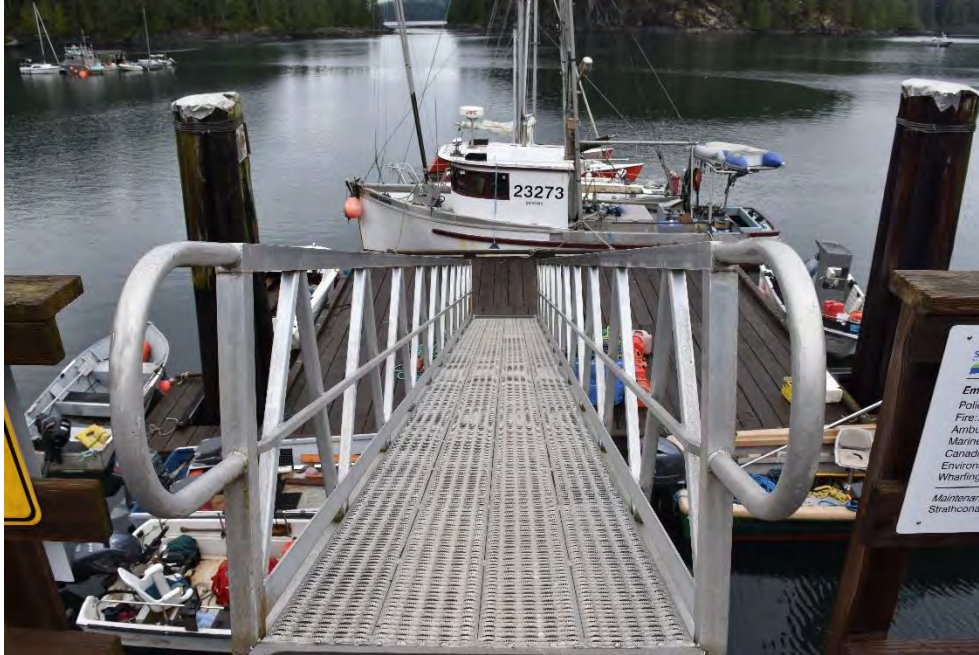
The access gangway is in good condition with no significant corrosion or deterioration noted (Photo 21). According to the reference drawings it was replaced approximately 10 years ago. The inspection findings are as follows:

Photo 21 - General View of Aluminum Gangway

Repairs are not considered necessary at this time; however ongoing monitoring of the gangway is recommended.

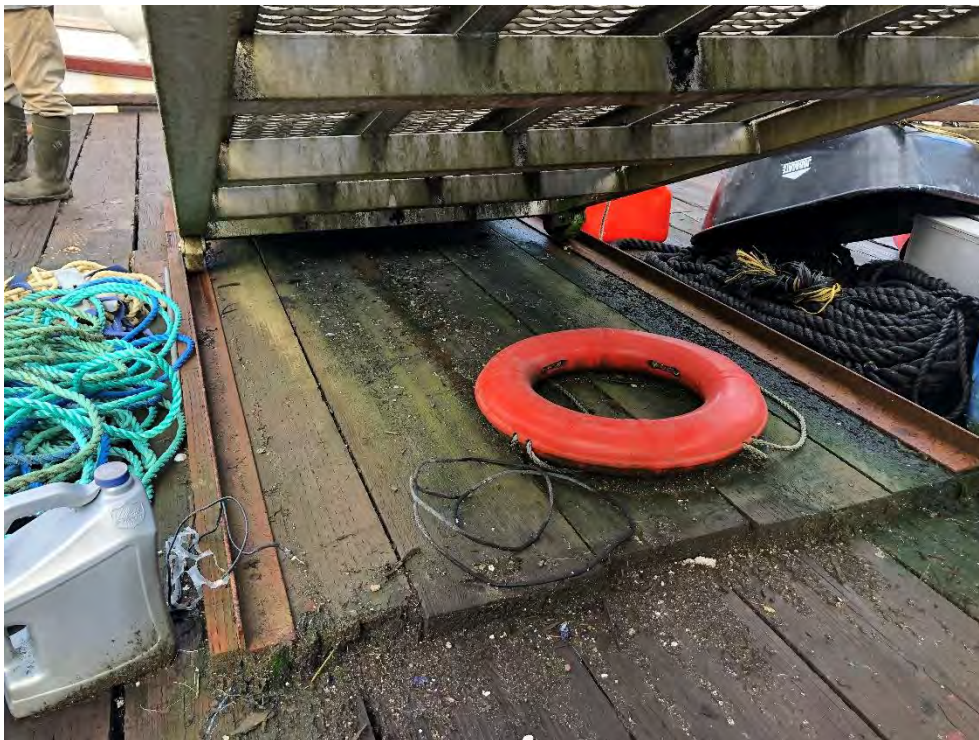
- The timber gangway slider plate is in fair condition with wearing and fungal decay and is well aligned with the gangway rollers (Photo 22).
- The structural members and welded connections appear to be in good condition.
- The upper hinge connections are well aligned, and the bolt connections are in good condition. The lower bolt on the south end connection has loosened slightly (Photo 23).

Photo 22 - Gangway slider plate and rollers

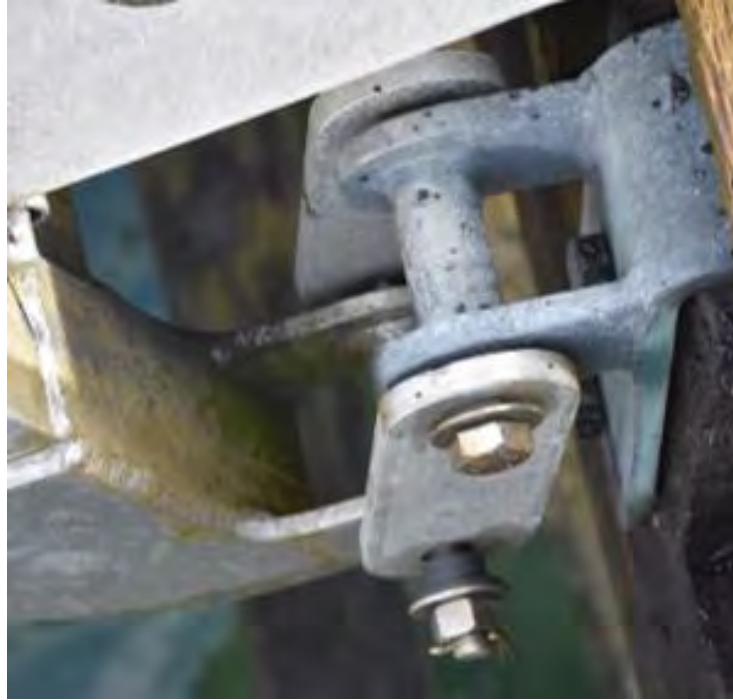
Photo 23 - Gangway Upper Hinge Connection with loose bolt

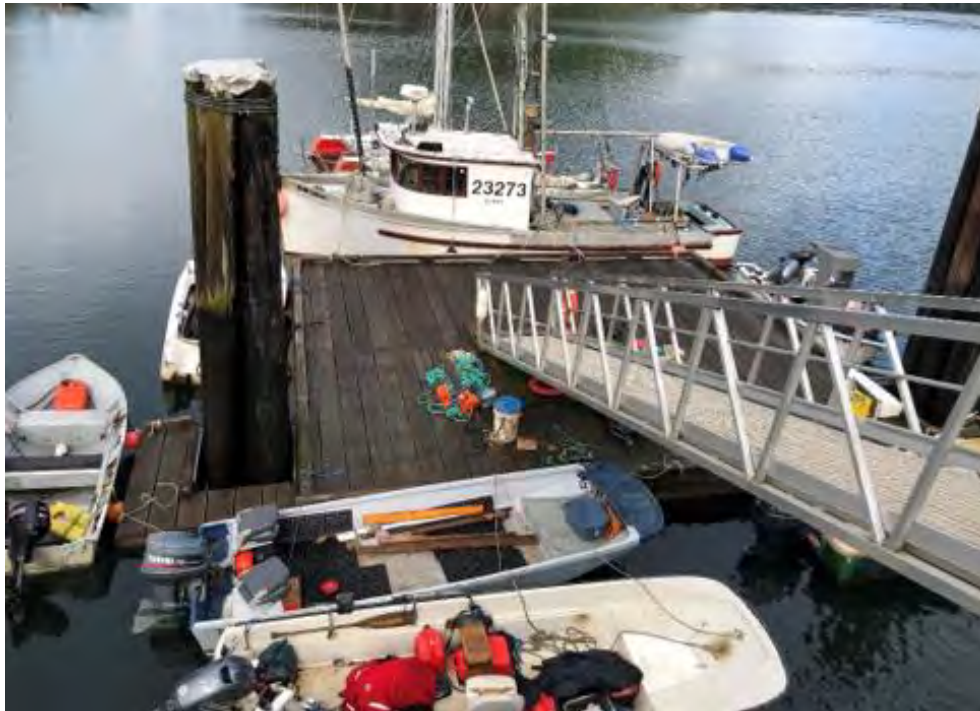
The float is in poor to fair condition (Photo 24). Inspection findings are as follows:

Photo 24 - General View of the float

The float capacity is a significant concern for the community. At the time of the inspection, the float was at full capacity, and multiple pleasure craft vessels had to be tied up to other vessels to access the float. In addition, other vessels must tie up at the mooring point to the southwest of the facility when spots have not been available. Consideration should be given to expanding the floating dock footprint for increased need. Consideration should be given to replacing the float along with the mooring system rather than continue regular minor maintenance/repairs.

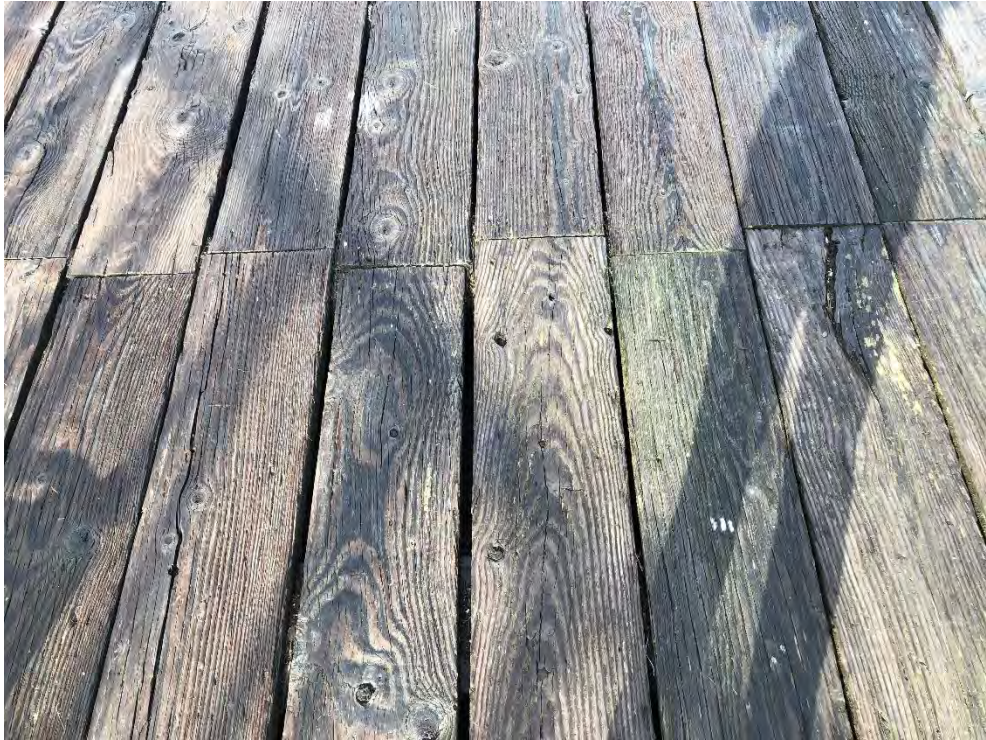
- The timber deck planks, bull rails and fascia boards have widespread weathering and fungal decay, (Photo 25 and Photo 26).
- The mooring wells are in good condition with repairs assumed to have been completed in the past 10 years. Wear strips have been installed on the inside of the wells.

Photo 25 - Typical condition of the timber decking

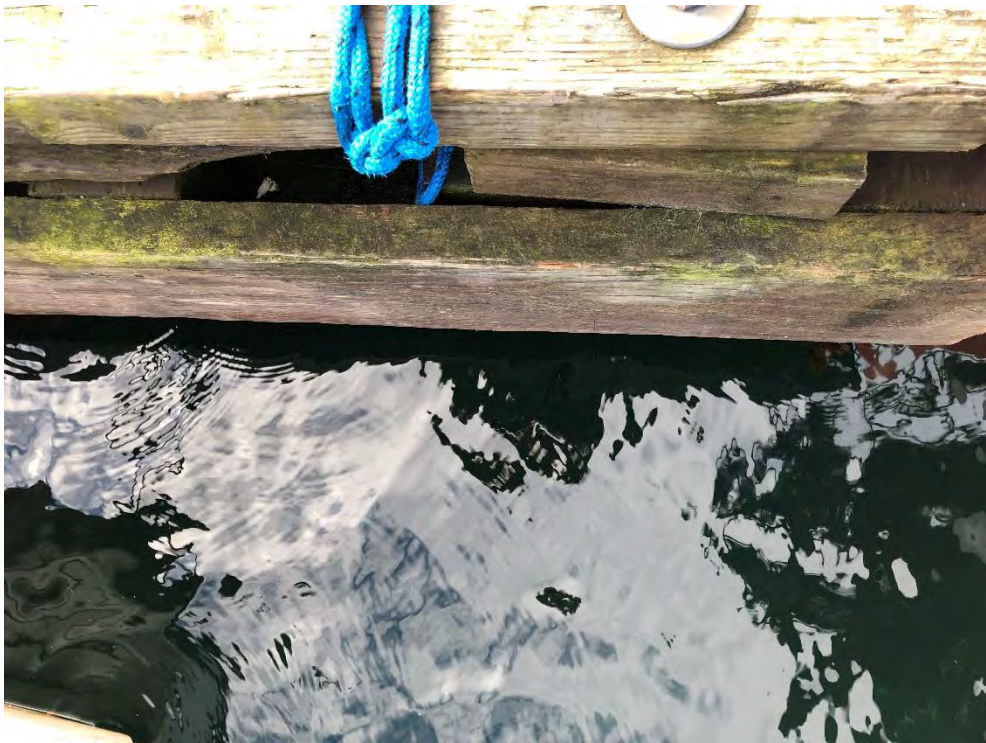
Photo 26 - Typical condition of the timber bull rails and fascia board

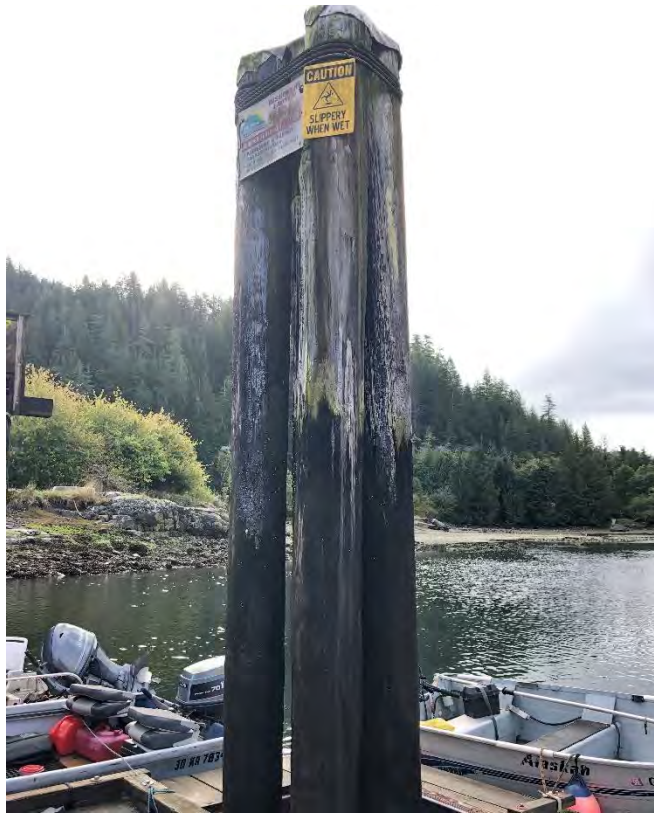
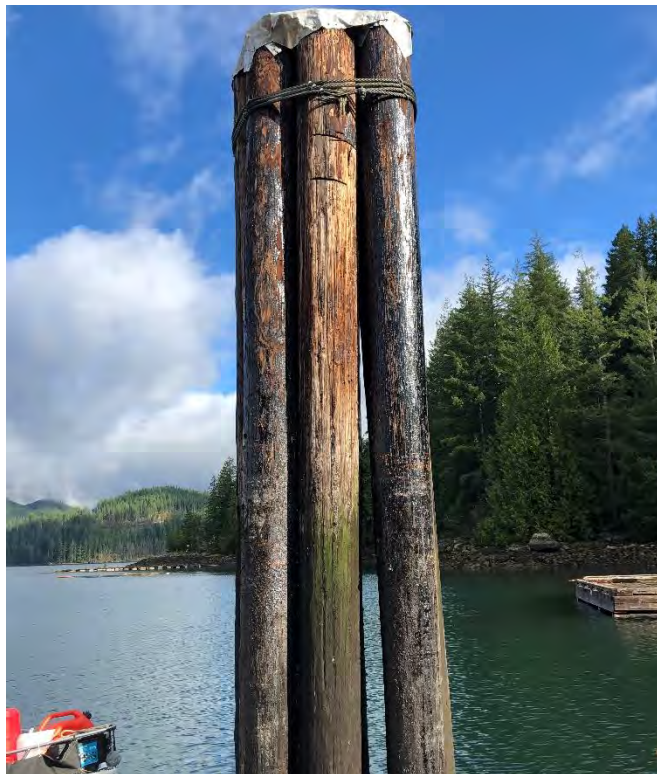
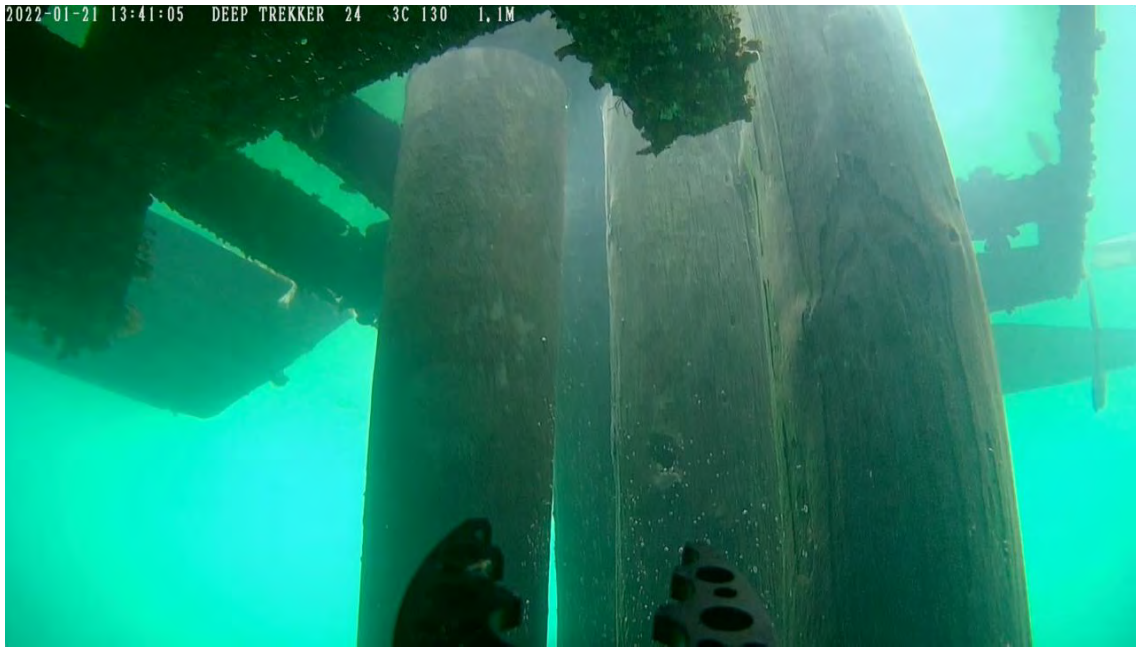
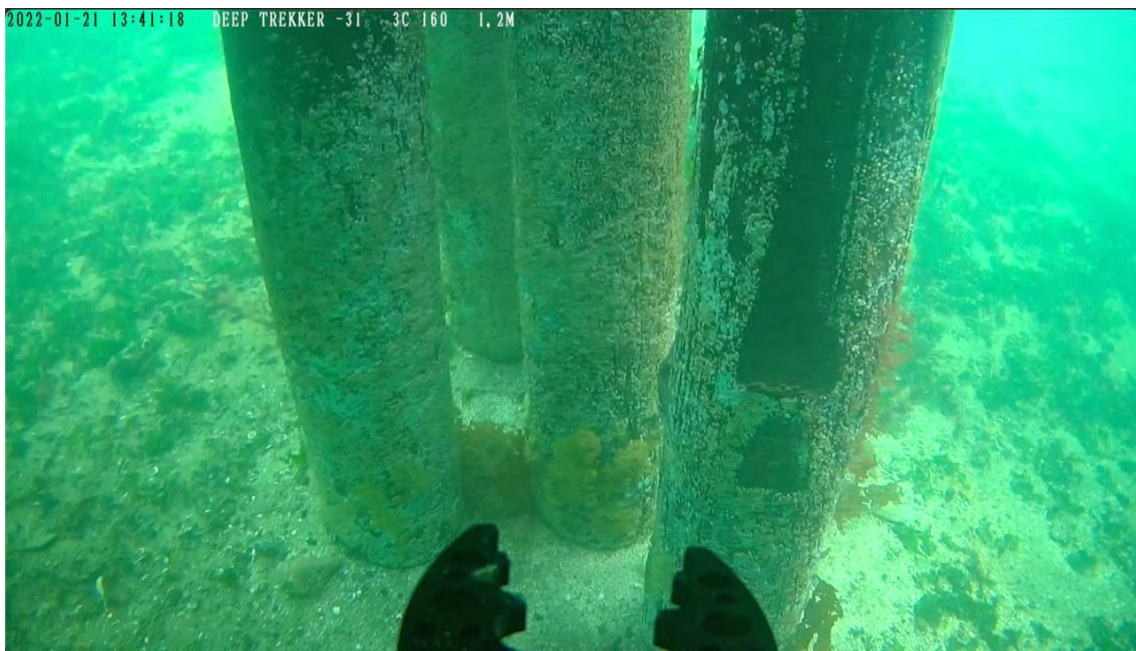
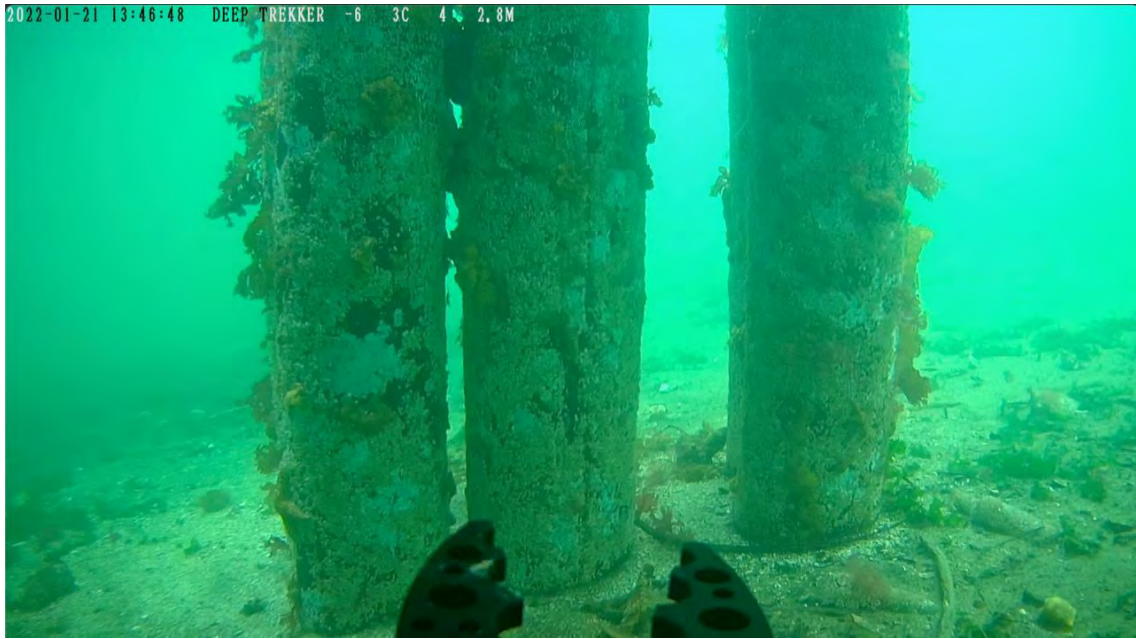
- The timber mooring piles are in fair to good condition, with widespread minor fungal decay and weathering. There are no significant signs of abrasion from the floats to the pile faces. The connections at the top of the mooring piles are in good condition, and the wire rope lashing is secure (Photo 27 to Photo 31).
