Marine Facility Condition Assessment of the Owen Bay Wharf

August 24th, 2022 | Revision 0

Submitted to: Strathcona Regional District (SRD)
Prepared by McElhanney Ltd.

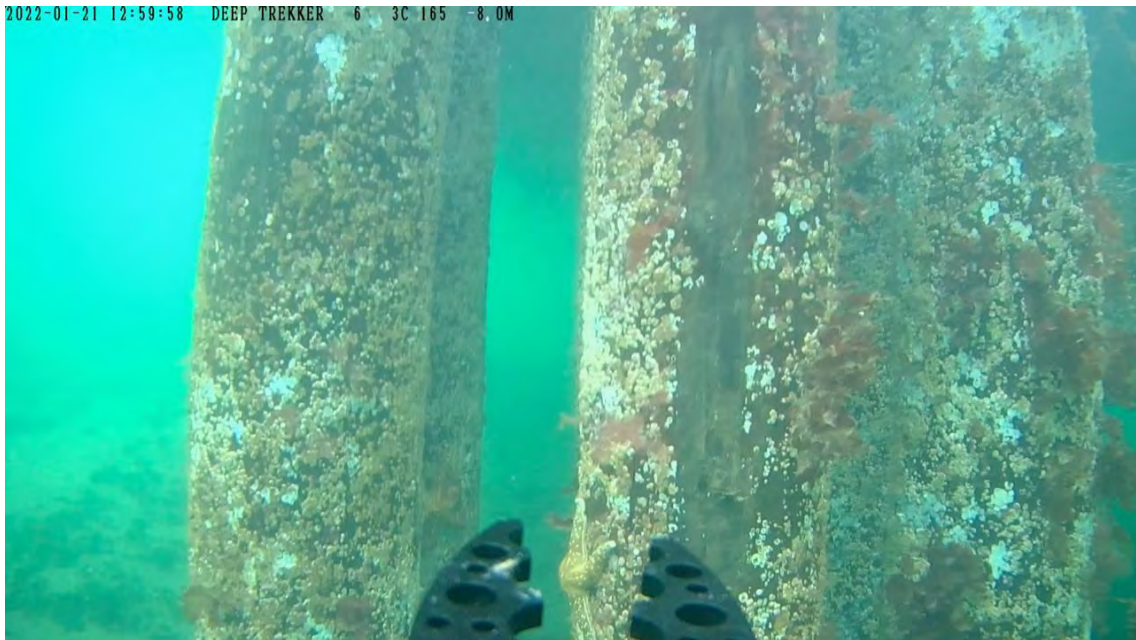
- One of the north mooring piles has some minor damage in the lower intertidal zone (Photo 32).
- The flotation elements are uncoated styrofoam billets (Photo 33).

Photo 32 - North Mooring Piles

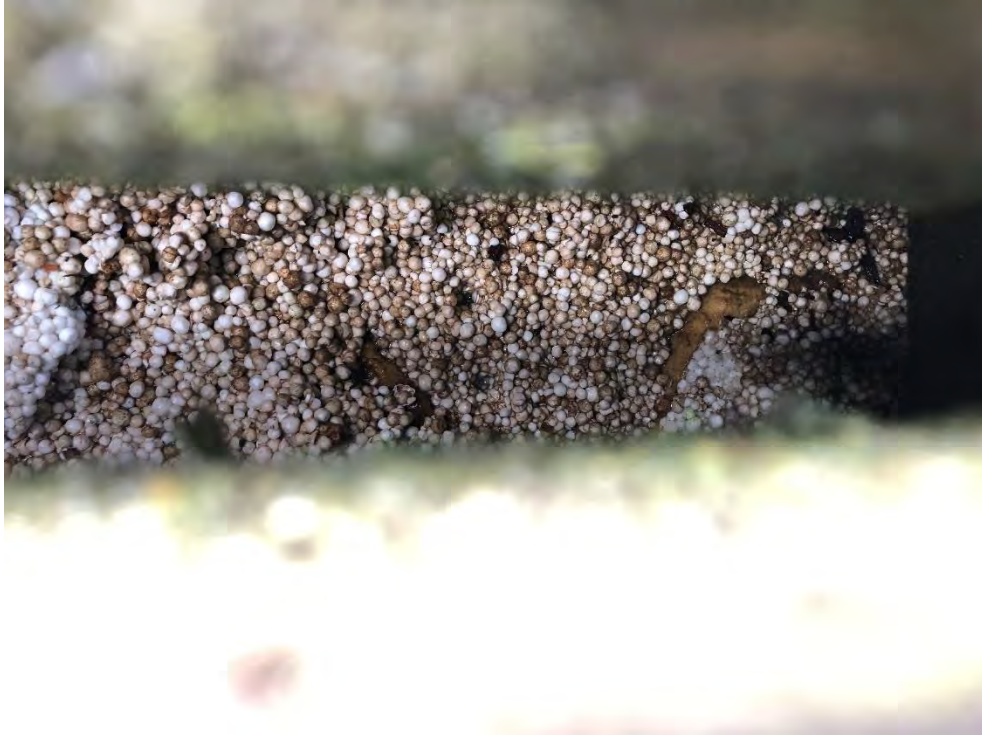
Photo 33 - Condition of exposed uncoated styrofoam billets

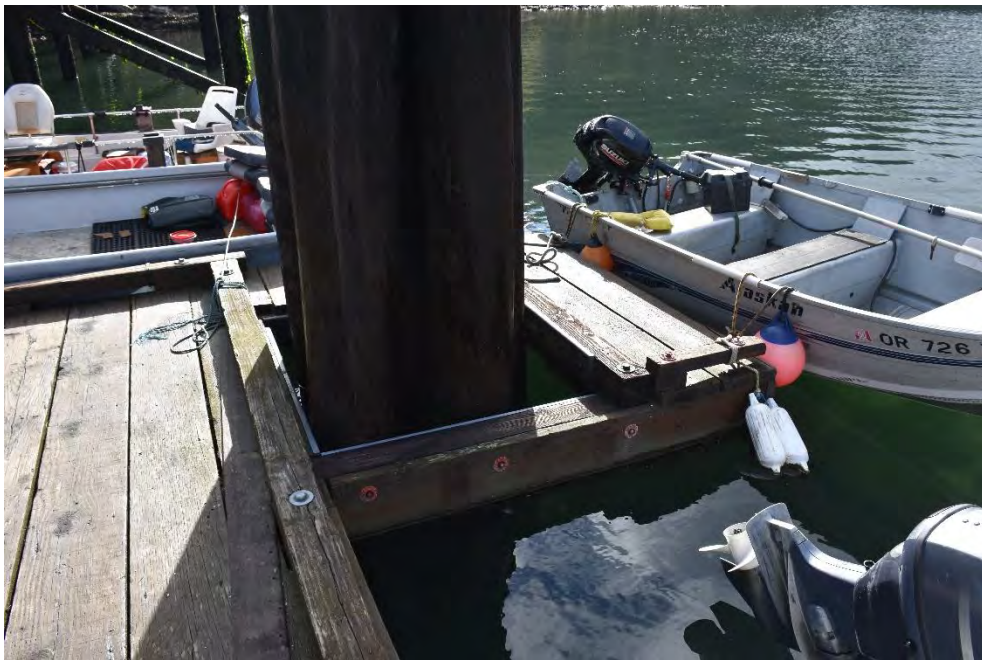
- There is significant flotation loss at the southeast corner of the float; the freeboard is approx. 300mm less than at the northwest corner. The mooring well is cantilevered off this end of the float and is partially submerged in the water (Photo 34 and Photo 35).

Photo 34 - South Mooring Well with significant flotation loss

The float capacity is a significant concern for the community. At the time of the inspection, the float was at full capacity, and multiple pleasure craft vessels had to be tied up to other vessels to access the float. In addition, other vessels must tie up at the mooring point to the southwest of the facility when spots have not been available. Consideration should be given to expanding the floating dock footprint for increased need. Consideration should be given to replacing the float along with the mooring system rather than continue regular minor maintenance/repairs.

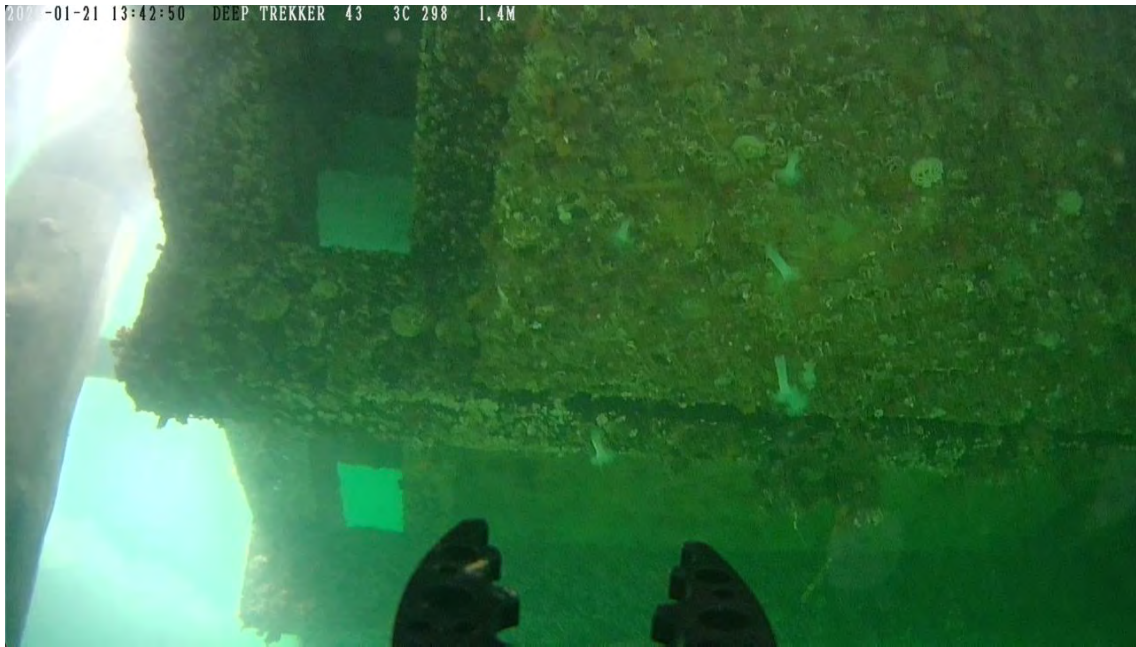
Photo 35 - Typical condition under the south end of the float
