STAFF REPORT

RE: **BYLAW NO. 625 - OYSTER RIVERBANK PROTECTION SERVICE**

**RE: STRATHCONA REGIONAL DISTRICT
Oyster River Riverbank Inspection
Inspection Findings, Remediation Recommendations and Management Plan
Our File 3436.005-300**

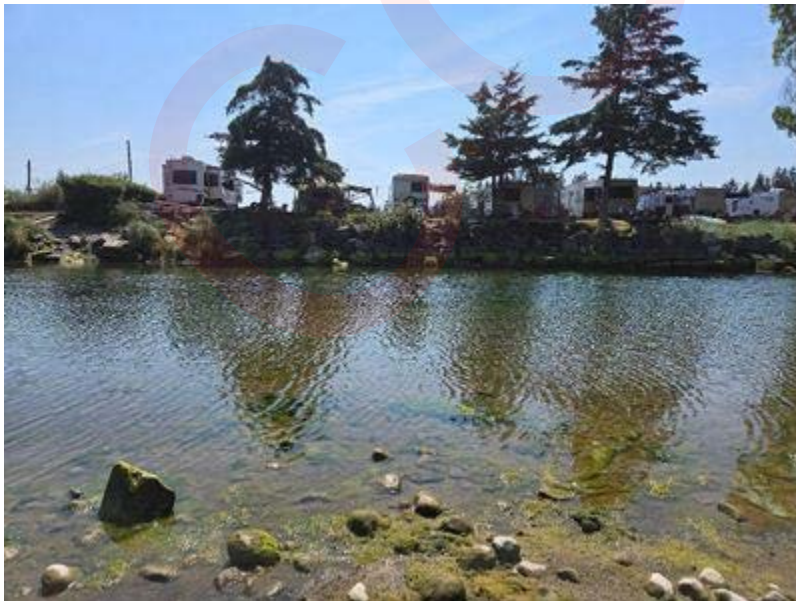
25 m section of riprap with concrete blocks, near vertical and failing

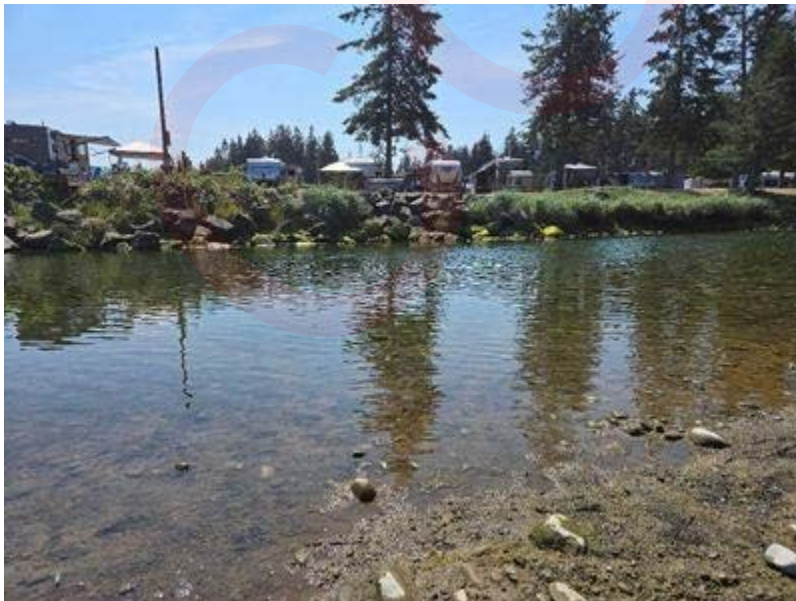
upstream end of riprap in ok condition

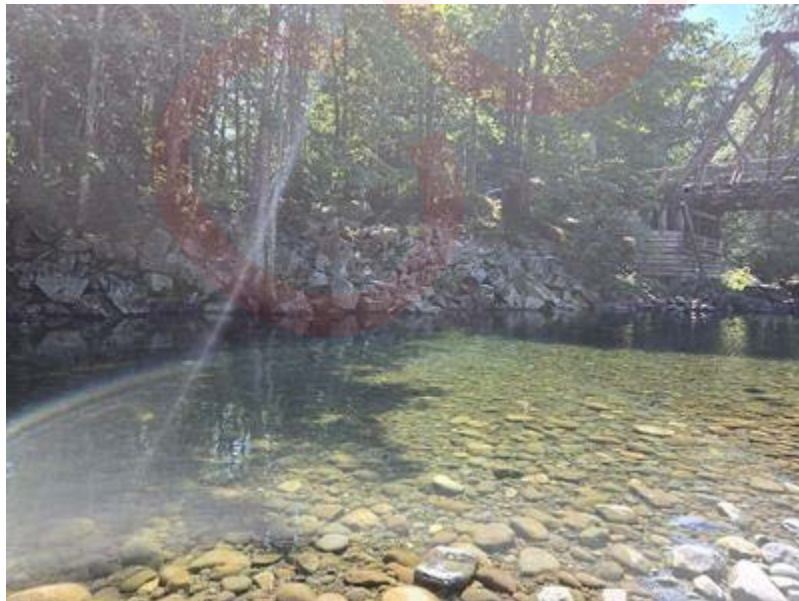
very steep blocky riprap on right bank downstream of railway bridge. OK condition

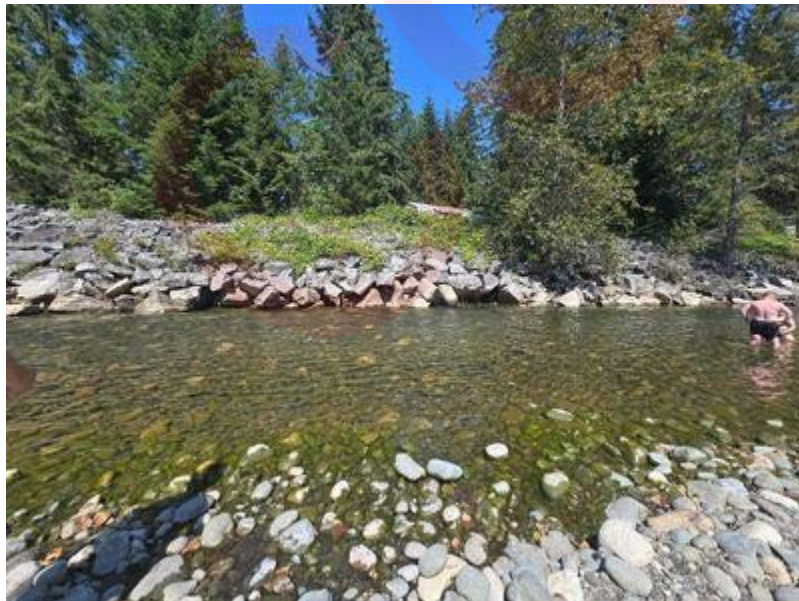
two spots where toe riprap is missing

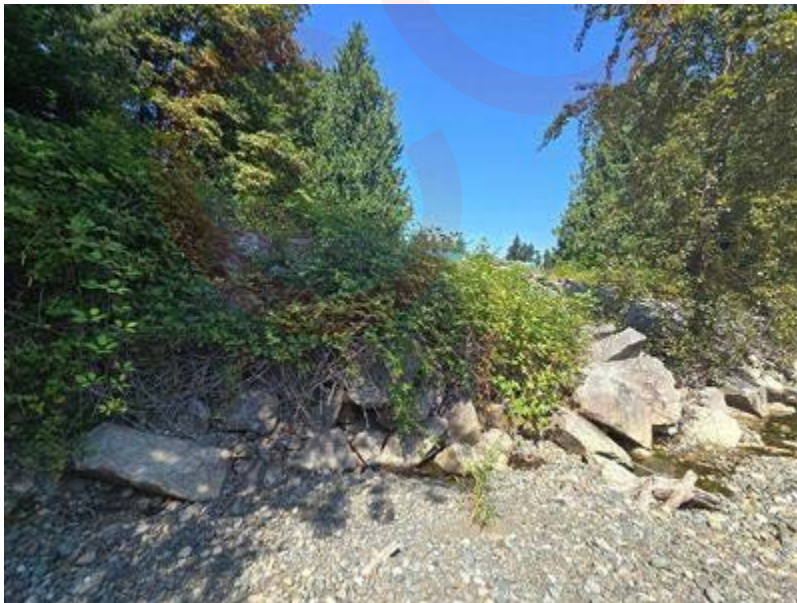
upstream limit of left bank riprap. 100 m downstream from bridge. riprap in good condition

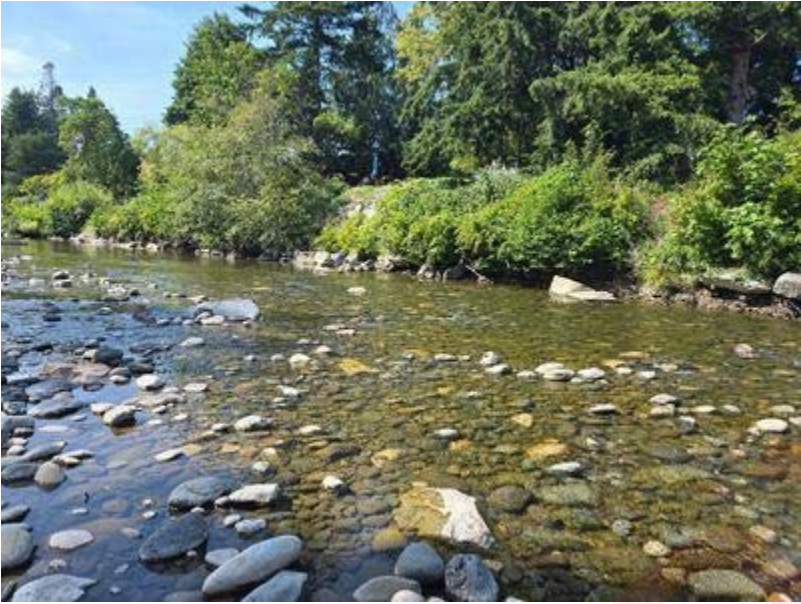
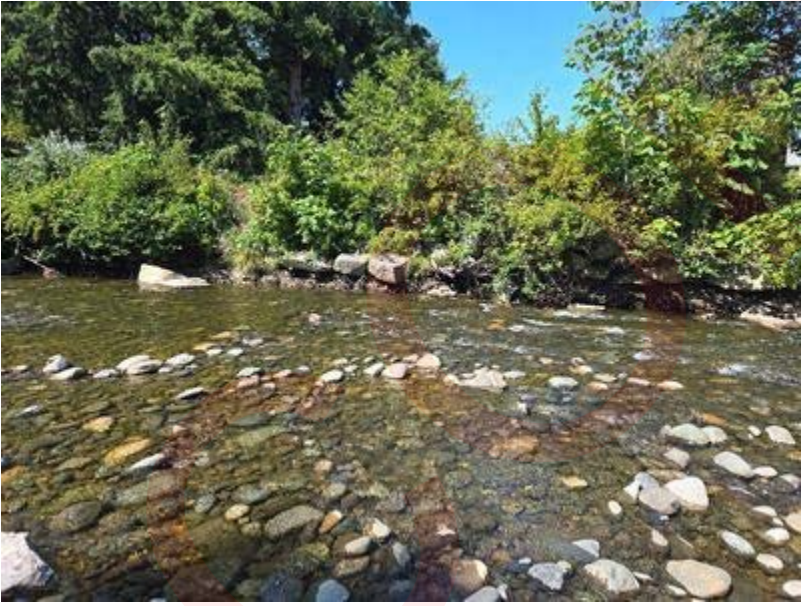
small riprap failure, bank exposed

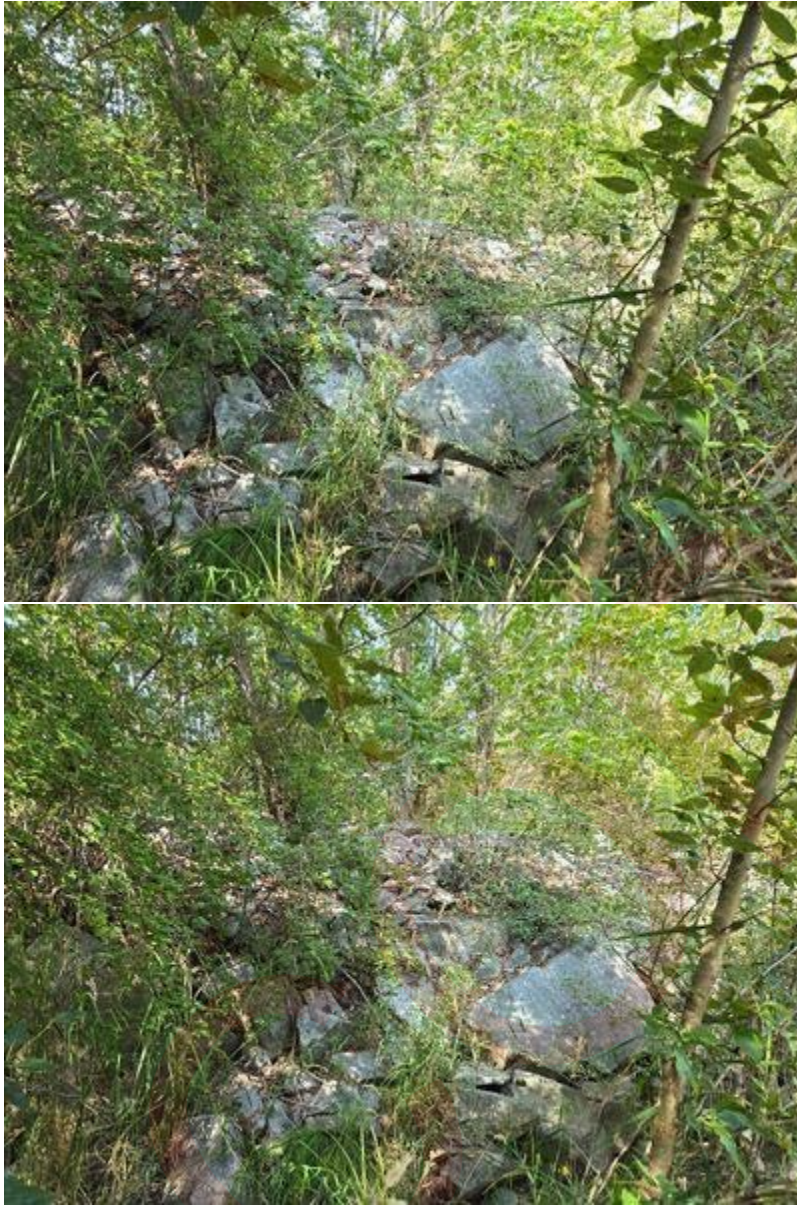
riprap is good condition

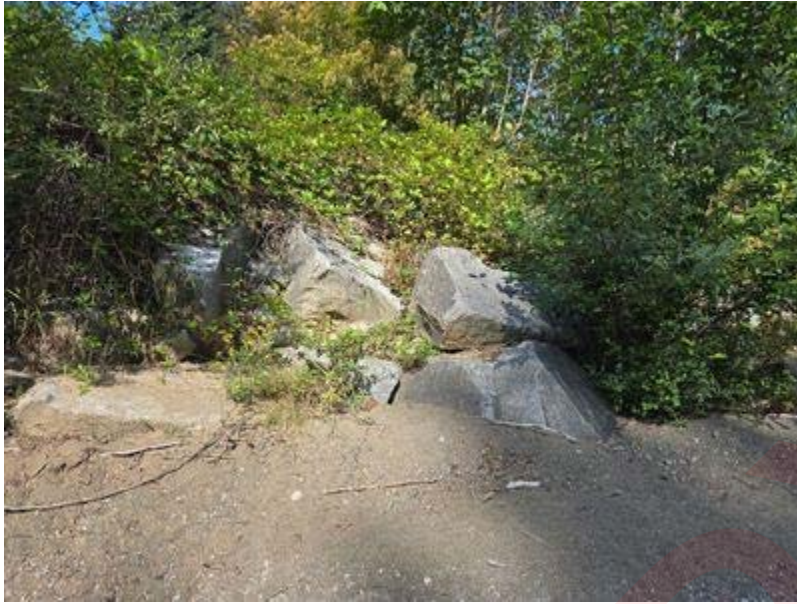
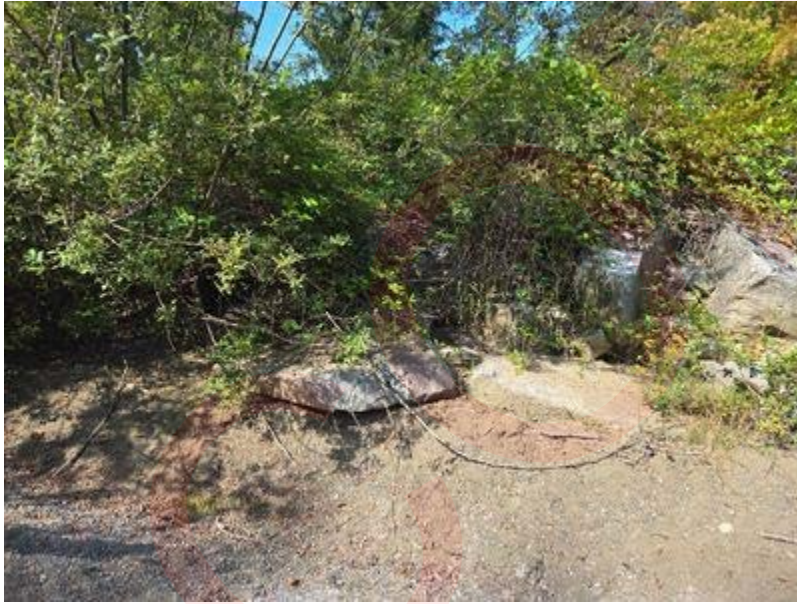
large riprap in good condition

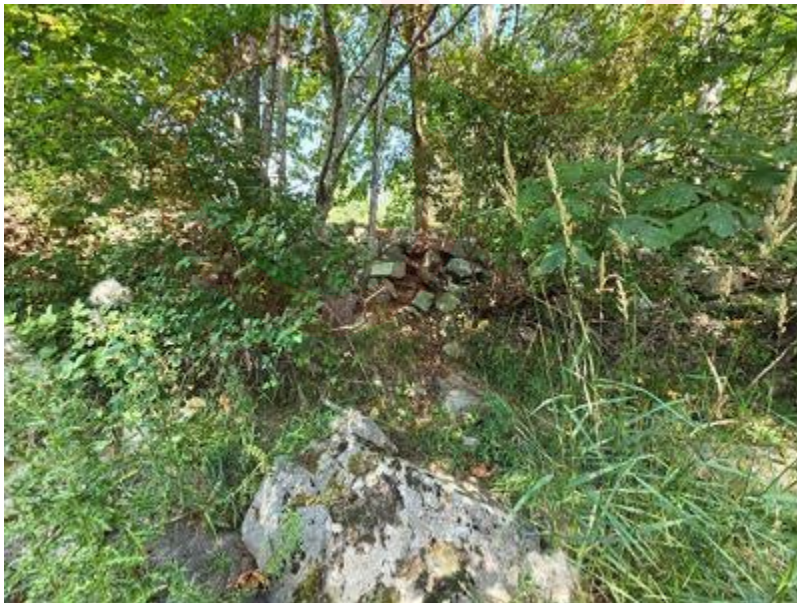
rirap in good condition

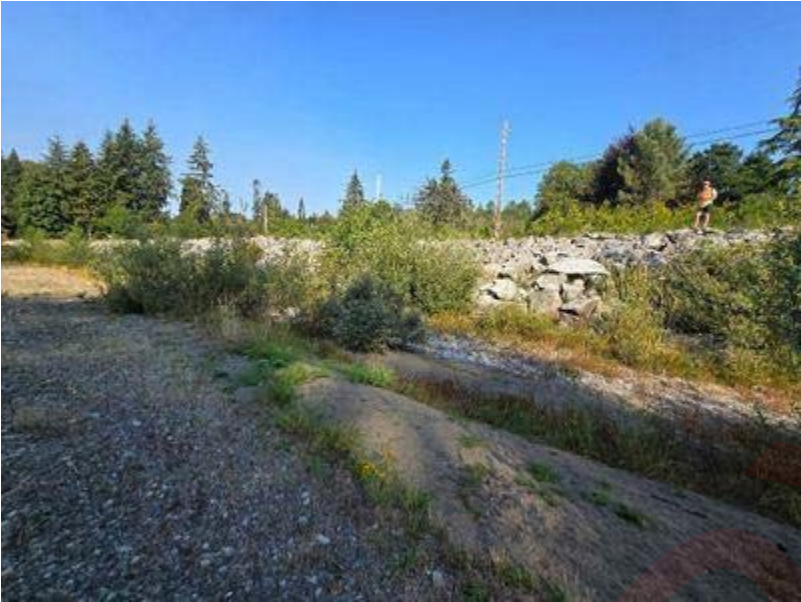
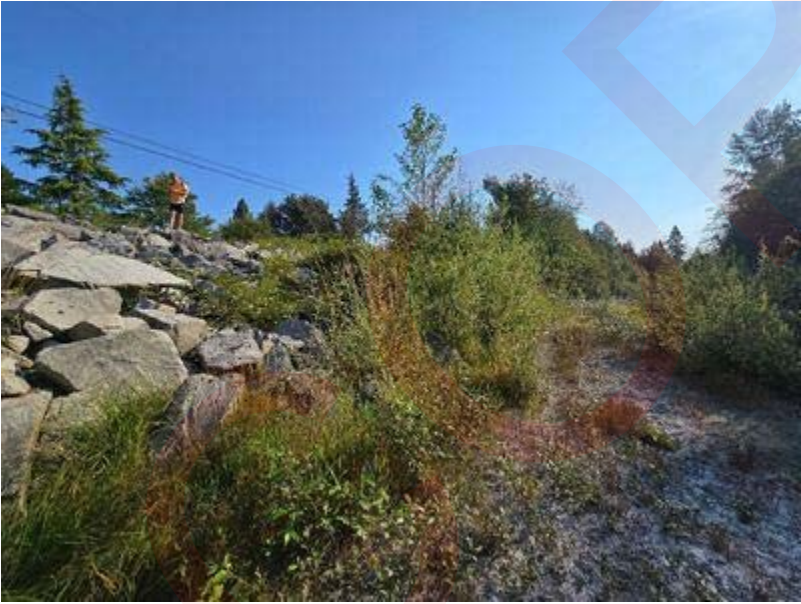
riprap in good condition. some vegetation along toe. old mesnder may be aggrading

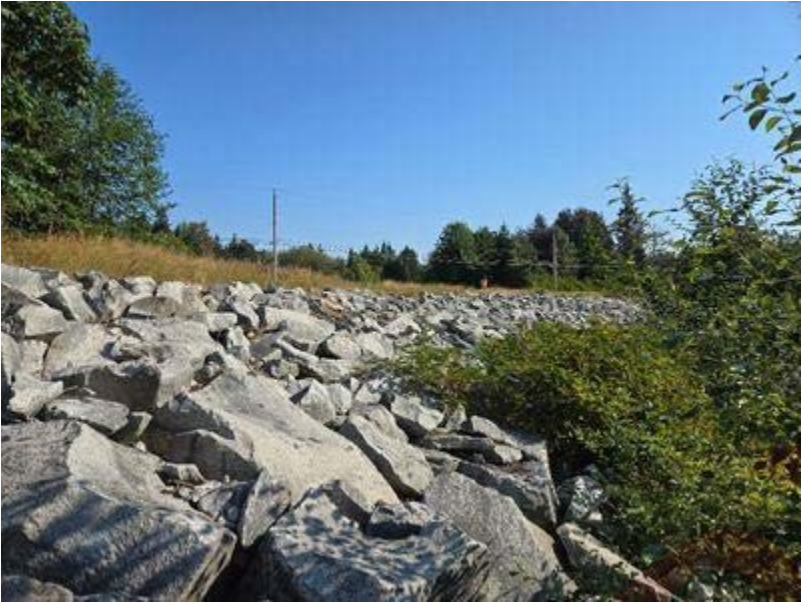
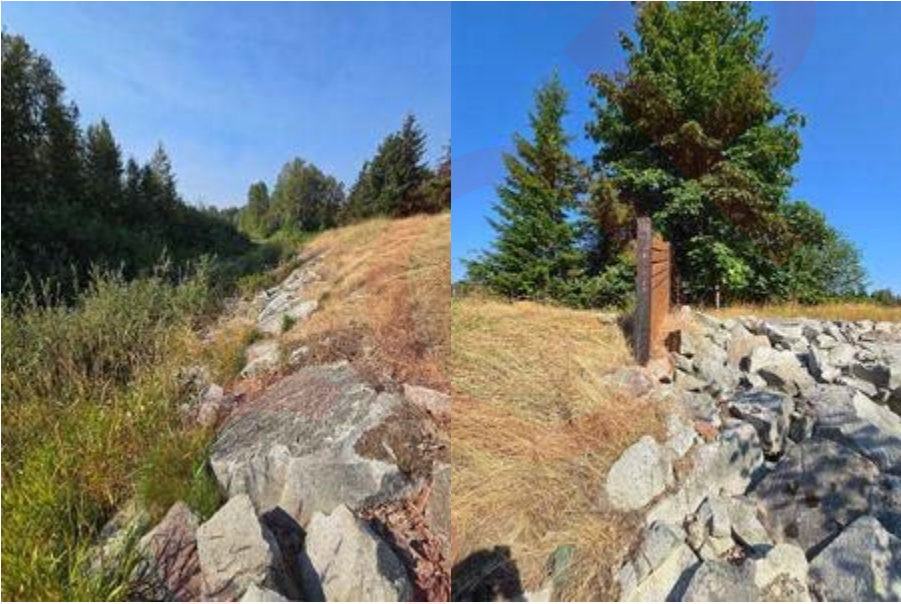
riprap in excellent condition. gate here. trees on land side of dike. possible transition from older installed riprap to newer riprap (downstream)

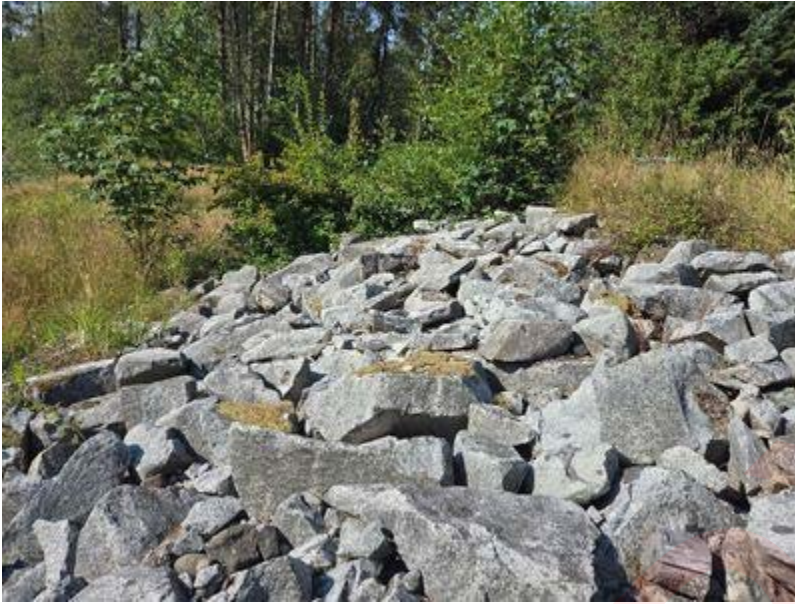
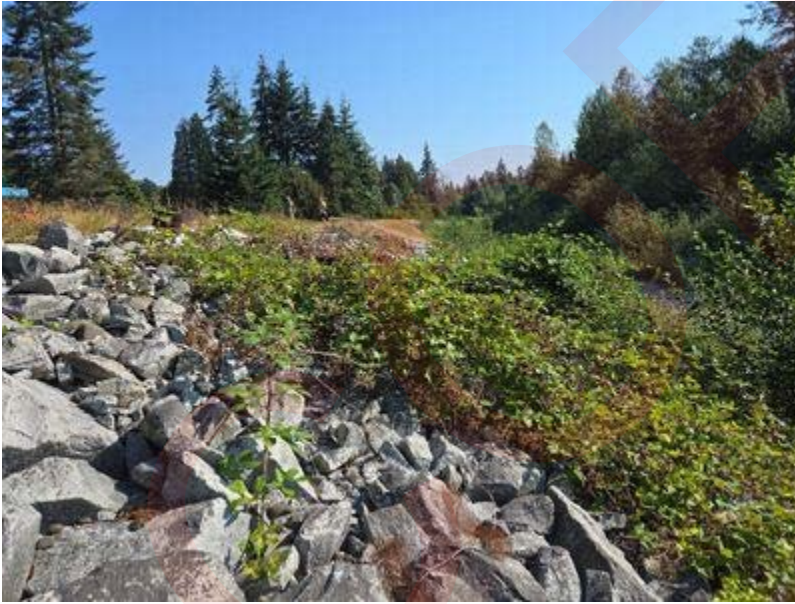
vegetation and small trees along toe of dike(riverside). riprap in excellent condition

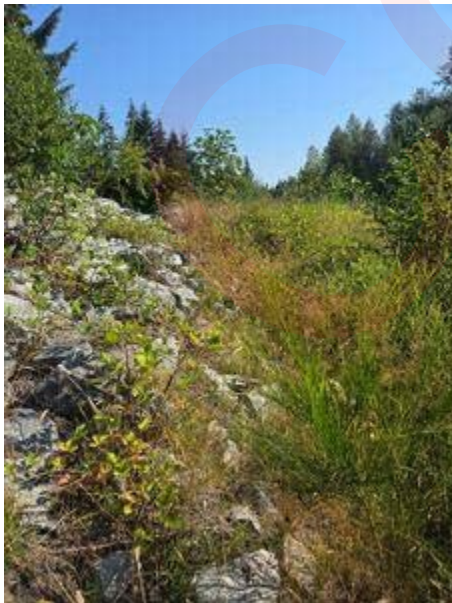
toe in excellent condition

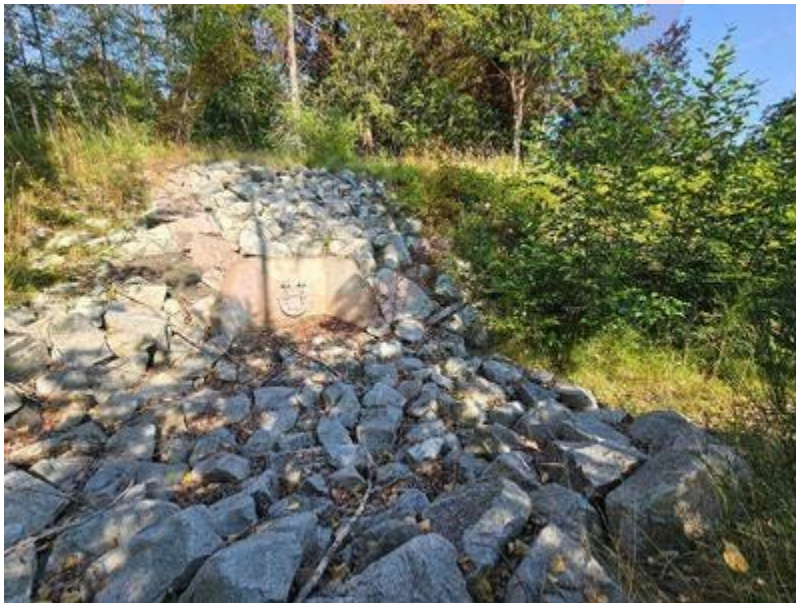
18 inch valve outlet on riverside of dike. riprap in excellent condition

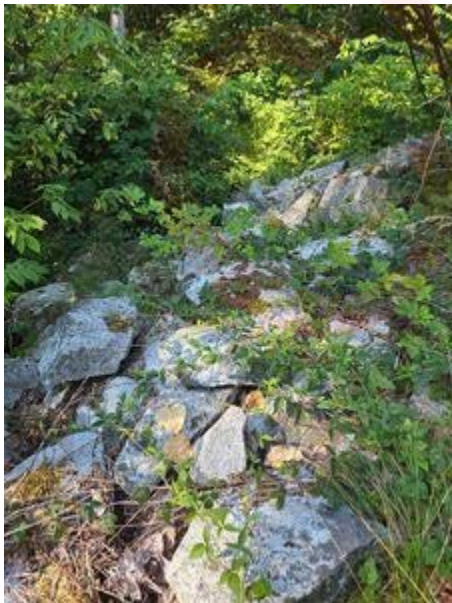
appears to be in good condition. mostly covered in vegetation

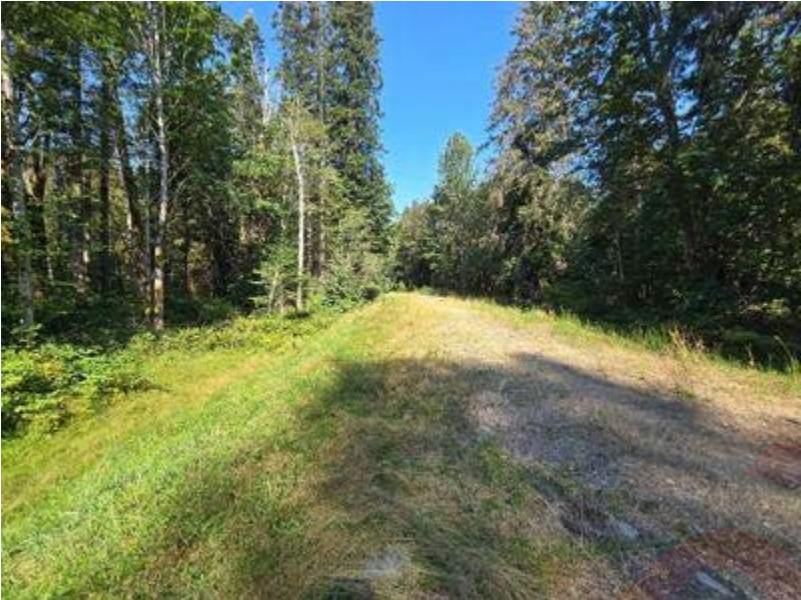
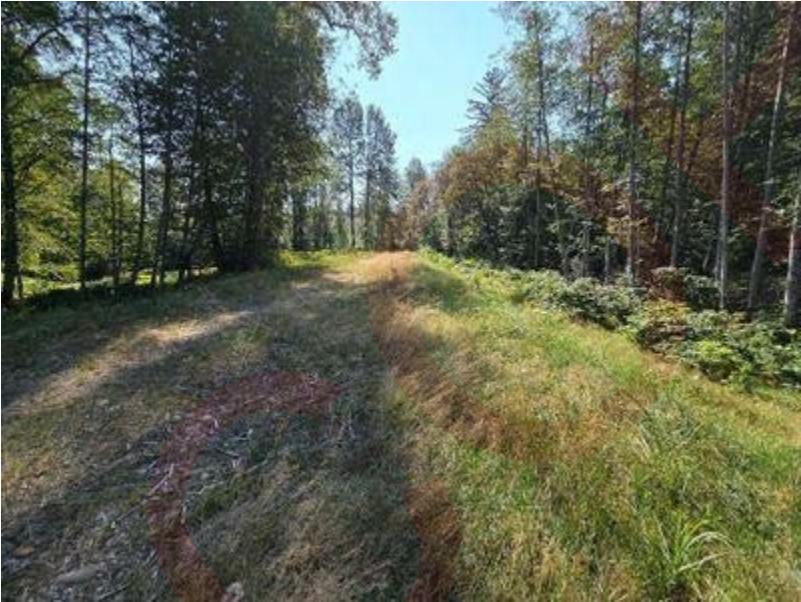
good condition dike

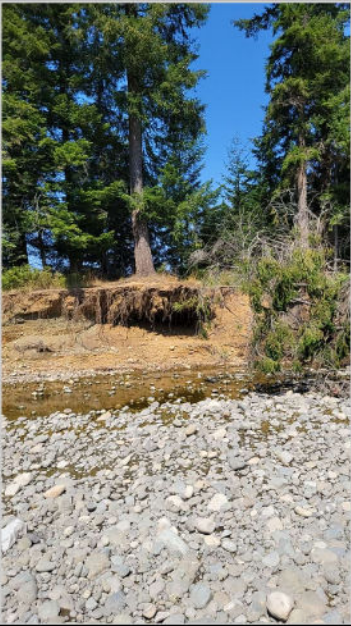
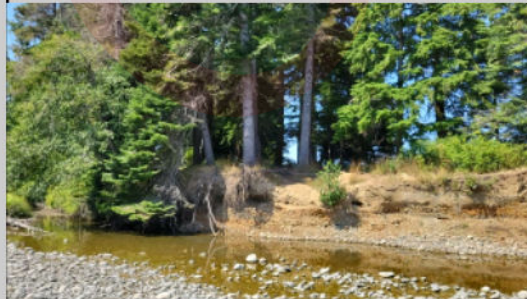
Observation Type	Please provide a description	Material	Dimensions	Crest Elevation	Filter Layer	Please provide a description	Condition Comments
Other	Severely eroded bank, one tree down, one 50% undercut, several others at risk near term

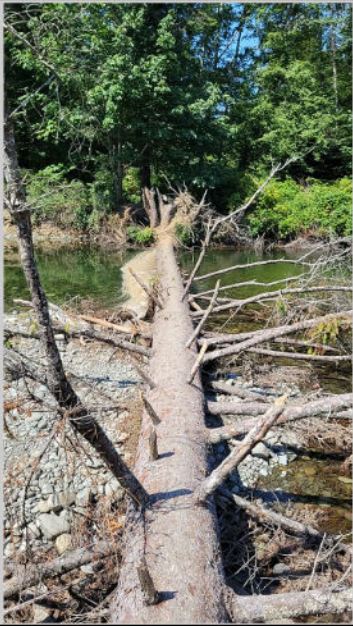
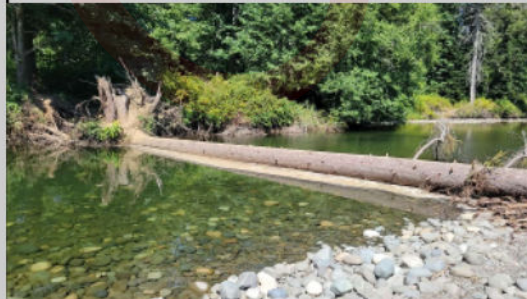
Observation Type	Please provide a description	Material	Dimensions	Crest Elevation	Filter Layer	Please provide a description	Condition Comments
Other	Down tree spanning entire creek, dia +0.6 m. Bank eroding and undercut

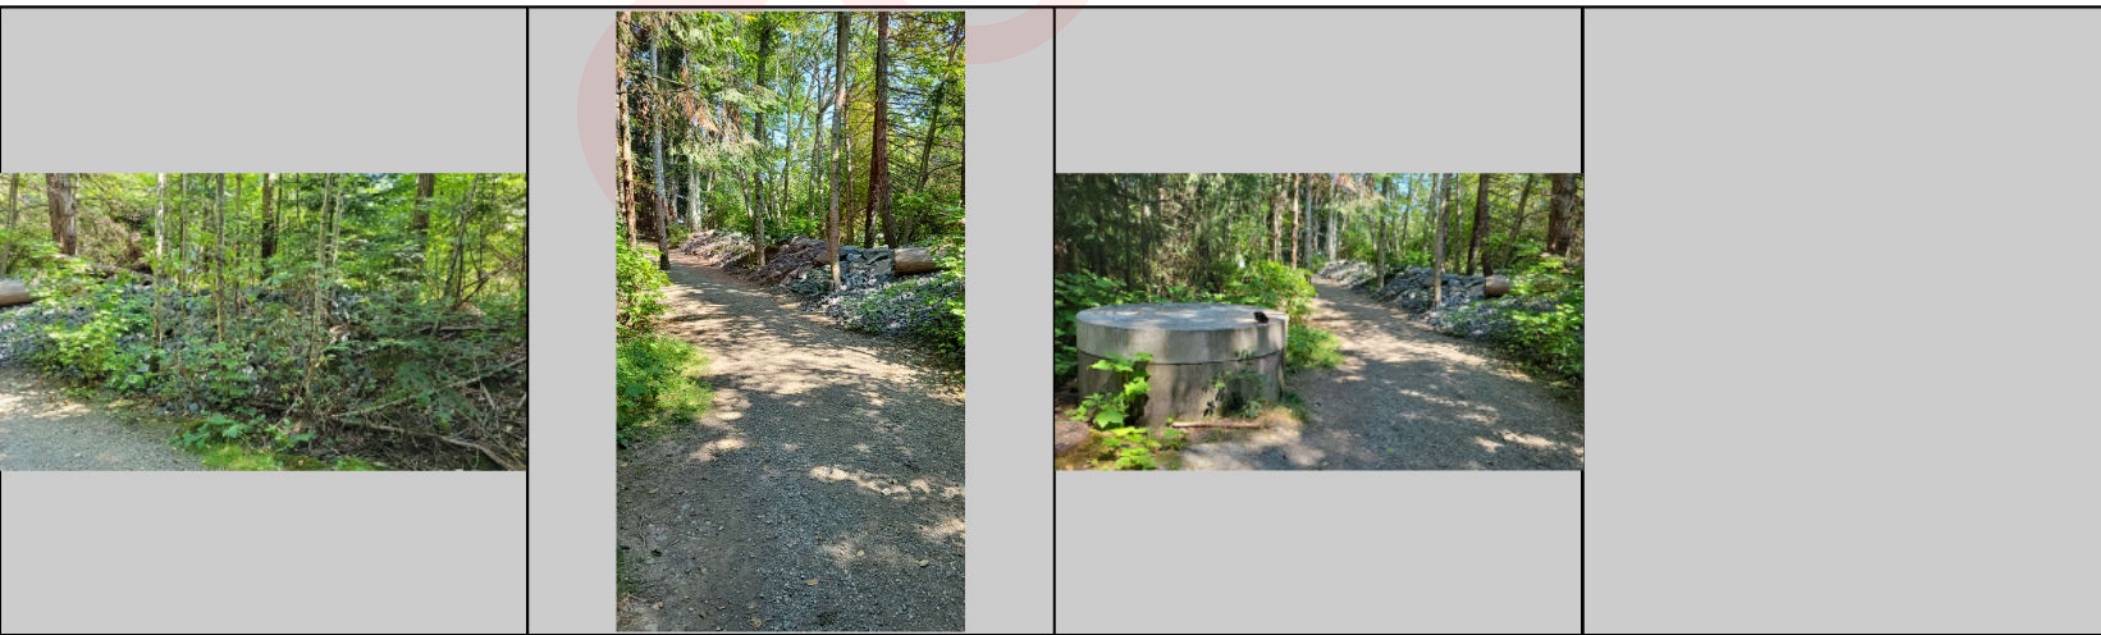
Observation Type	Please provide a description	Material	Dimensions	Crest Elevation	Filter Layer	Please provide a description	Condition Comments
Other	Riprap windrow (berm?) on left bank. Looks recent, size ranges from 150 mm to 600 mm. Upstream ties into existing old earth berm. Possibly protects wellhead?

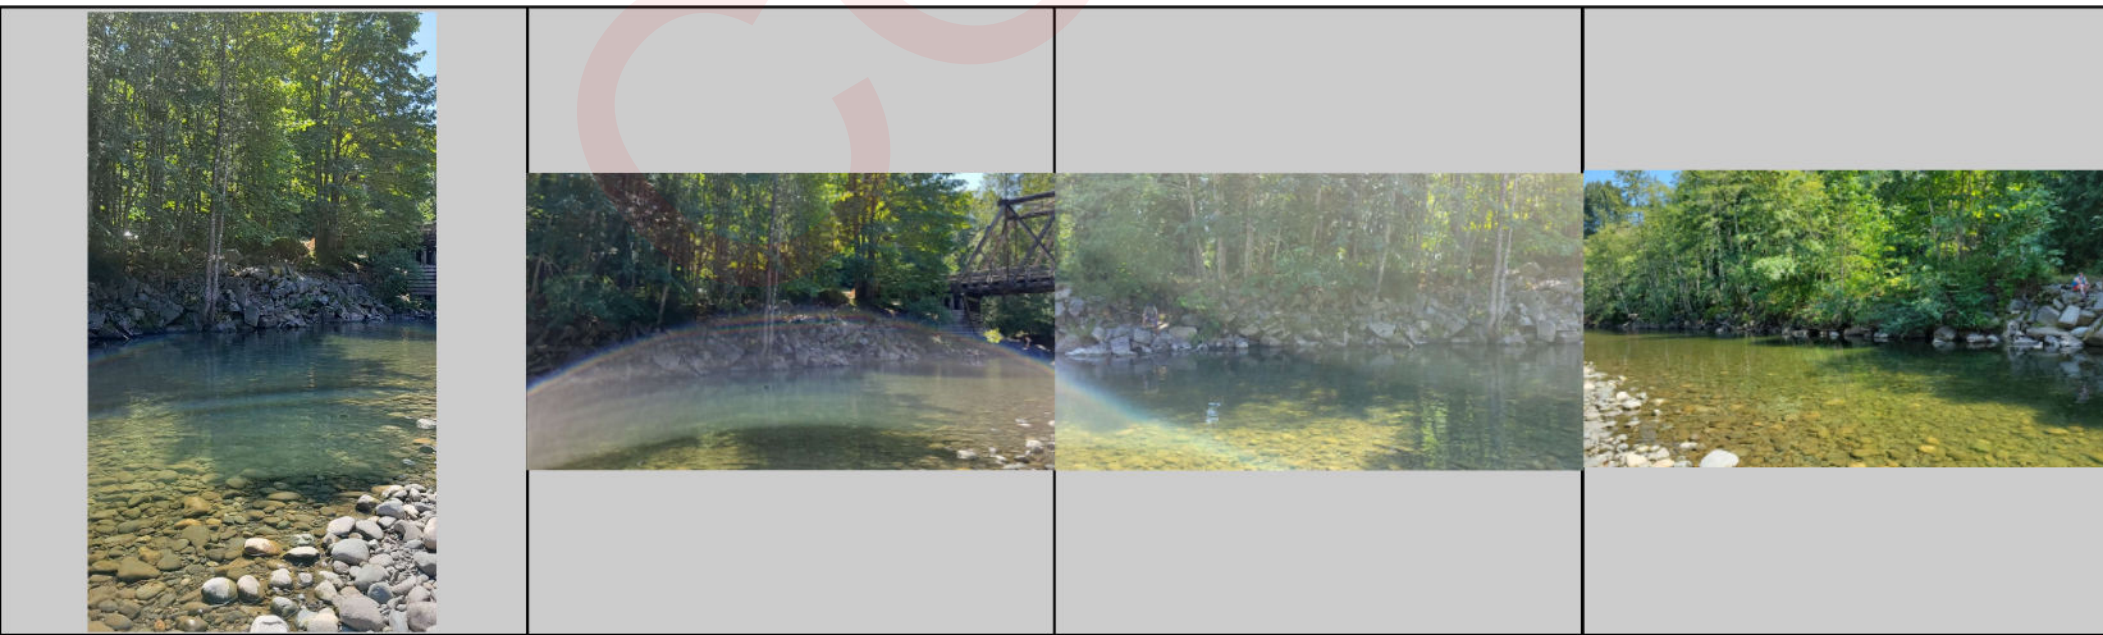
Observation Type	Please provide a description	Material	Dimensions	Crest Elevation	Filter Layer	Please provide a description	Condition Comments
Bank Protection		Rock riprap	Approx 250 of old riprap, extending ds of former rail bridge. Assumed single layer thickness, rock size est d50 500 mm, slope up to 1:1 or steeper at bridge	Top of bank, reducing to half to on ly toe at low bank st ds	Unknown		75, not actively failing but material has been lost over time

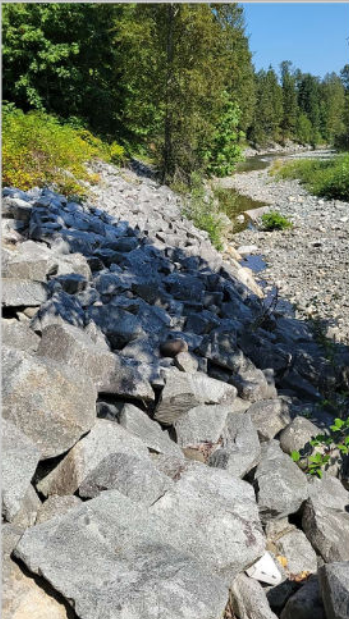
Observation Type	Please provide a description	Material	Dimensions	Crest Elevation	Filter Layer	Please provide a description	Condition Comments
Bank Protection		Rock riprap	Approx 275m length (bridge to bridge nearly), generally 2:1 slope, interlocked well, 750 to 1000 mm d50, smaller at top of slope	Full bank, good coverage	Unknown		90+, generally good condition

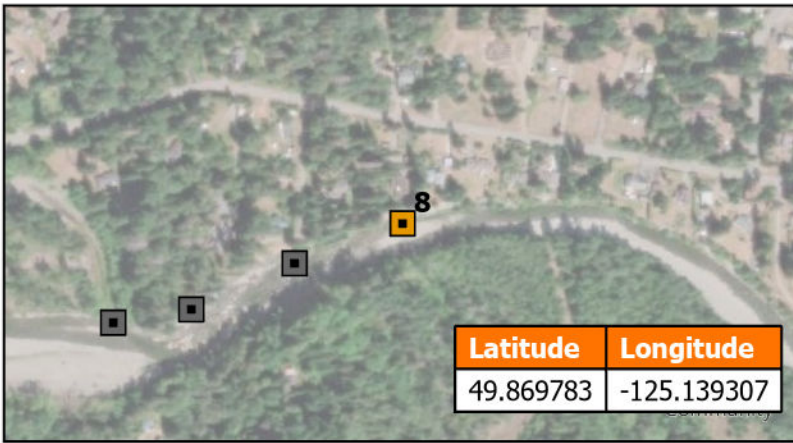
Observation Type	Please provide a description	Material	Dimensions	Crest Elevation	Filter Layer	Please provide a description	Condition Comments
Bank Protection		Rock riprap	Approx 80m slope 2:1 to 3:1, ties into newer bridge riprap, d50 300-400 mm	Full bank coverage	Unknown		Some larger material in the thalweg at the bridge (could be bridge riprap).90+

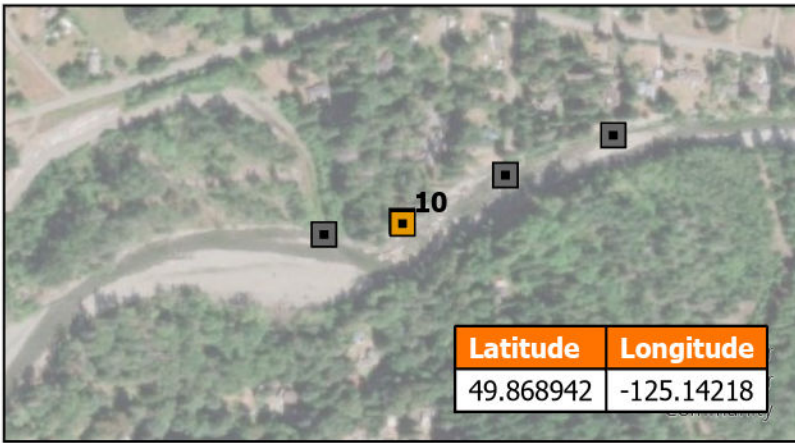
Observation Type	Please provide a description	Material	Dimensions	Crest Elevation	Filter Layer	Please provide a description	Condition Comments
Other	Tall eroding cutbank of sand/fines

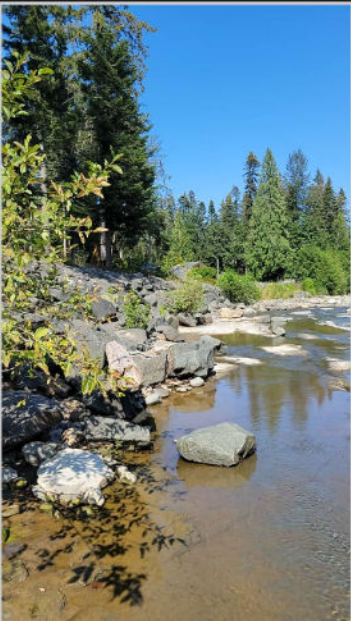
Observation Type	Please provide a description	Material	Dimensions	Crest Elevation	Filter Layer	Please provide a description	Condition Comments
Bank Protection		Rock riprap	Approx m of 800 mm rock, slope from 2:1 to 1:1, ds section has toe extending out from bank	Full coverage	No		95, good condition, some local loss of toe rocks
