January 20, 2022 | Revision A

Marine Facility Condition Assessment of the Port Neville Wharf

Submitted to: Strathcona Regional District (SRD)
Prepared by McElhanney Ltd.

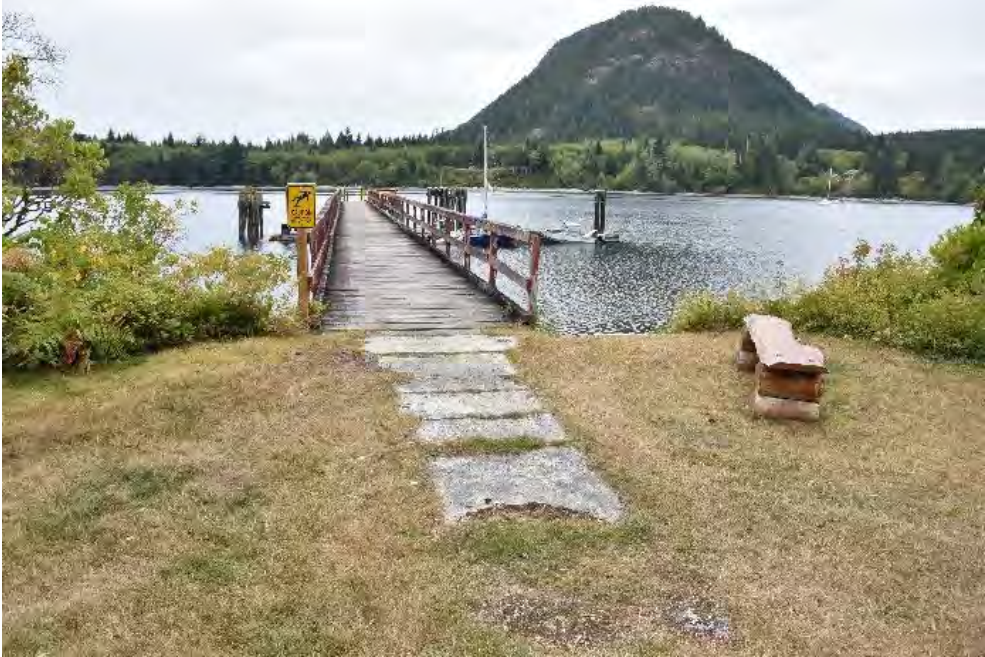
The pier approach is in generally good condition (Photos 1). There are no signs of settlement in this area, and the slope around the pier abutment appears stable. No load rating sign has been posted.

Photo 1 – Pier Approach Area

Repairs are not considered necessary at this time; however ongoing monitoring of the pier approach is recommended. Consideration should also be given to posting a load rating sign and extending safety barriers to the approach area.

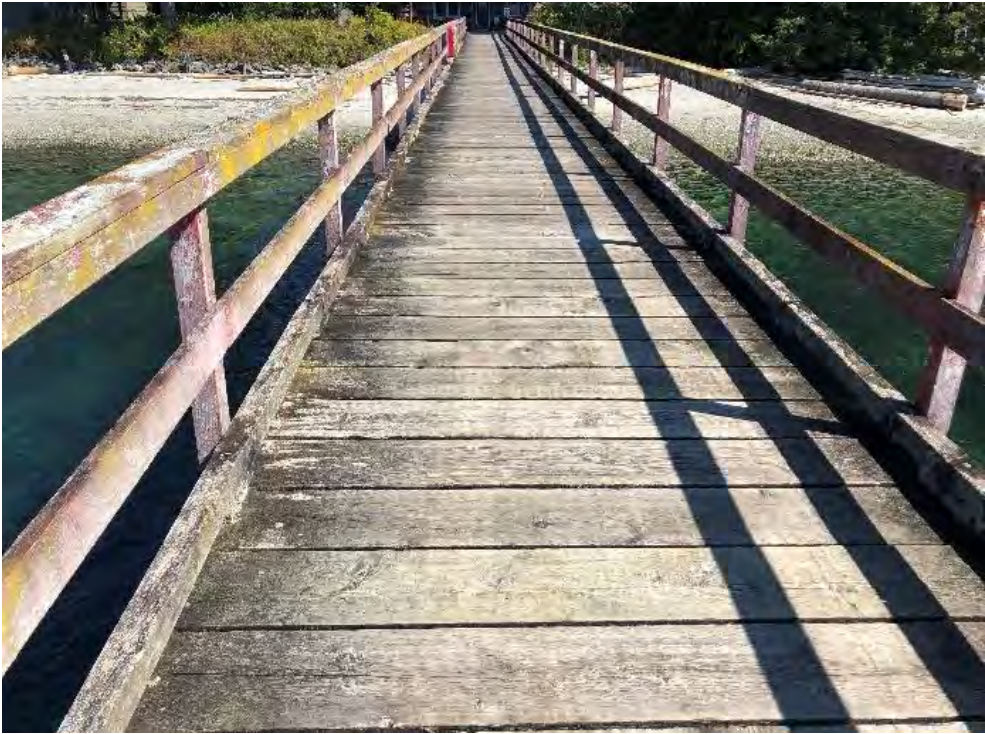
The pier topsides are generally in poor to fair condition with widespread weathering and fungal decay (Photos 2 & 3). Inspection findings are as follows:

Photo 2 – Pier Structure Topsides

- Between piles 12A and 13A (Photo 9)
- Identified during the second inspection on December 7th, 2021, the top rail connection directly above pile 14B has deteriorated and is only connected on one end (Photo 10). *It is recommended that the bull rails and handrail posts be fully replaced and secured in places with deterioration and/or missing bolts. Consideration should be given to painting the handrails to extend the service life of the existing timber. Consideration should also be given to a full phased replacement of the topsides over the next 2-4 years.*

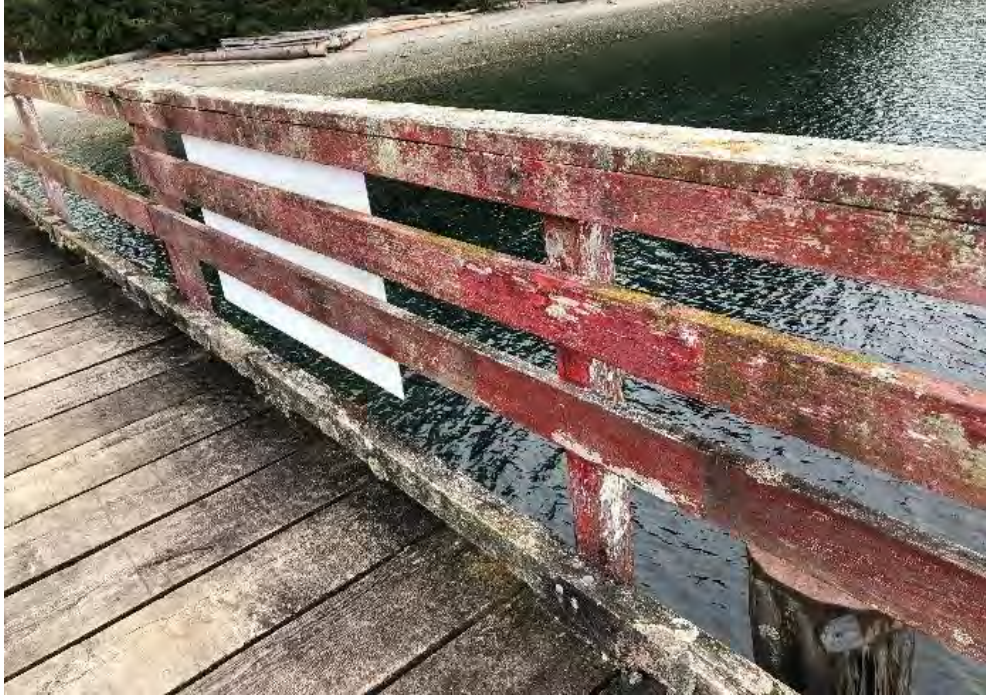
- The handrails appear generally well secured. The handrail posts are connected to the pier structure with two bolts, one through the outer stringer, and one through the bull rail. In some locations, the bull rails are deteriorated or not fully secured, and the handrail posts can shift, however they are still well secured to the stringer. There is significant deterioration to multiple other top rail connections, the approximate locations are directly above the following piles:

Photo 3 – Pier Structure Handrails

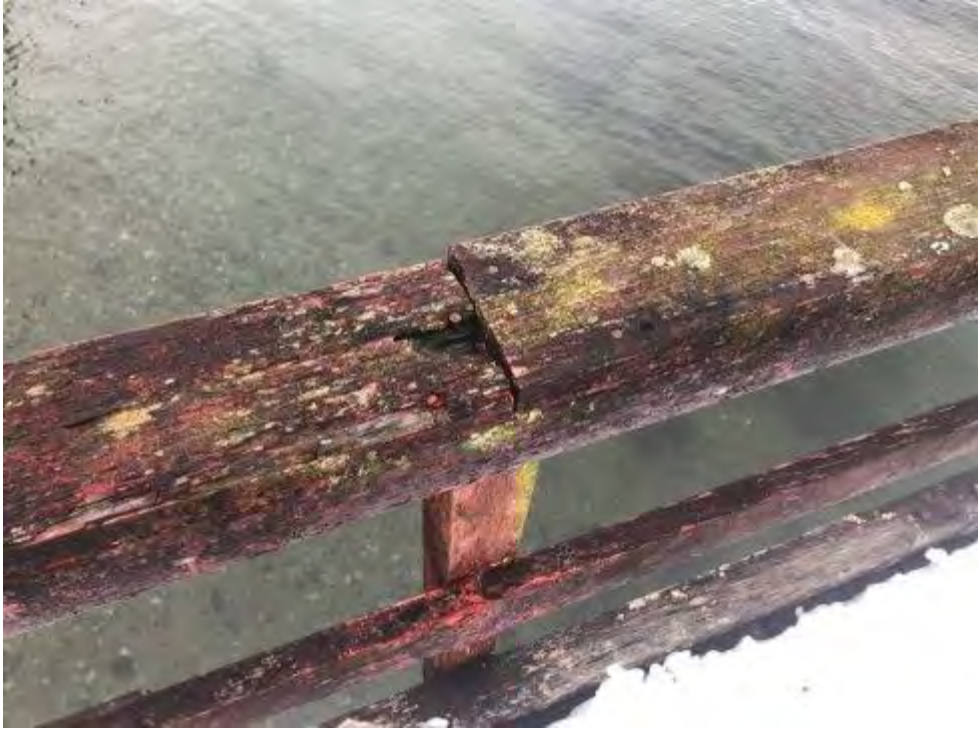
- Between piles 4B and 5B (Photo 4)
 - Between piles 7A and 8A (Photo 5)
 - Between piles 8B and 9B (Photo 6)
 - Between piles 9A and 10A (Photo 7)
 - Between piles 11A and 12A (Photo 8)

Photo 5 – Handrail deterioration between piles 7A and 8A

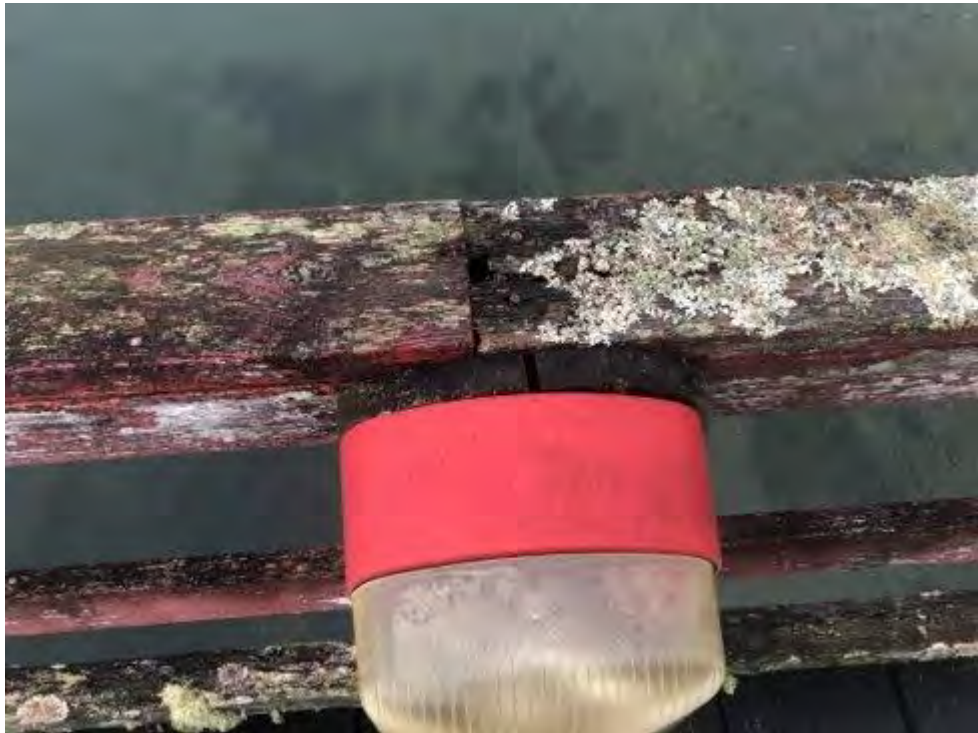
Photo 6 – Handrail deterioration between piles 8B and 9B

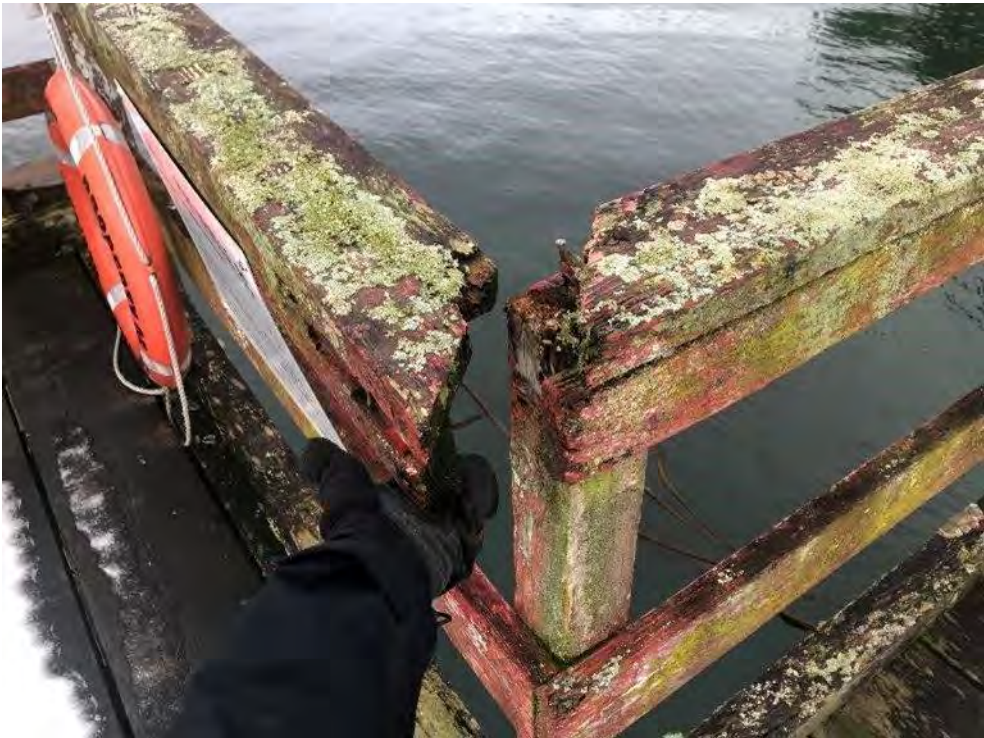
Photo 10 – Handrail deterioration between piles 14B and 14C

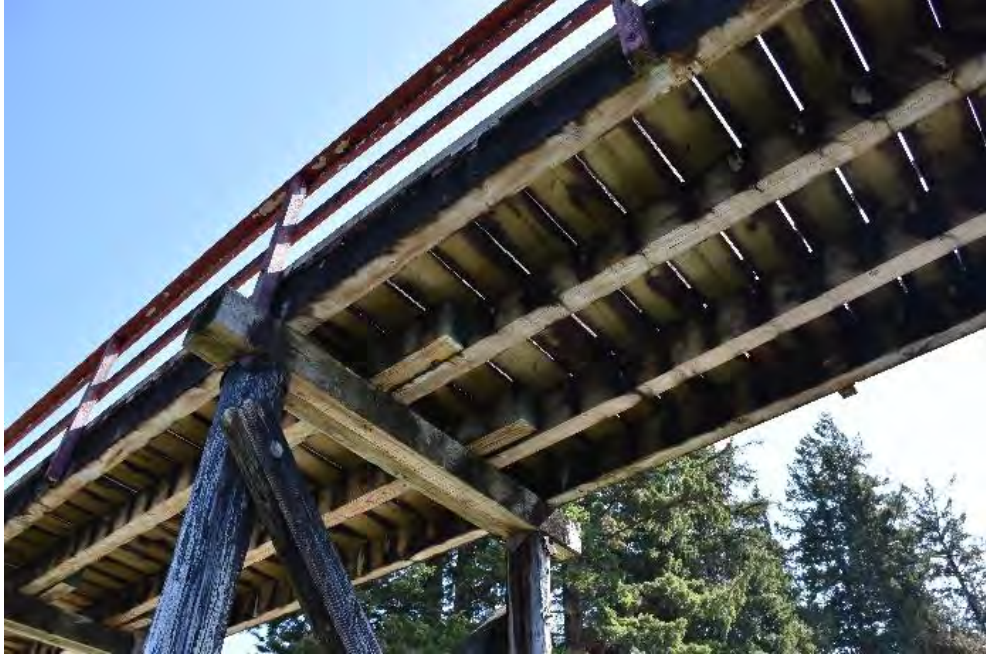
The treated timber stringers are generally in good condition (Photo 11). The stringers appear well secured between the decking and the pile caps, and there are no signs of significant splitting or structural deterioration. The ends of the stringers, where the end grain is present, does not show significant evidence of moisture or fungal decay. No cross-sectional loss was found in the stringers during the timber coring inspection.

Photo 11 – Typical View of Timber Stringers

Repairs are not considered necessary at this time; however ongoing monitoring of the stringers is recommended.

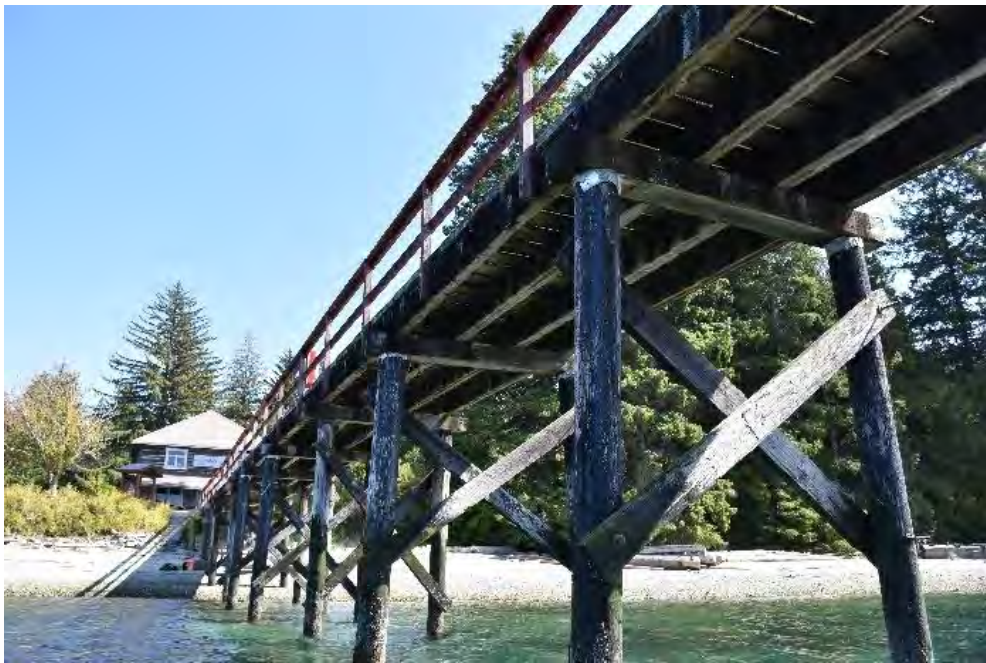
The treated timber pile caps are generally in fair to good condition (Photo 12 & 13). The pile caps appear well secured, and there are no signs of significant splitting or structural deterioration. The pile caps are typically aligned well over the piles, with no evidence of shifting or displacement. There is minor weathering and deterioration to the end grains of the pile caps, notably at Bent 12 (Photo 14). No cross-sectional loss was found in the pile caps during the timber coring inspection.

Photo 12 – General View of Timber Pile Cap Bents

Repairs are not considered necessary at this time, however ongoing monitoring of the pile caps and of the deterioration at the end grains is recommended.

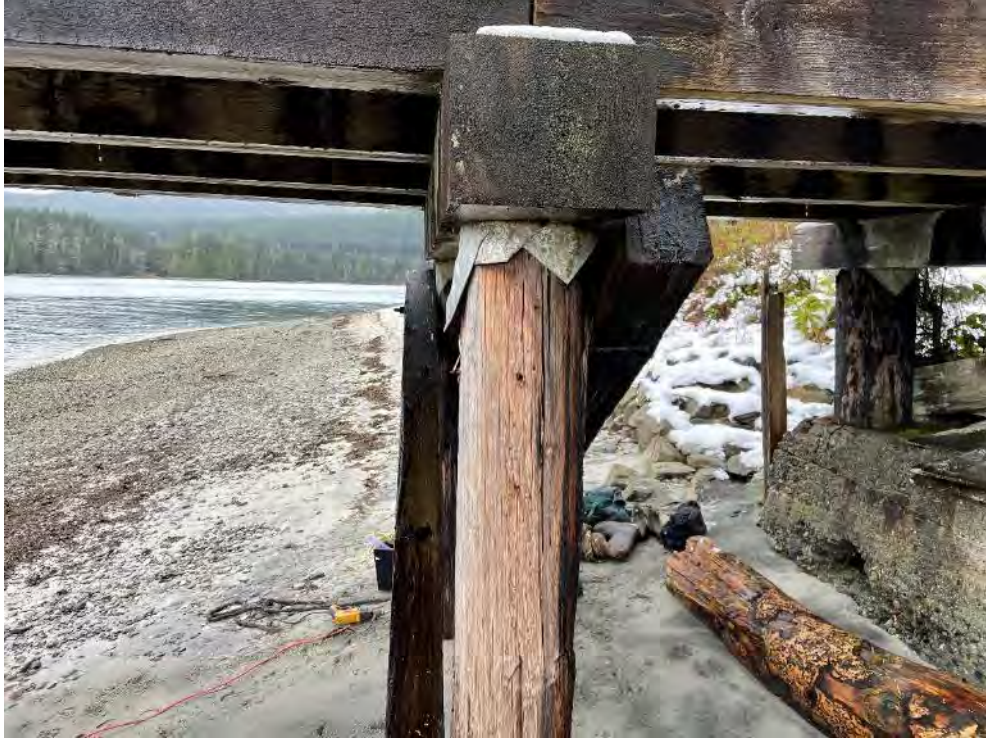
Photo 13 – Typical Timber Pile Cap End Grain

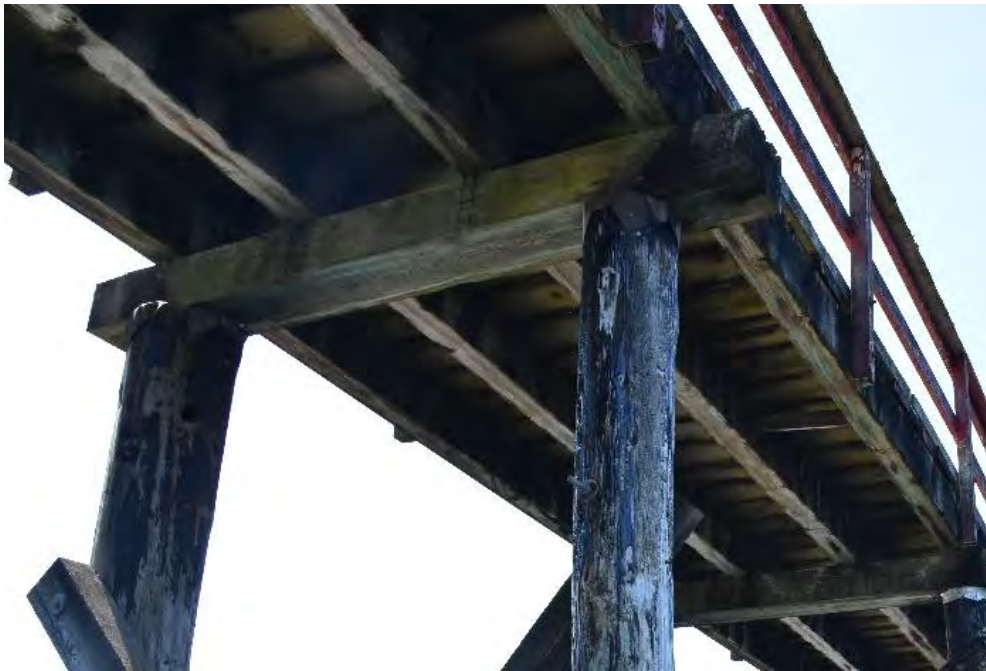
Photo 14 – Timber Pile Cap at Bent 12

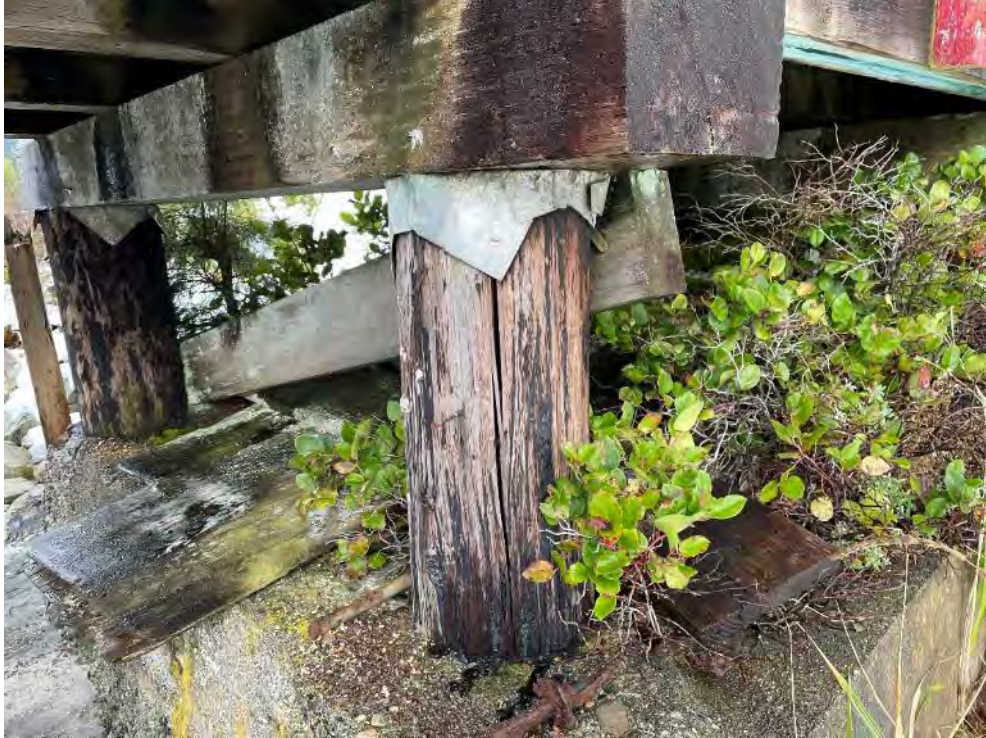
Location	Description	Recommendation
Pile 2A	Large split at the top of the pile. (Photo 15) 50% CSL due to internal fungal decay in the top 0.6m.	Replace timber pile.
Pile 2B	25% CSL due to internal fungal decay in the top 0.3m.	Monitor.
Pile 3A	25% CSL due to internal fungal decay in the top 0.3m.	Monitor.
Pile 3B	Moderate splitting at the top of the pile. (Photo 16) 25% to 75% CSL due to internal fungal decay in the top 0.9 m.	Replace timber pile.
Pile 4B	25% CSL due to internal fungal decay in the top 0.3m with wet fibres. Concrete footing is exposed, with signs of undermining and spalling of the concrete. (Photo 17)	Monitor.
Pile 5A	Moderate splitting at the base of the pile. (Photo 18)	Monitor.
Pile 5B	25-50% CSL due to internal fungal decay in the top 0.3m with wet fibres.	Replace timber pile.
Pile 7A	Pile is slightly misaligned. (Photo 19)	Monitor.

Photo 15 – Split in Pile 2A

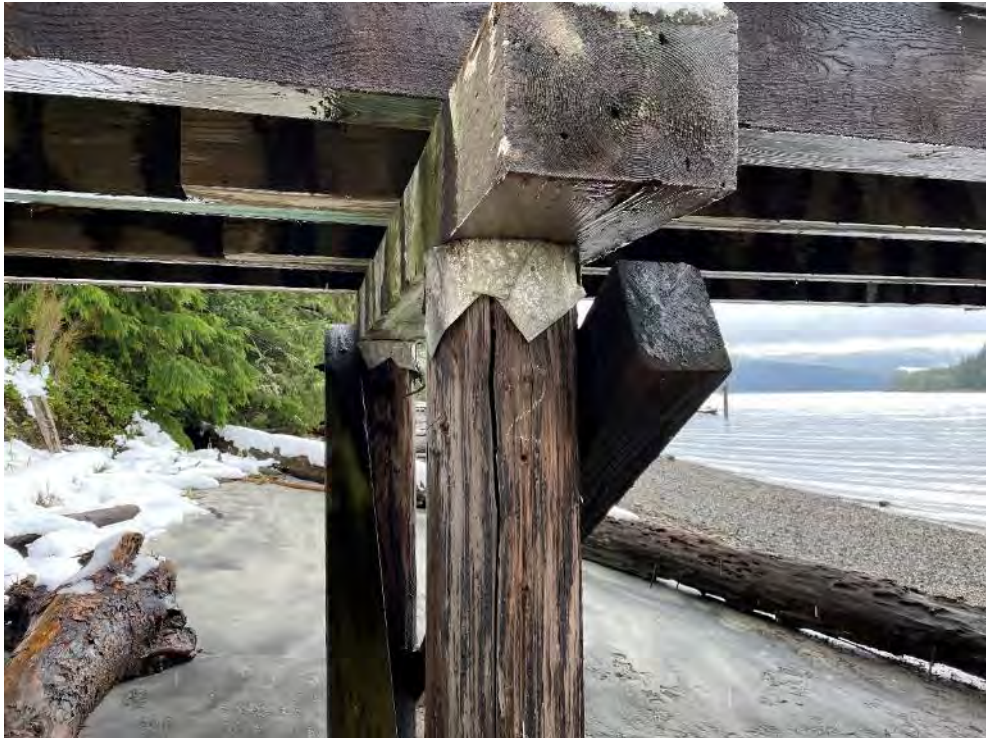
Photo 16 – Split in Pile 3B

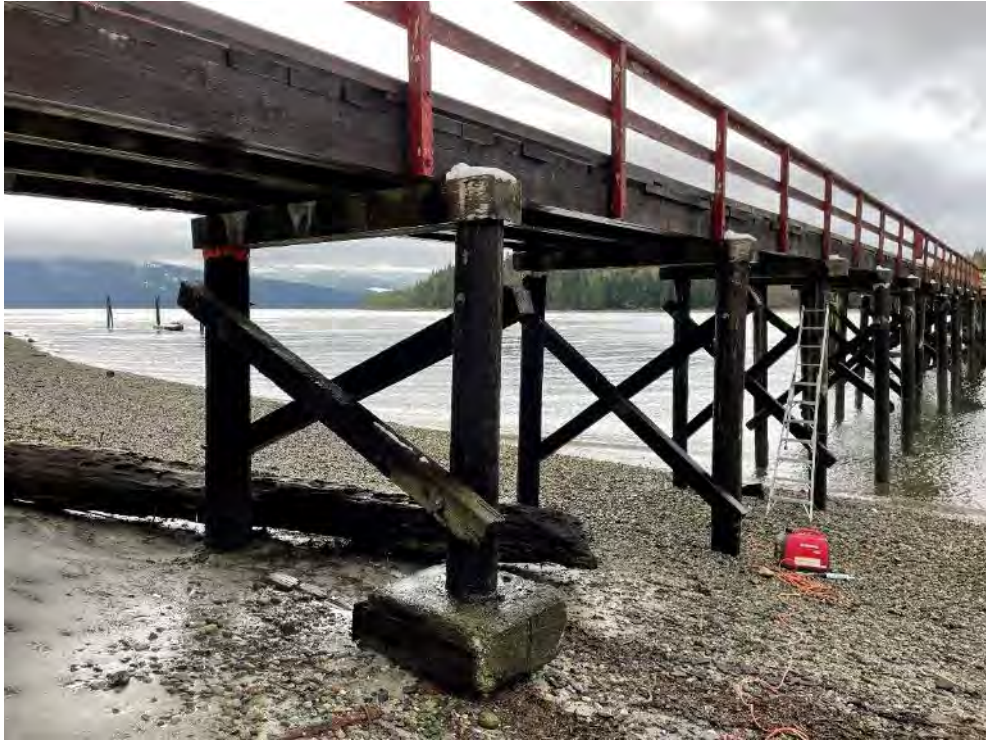
Photo 17 – Pile 4B concrete footing

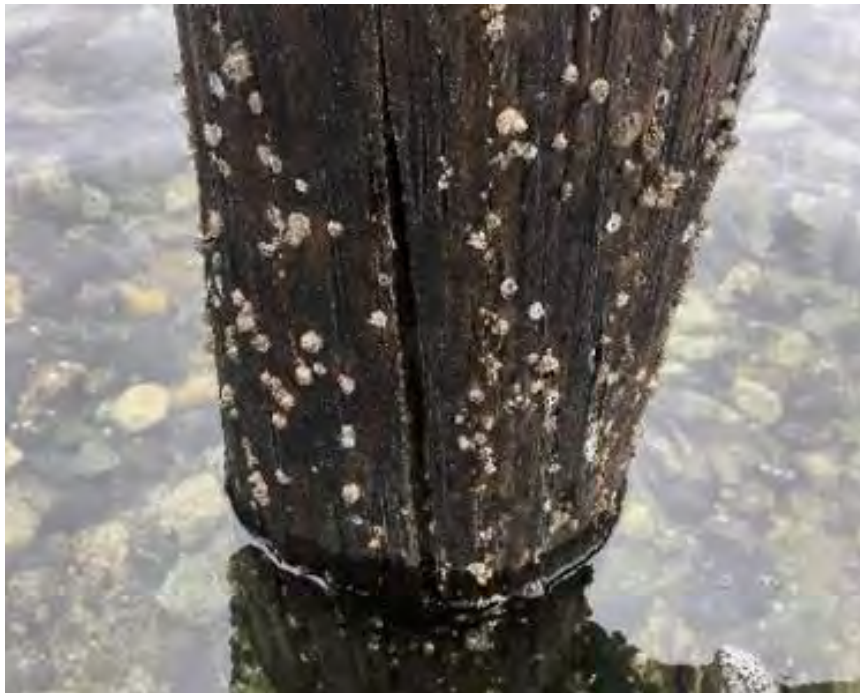
Photo 18 – Split in Pile 5A

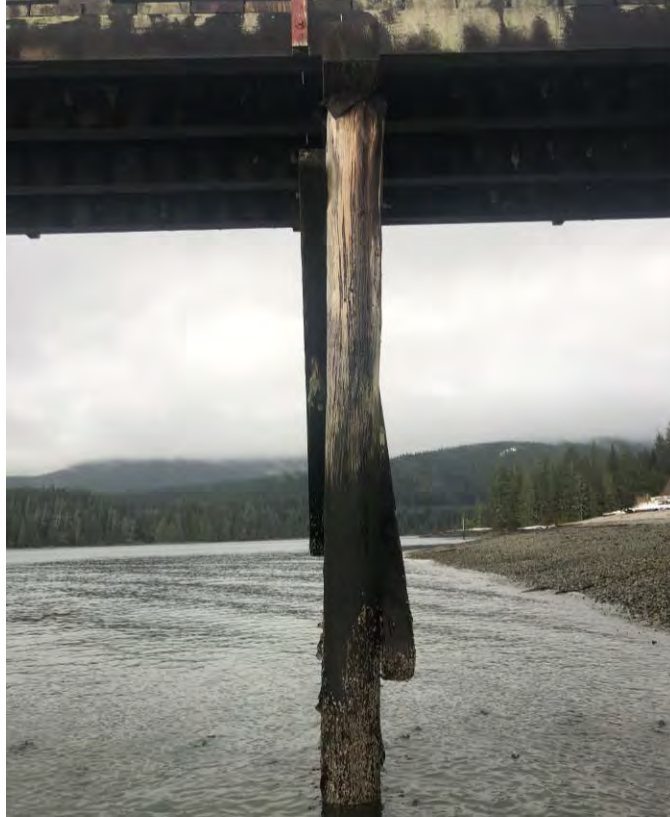
Photo 19 – Pile 7A

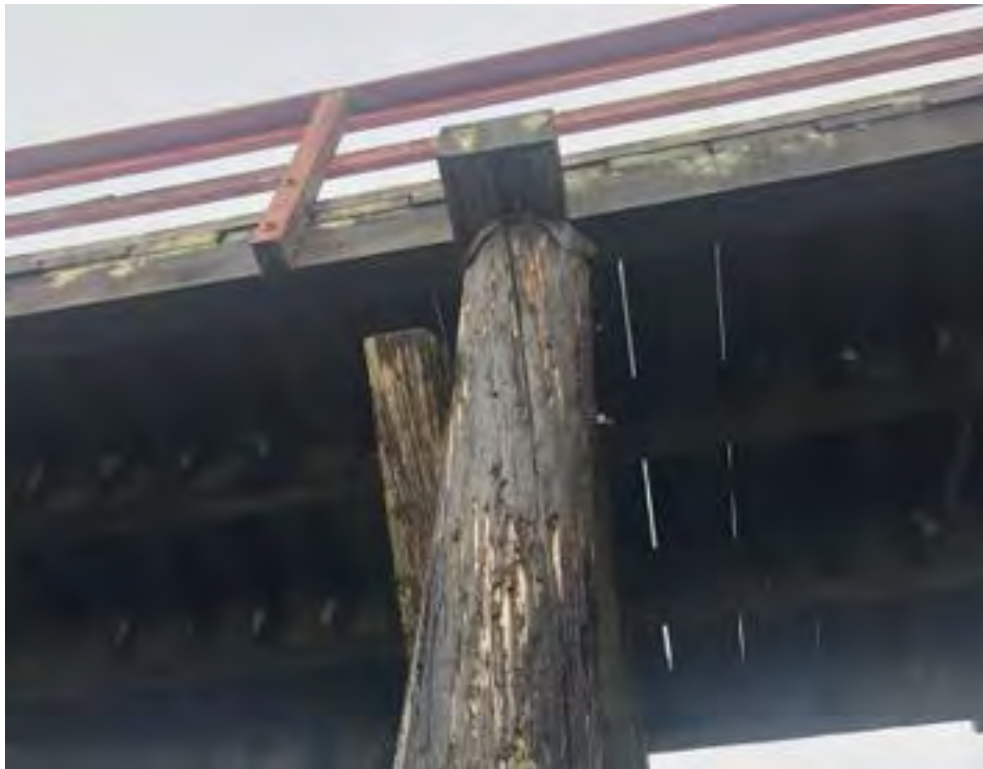
Pile 8A	Moderate splitting at the top of the pile. (Photo 20)	Monitor.
Pile 9A	Large open bolt hole at the top of the pile, likely from a previous cross-brace bolted connection. (Photo 21)	Monitor.
Pile 10A	Moderate splitting at the top of the pile. (Photo 22)	Monitor.
Pile 12A	Large open bolt hole at the top of the pile, likely from a previous cross-brace bolted connection. (Photo 23)	Monitor.
Pile 15B	Moss growing out of the top, indicating that there is fungal decay in the interior of the pile in this location. (Photo 24)	Monitor.

Photo 20 – Split in Pile 8A

Repairs are not considered necessary at this time; however ongoing monitoring of the piles and areas of damage is recommended. It is anticipated that the piles identified with splitting and open holes will have established internal fungal decay in the next 5-10 years and should be considered for replacement.

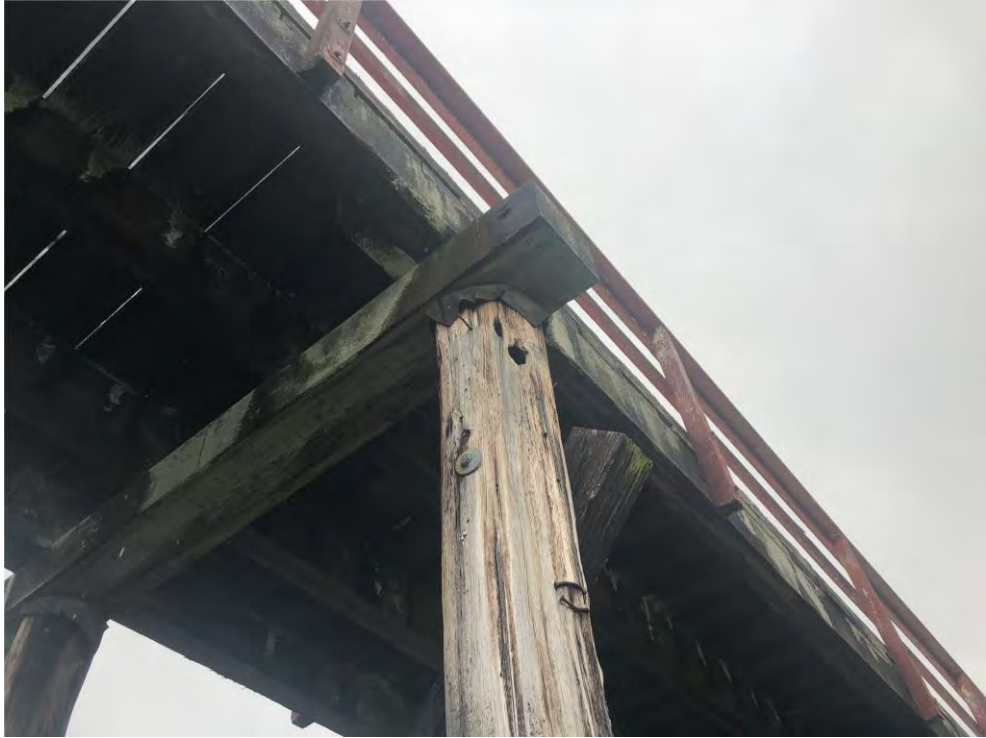
Photo 21 – Hole in Pile 9A

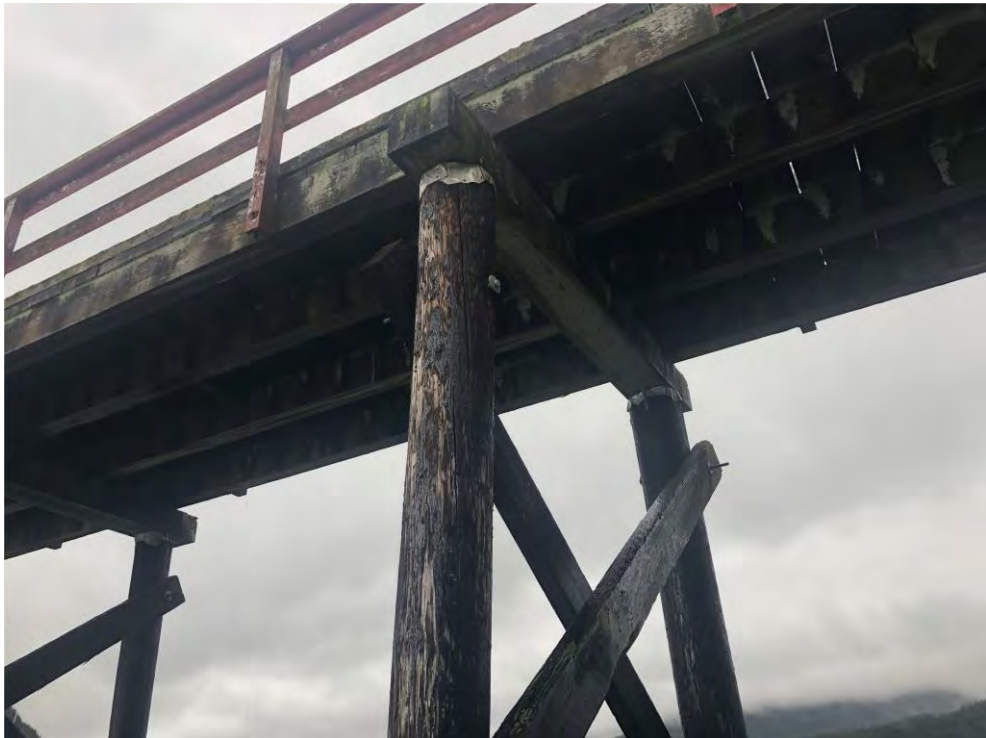
Photo 22 – Small split in Pile 10A

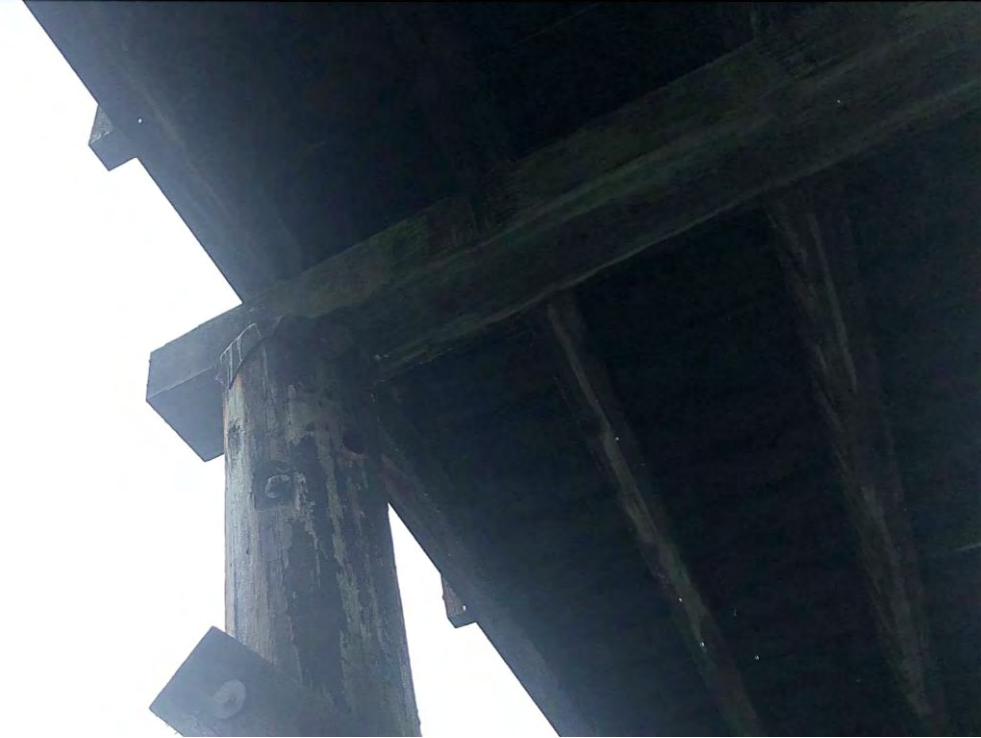
Photo 23 – Hole in Pile 12A

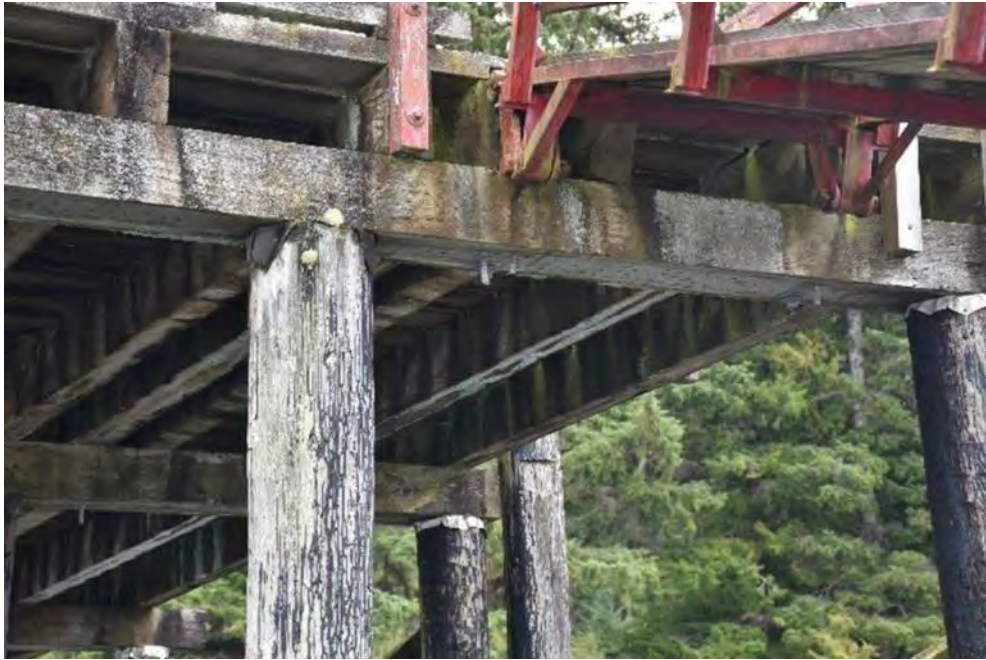
Photo 24 – Moss growth in Pile 15B

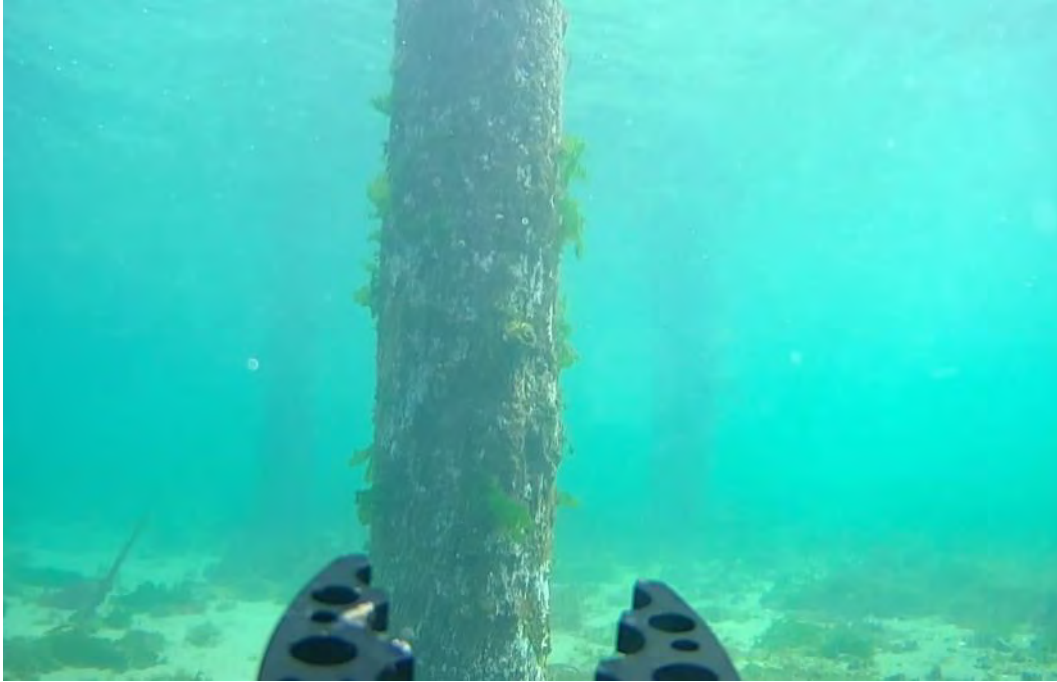
- Fender Pile 10B has a marine borer cavity in the lower intertidal zone with 25% cross-sectional loss (CSL) (Photo 25).
- Fender pile 14A has a large marine borer cavity with 50% CSL, and likely severe cross section loss due to fungal decay (Photos 26 & 27). Marine growth appears to be coming out of the pile.
- Fender pile 15C has a large marine borer cavity with 50% CSL, and likely severe cross section loss due to fungal decay (Photo 28).

Photo 25 – Underwater image of damage to fender Pile 10B

McElhanney understands that the fender piles are not longer used for vessel moorage and repairs are not considered necessary at this time as the fender piles are not structurally important to the pier.

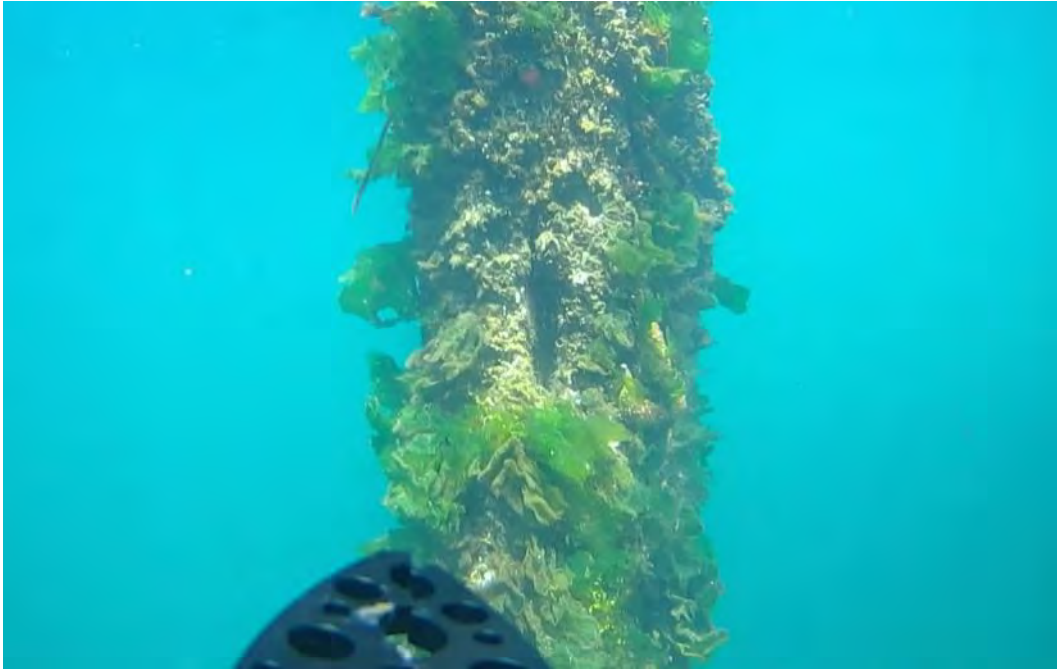
Photo 26 – Fender Pile 14A

Photo 27 – Underwater image of marine borer cavity of fender pile 14A

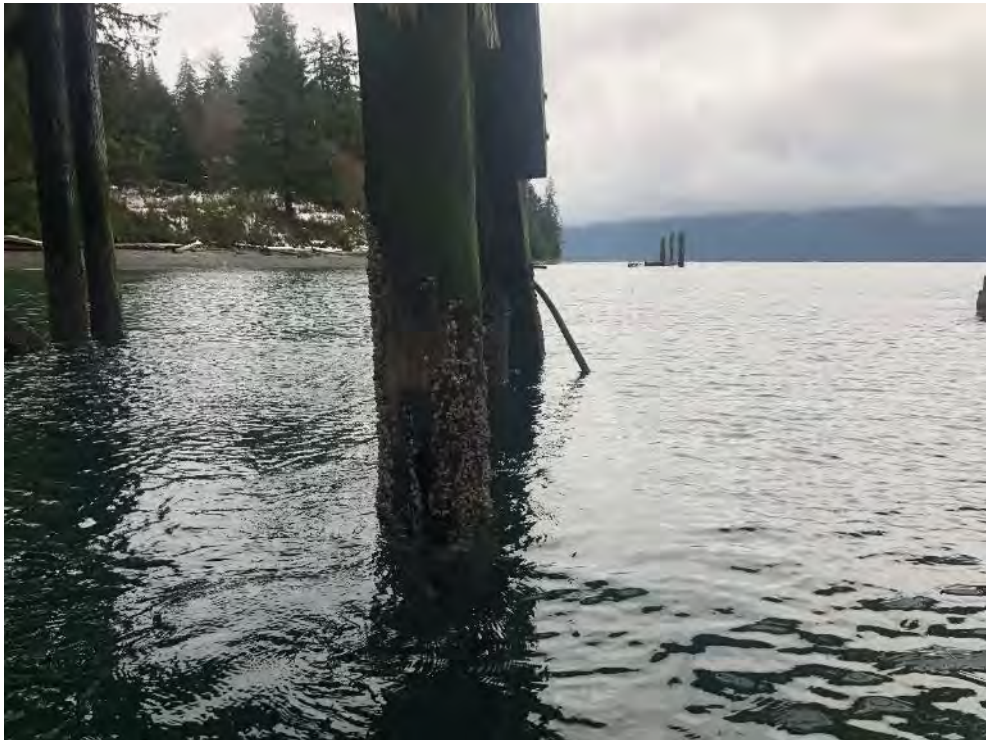
Photo 28 – Fender Pile 15C

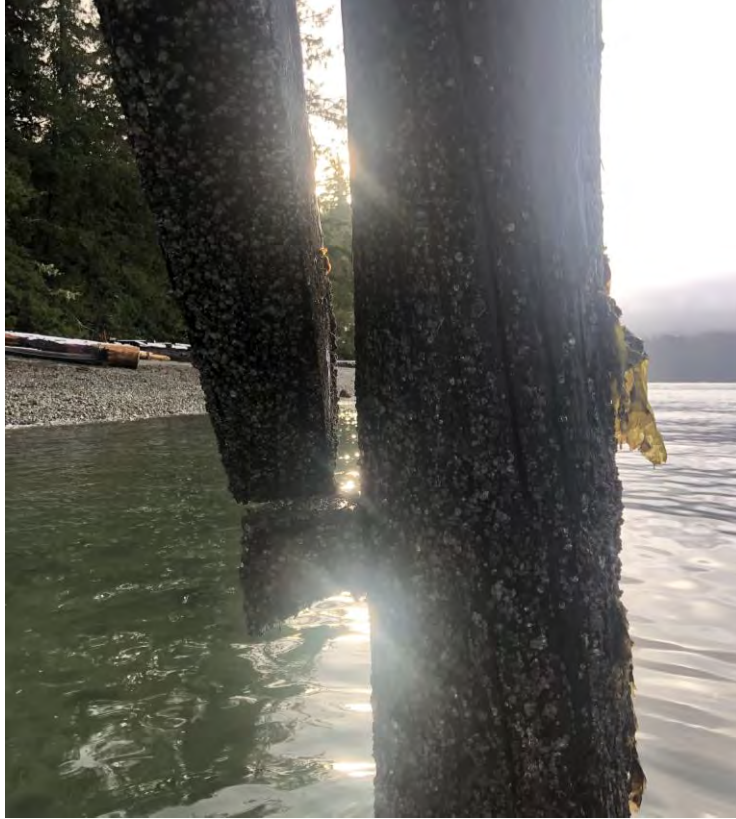
- There is widespread weathering, and minor fungal decay to the end grains of the members, however all cross braces appear well secured to the piles, apart from two locations.
- The cross bracing at Bent 8 appears to not be connected to pile 8A and is only resting on a timber block secured to the pile. (Photo 29)
- The cross bracing at Bent 15 is connected to the fender pile 15C, which has signs of significant cross-section loss. (Photo 30)

Photo 29 – Cross Bracing at Bent 8

It is recommended that the cross braces at Bents 8 and 15 are re-secured. Ongoing monitoring of the cross bracing is recommended.

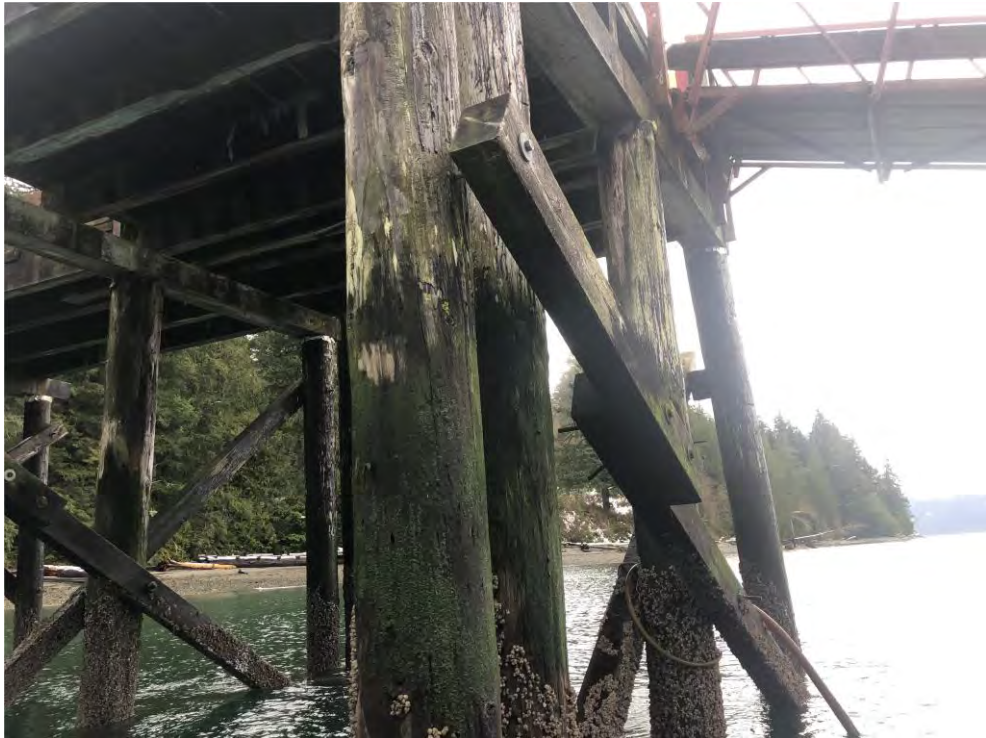
Photo 30 – Cross Bracing at Bent 15

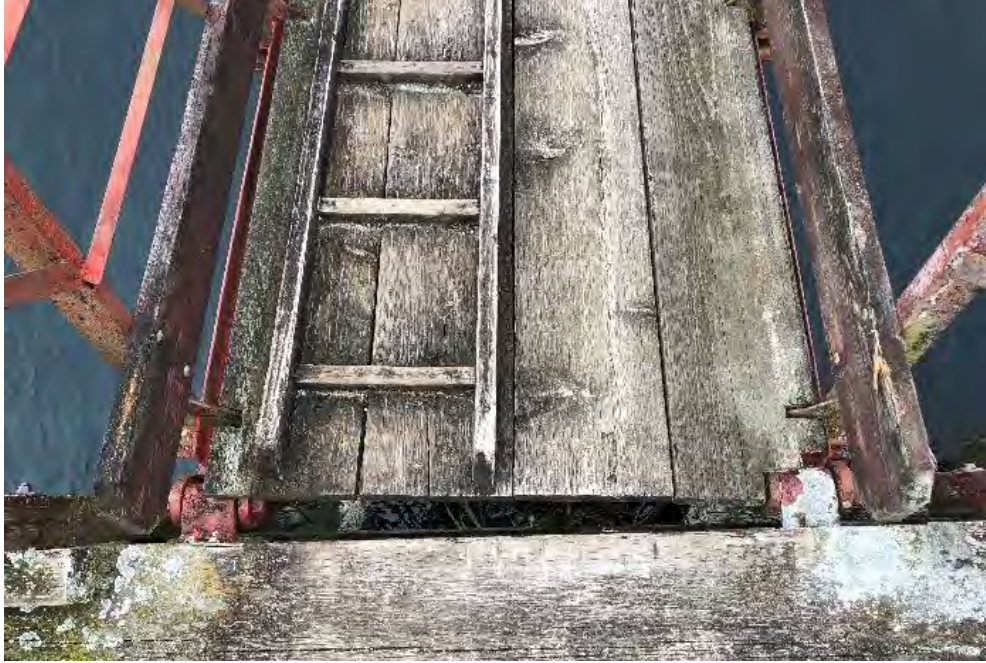
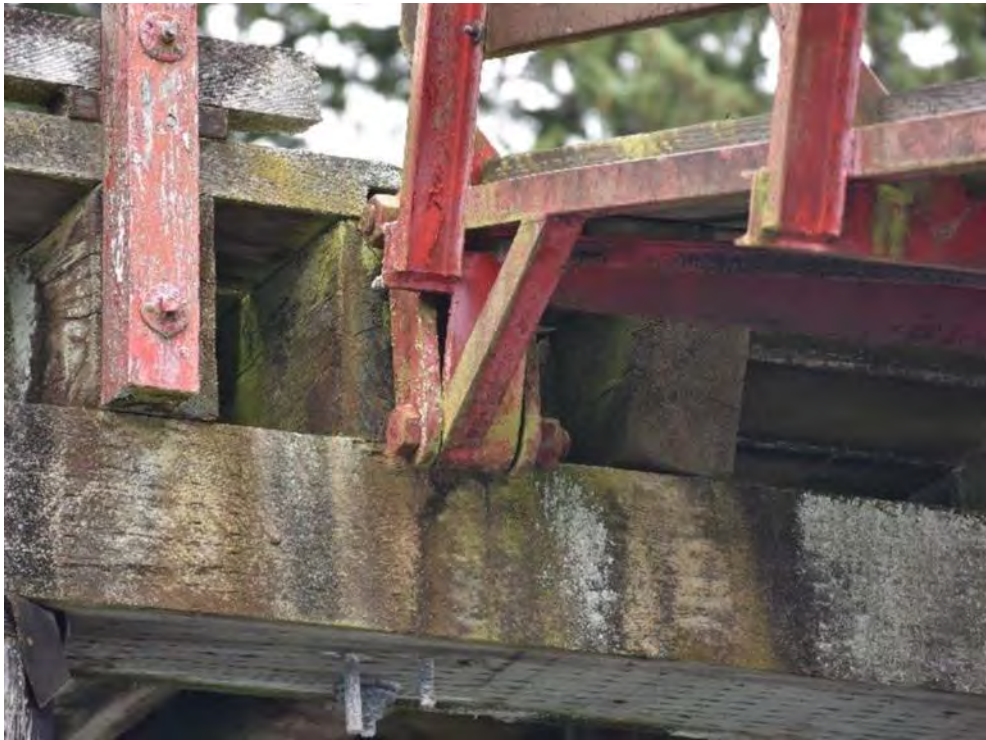
- The upper hinge connection is slightly misaligned (Photos 31 and 32) which is likely to result in advanced wearing of the pinned connection.
- The timber gangway slider plate is in good condition with minor wearing and is well aligned with the gangway roller (Photo 33)
- The deck planks and anti-slip surface have moderate wearing (Photo 34).
- The steel truss members have typical minor to moderate coating failures and corrosion. No significant deterioration of the welded connections was noted (Photo 35).

Photo 31 – Gangway Upper Hinge Connection

Photo 32 – Gangway Upper Hinge Connection

McElhanney recommends that the access gangway be replaced in conjunction with future replacement of the floating docks.

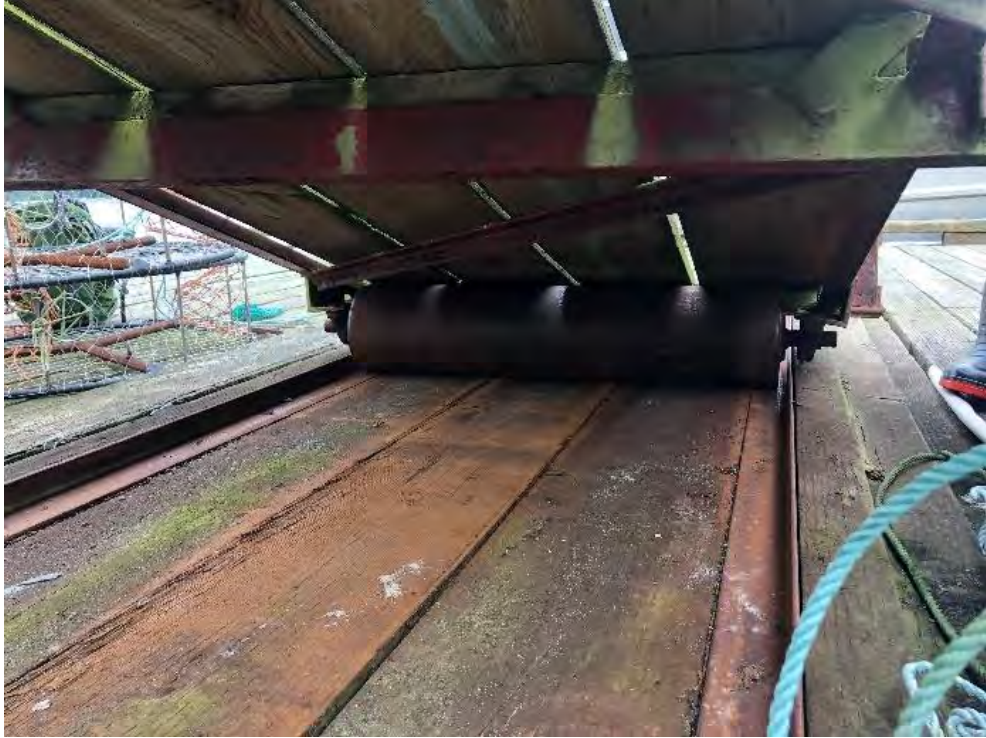
Photo 33 – Gangway Timber Slider Plate and Roller

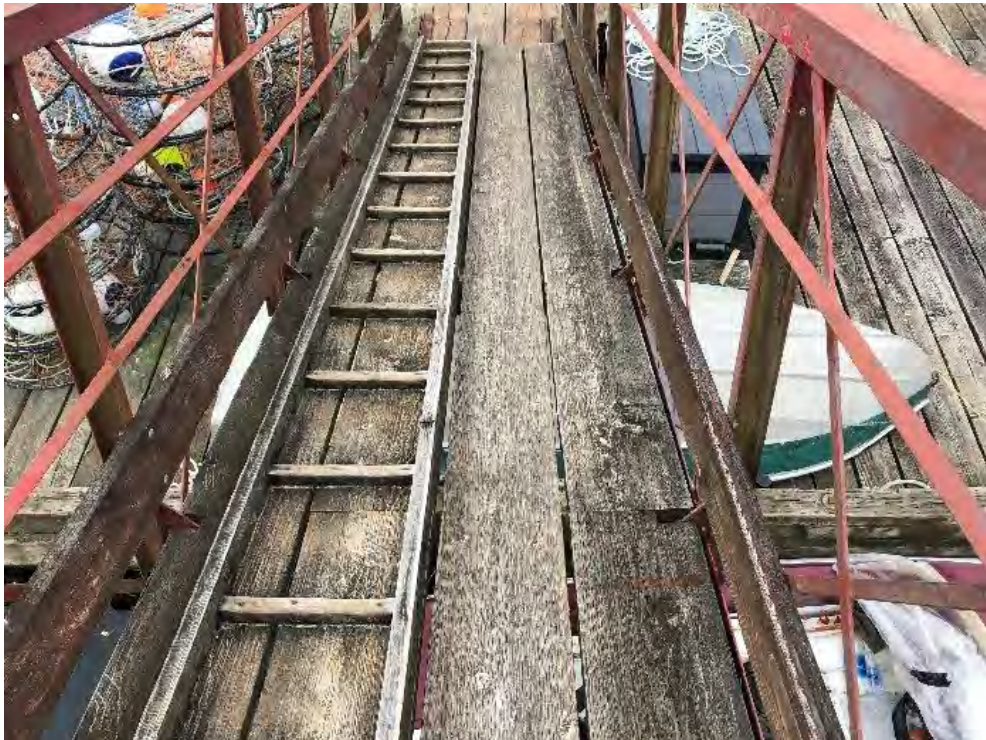
Photo 34 – Gangway Timber Deck Planks
