January 20, 2022 | Revision A

Marine Facility Condition Assessment of the Port Neville Wharf

Submitted to: Strathcona Regional District (SRD)
Prepared by McElhanney Ltd.

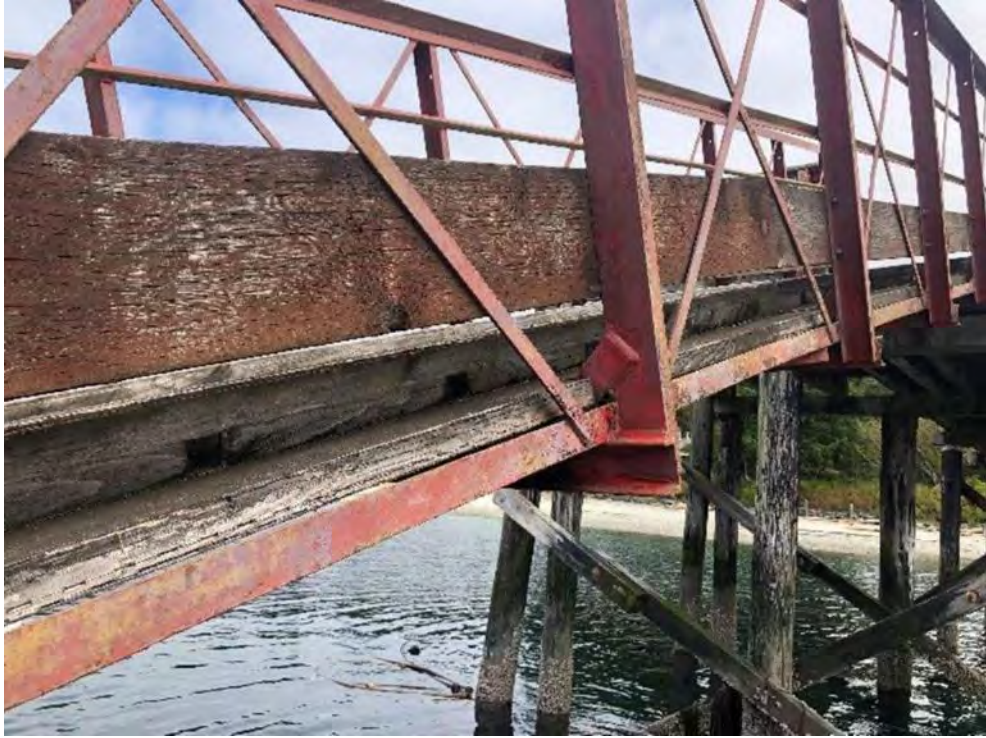
- The upper hinge connection is slightly misaligned (Photos 31 and 32) which is likely to result in advanced wearing of the pinned connection.
- The timber gangway slider plate is in good condition with minor wearing and is well aligned with the gangway roller (Photo 33)
- The deck planks and anti-slip surface have moderate wearing (Photo 34).
- The steel truss members have typical minor to moderate coating failures and corrosion. No significant deterioration of the welded connections was noted (Photo 35).

Photo 35 – Steel Gangway

McElhanney recommends that the access gangway be replaced in conjunction with future replacement of the floating docks.

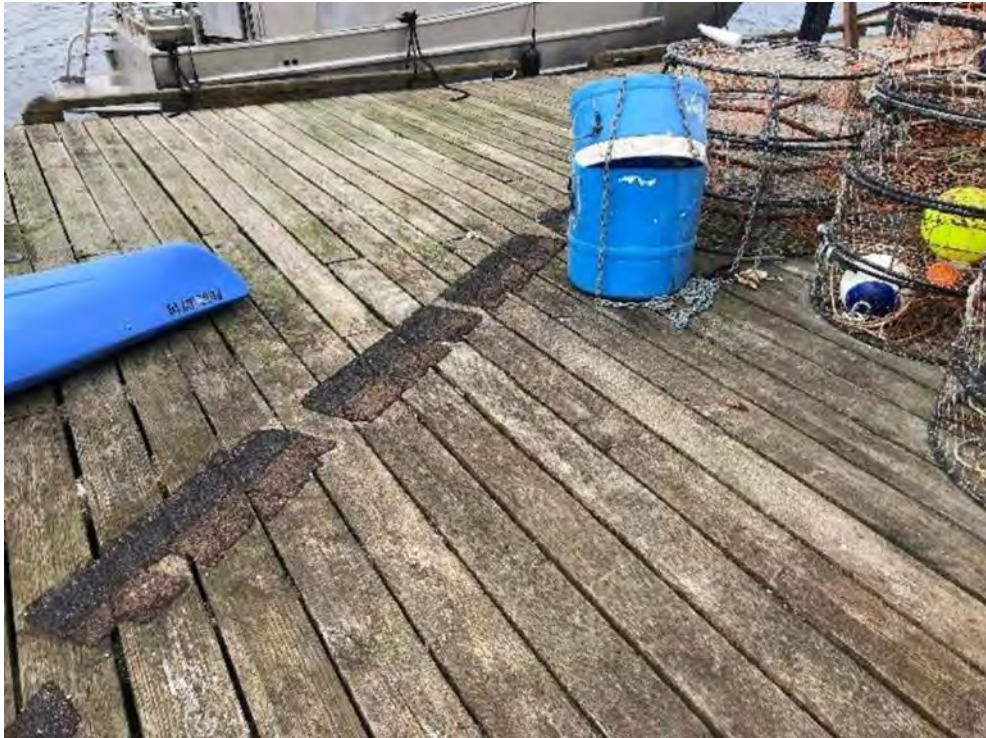
Float A is in poor to fair condition with minor deterioration to the topsides (Photo 36). Inspection findings are as follows:

Photo 36 – General view of Float A

Consideration should be given to replacing Floats A and B along with the mooring system rather than continue regular minor maintenance/repairs.

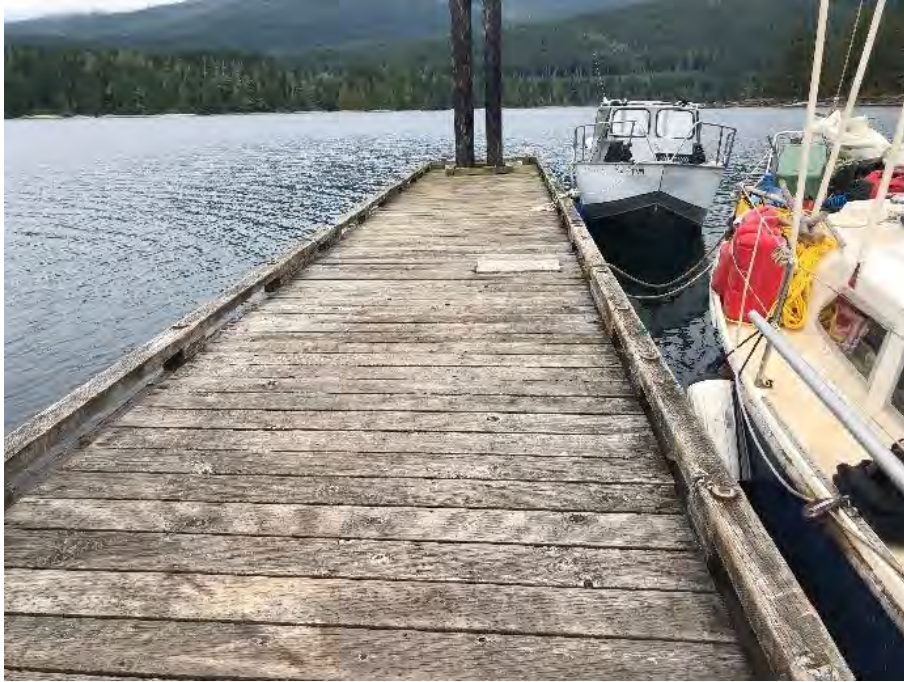
- The timber deck planks have widespread moderate weathering and fungal decay, with localized deterioration. There is one location on Float B with plywood repair to the decking which is a tripping hazard (Photo 37)
- The floatation elements appear in fair condition.
- The west connection between Float A and Float B is rope (Photo 38). This is currently functioning properly, however this may be subject to rapid wearing and should be replaced with a steel chain in the future.
- The bull rails and fascia boards have widespread mechanical damage (Photo 39). The bull rail is missing in two locations.
- The east connection between Float A and Float B is chain which is causing moderate wearing to the floats (Photo 40).
- The mooring piles and mooring dolphins have moderate abrasion with the dock structures (Photo 41 to 33).

Photo 37 – General view of Float B

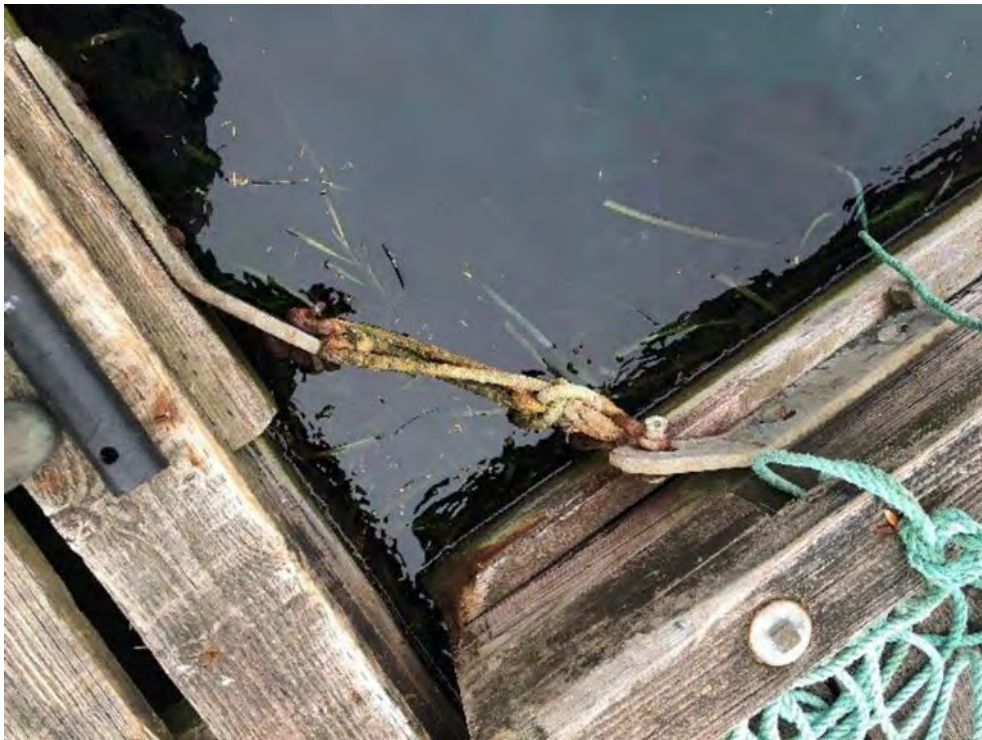
Photo 38 – Rope connection to Float B

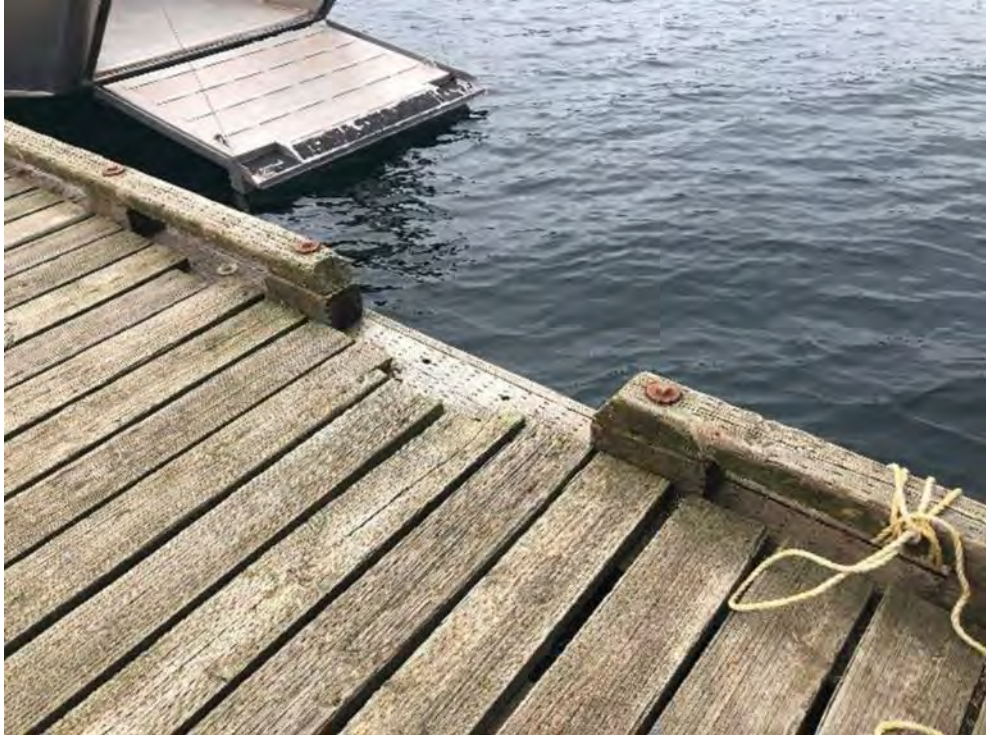
Photo 39 – Missing Bull rail on Float A

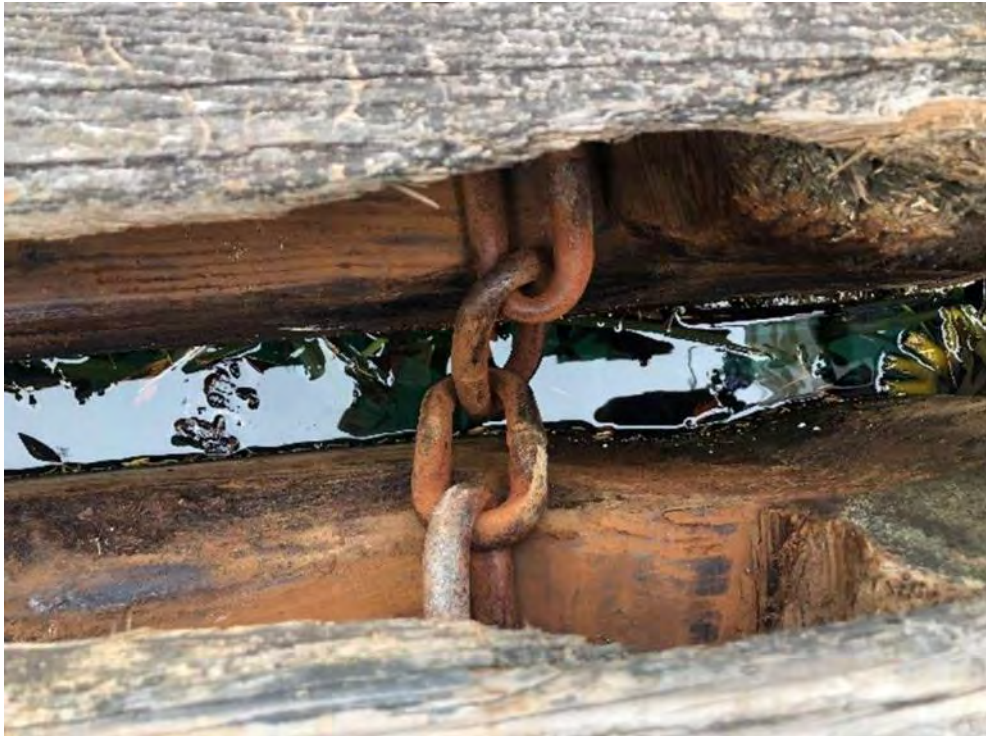
Photo 40 – Chain Connection to Float B

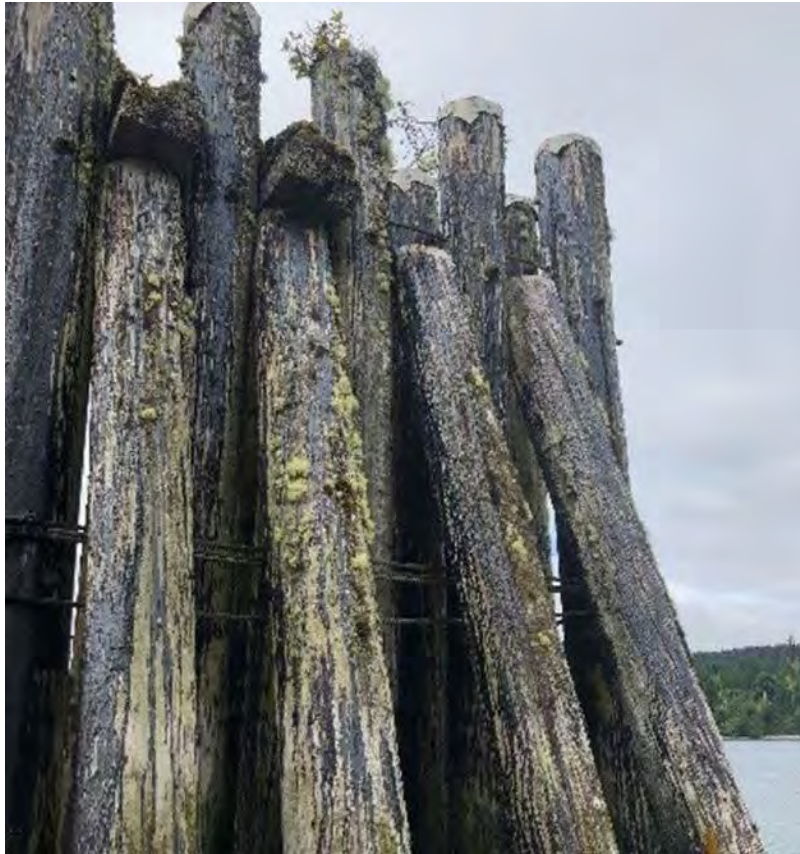
The timber mooring dolphins are in very poor condition. There is severe cross section loss due to internal fungal decay and marine borer cavity, as well as mechanical damage due to wearing of the floats.

- The north dolphin has vegetation growth near the tops of some of the piles. The timber blocking near the tops of the piles is deteriorating, and the cable wraps are loose (Photo 44)
- The south dolphin has significant vegetation growth near the tops of the piles. There is also severe cross section loss due to internal fungal decay and marine borer cavity in the intertidal zone, specifically on the front facing piles. The timber blocking is in poor condition, and the cable wraps are loose, but remain in place (Photo 45).

Photo 44 – North Mooring Dolphin

McElhanney understands that the mooring dolphins are no longer in service. To mitigate the risk of timber members contacting the dock, it is recommended that the timber dolphins be entirely removed and disposed of.

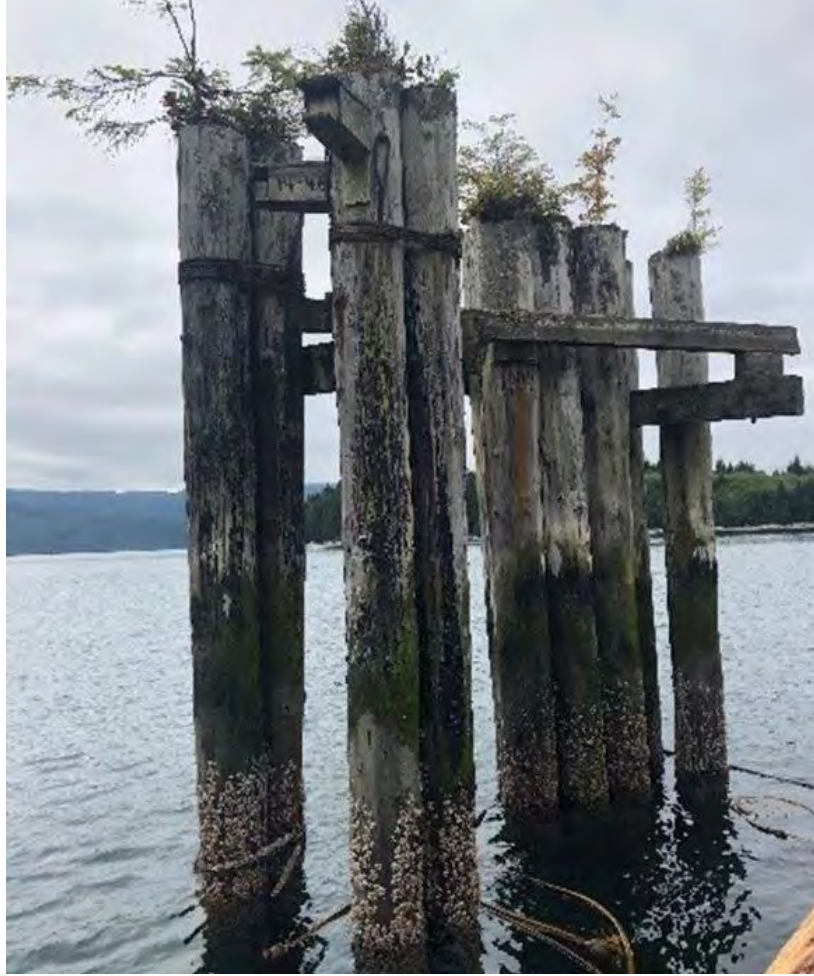
Photo 45 – South Mooring Dolphin
