April 11<sup>th</sup>, 2022 | Revision 0

# **Marine Facility Condition Assessment of the Surge Narrows Wharf**

Submitted to: Strathcona Regional District (SRD)  
Prepared by McElhanney Ltd.

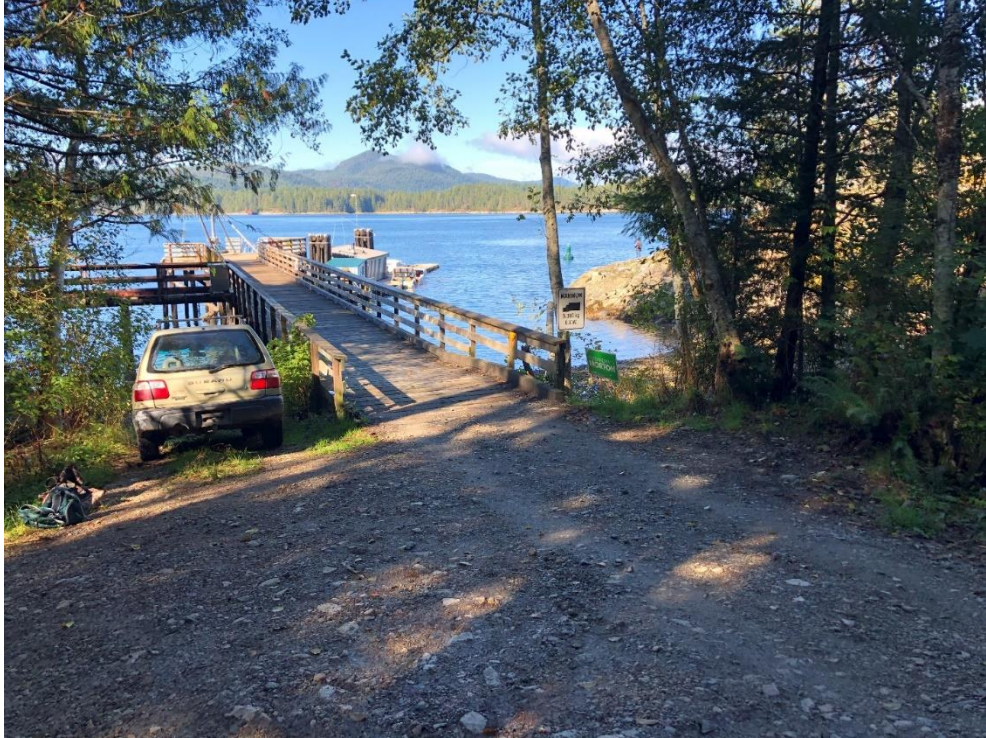
The approach is in generally good condition (Photo 1). There are no signs of settlement in this area, and the slope around the abutment appears stable. The load rating sign specifies a maximum gross vehicle weight of 5,300kg (Photo 2).

*Photo 1 - Approach area*

*Repairs are not considered necessary at this time; however ongoing monitoring of the approach is recommended. Consideration should be given to extending the safety barriers to the approach area.*

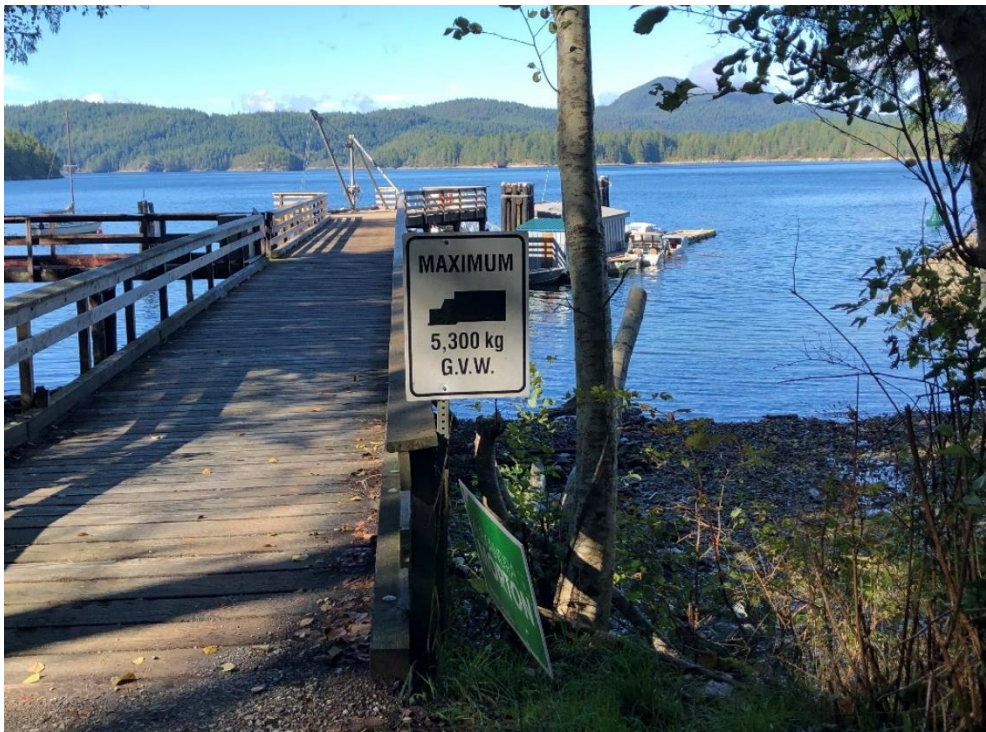
*Photo 2 - Load rating sign*

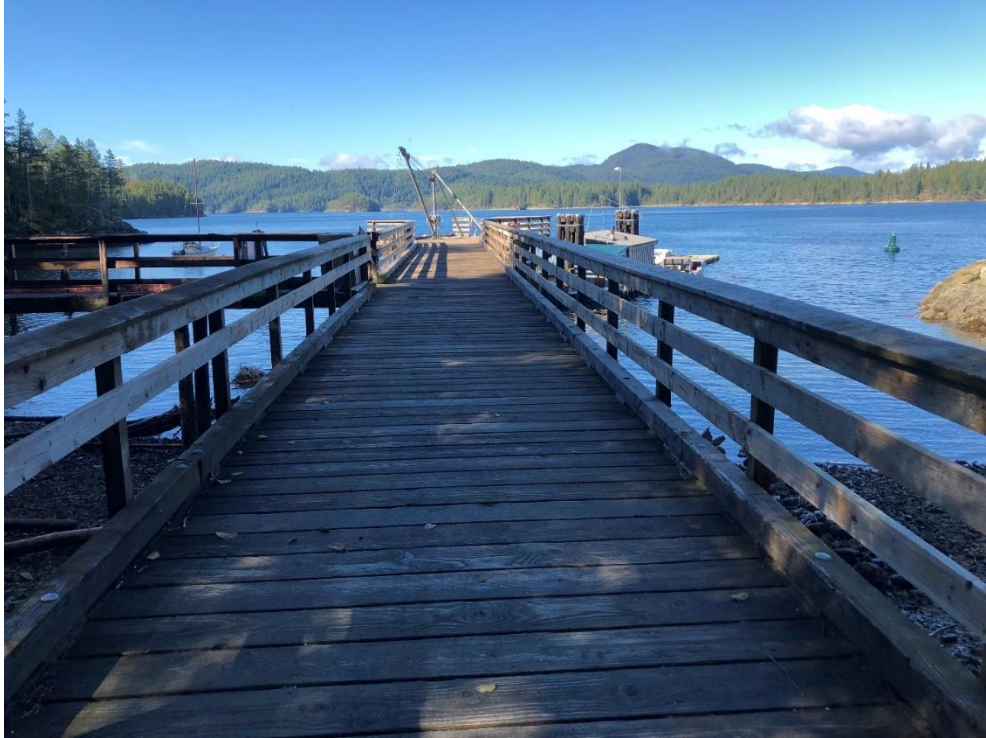
The topsides are generally in good condition with minor widespread weathering (Photo 3). Inspection findings are as follows:

*Photo 3 - Wharf Structure Topsides*

*The lower mid rail of the handrails should be installed where it is missing. Consideration should be given to removing access to the private property. Ongoing monitoring of the condition of the topsides is recommended.*

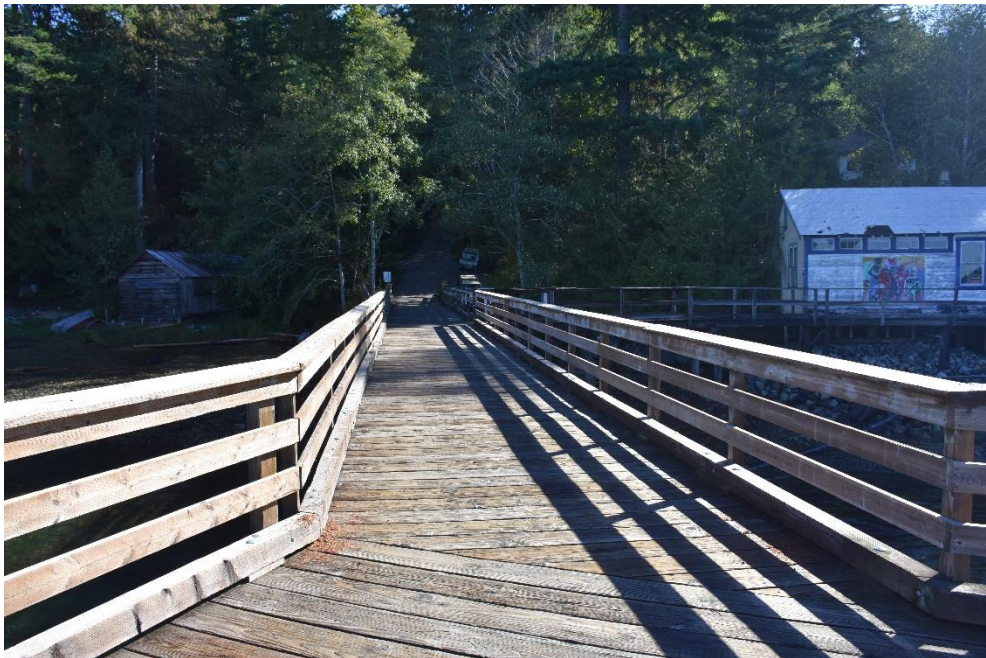
- The timber handrails are well secured and in good condition (Photo 4). These were replaced in 2013 according to the repair drawings by Herold Engineering. One section of the handrails on the south end is missing the lower mid-rail (Photo 5).
- The timber deck planks are in good condition with widespread minor weathering (Photo 6). All deck planks appear generally well secured. The decking was also replaced in 2013.
- There is one section along the wharf structure which leads to private property. This area is closed off to the general public (Photo 7).

*Photo 4 - Wharf Structure Handrails*

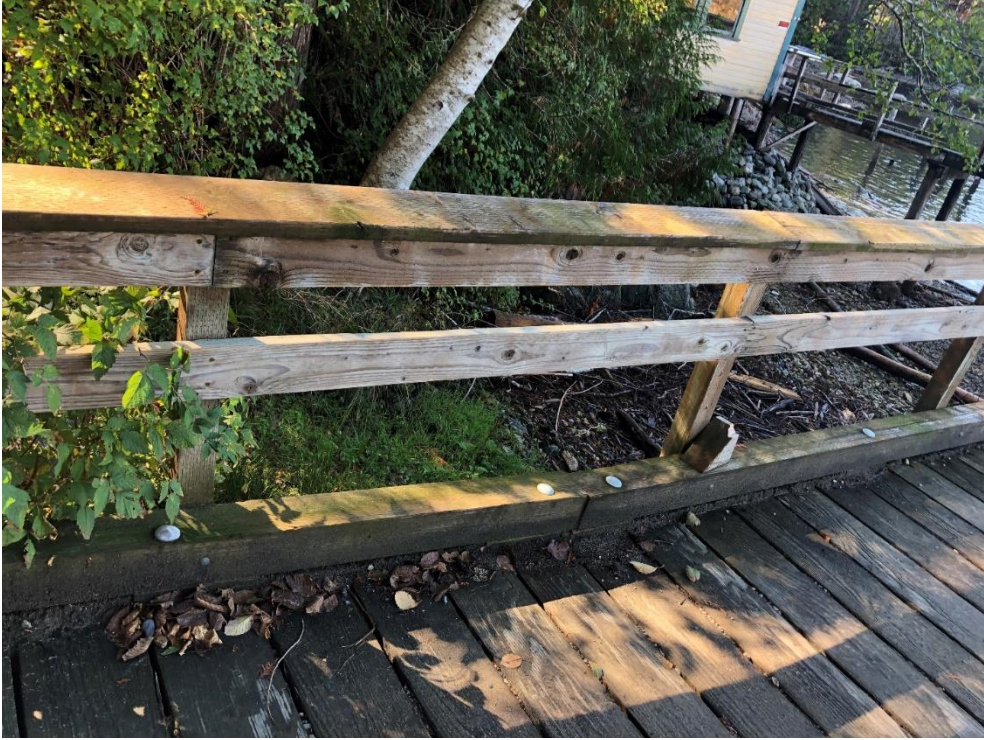
*Photo 5 - Missing lower mid-rail*

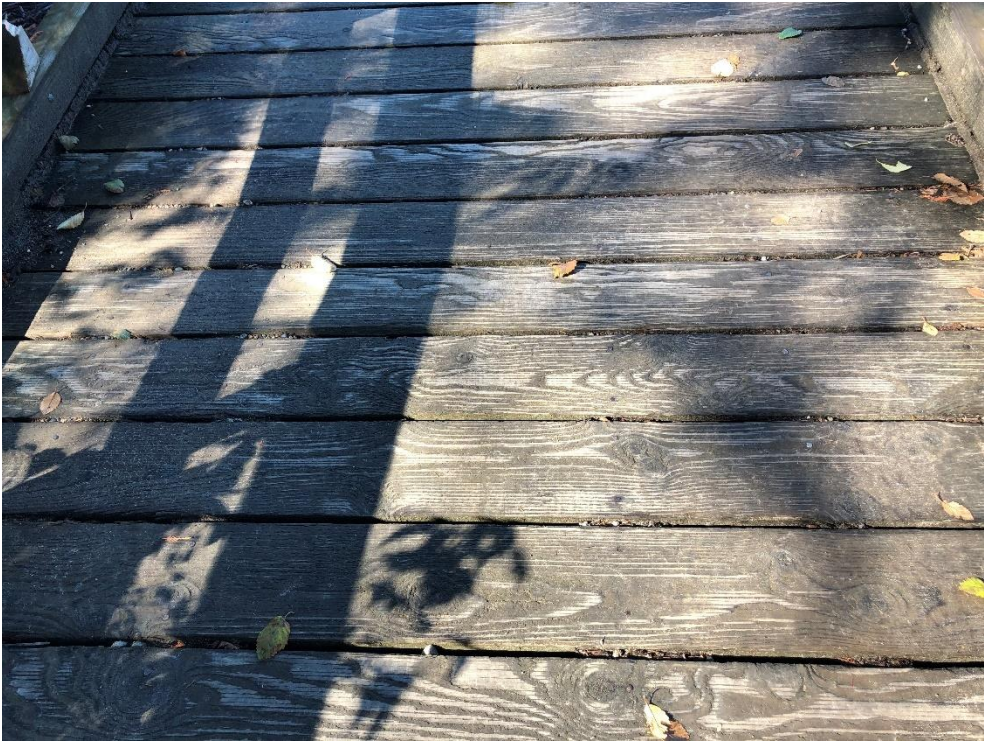
*Photo 6 - Wharf Structure Decking*

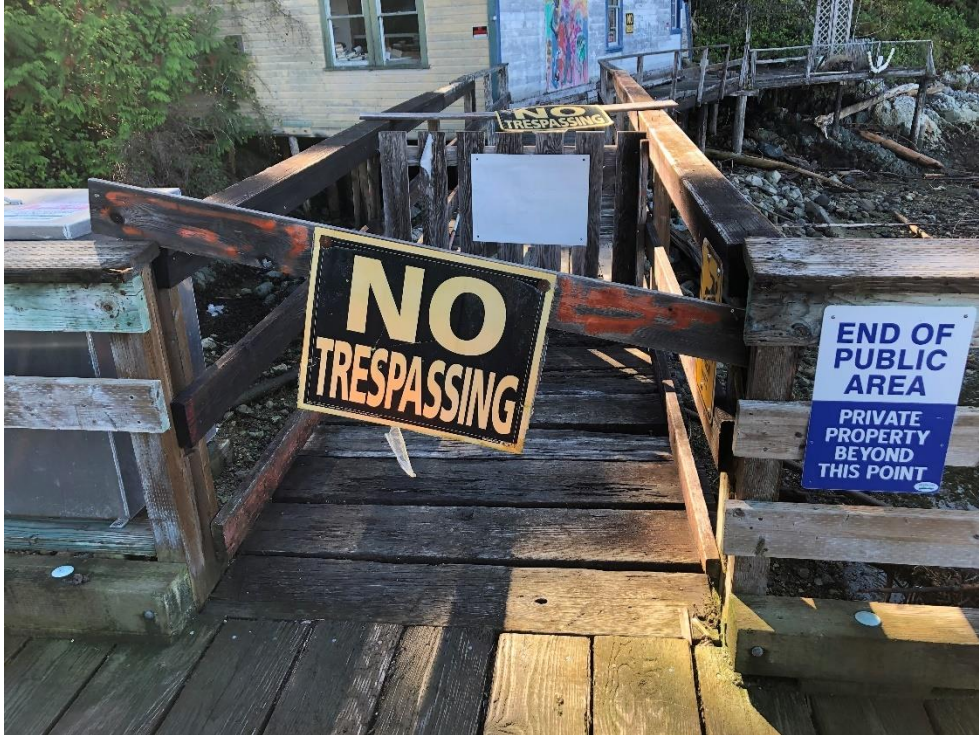
*Photo 7 - Access to private property*

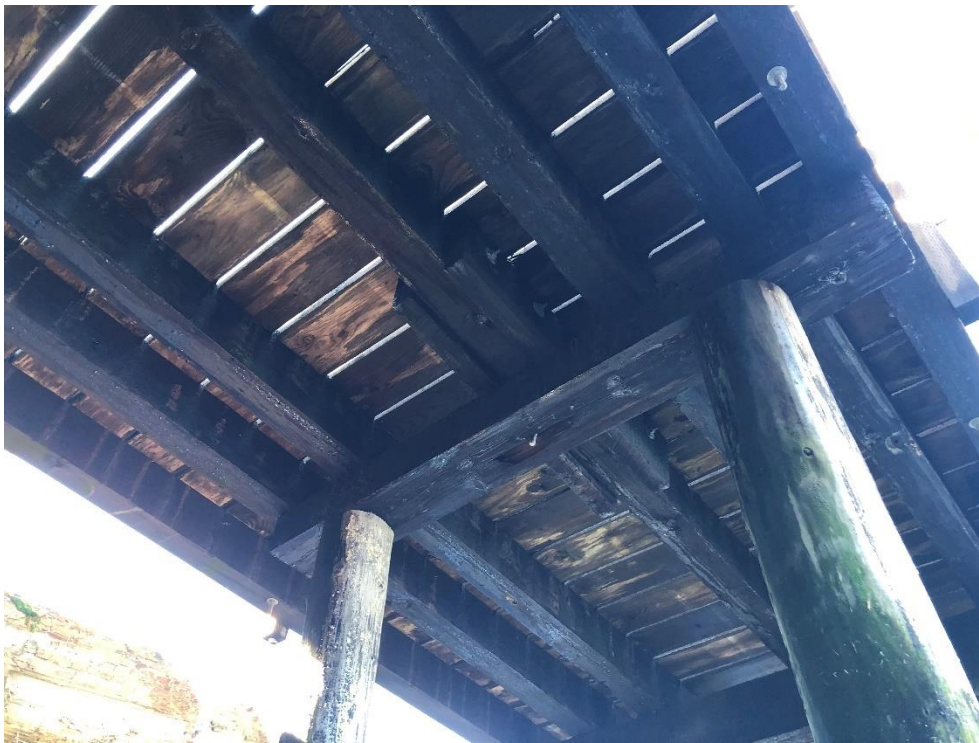
The timber stringers are generally in good condition (Photo 8). The stringers appear well secured between the decking and the pile caps, and there are no signs of significant splitting or structural distress.

*Photo 8 - Typical View of Timber Stringers*

*Repairs are not considered necessary at this time; however ongoing monitoring of the stringers is recommended.*

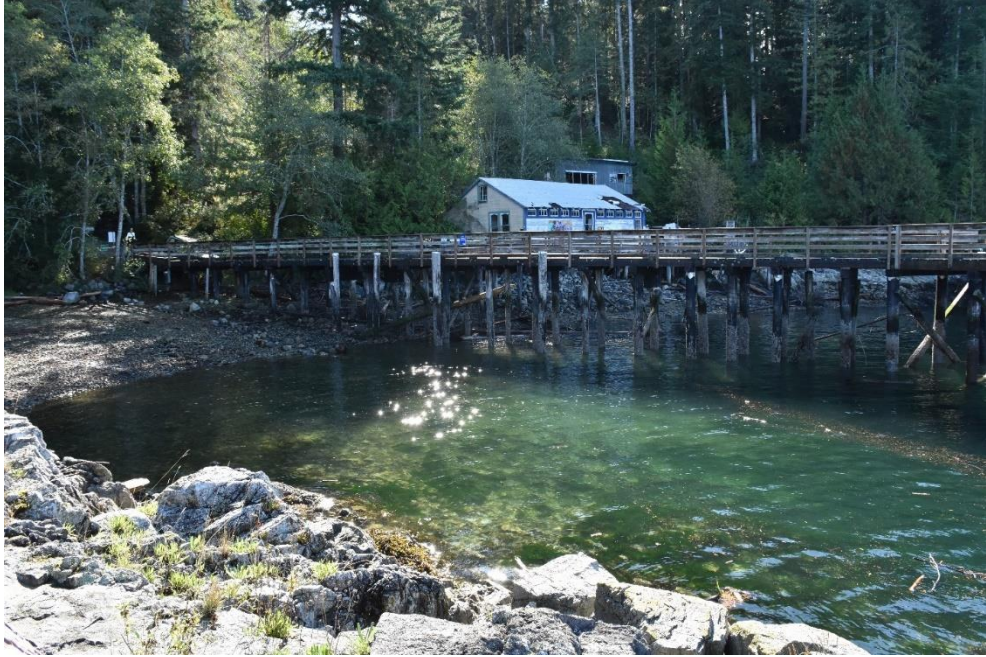
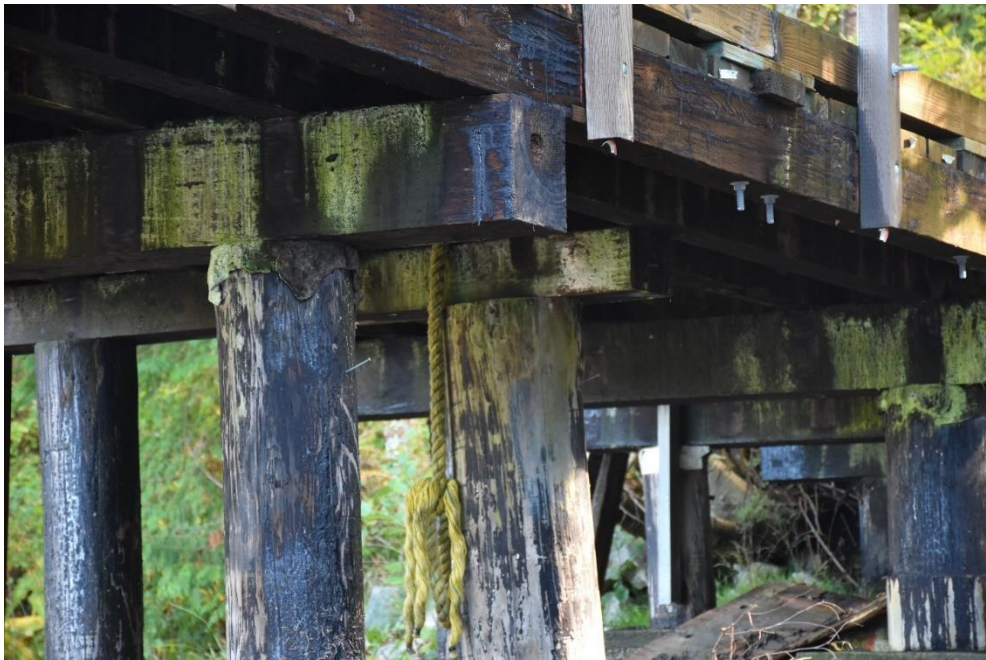
The treated timber pile caps are generally in fair condition, with widespread weathering and green algae growth, and damage to isolated members (Photo 9 to Photo 10). The pile caps appear well secured, and are typically aligned well over the piles, with no signs of shifting. Inspection findings are as follows in Table 1 below:

*Photo 9 - General View facing south of the timber pile caps*

*Photo 10 - Weathering and green algae growth on pile caps*

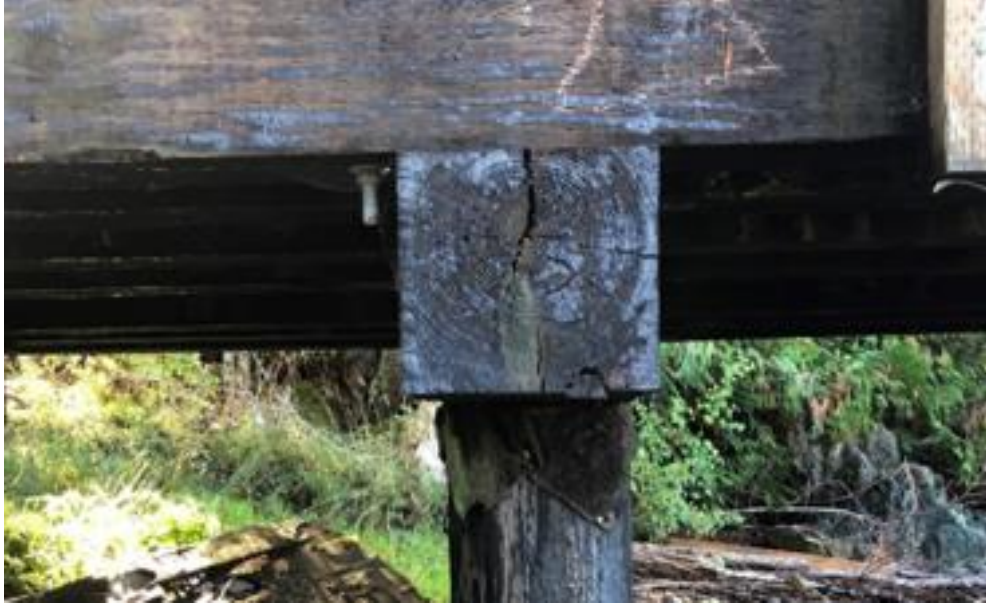
Location	Description of Findings	Photo
<b>Bent No. 1</b>	The pile cap is split on the north end.	Photo 11
<b>Bent No. 2</b>	The pile cap has a minor split at the south end grain.	Photo 12
<b>Bent No. 4</b>	The pile cap is fractured at the base in the center, and the end of one of the through bolts is exposed.	Photo 13
<b>Bent No. 6</b>	The pile cap is above 2 corbels on each pile. The corbels are in fair condition and secured vertically with a steel angle on one side. The top corbel at the north end is showing signs of splitting.	Photo 14 to Photo 15
<b>Bent No. 7</b>	The pile cap is above 2 corbels on the south pile. The corbels are in fair condition and stabilized vertically with a steel angle on one side. The bottom corbel is showing minor signs of splitting at the end grain.	Photo 16 to Photo 17
<b>Bent No. 10</b>	The pile cap is fractured at the base in the center, and the end of one of the through bolts is exposed.	Photo 18

*Photo 11 - Split at the north end of the pile cap at Bent 1*

*Replacements of piles caps at Bent Nos. 1, 2, 4, 6, 7, 8, 10, 11, 12, 13 and 14 is strongly recommended. It is recommended that the corbels at bent 6 are laterally braced with sister channels, and all the corbels at Bent Nos. 6, 7, and 13 are braced vertically on both sides of the pile with either strapping or steel angles. Ongoing monitoring of the remaining pile caps is recommended.*

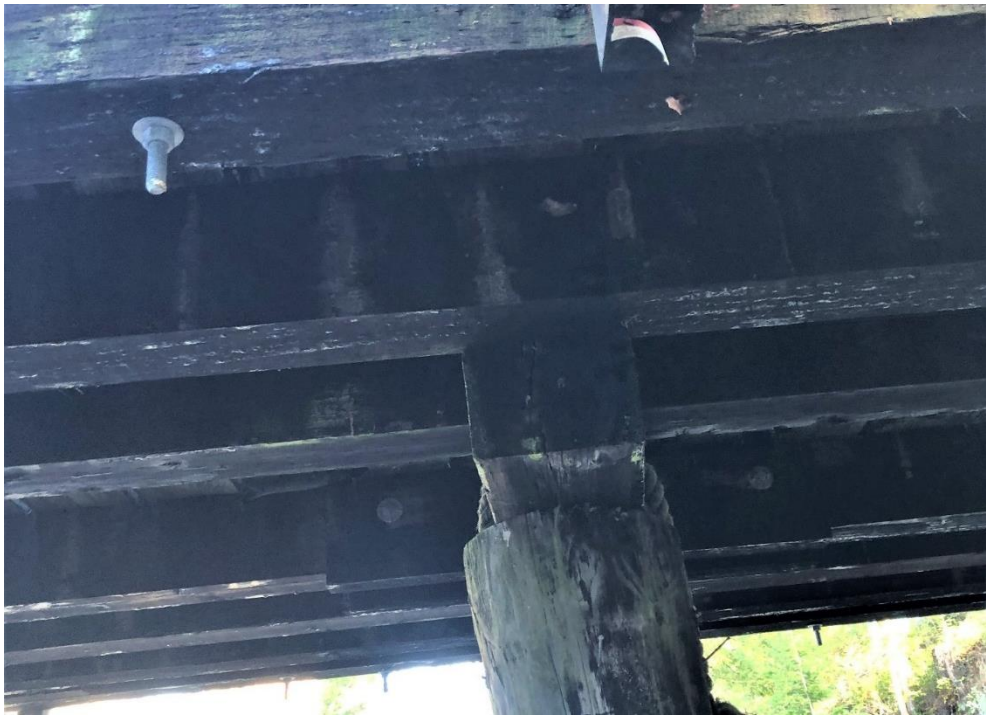
*Photo 12 - Minor splitting of the pile cap at Bent 2*

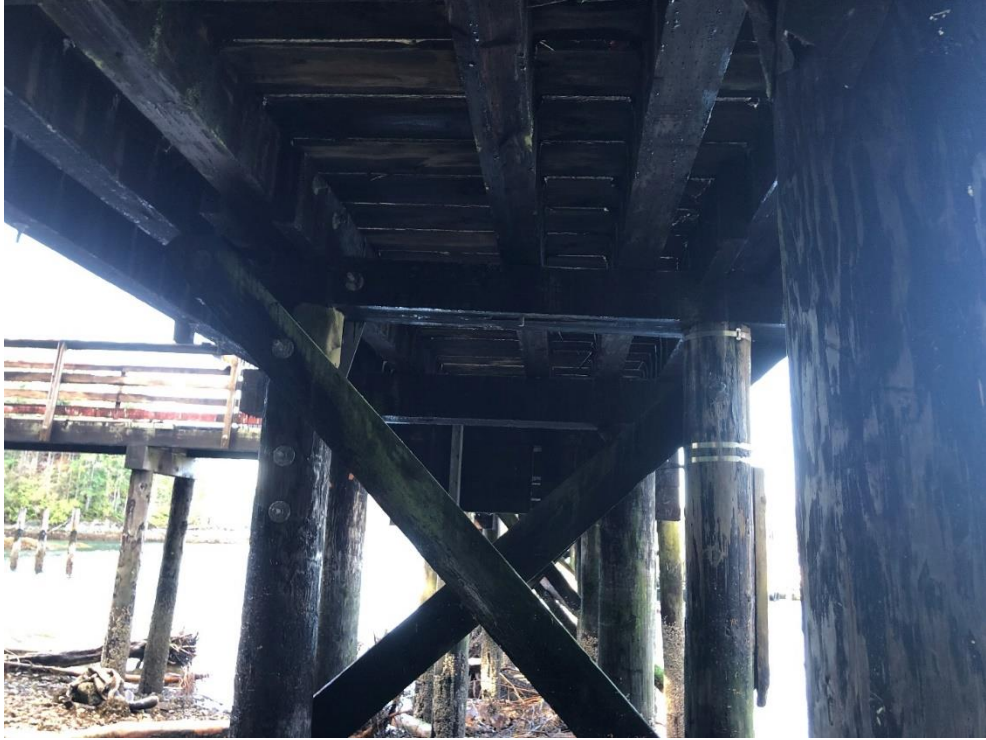
*Photo 13 - Pile cap at Bent 4*

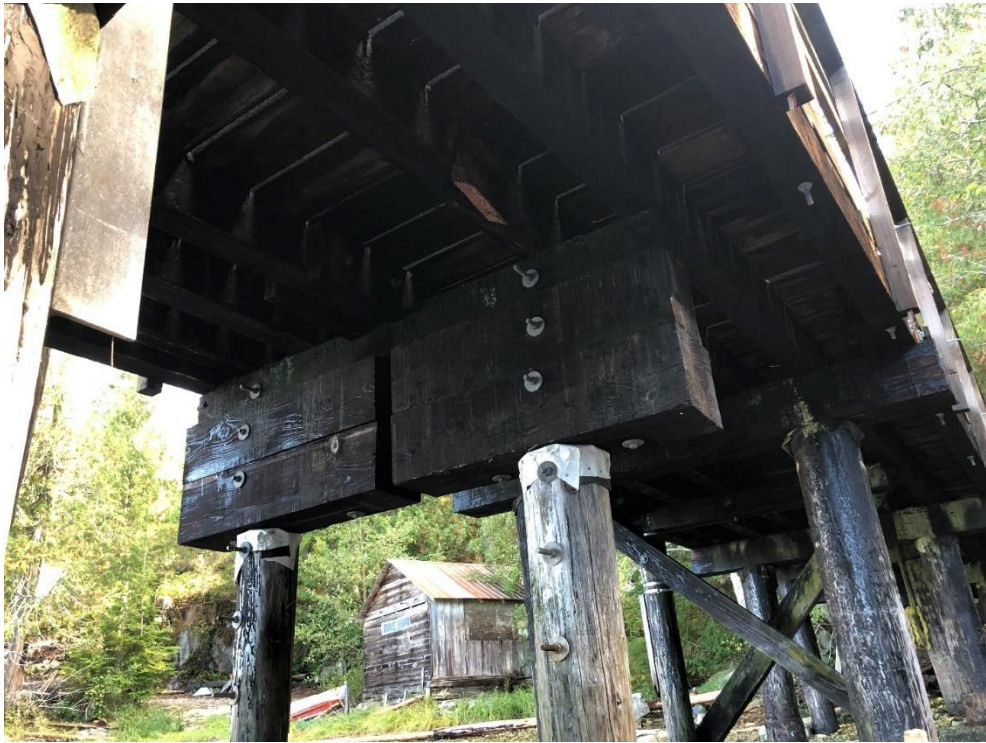
*Photo 14 - Pile cap at Bent 6 and corbels*

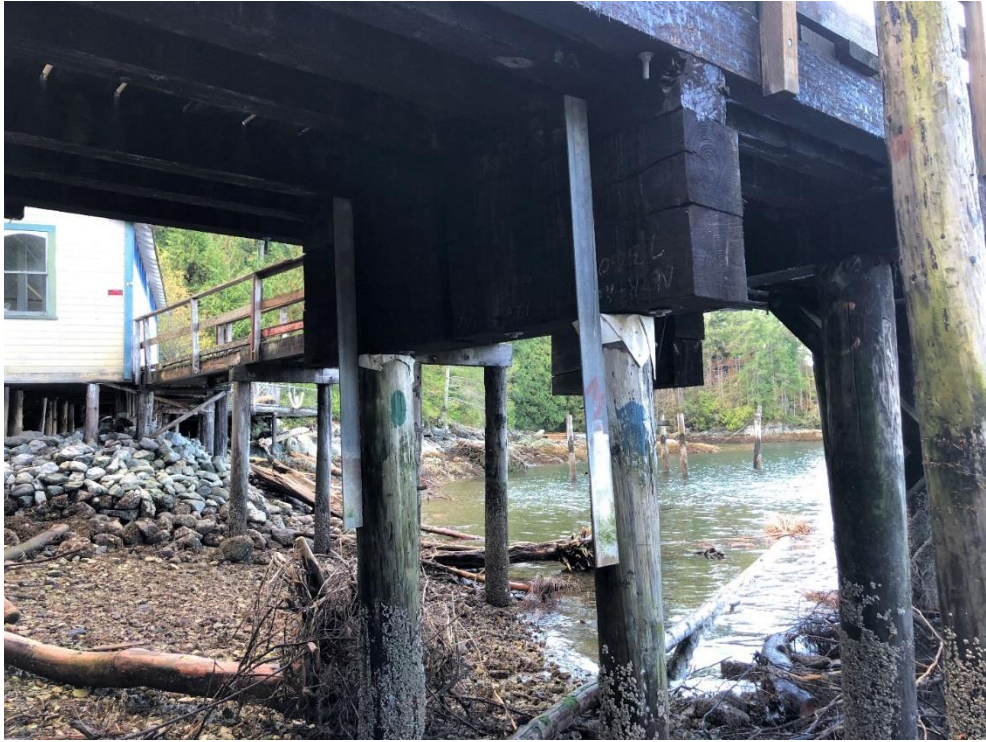
*Photo 15 - Split in corbel at Bent 6*

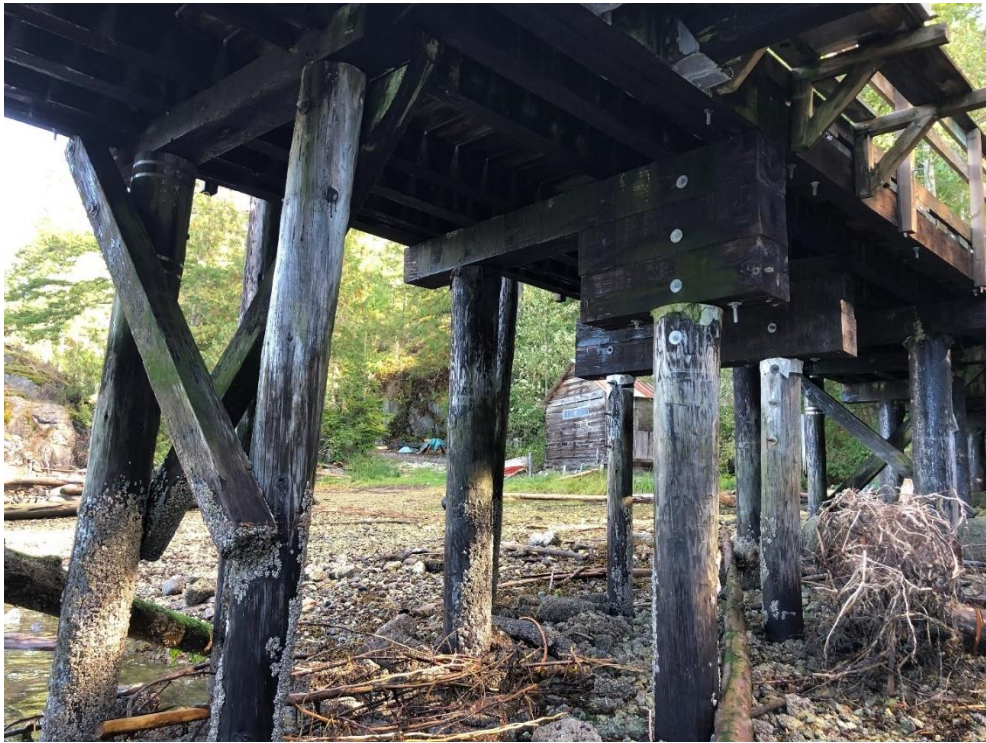
*Photo 16 - Pile cap at Bent 7 and corbels*

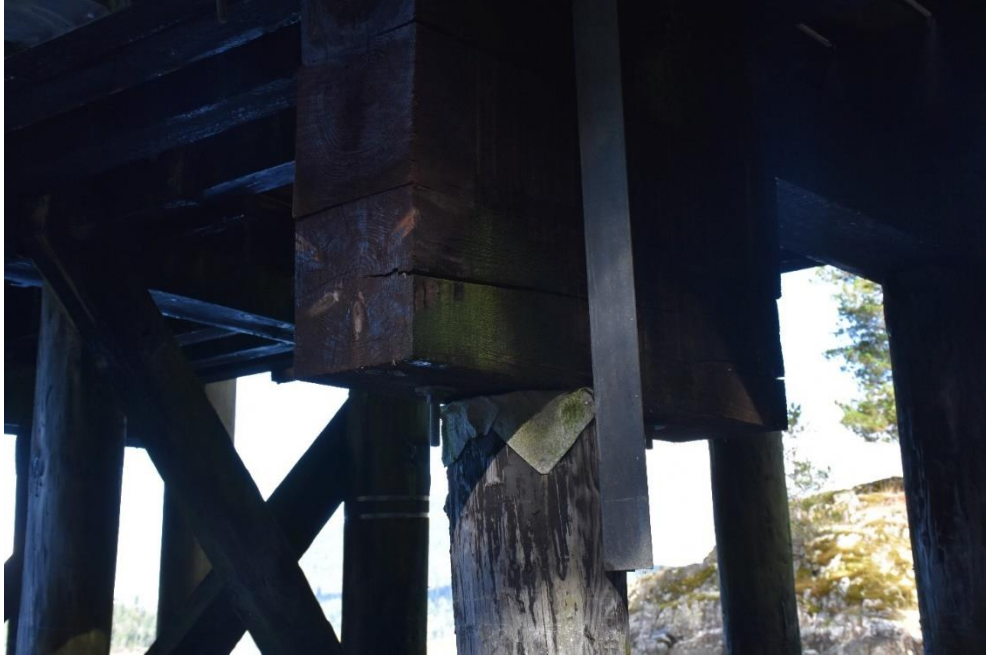
*Photo 17 - Split in corbel at Bent 7*

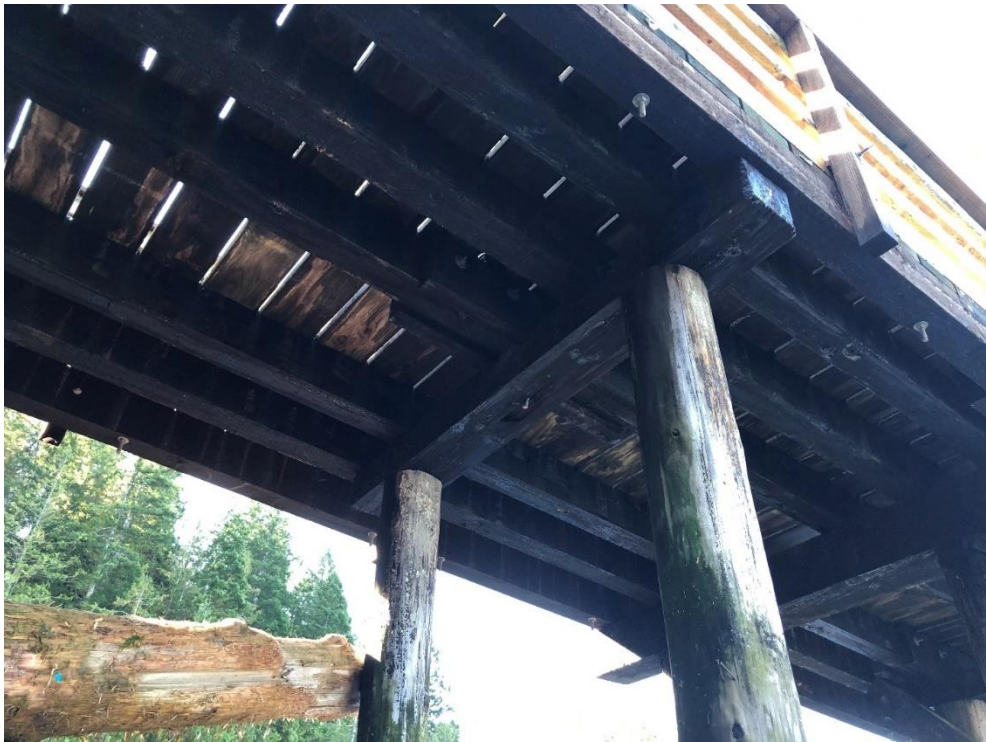
*Photo 18 - Pile cap at Bent 10*

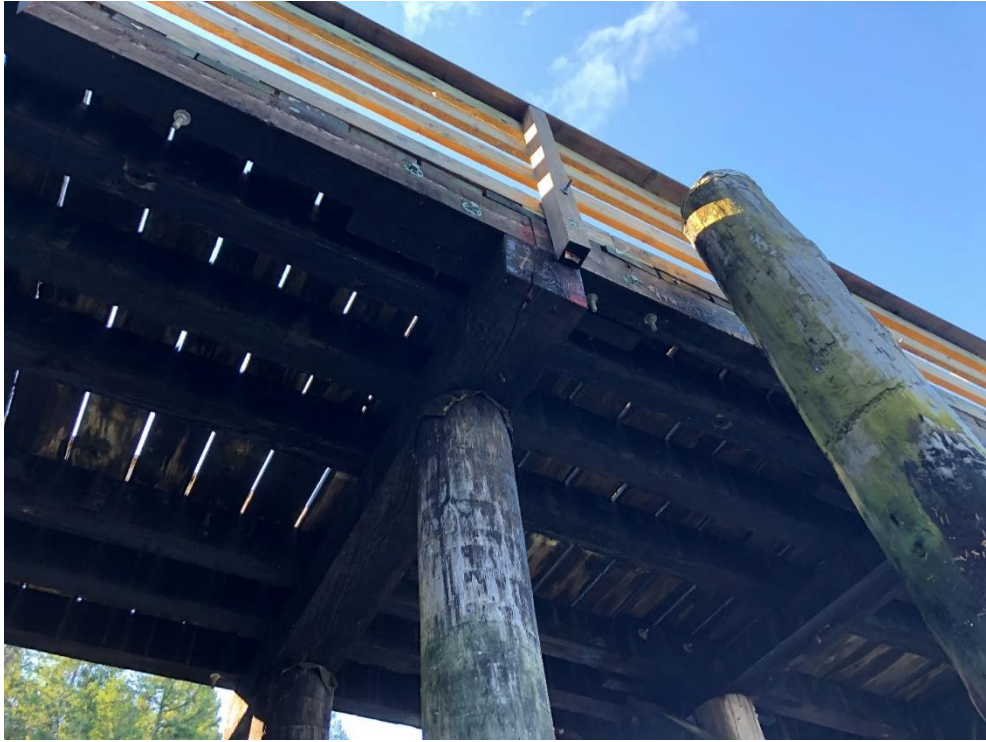
<b>Bent No. 11</b>	The pile cap is splitting at the north end grain.	Photo 19
<b>Bent No. 12</b>	The pile cap is fractured at the base in the center, and the end of one of the through bolts is exposed.	Photo 20
<b>Bent No. 13</b>	The pile cap at is above 2 corbels on the south pile. The corbels are in fair condition and stabilized vertically with a steel angle on one side. The corbel is showing minor signs of splitting at the end grain.	Photo 21
<b>Bent No. 14</b>	The pile cap has some damage at the end grain on the north end.	Photo 22
<b>Bents Nos. 2, 4, 6, 8, 10, 12 and 14</b>	The pile caps do not extend the full length of the deck. The pile caps end approximated one foot before the end stringer on the south end. The end stringers therefore span 2 bents at these locations.

*Photo 19 - Pile cap at Bent 11*

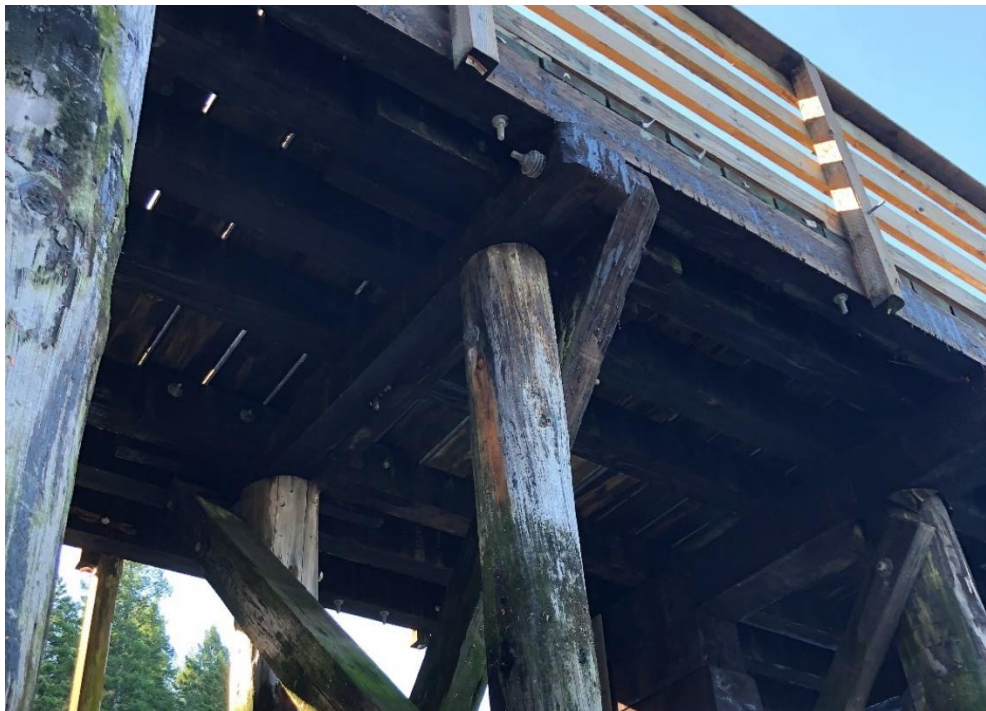
*Photo 20 - Pile cap at Bent 12*

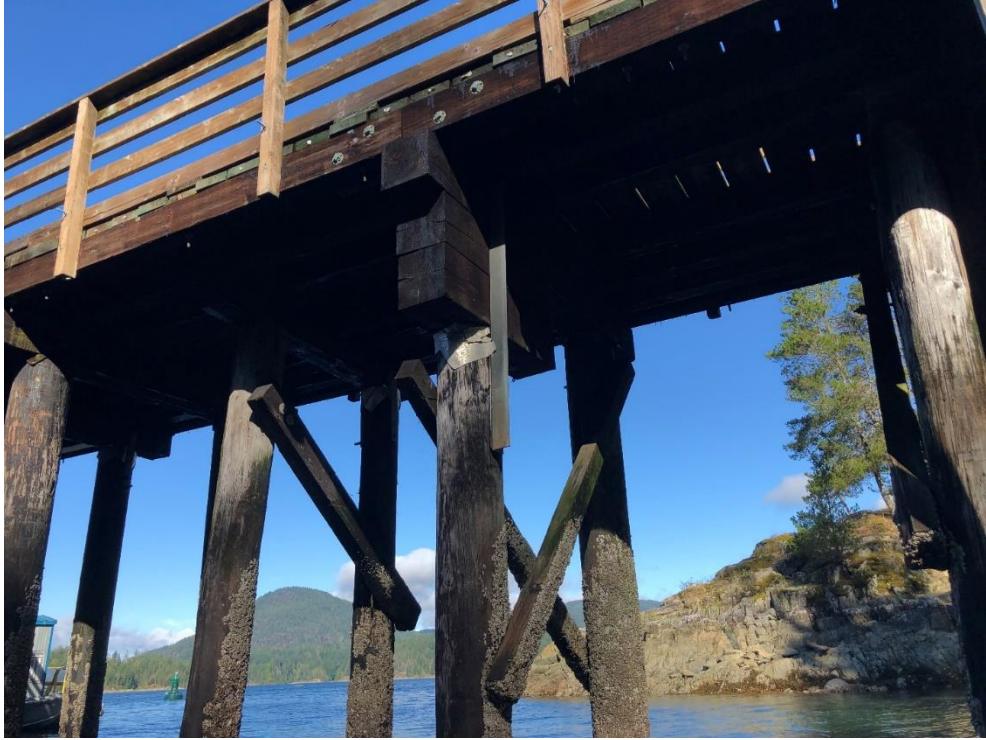
*Photo 21 - Pile cap at Bent 13 with corbels*

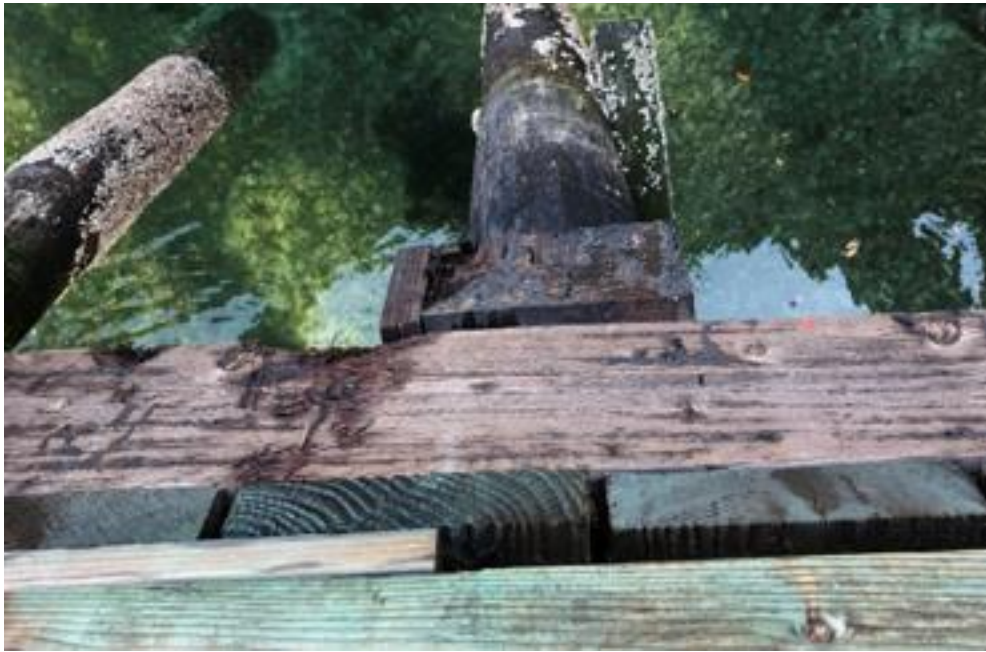
*Photo 22 - Pile cap at Bent 14*

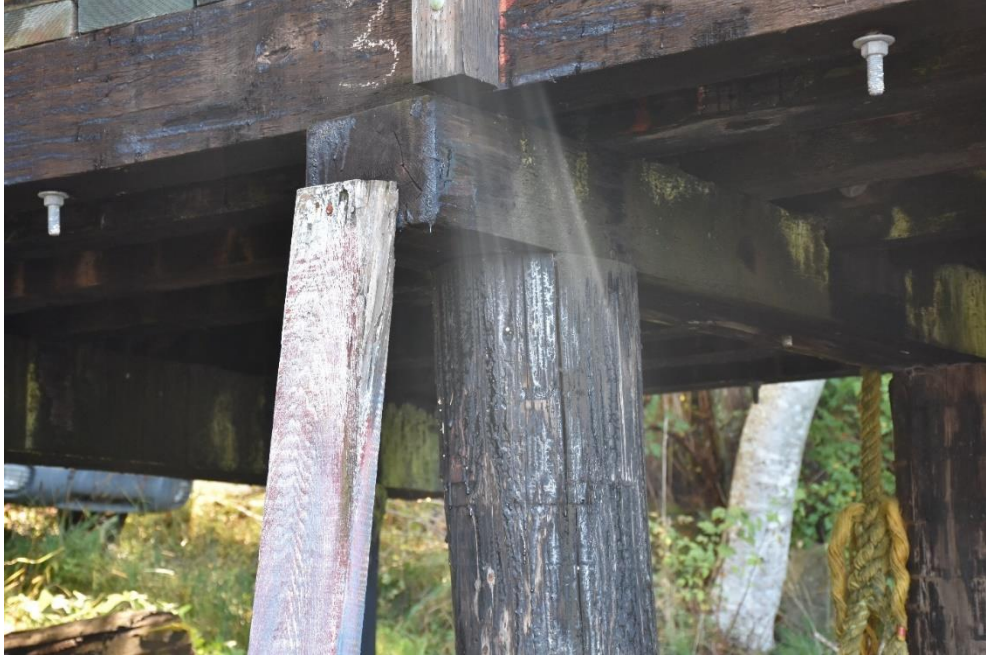
*Photo 23 - Pile 2B*

- Pile No. 2B has a minor split at the top of the pile (Photo 23)
- Pile No. 4B has a split at the top of the pile. It has previously been banded to prevent further splitting (Photo 24).
- Pile No. 10B has multiple minor bolt holes in the intertidal zone (Photo 25).
- Pile No. 11B has a severe marine borer cavity in the intertidal zone (Photo 26).
- Pile 19A has a minor split in the intertidal zone (Photo 27).
- Pile 22A has some damage in the intertidal zone (Photo 28).
- The majority of the existing capping over the piles is deteriorated or missing.

*The missing and deteriorated capping should be replaced to prevent further damage to the tops of the piles. Ongoing monitoring of the piles and areas of damage is recommended. It is recommended that any holes be plugged with a treated timber dowel if possible. It is anticipated that the piles identified with holes and splitting will have established internal fungal decay in the next 5-10 years and should be considered for replacement.*

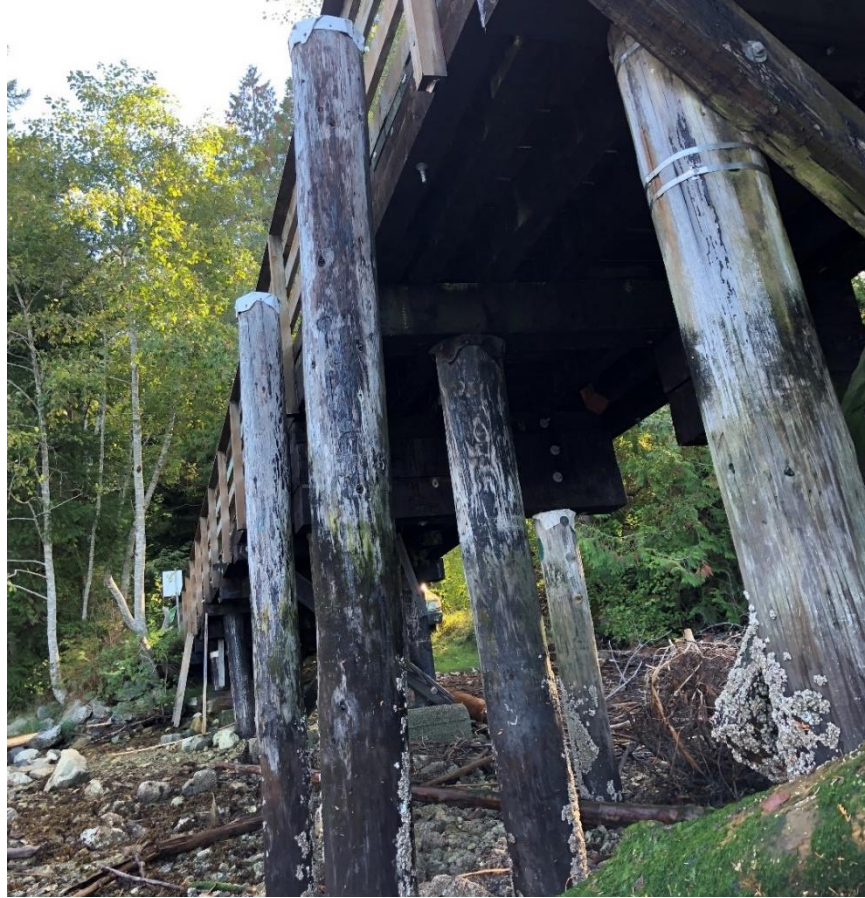
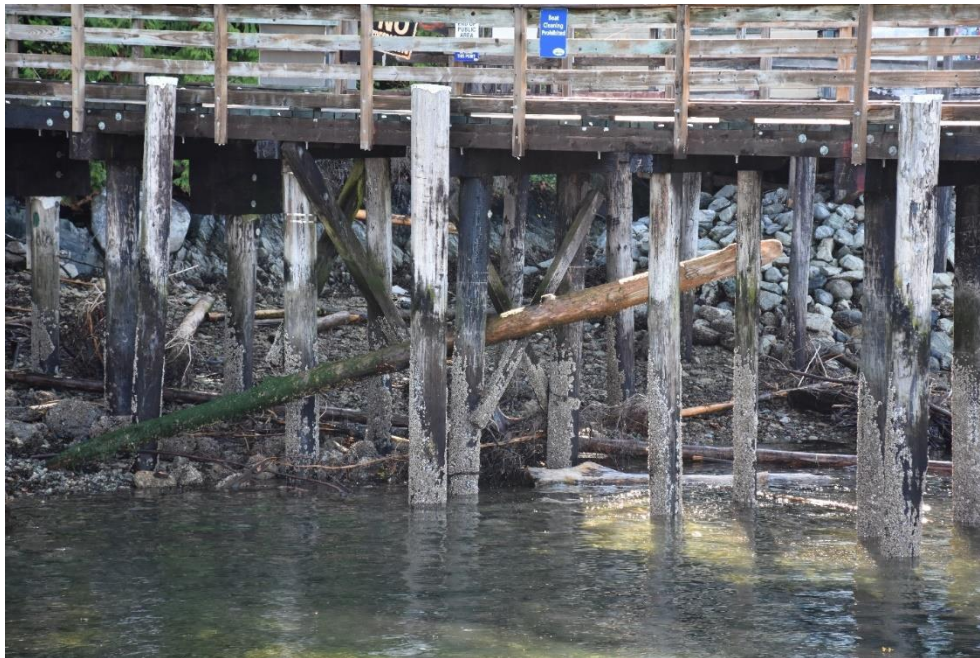
The timber fender piles are generally in fair condition, with no signs of significant deterioration or mechanical damage (Photo 29 to Photo 30).

*Photo 29 - North end fender piles*

*Photo 30 - North end fender piles and log debris*

*McElhanney understands that the fender piles are not longer used for vessel moorage and repairs are not considered necessary at this time. Continued monitoring of the fender piles is recommended.*

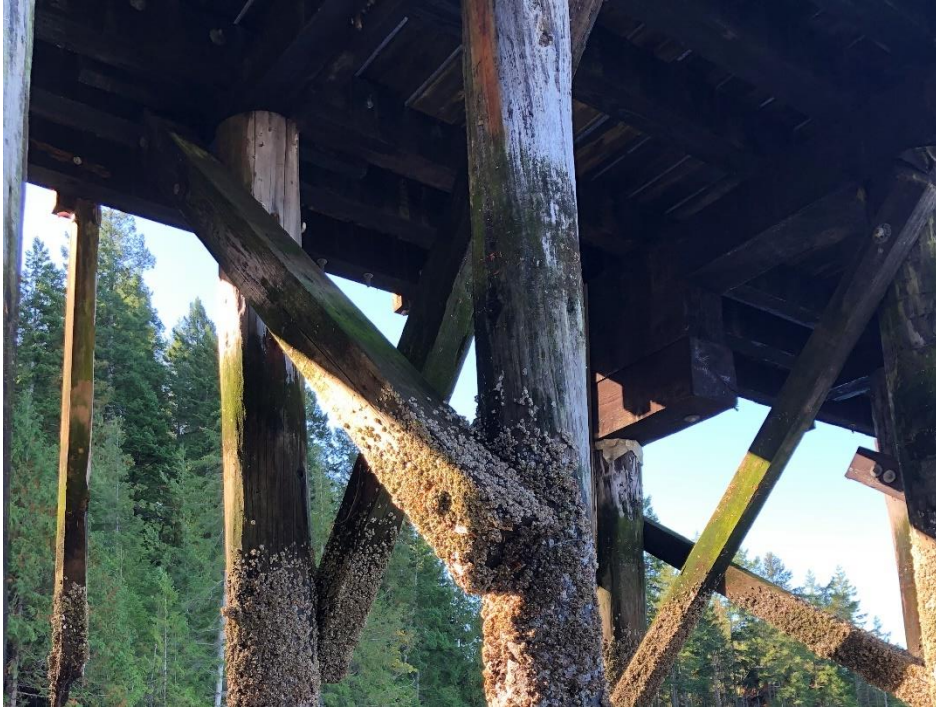
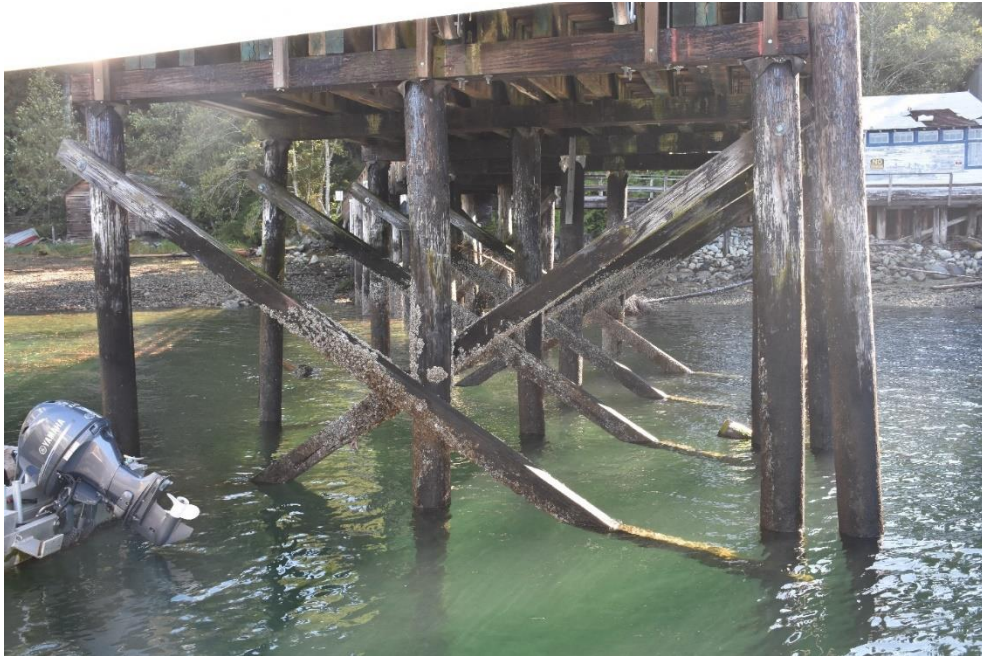
The timber cross bracing is generally in fair to good condition (Photo 31 to Photo 32). Inspection findings are as follows:

- There is widespread weathering, and minor fungal decay to the end grains of the members, however all cross braces appear well secured to the piles.
- There are two locations where timber log debris is trapped under the wharf structure and is resting on the cross-bracing. (Photo 33 to Photo 34).
- It appears a timber member was added as a side brace from the deck to pile 11B, however it is no longer secured to the pile and is hanging from the deck (Photo 35).

*Photo 31 - General condition of the Cross Bracing*

*Photo 32 - General view of Cross Bracing*

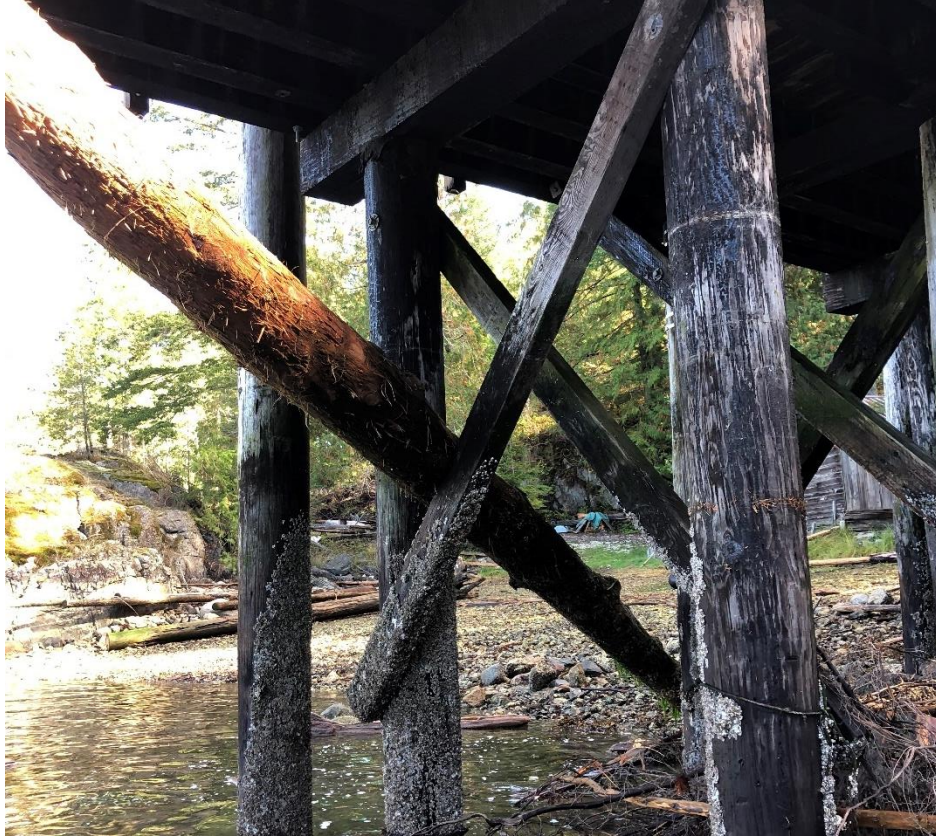
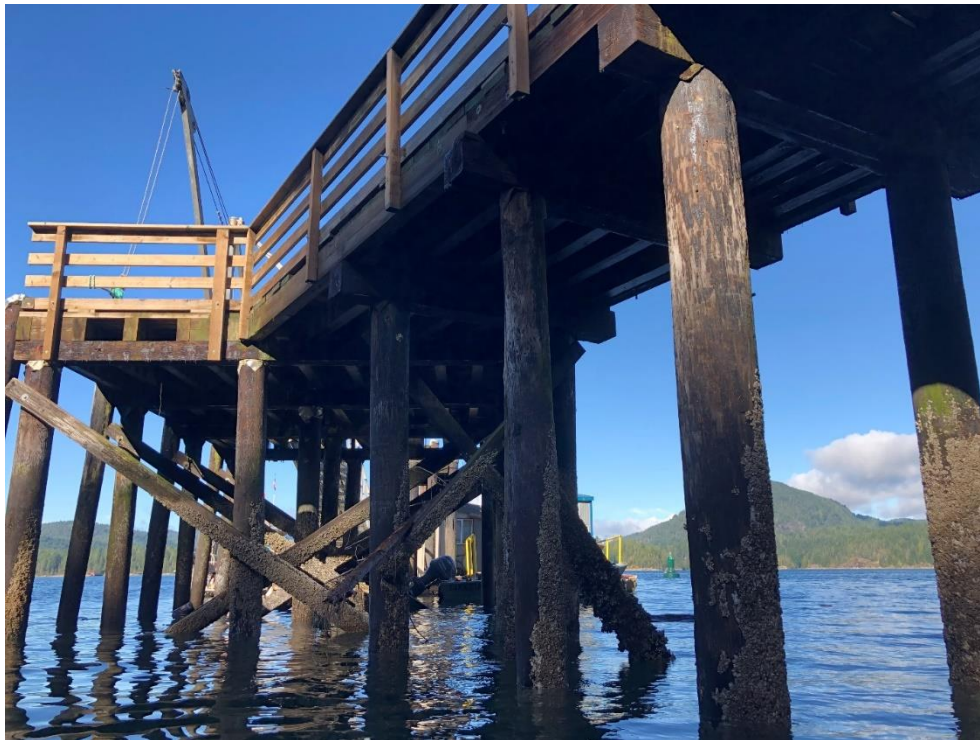
*Photo 33 - Log resting on the Cross Bracing*

*Photo 34 - Log resting on the Cross Bracing*

*It is recommended that the timber log debris and the hanging side brace at pile 11B are removed. Ongoing monitoring of the cross bracing is recommended.*
