April 11<sup>th</sup>, 2022 | Revision 0

# **Marine Facility Condition Assessment of the Surge Narrows Wharf**

Submitted to: Strathcona Regional District (SRD)  
Prepared by McElhanney Ltd.

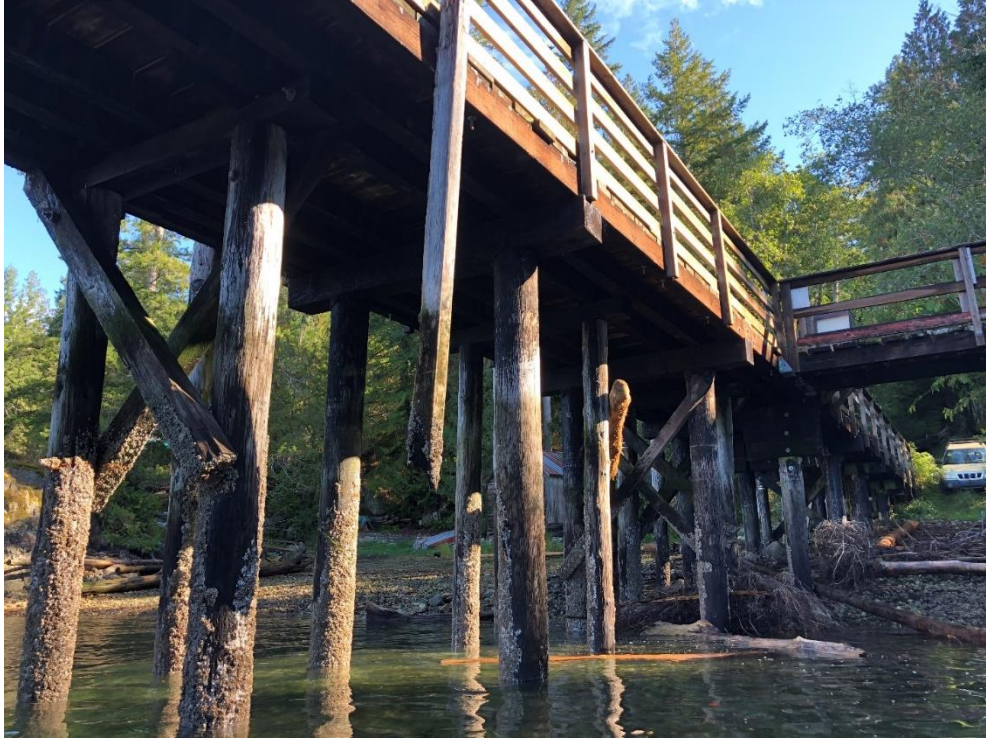
- There is widespread weathering, and minor fungal decay to the end grains of the members, however all cross braces appear well secured to the piles.
- There are two locations where timber log debris is trapped under the wharf structure and is resting on the cross-bracing. (Photo 33 to Photo 34).
- It appears a timber member was added as a side brace from the deck to pile 11B, however it is no longer secured to the pile and is hanging from the deck (Photo 35).

*Photo 35 - Hanging side brace at pile 11B*

*It is recommended that the timber log debris and the hanging side brace at pile 11B are removed. Ongoing monitoring of the cross bracing is recommended.*

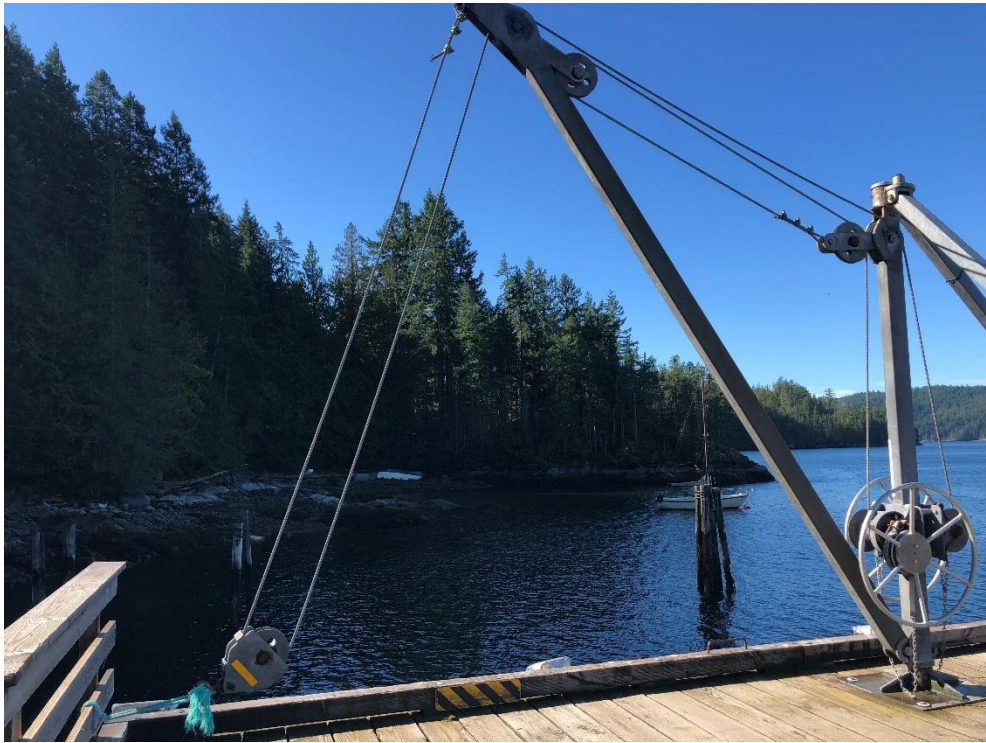
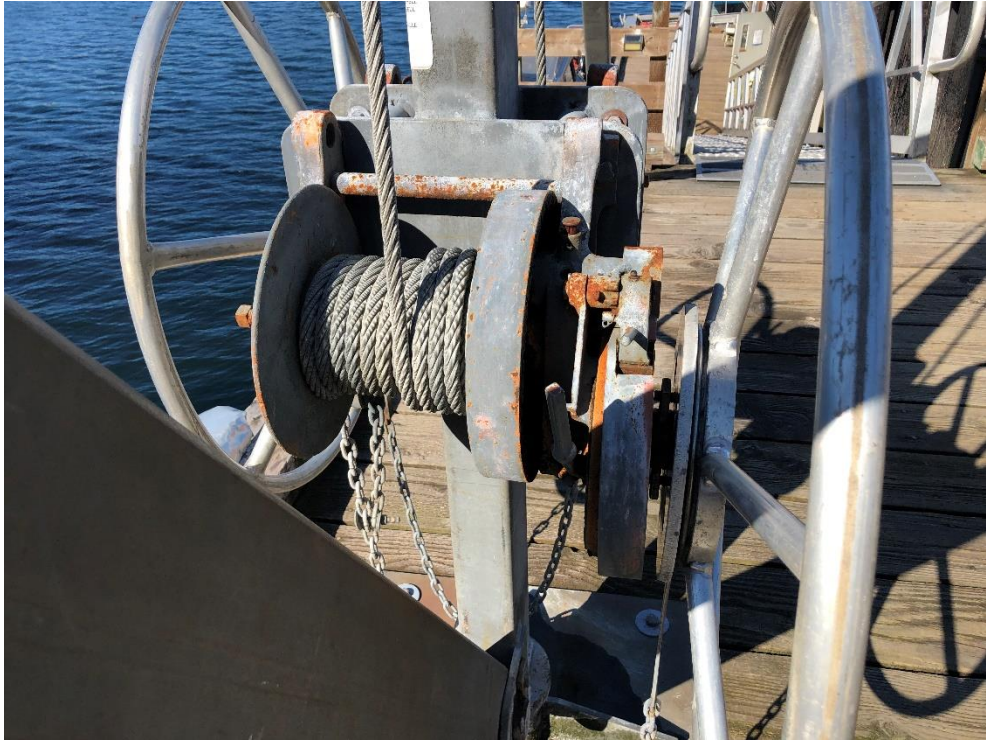
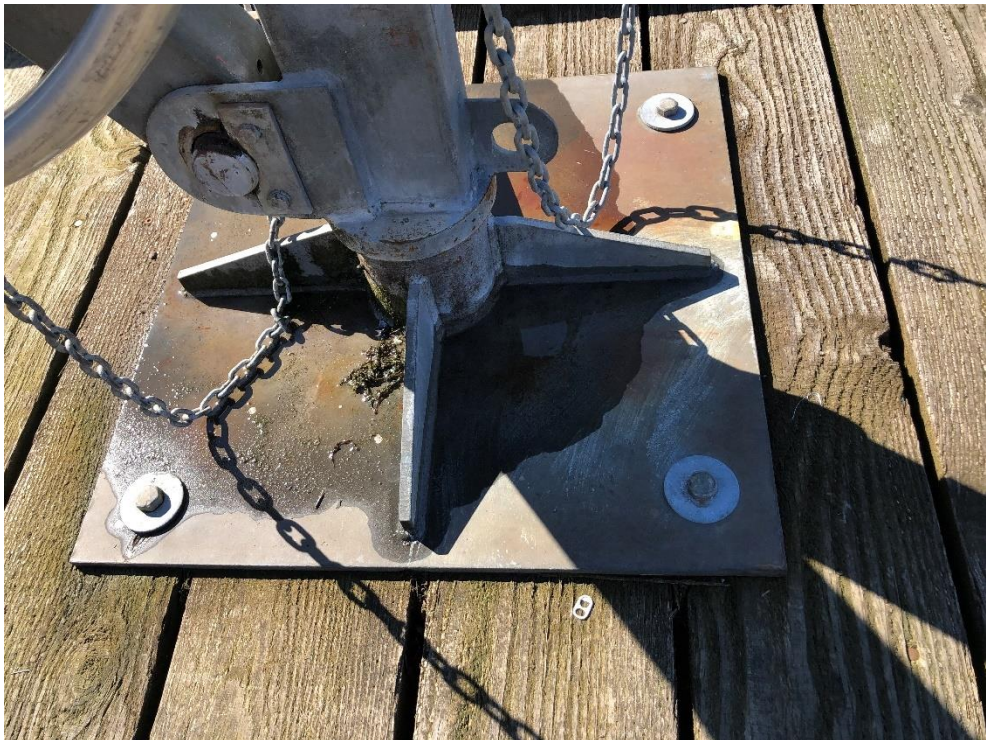
The Derrick Loading Crane appears to be in fair condition with signs of corrosion (Photo 36 to Photo 38). The crane appears to still be in use. The hanging tackle is being secured to the timber handrails with a rope.

*Photo 36 - Derrick Loading Crane*

*Consideration should be given to removing the crane if usage cannot be monitored.*

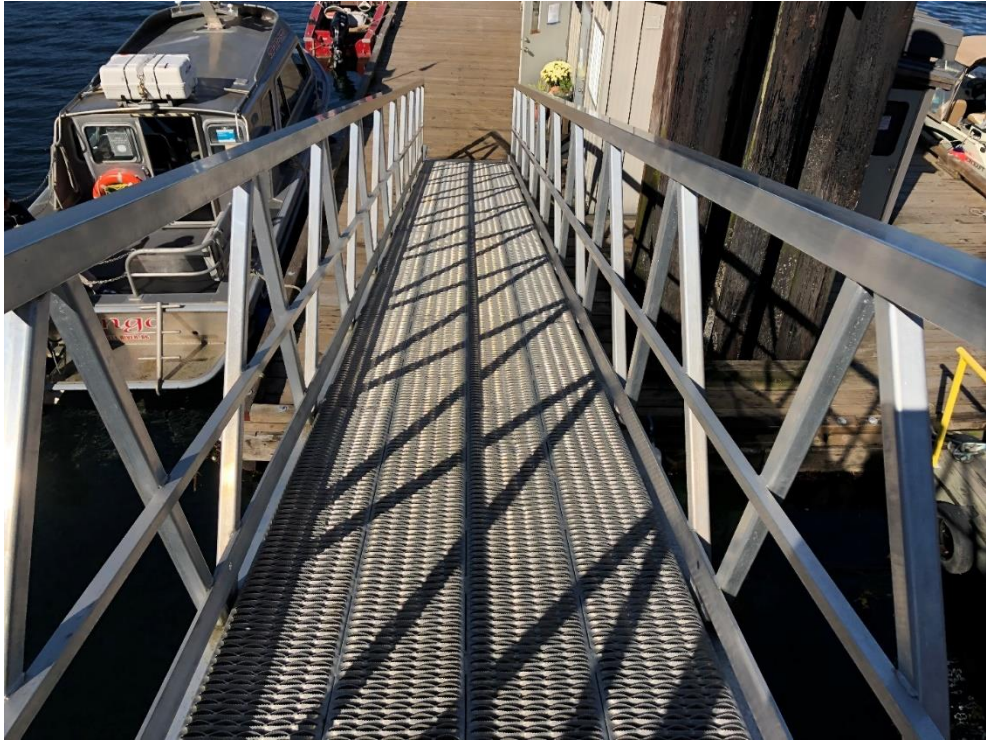
The access gangway is in good condition with no significant corrosion or deterioration of the welded connections (Photo 39). According to the repairs drawings it was replaced in 2013. The inspection findings are as follows:

*Photo 39 - General View of Aluminum Gangway*

*Repairs are not considered necessary at this time; however ongoing monitoring of the gangway is recommended.*

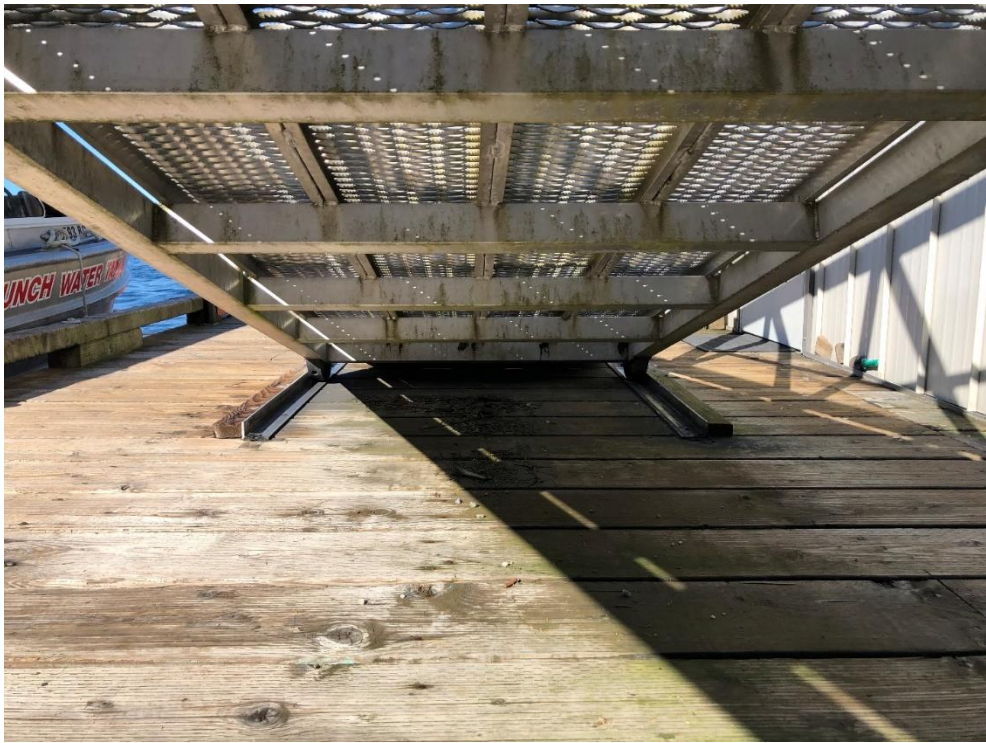
- The gangway slider plate is in good condition and is well aligned with the gangway rollers (Photo 40).
- The upper hinge connections are well aligned, and the bolted connections are in good condition (Photo 41).

*Photo 40 - Gangway slider plate and rollers*

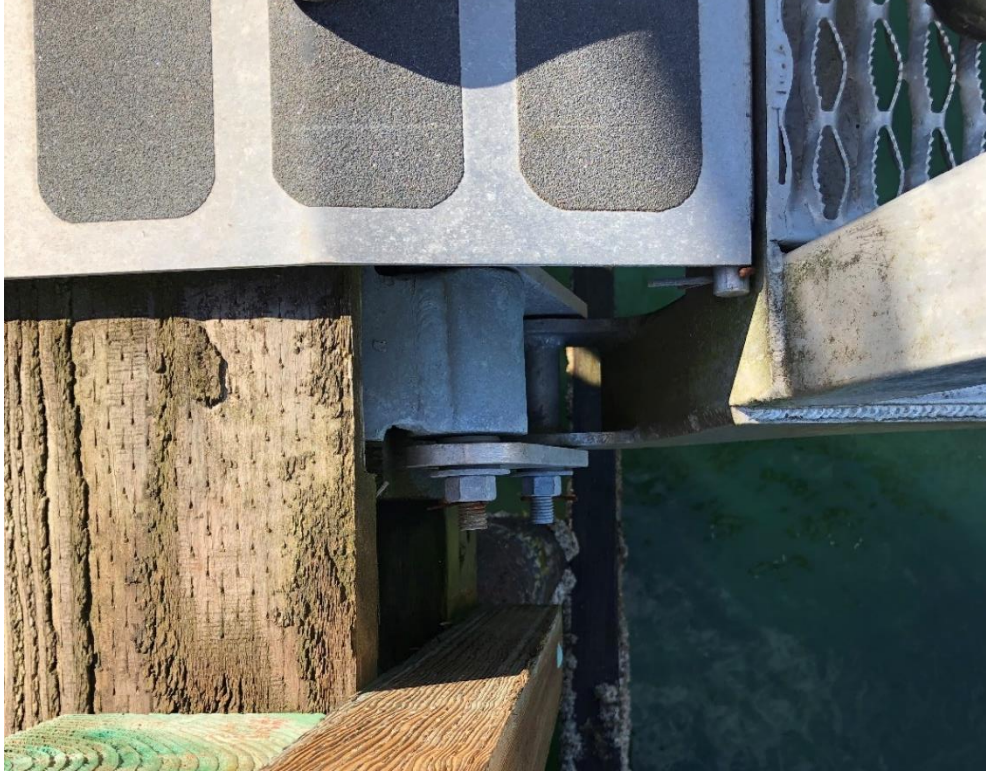
*Photo 41 - Gangway Upper Hinge Connection*

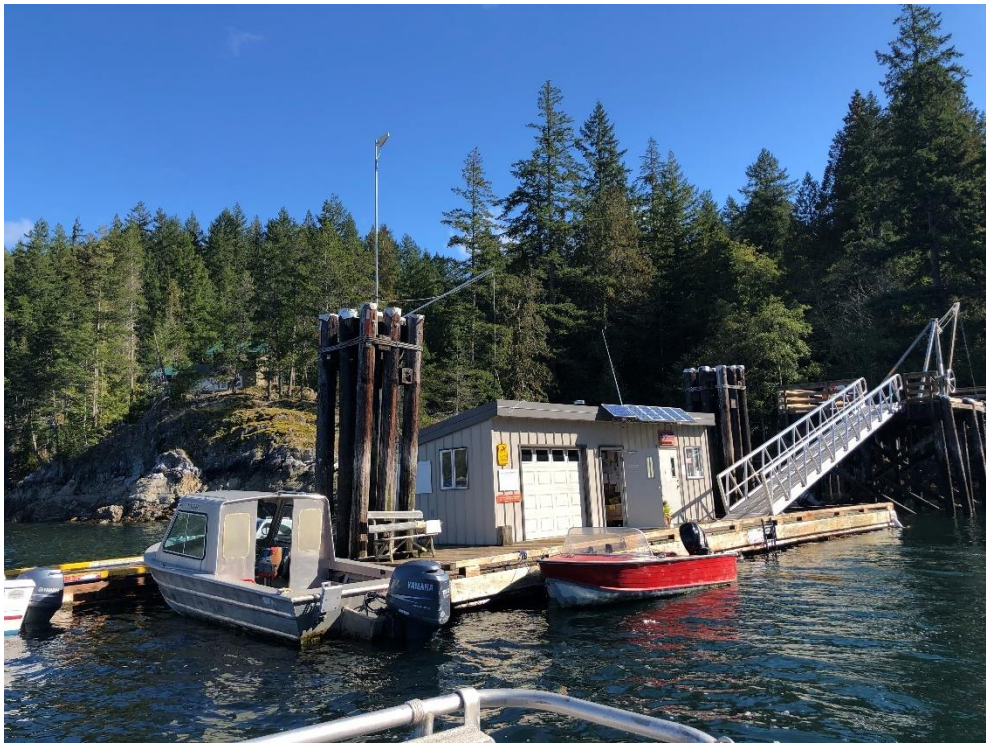
The main float is in fair condition (Photo 42). Inspection findings are as follows:

*Photo 42 - General View of the Main Float*

*Consideration should be given to adding and/or replacing some of the flotation elements to improve the consistency of the freeboard of the main dock. Ongoing monitoring of the main float is recommended.*

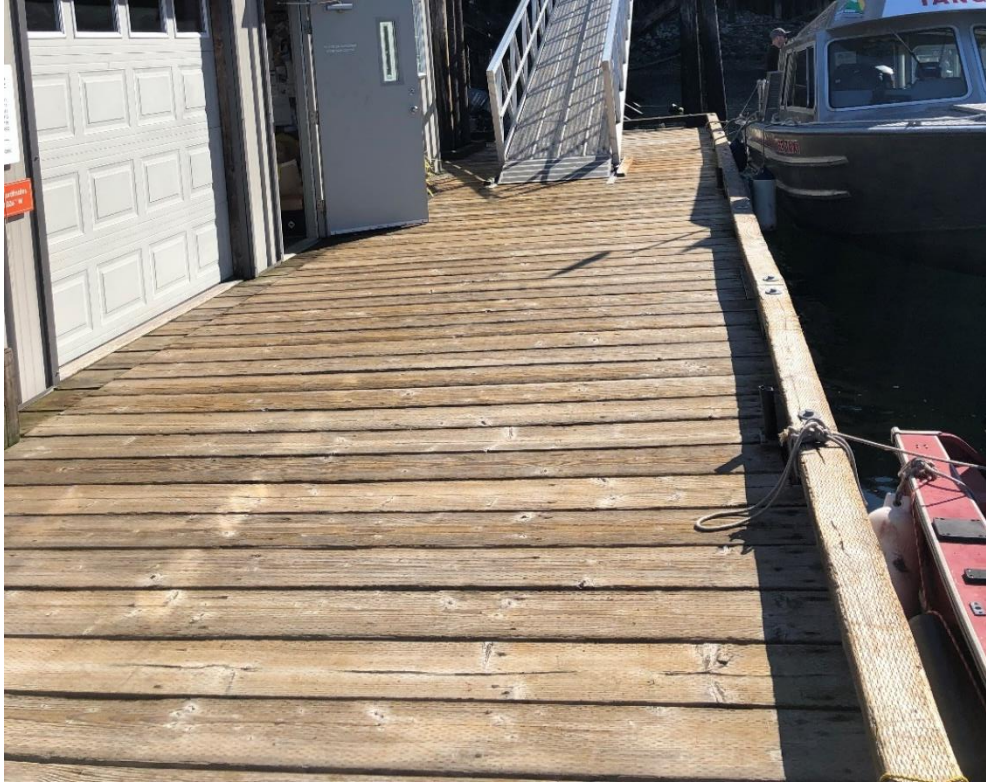
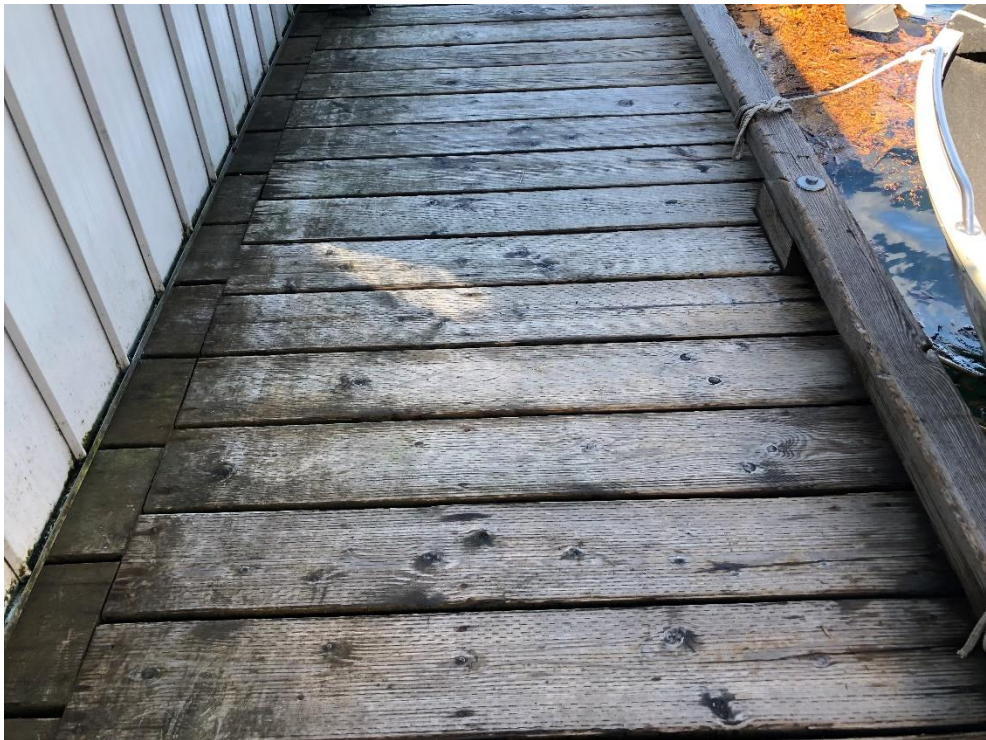
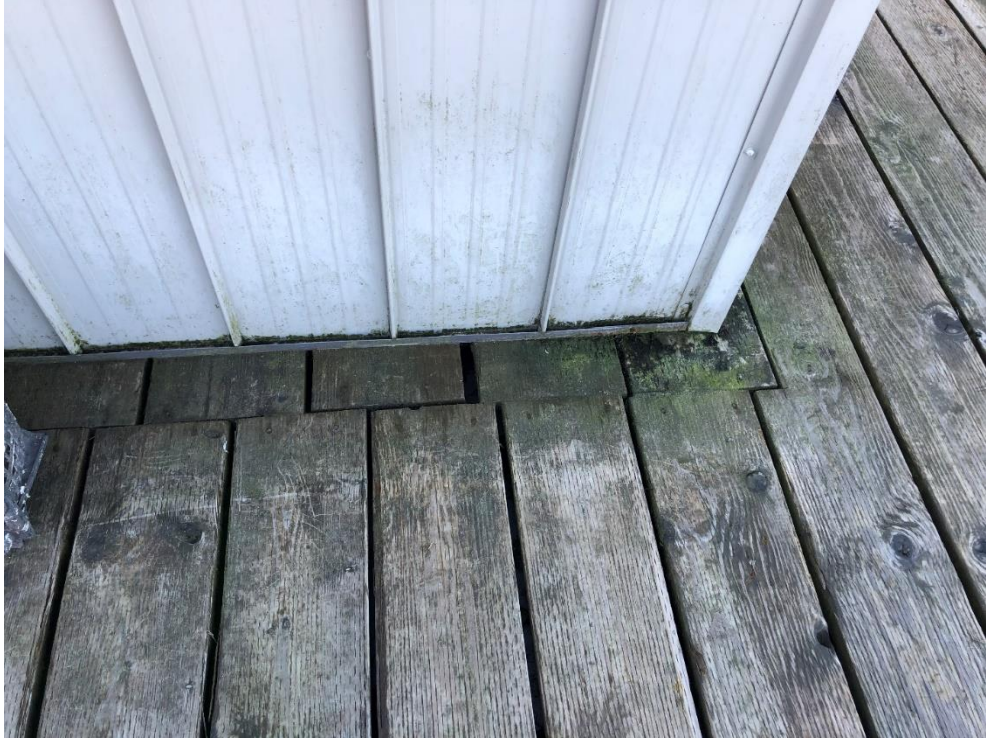
- The timber deck planks were replaced in 2013 and are in good condition with minor weathering (Photo 43 to Photo 45).
- The bull rails and fascia board are in fair to good condition, with minor weathering (Photo 46).
- The floating dock does not appear to have consistent floatation, with flotation loss of 6 inches noted at the middle east side of the float. It appears there are no floatation elements in this area, which is directly surrounding the mooring well (Photo 47 to Photo 49). Additionally, the freeboard at the north end of the dock is about 6 inches less than the south end. This could be due to the weight of the postal shed, which is further on the north end of the dock.
- The mooring piles and mooring dolphins have moderate abrasion with the dock structures (Photo 50 to Photo 57).

*Photo 43 - Typical condition of the Main Float deck*

*Photo 44 - Typical condition of the Main Float deck*

*Photo 45 - Typical condition of the deck beneath the postal shed*

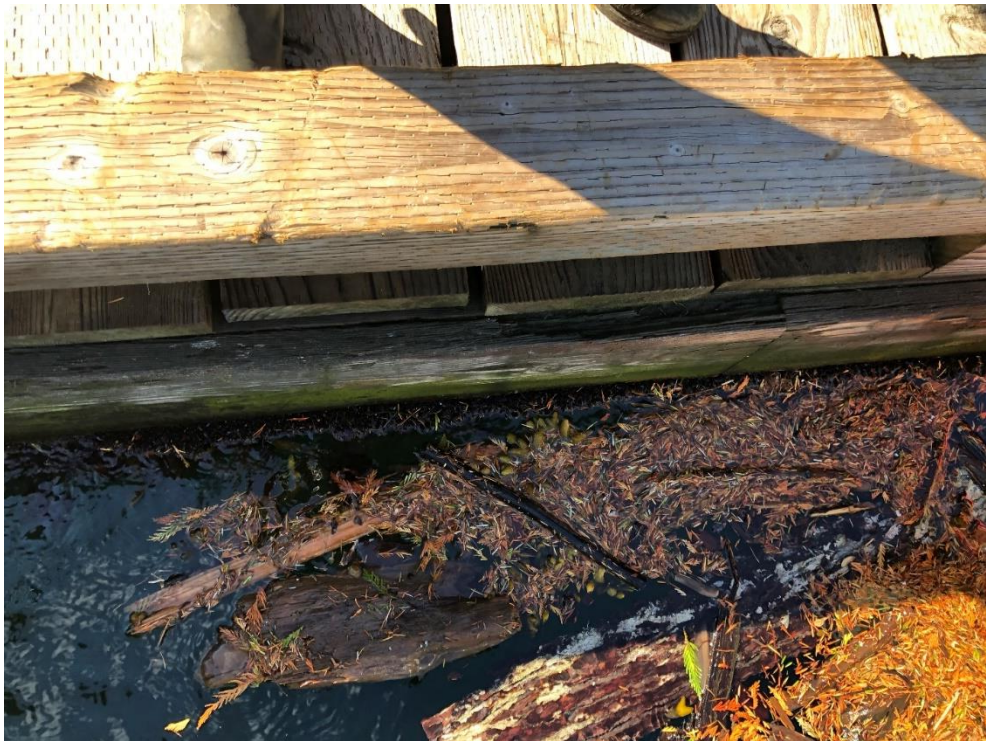
*Photo 46 - Typical condition of the timber bull rails and fascia board on the Main Float*

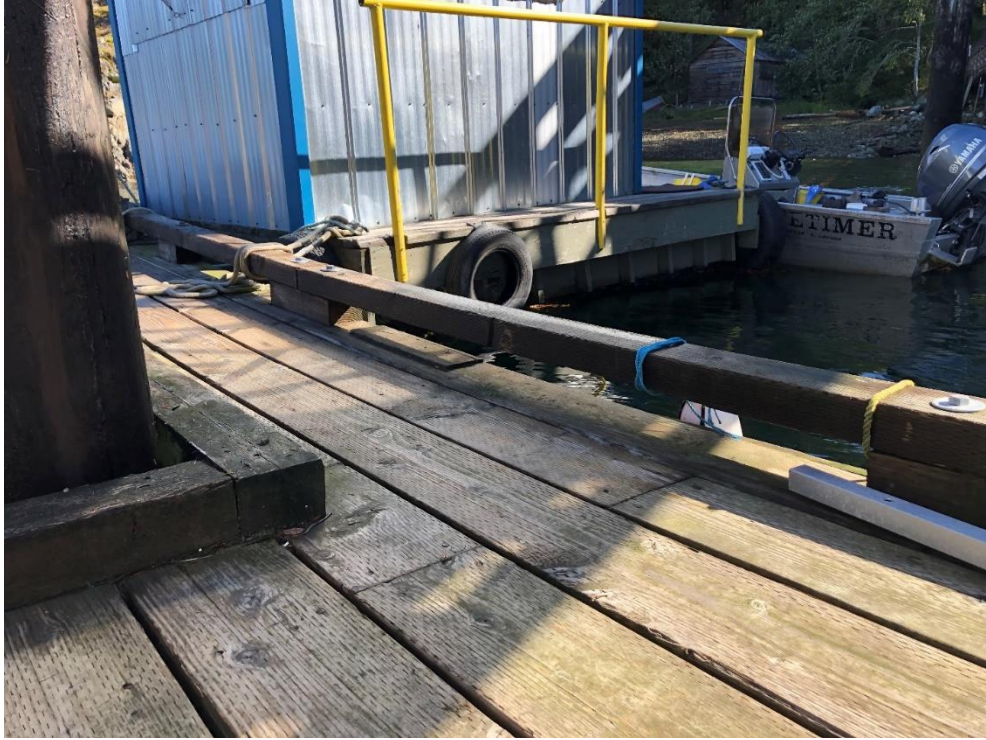
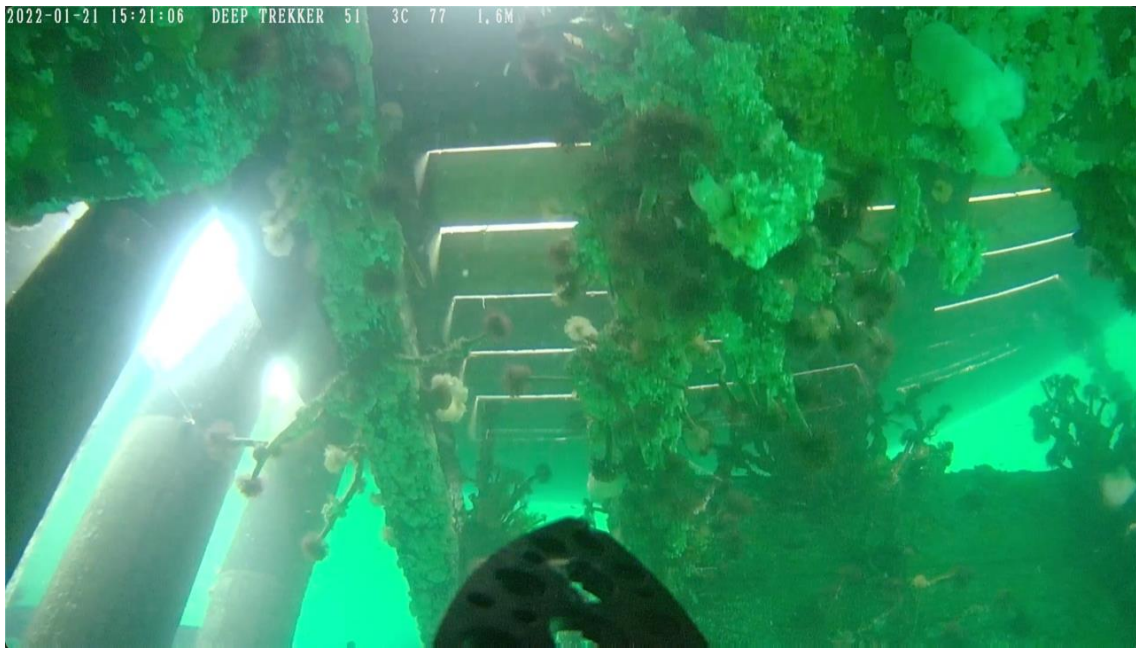
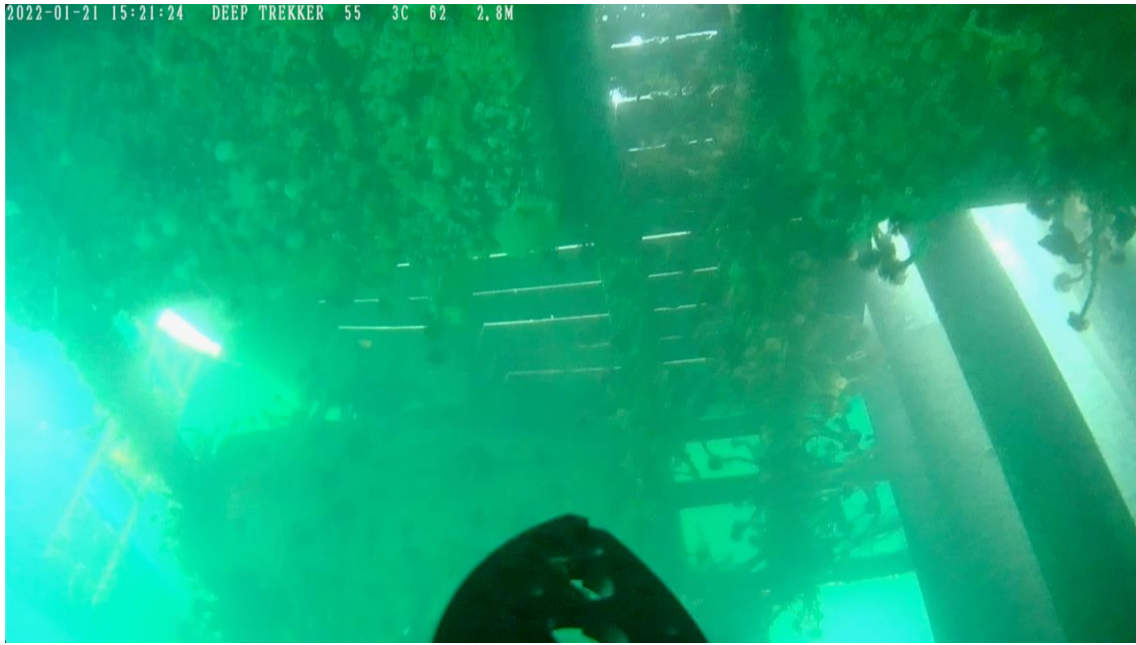
*Photo 47 - Flotation loss at centre of the Main Float on the east end*

*Photo 48 - Main Float on the east end*

*Photo 49 - Main Float on the east end*

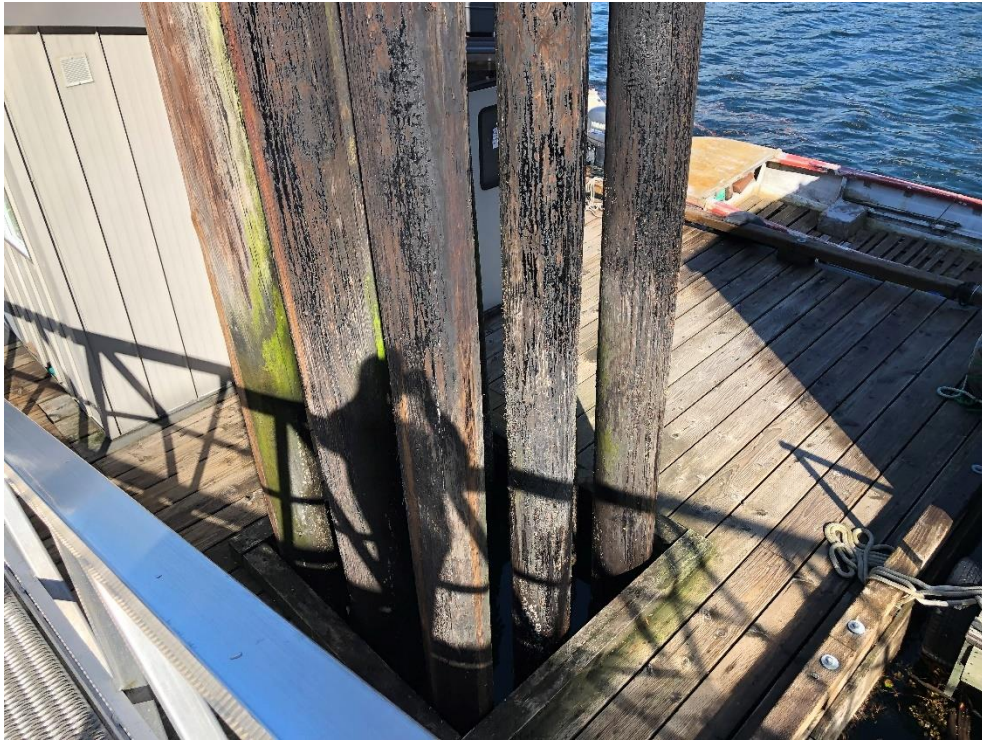
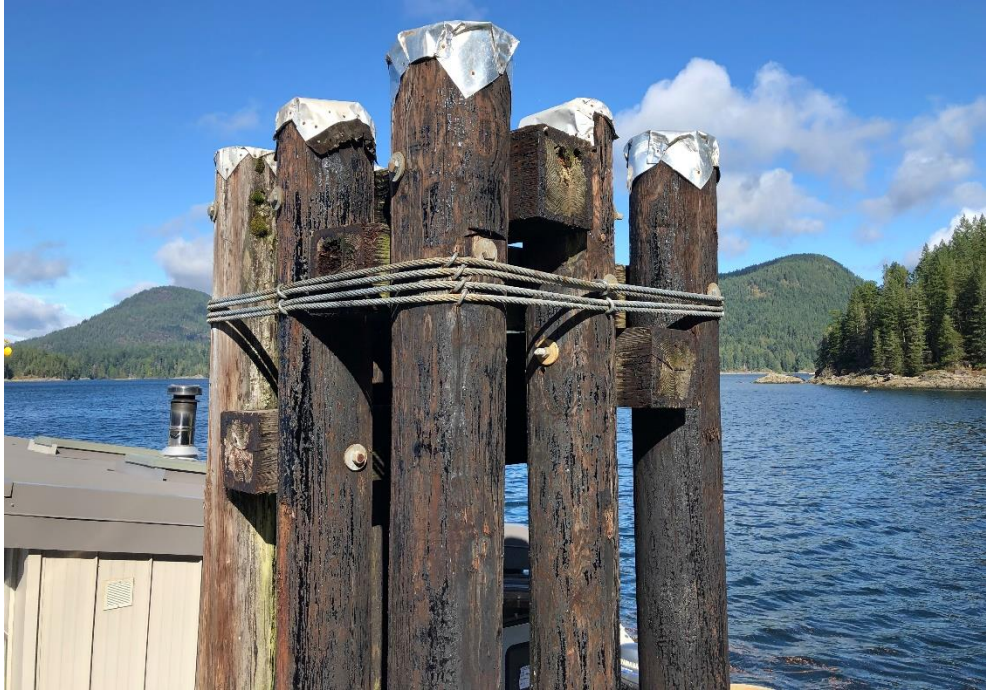
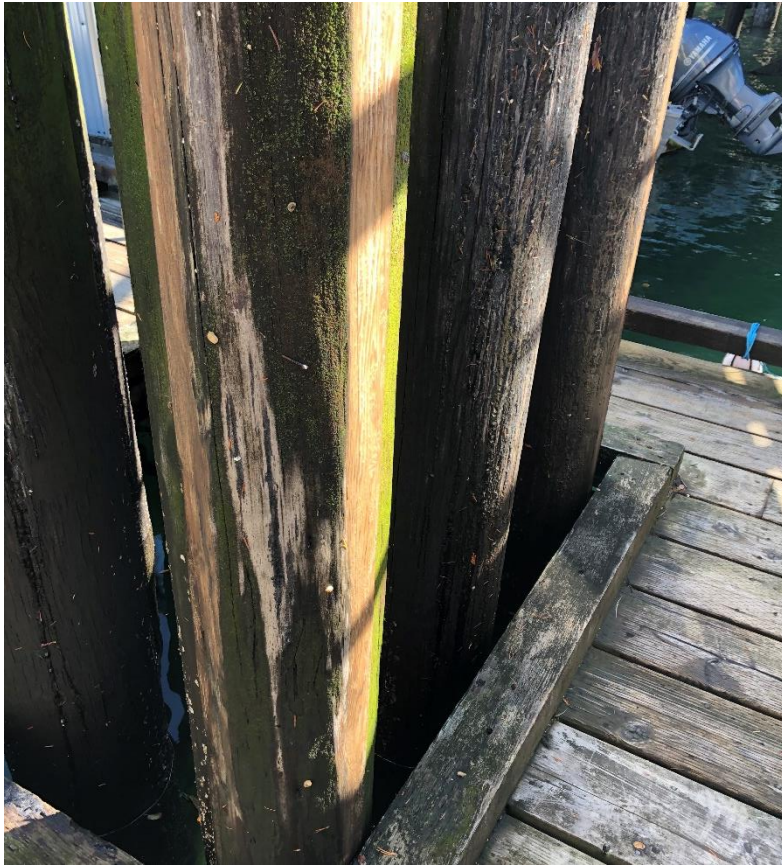
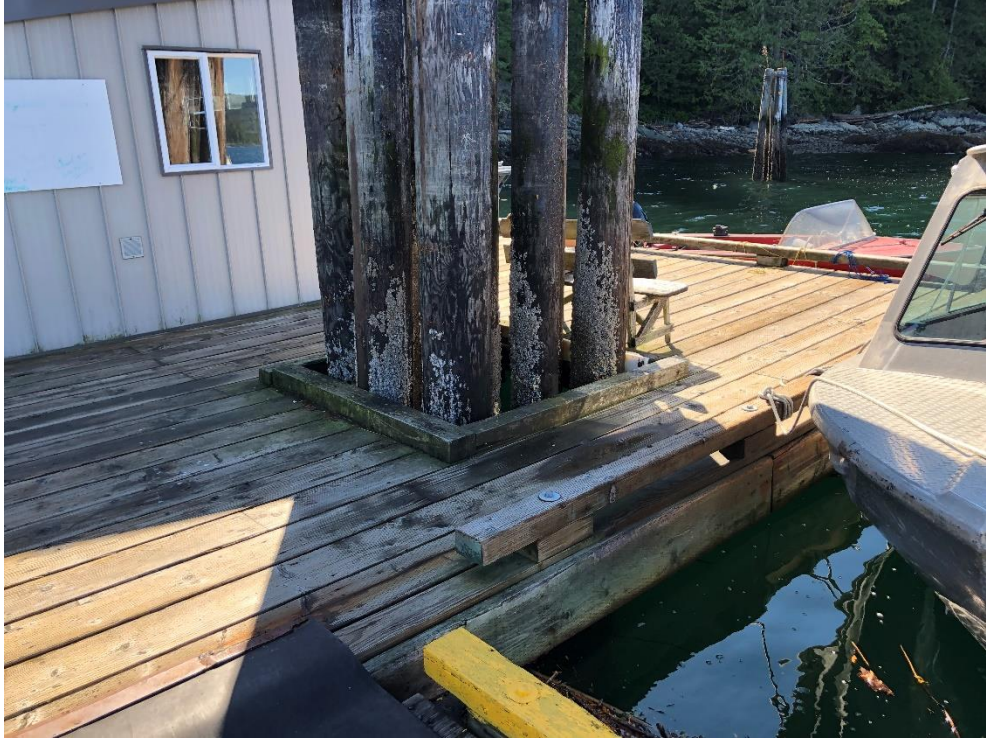
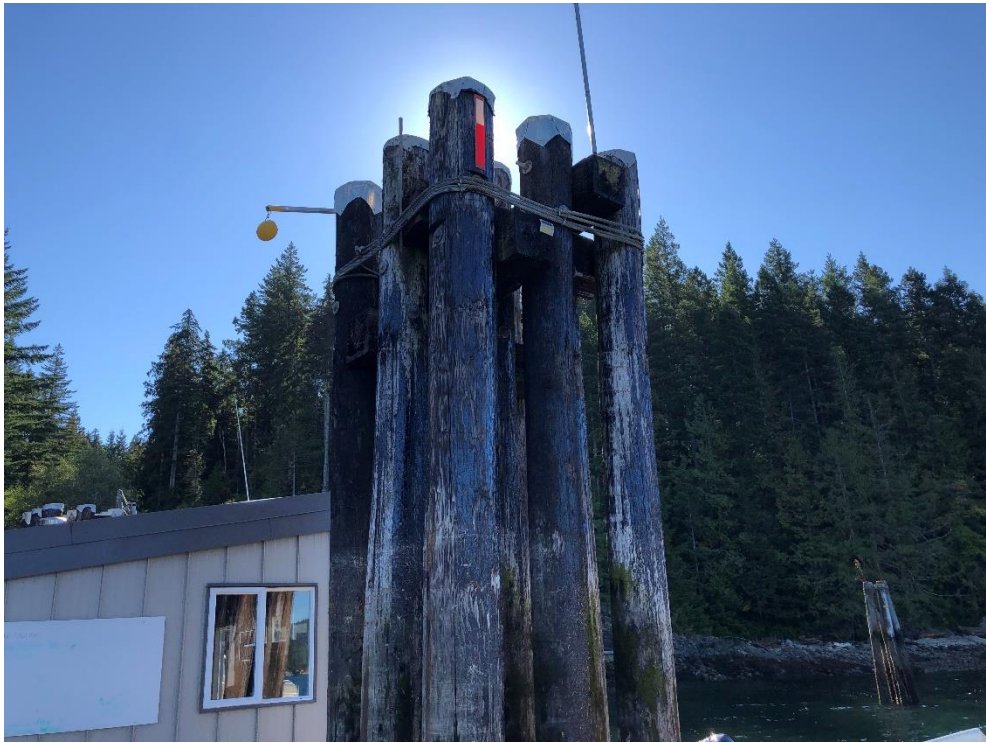
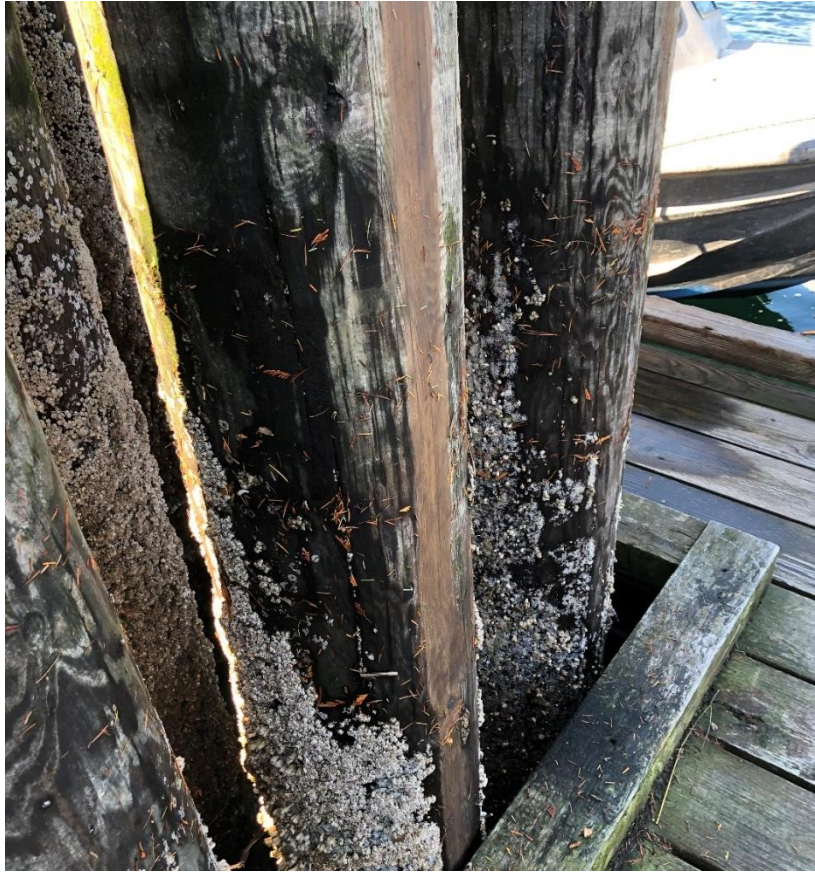
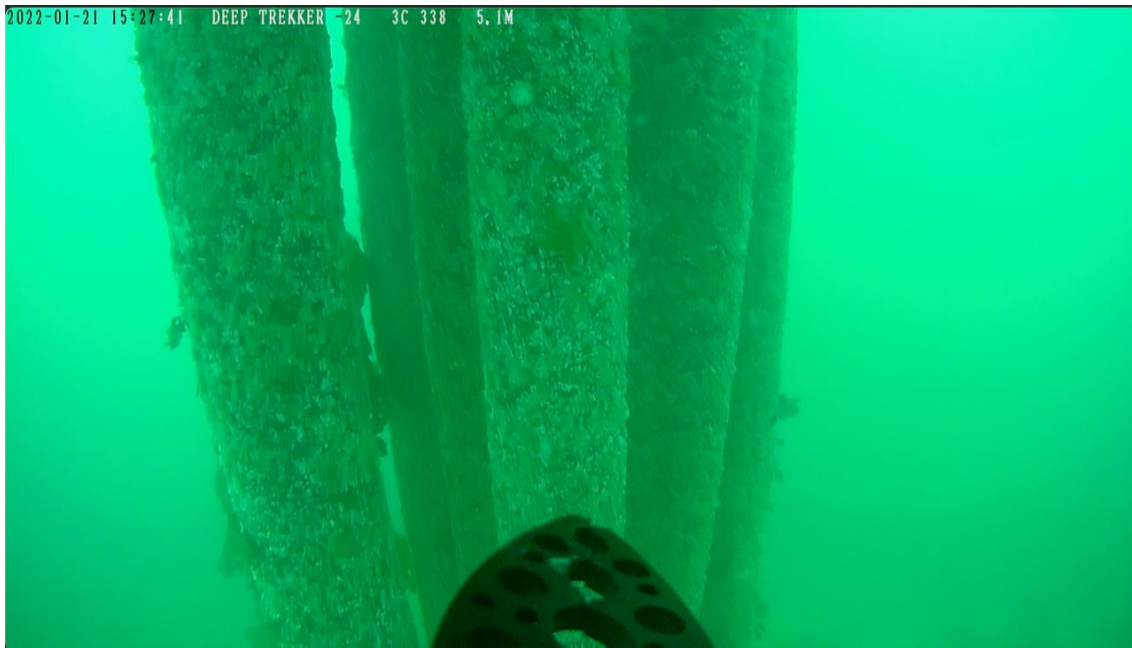
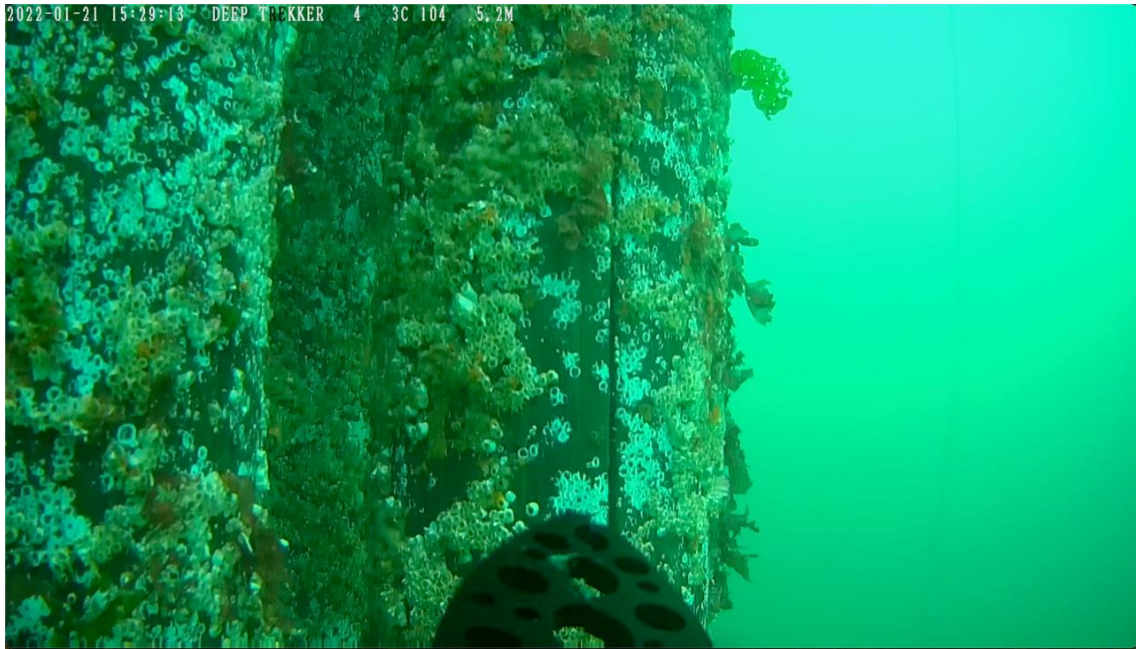
*Photo 50 - East end Mooring Piles*

*Photo 55 - West end Mooring Piles – up to 10% CSL*

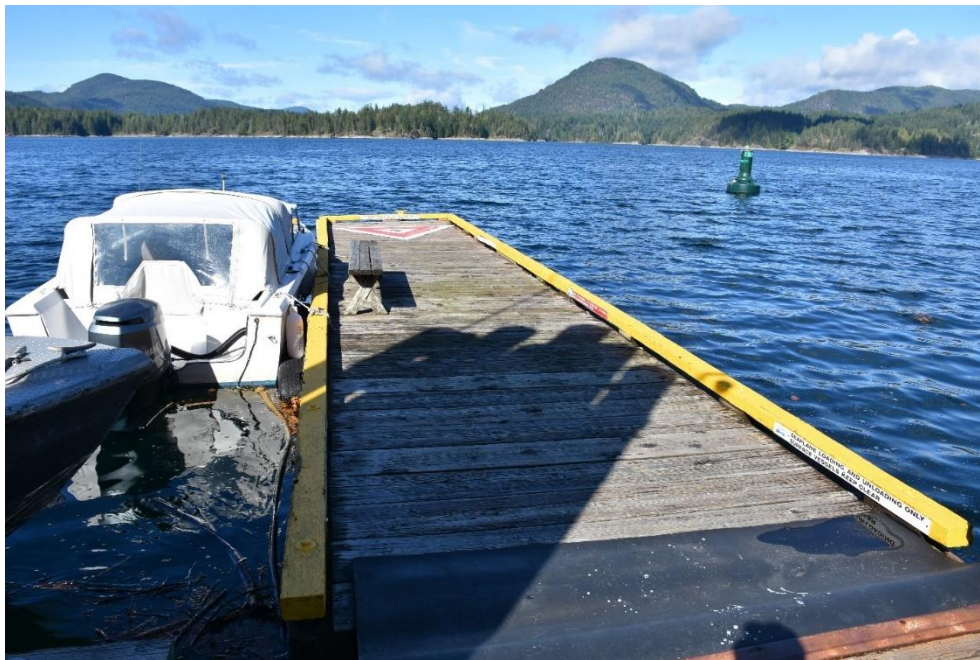
The seaplane float is in fair condition (Photo 58). Inspection findings are as follows:

*Photo 58 - General view of the Seaplane Float*

*Consideration should be given to replacing the seaplane float along with the mooring system rather than continue regular minor maintenance/repairs. Consideration should also be given to the addition of a security gate to prevent access to the seaplane float.*

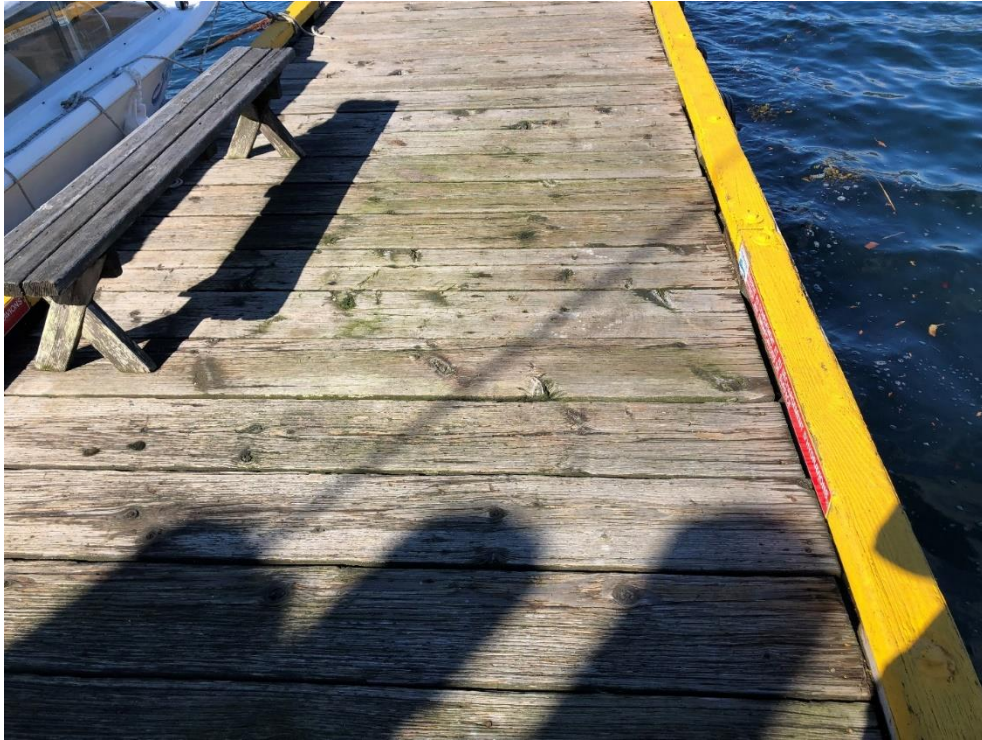
- The timber deck planks, bull rails and fascia boards have widespread weathering and fungal decay (Photo 59 to Photo 60).
- On the north end of the seaplane float, rubber tires have been bolted to the fascia boards as fenders (Photo 60).
- There is some floatation loss at the west side of the seaplane float end, with the freeboard approx. 5 inches less than the east side. Additionally, the seaplane float freeboard is about 5 inches less than the main float, resulting in a step down between the docks which may pose a tripping hazard. A rubber mat has been installed as a transition mat (Photo 61).
- The seaplane float is secured by mooring anchor chains, on concrete anchors.

*Photo 59 - Typical condition of the Seaplane Float deck*

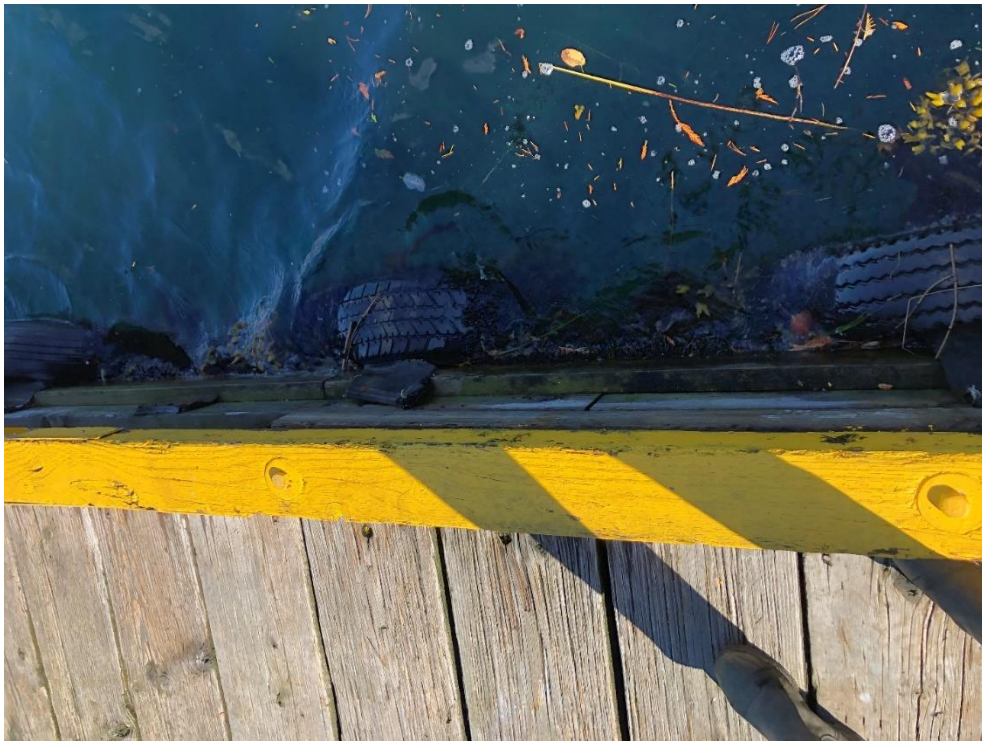
*Photo 60 - Typical condition of the timber bull rails, fascia board and rubber tire fendering on the Seaplane Float*

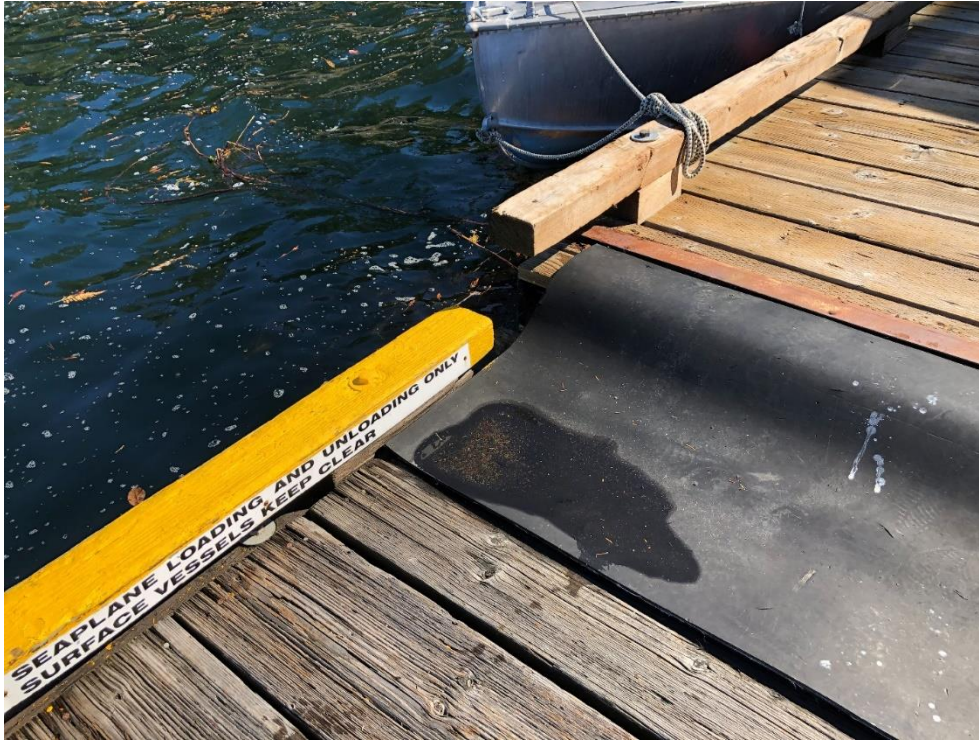
*Photo 61 - Transition from the Main Float to the Seaplane Float*
