RE: BYLAW NO. 487- ELECTORAL AREA C WHARVES SERVICE

FEASIBILITY STUDY

ELECTORAL AREA C WHARVES SERVICE

Marine Facility Condition Assessment of the Surge Narrows Wharf

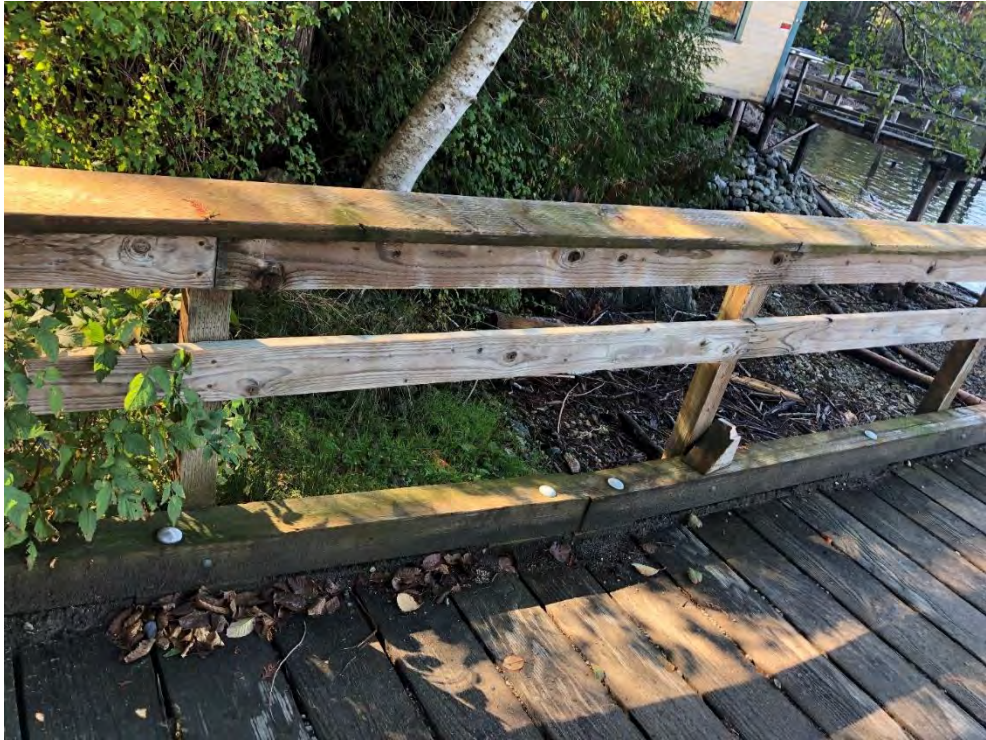
- The timber handrails are well secured and in good condition (Photo 4). These were replaced in 2013 according to the repair drawings by Herold Engineering. One section of the handrails on the south end is missing the lower mid-rail (Photo 5).
- The timber deck planks are in good condition with widespread minor weathering (Photo 6). All deck planks appear generally well secured. The decking was also replaced in 2013.
- There is one section along the wharf structure which leads to private property. This area is closed off to the general public (Photo 7).

Photo 5 - Missing lower mid-rail

The lower mid rail of the handrails should be installed where it is missing. Consideration should be given to removing access to the private property. Ongoing monitoring of the condition of the topsides is recommended.

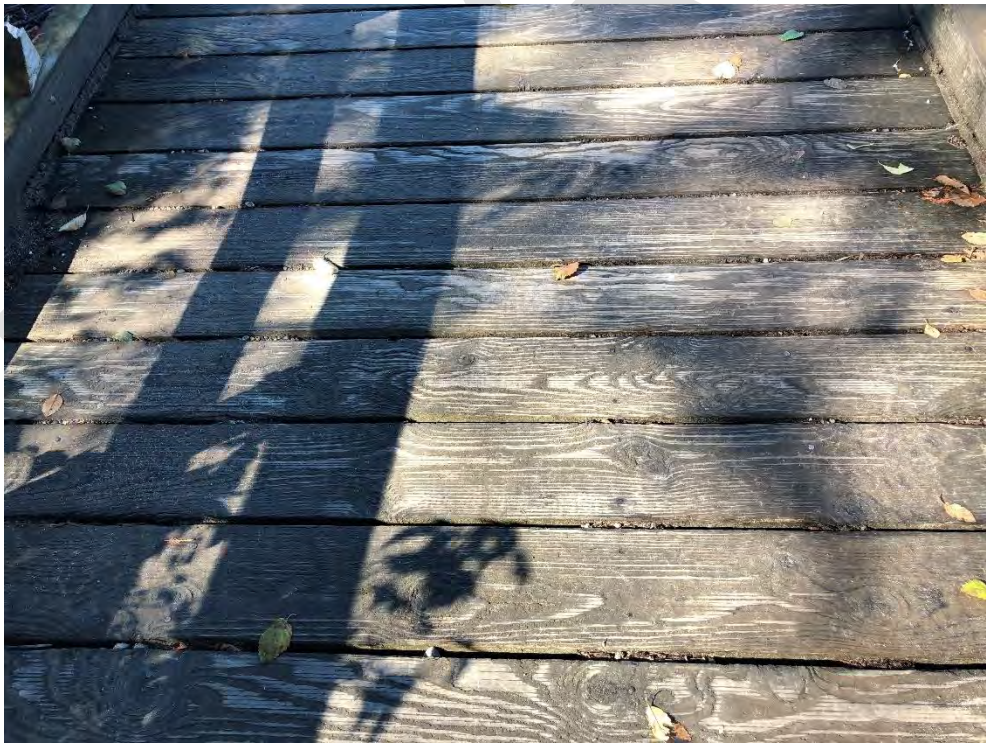
Photo 6 - Wharf Structure Decking

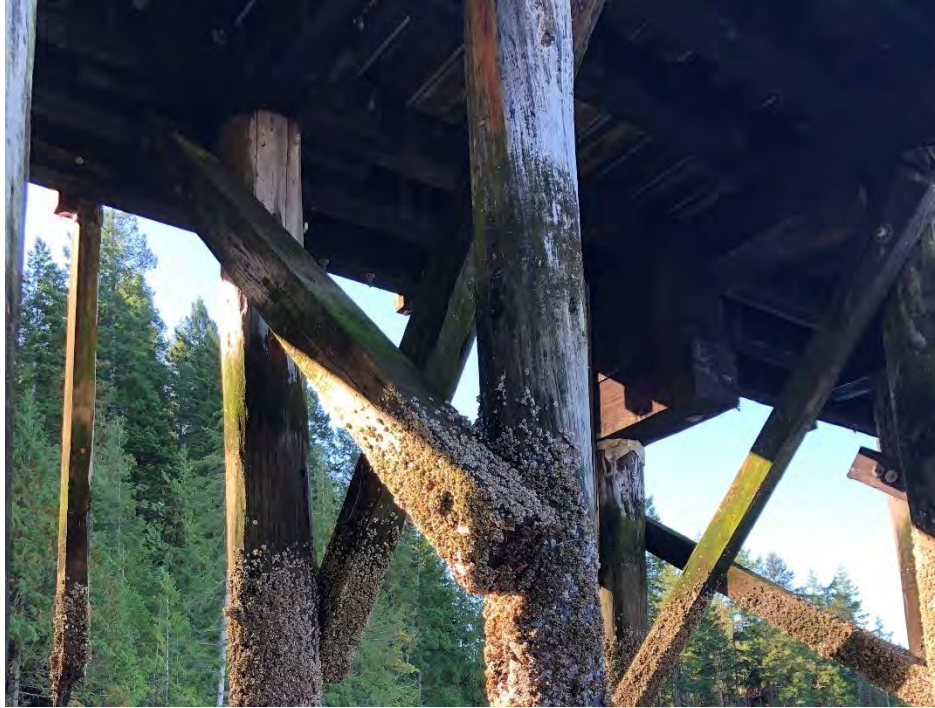
The timber cross bracing is generally in fair to good condition (Photo 31 to Photo 32). Inspection findings are as follows:

- There is widespread weathering, and minor fungal decay to the end grains of the members, however all cross braces appear well secured to the piles.
- There are two locations where timber log debris is trapped under the wharf structure and is resting on the cross-bracing. (Photo 33 to Photo 34).
- It appears a timber member was added as a side brace from the deck to pile 11B, however it is no longer secured to the pile and is hanging from the deck (Photo 35).

Photo 31 - General condition of the Cross Bracing

It is recommended that the timber log debris and the hanging side brace at pile 11B are removed. Ongoing monitoring of the cross bracing is recommended.

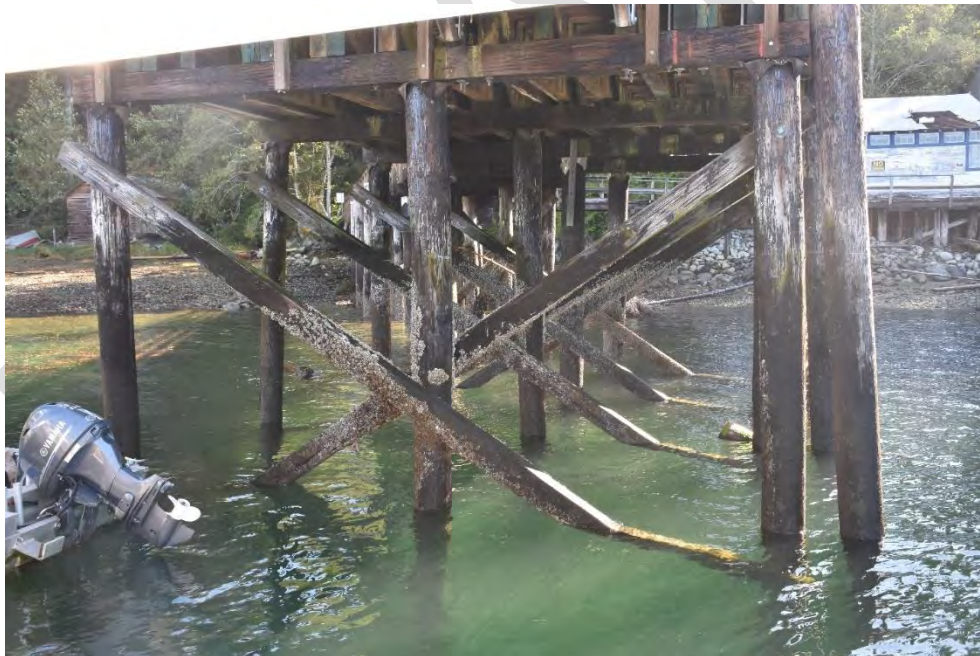
Photo 32 - General view of Cross Bracing

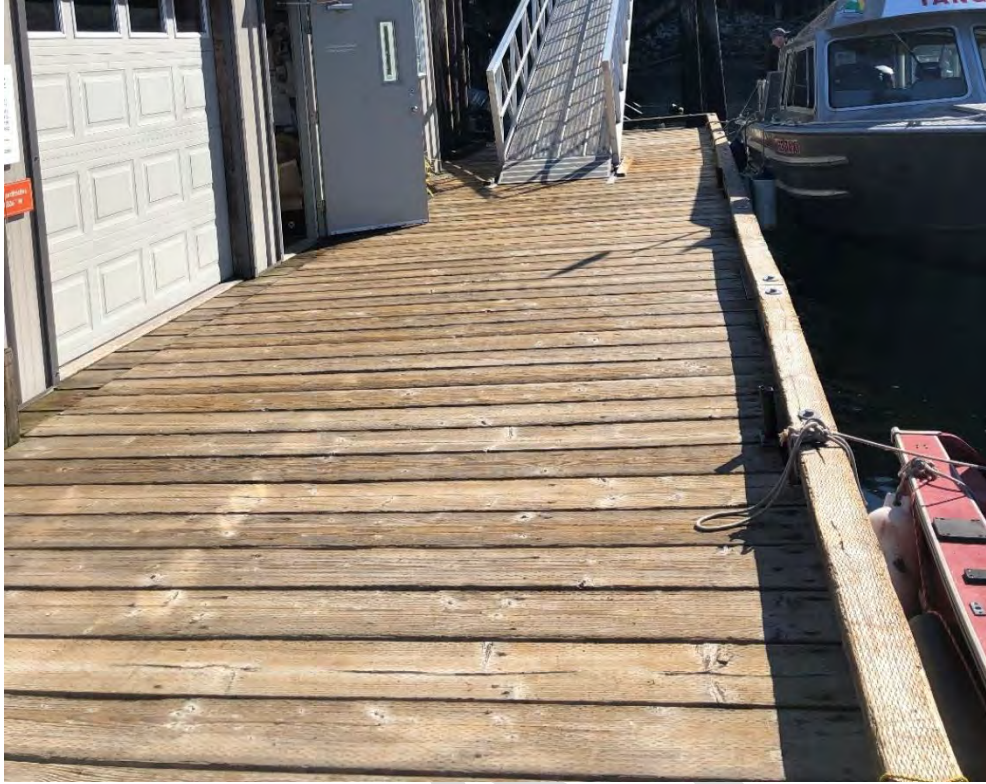
Photo 43 - Typical condition of the Main Float deck

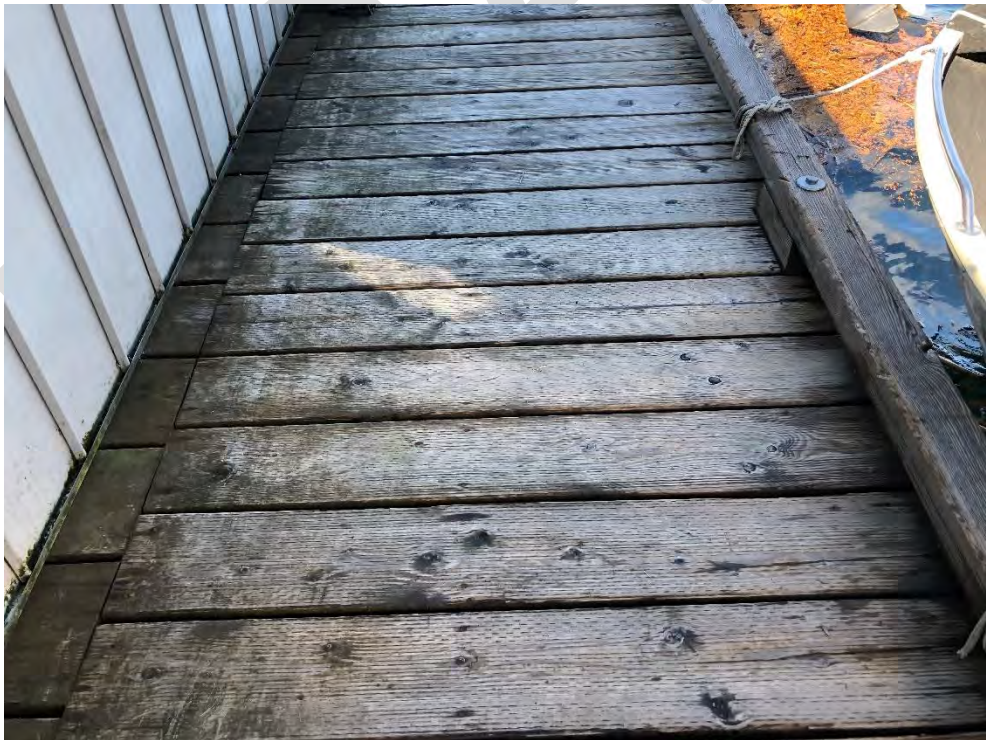
Photo 44 - Typical condition of the Main Float deck

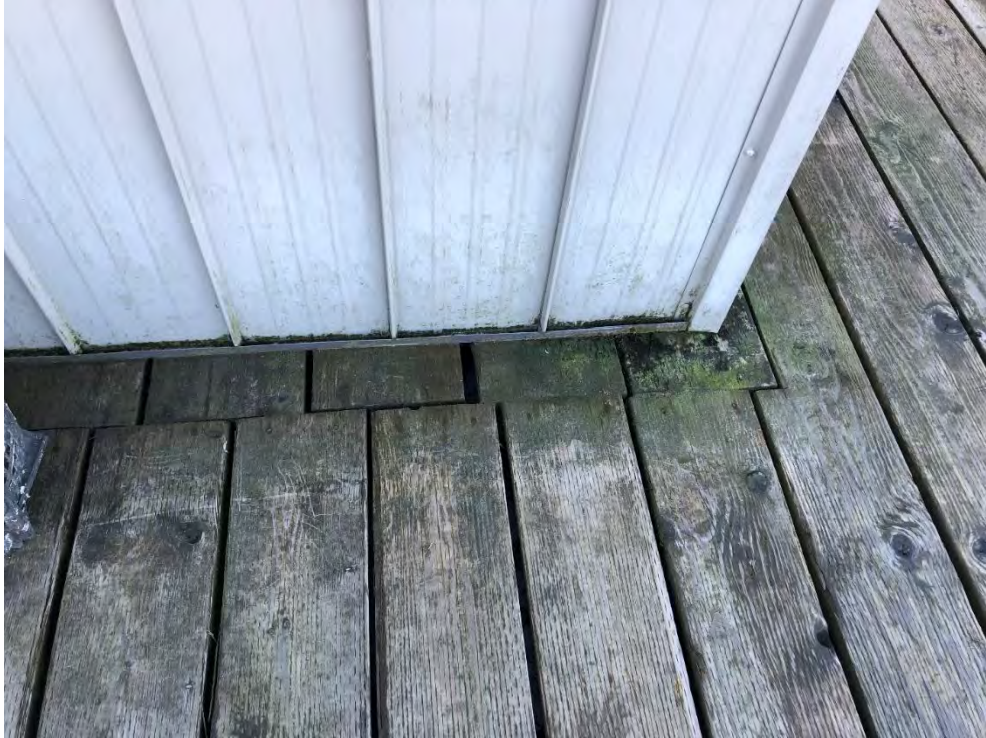
Photo 45 - Typical condition of the deck beneath the postal shed

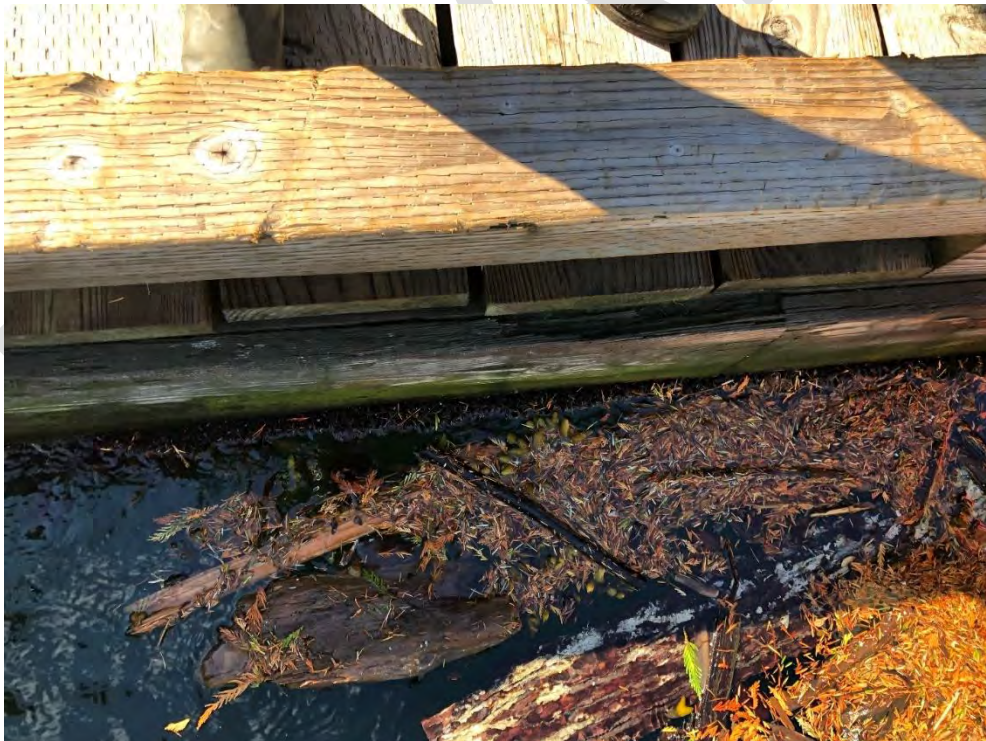
Photo 46 - Typical condition of the timber bull rails and fascia board on the Main Float

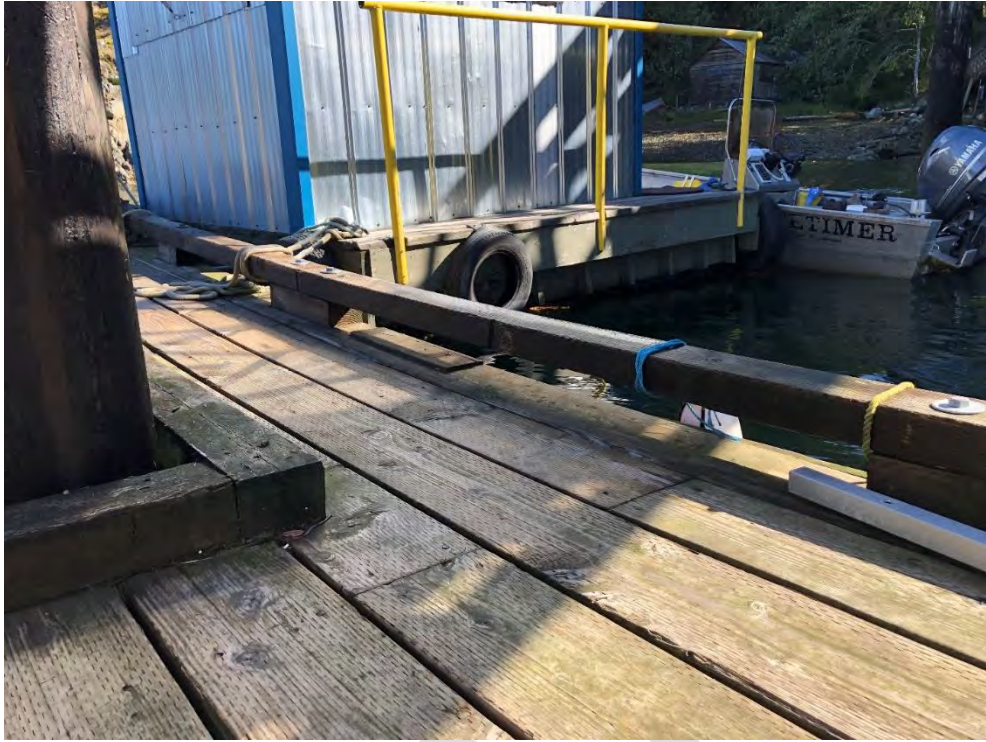
Photo 47 - Flotation loss at centre of the Main Float on the east end

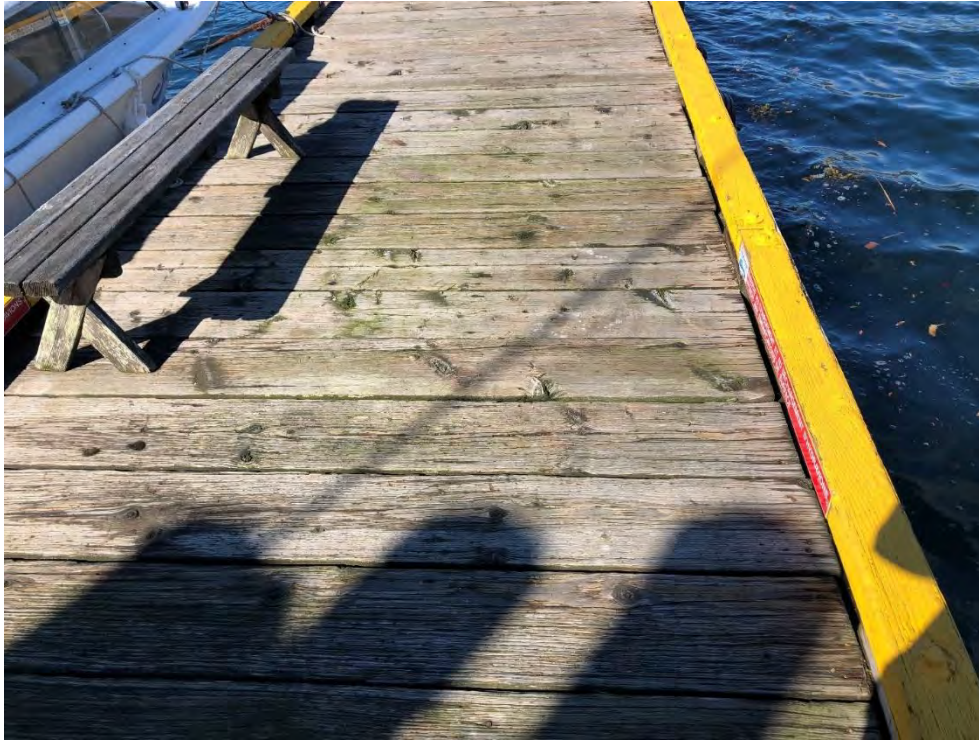
Photo 59 - Typical condition of the Seaplane Float deck

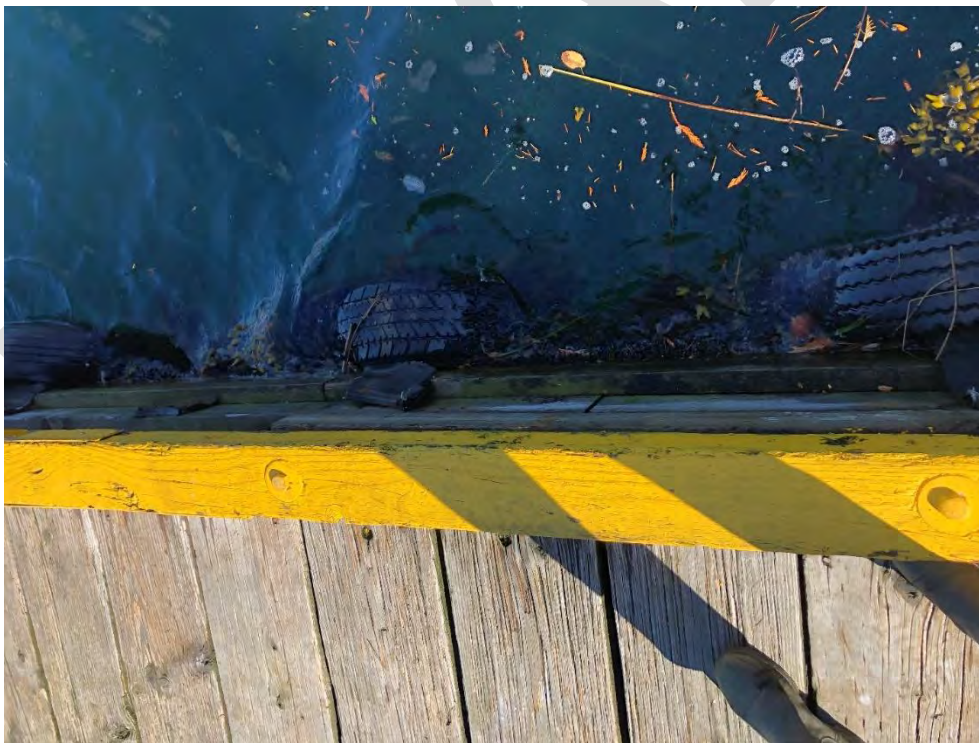
Photo 60 - Typical condition of the timber bull rails, fascia board and rubber tire fendering on the Seaplane Float

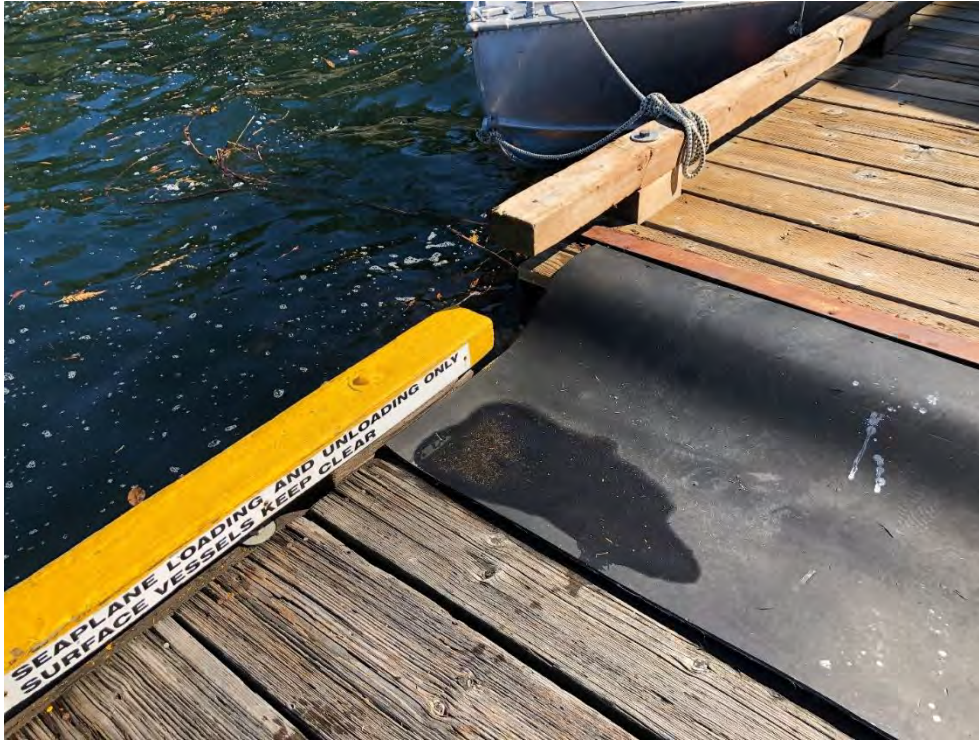
Photo 61 - Transition from the Main Float to the Seaplane Float

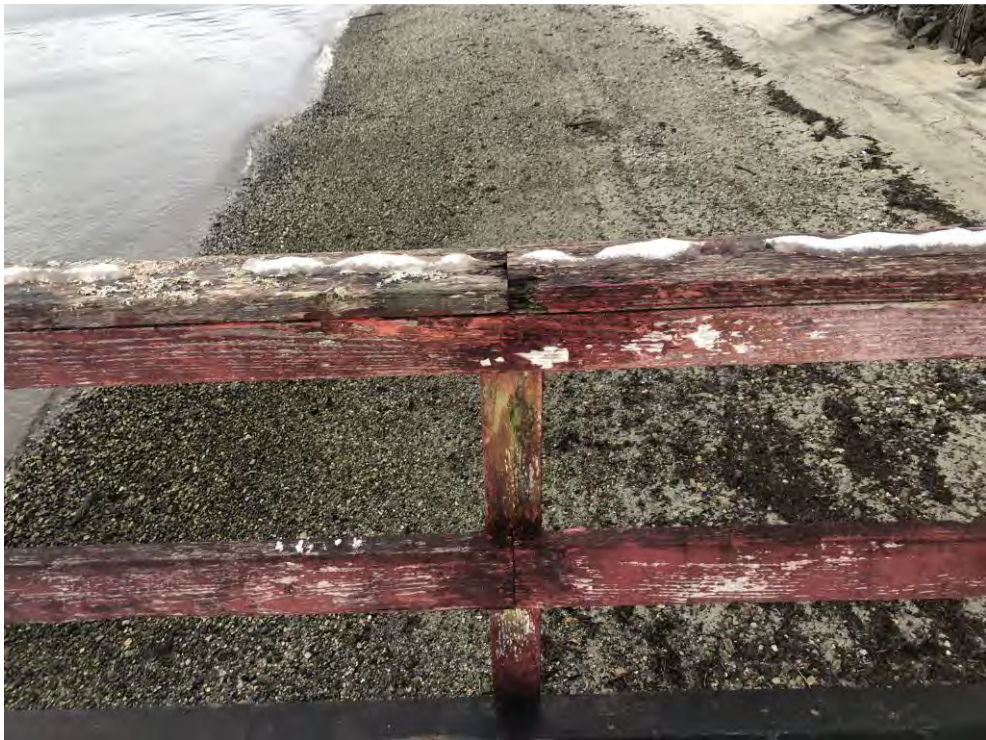
Photo 4 – Handrail deterioration between piles 4B and 5B

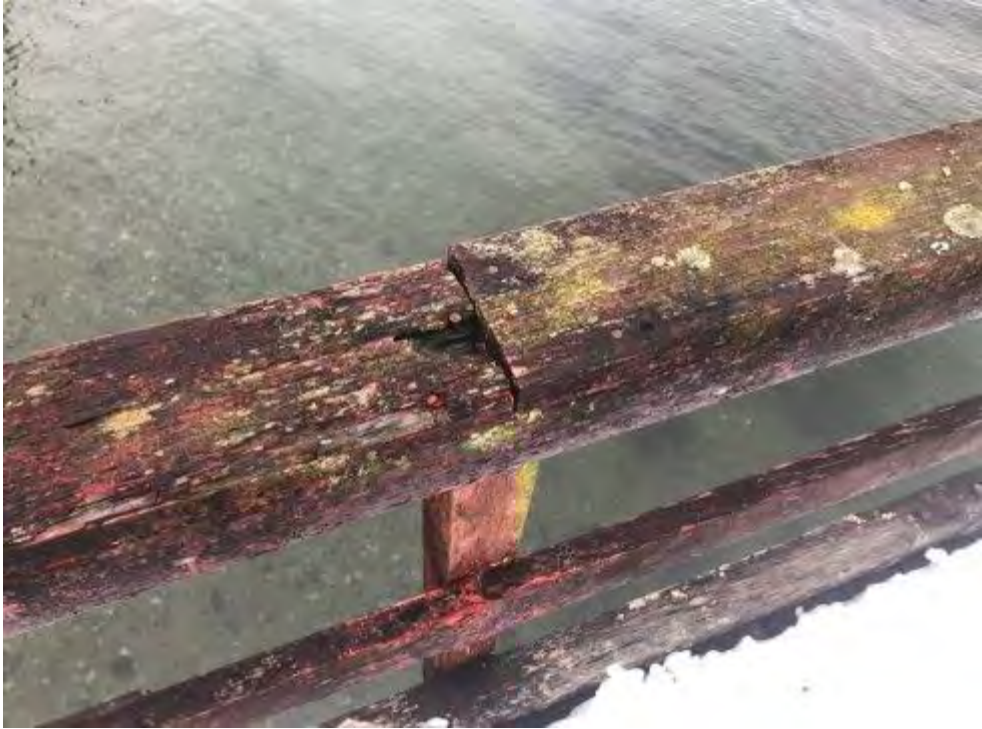
Photo 5 – Handrail deterioration between piles 7A and 8A

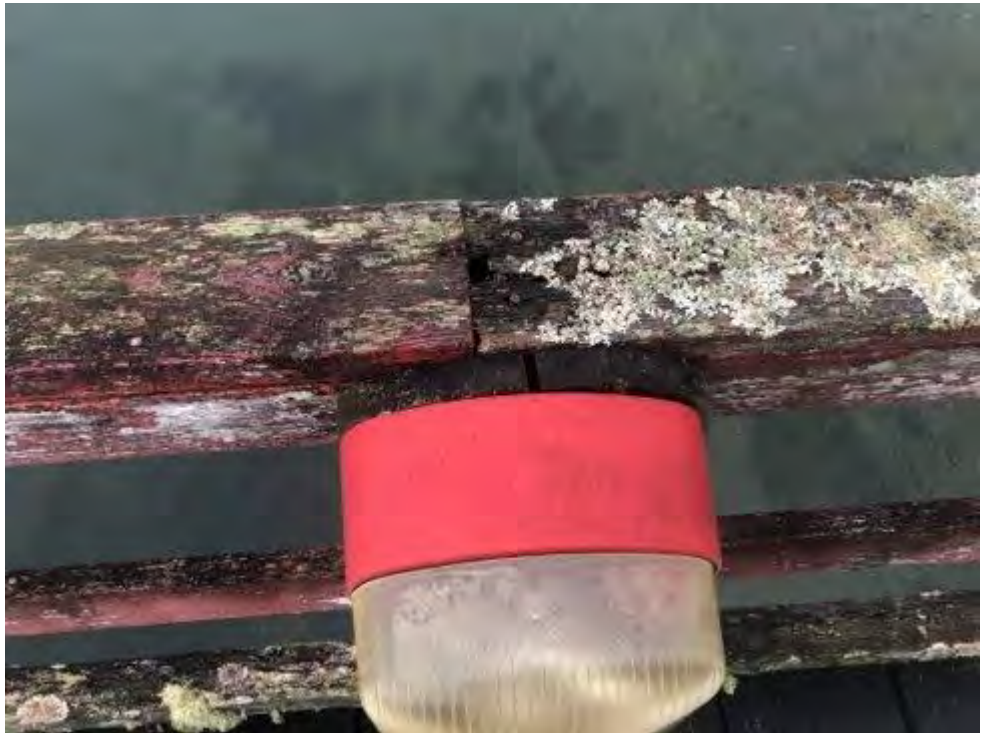
Photo 6 – Handrail deterioration between piles 8B and 9B

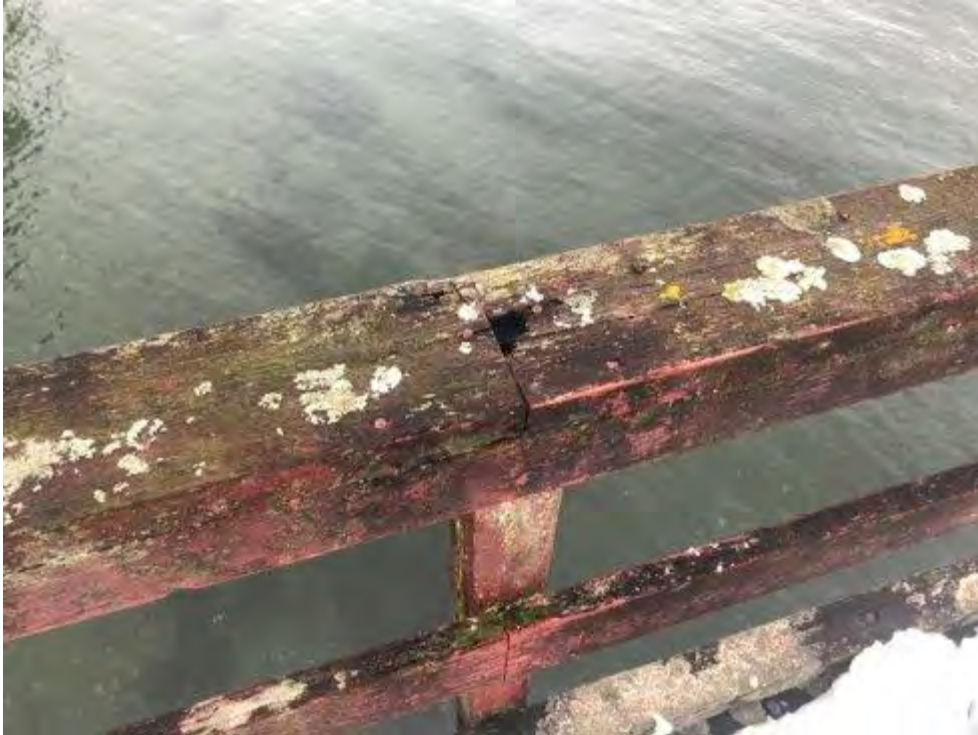
Photo 7 – Handrail deterioration between piles 9A and 10A

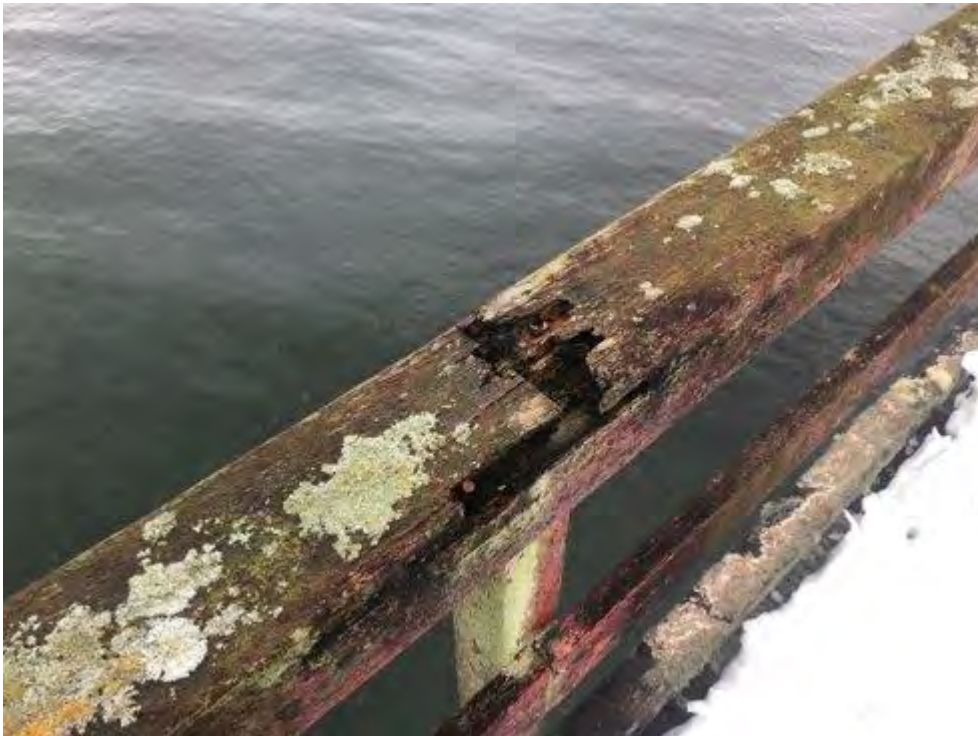
Photo 8 – Handrail deterioration between piles 11A and 12A

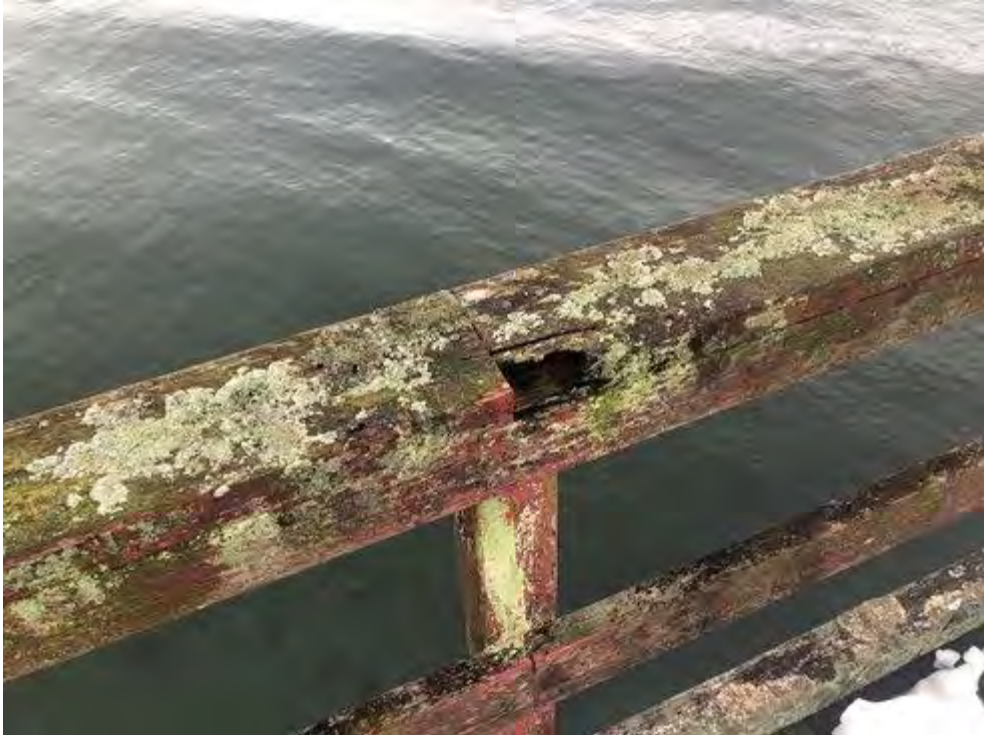
Photo 9 – Handrail deterioration between piles 12A and 13A

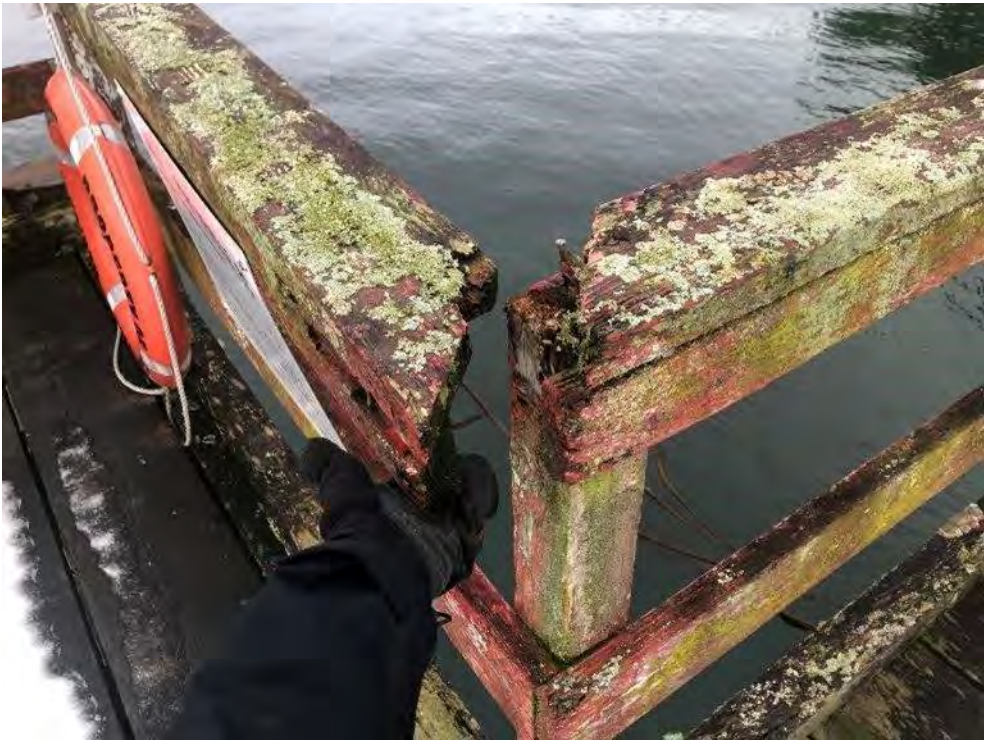
Photo 10 – Handrail deterioration between piles 14B and 14C

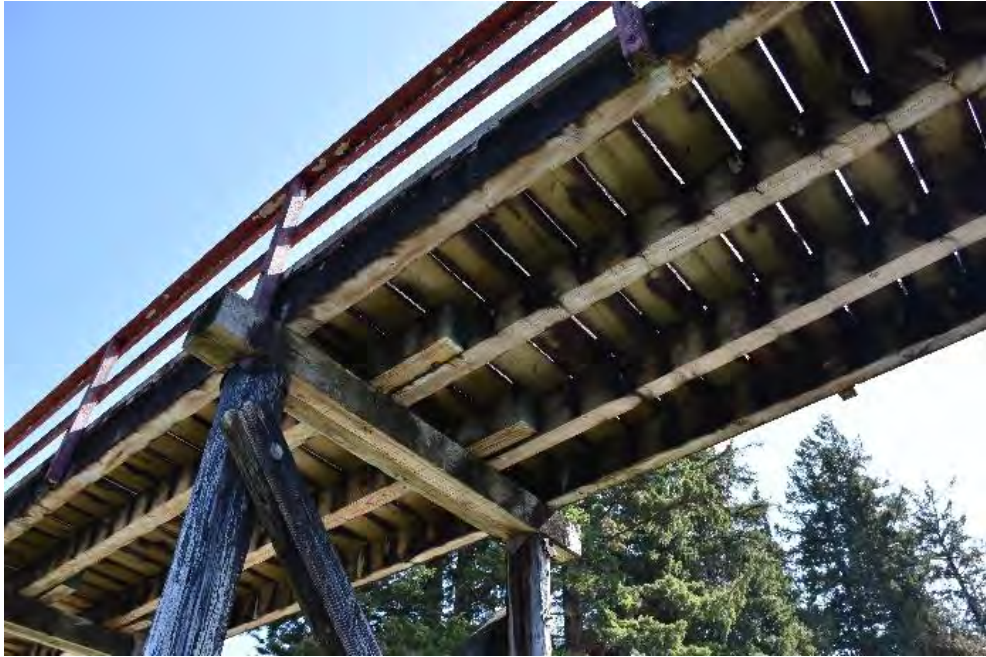
Photo 11 – Typical View of Timber Stringers

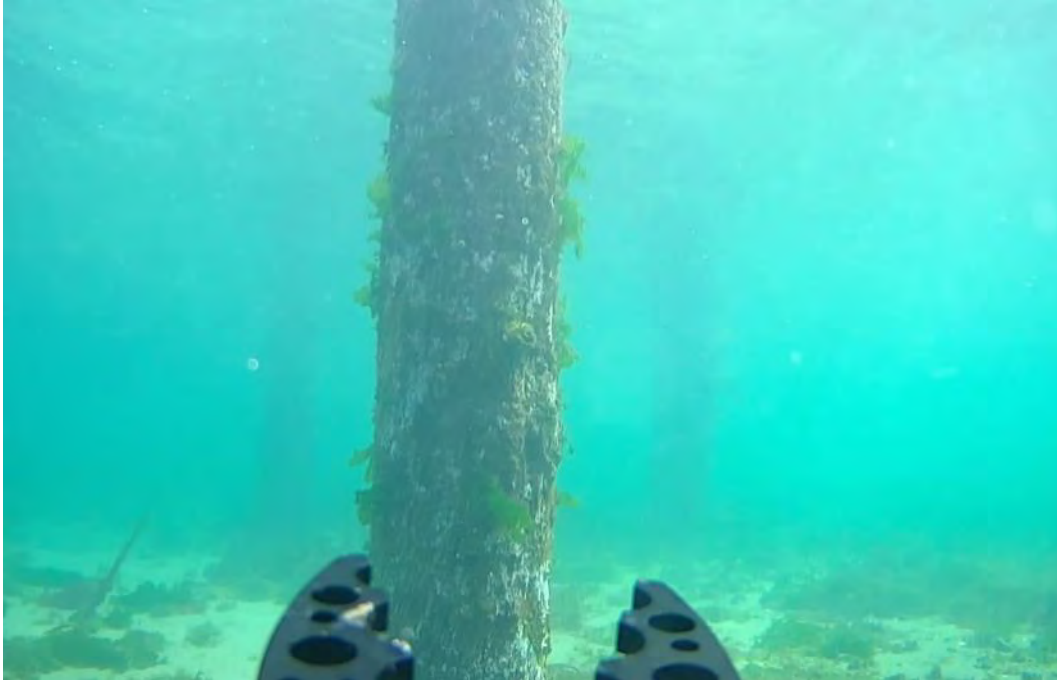
Photo 25 – Underwater image of damage to fender Pile 10B

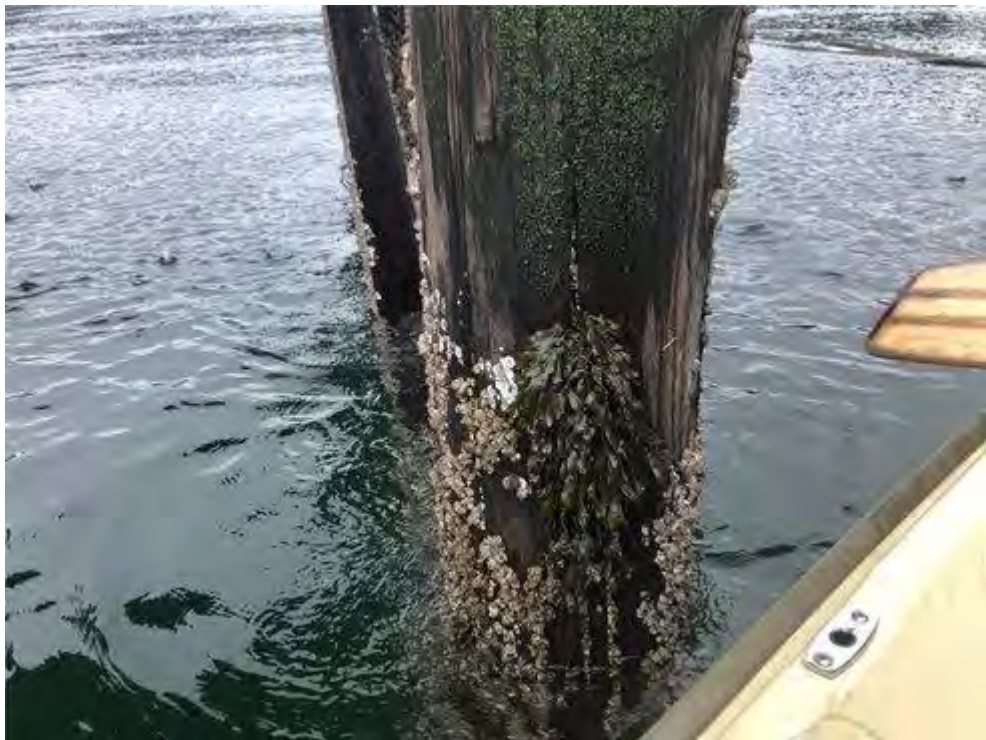
Photo 26 – Fender Pile 14A

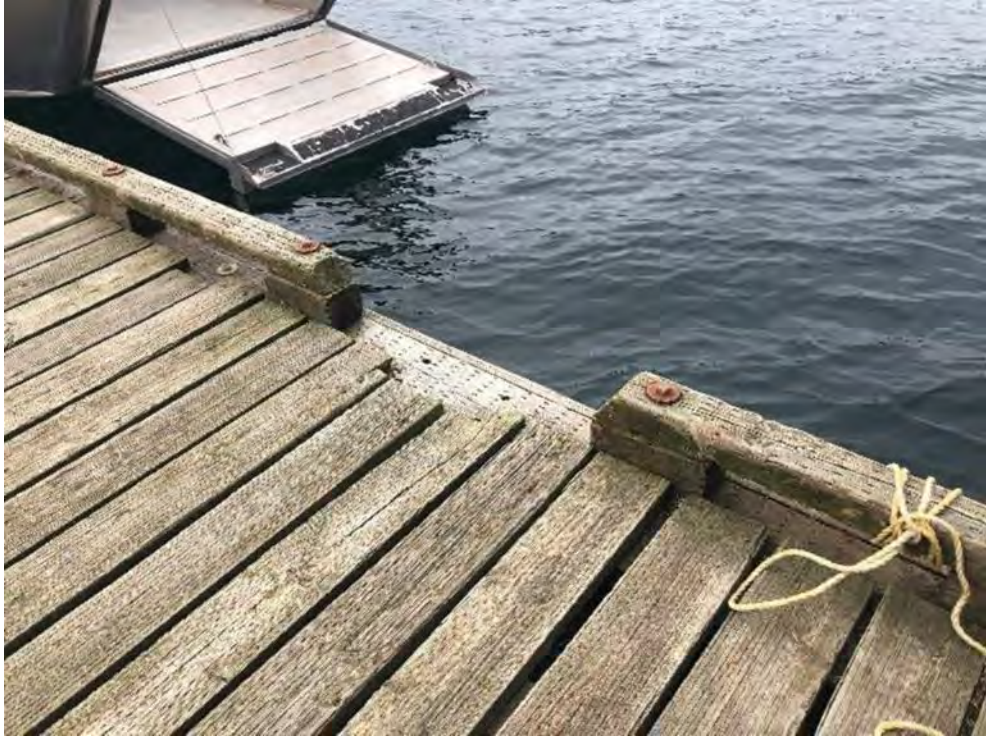
Photo 39 – Missing Bull rail on Float A

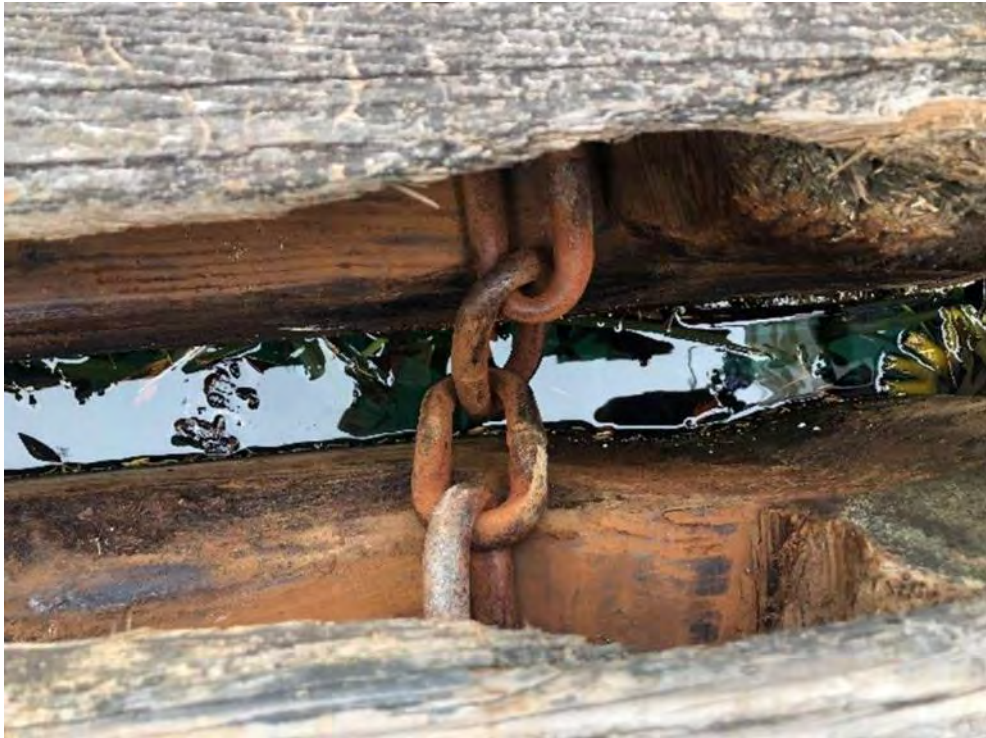
Photo 40 – Chain Connection to Float B

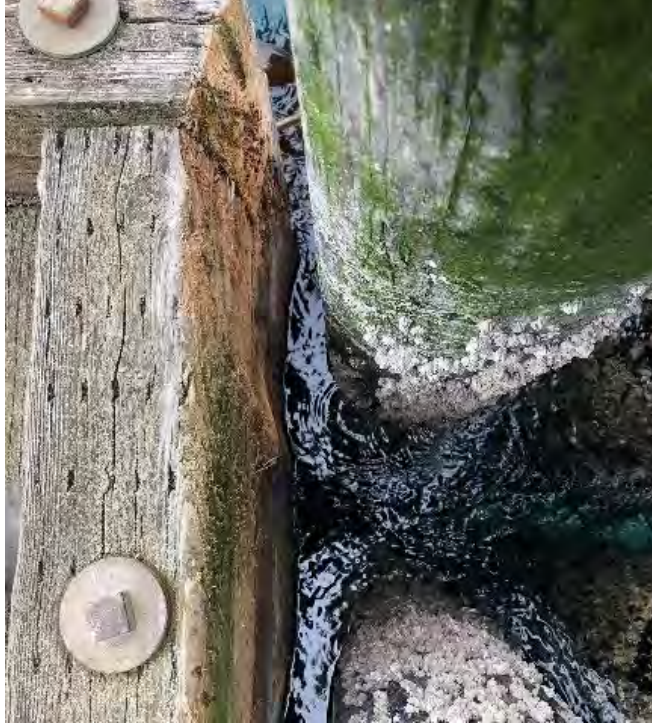
Photo 41 – Wearing to Float A from North Mooring Dolphin

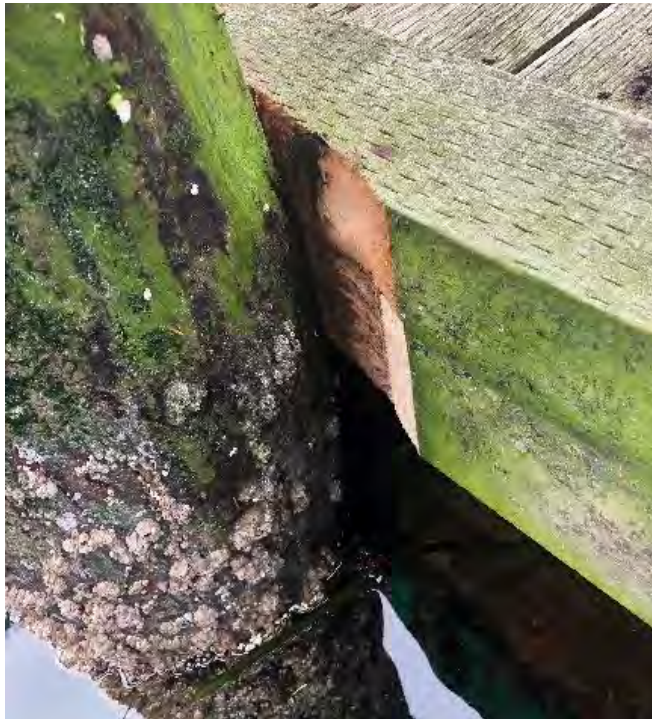
Photo 42 – Wearing to Float A from South Mooring Piles

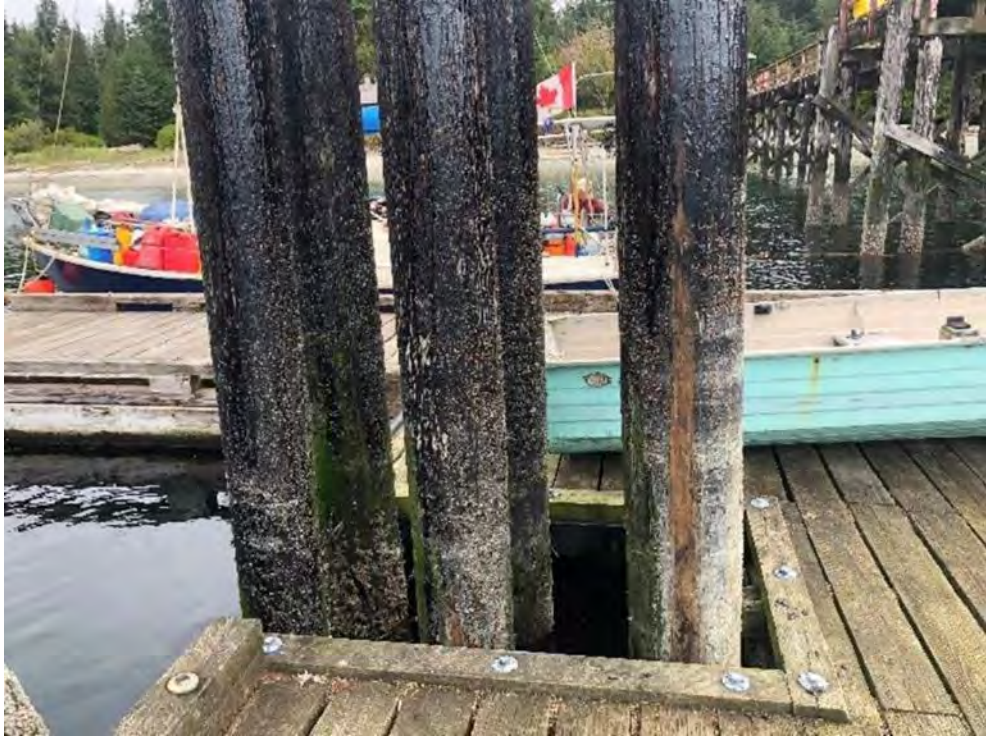
Photo 43 – Float A North Mooring Piles

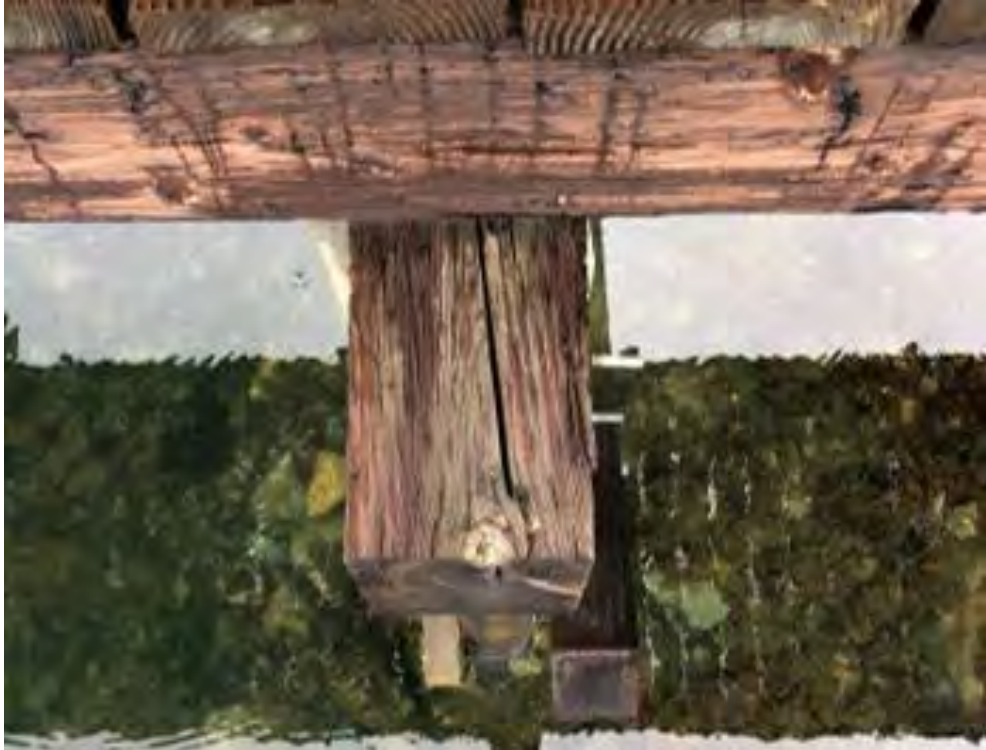
Photo 11 - Moderate to Severe splitting of the Pile cap at Bent 6

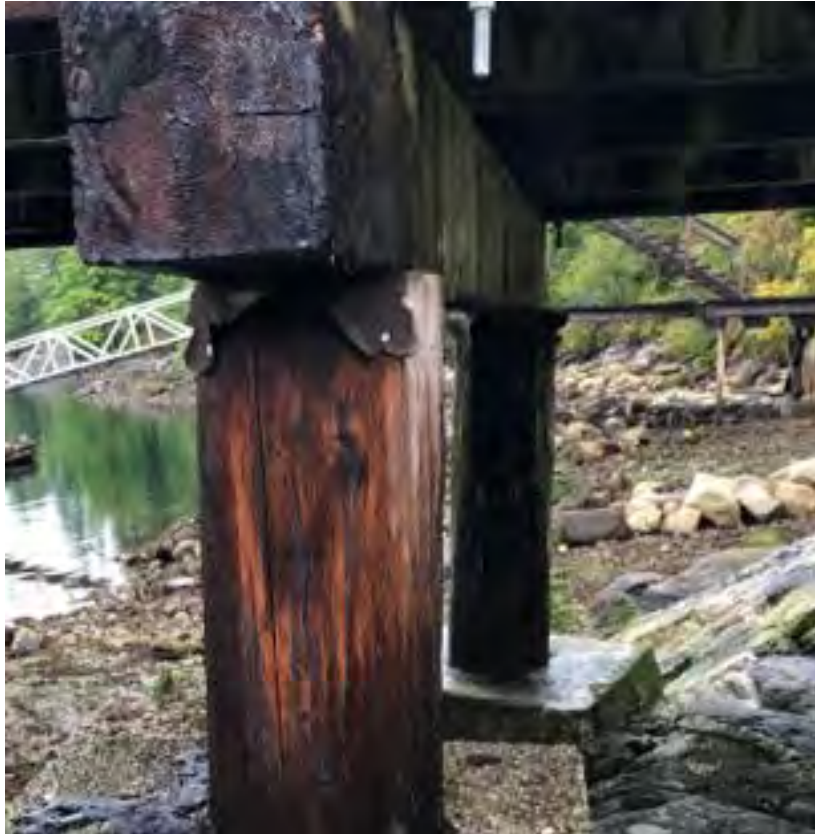
Photo 17 - Minor splitting on Pile 4B

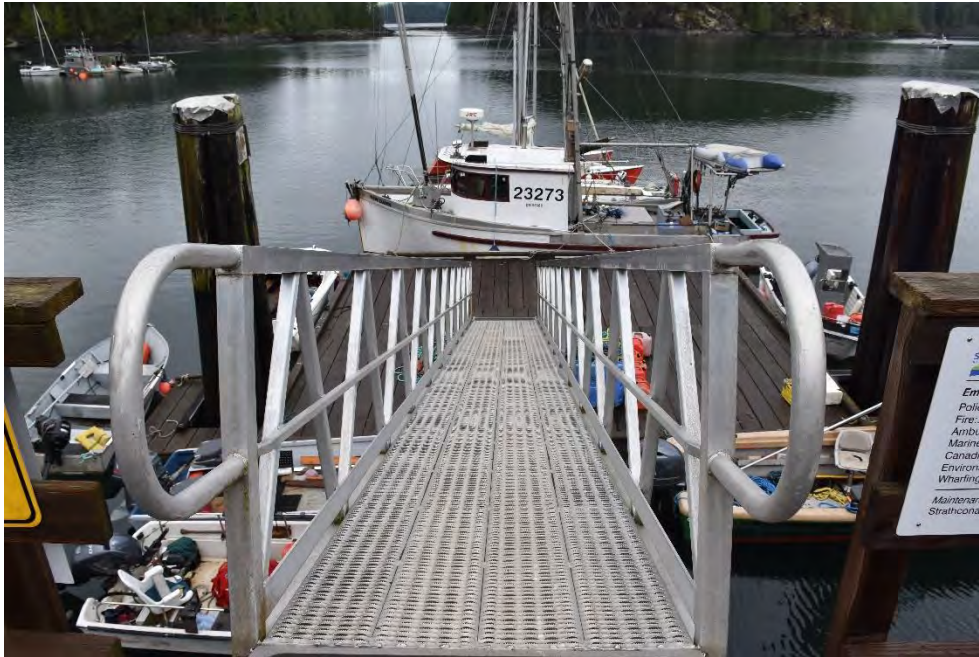
Photo 21 - General View of Aluminum Gangway

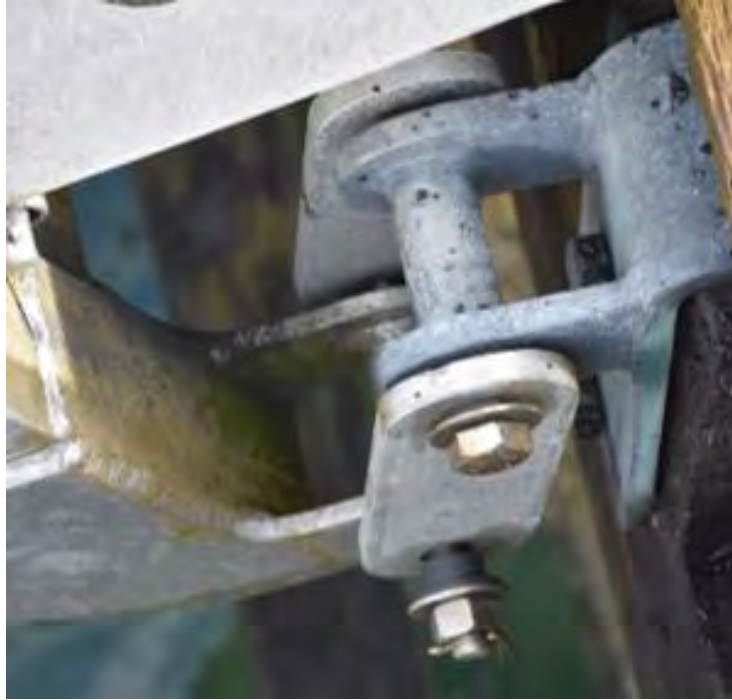
Photo 23 - Gangway Upper Hinge Connection with loose bolt

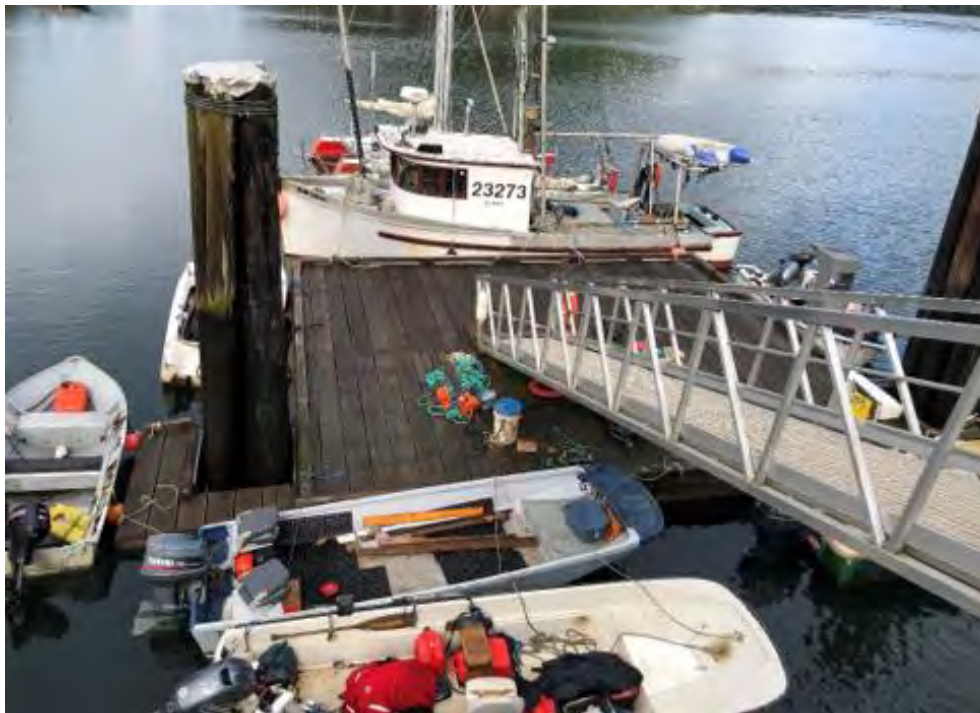
Photo 24 - General View of the float
