RE: BYLAW NO. 487- ELECTORAL AREA C WHARVES SERVICE

FEASIBILITY STUDY

ELECTORAL AREA C WHARVES SERVICE

Marine Facility Condition Assessment of the Surge Narrows Wharf

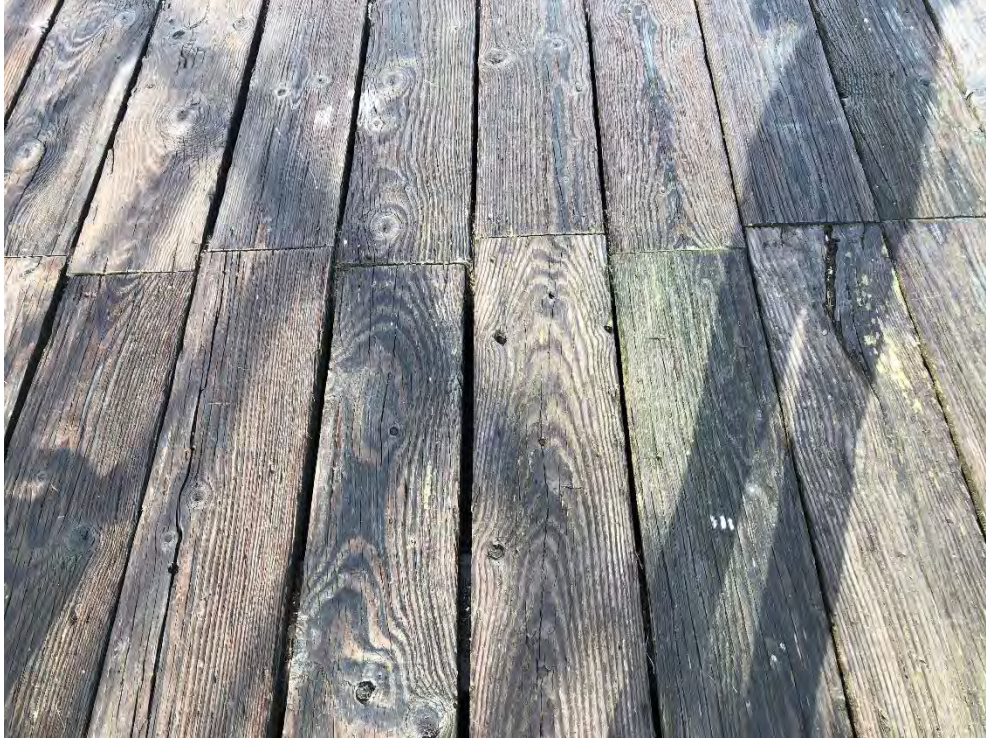
Photo 25 - Typical condition of the timber decking

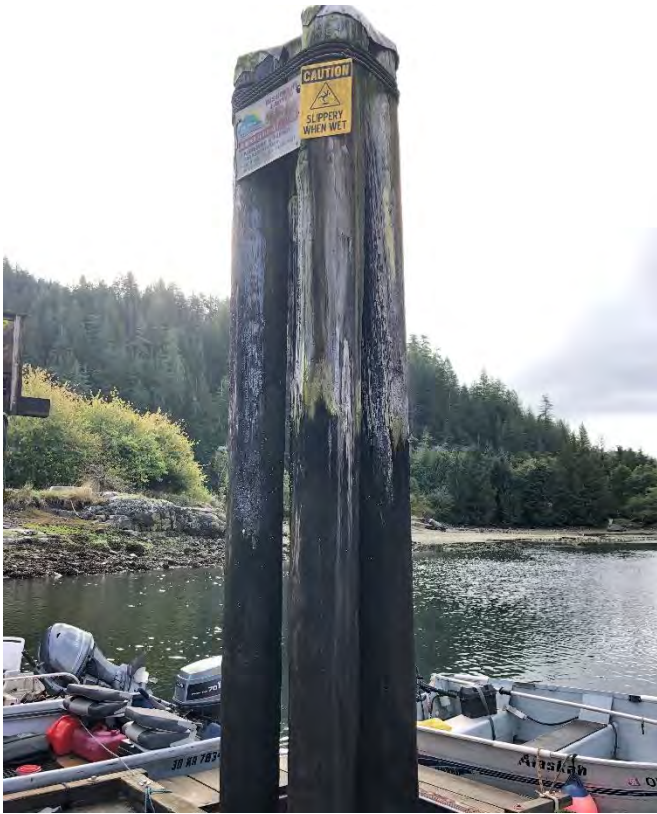
Photo 27 - South Mooring Piles

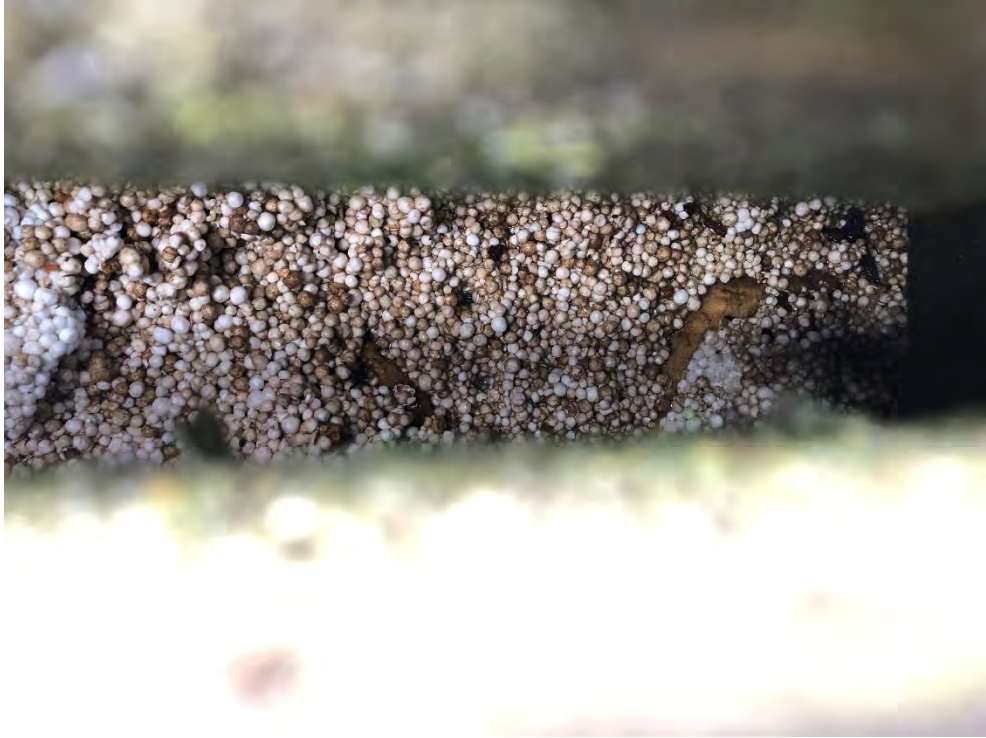
Photo 33 - Condition of exposed uncoated styrofoam billets

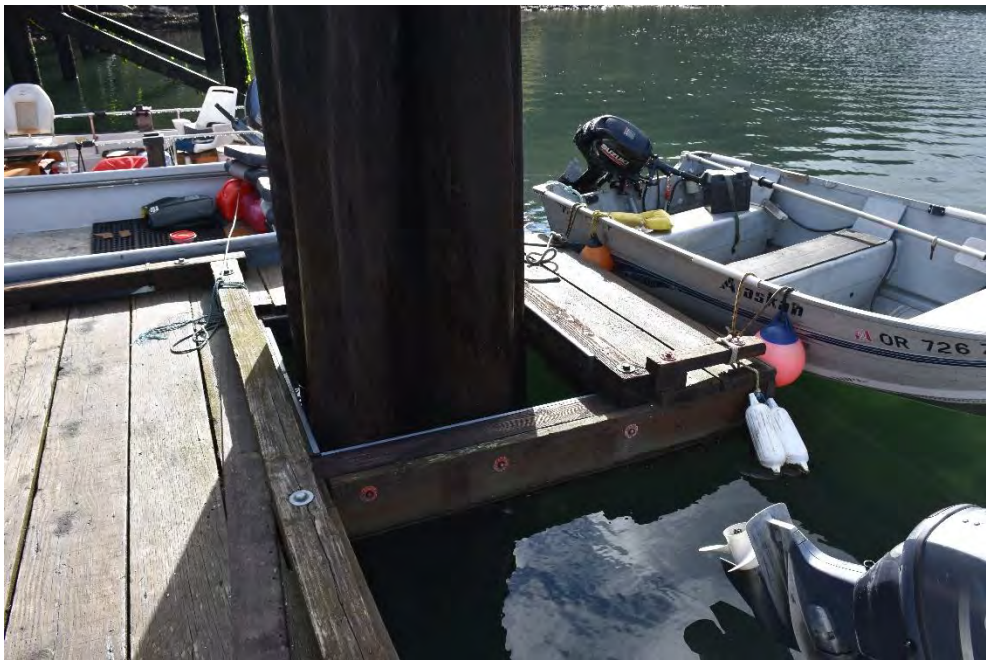
Photo 34 - South Mooring Well with significant flotation loss

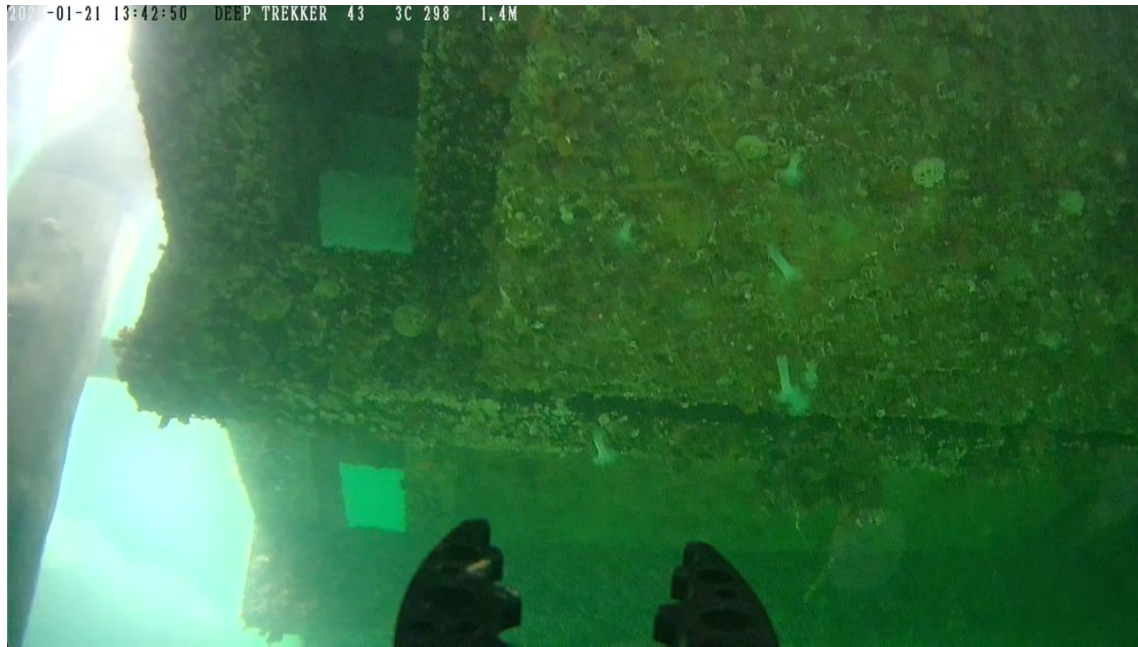
Photo 35 - Typical condition under the south end of the float
