A BYLAW TO AUTHORIZE THE DISPOSITION OF THE PORT NEVILLE WHARF FACILITY

January 20, 2022 | Revision A

Marine Facility Condition Assessment of the Port Neville Wharf

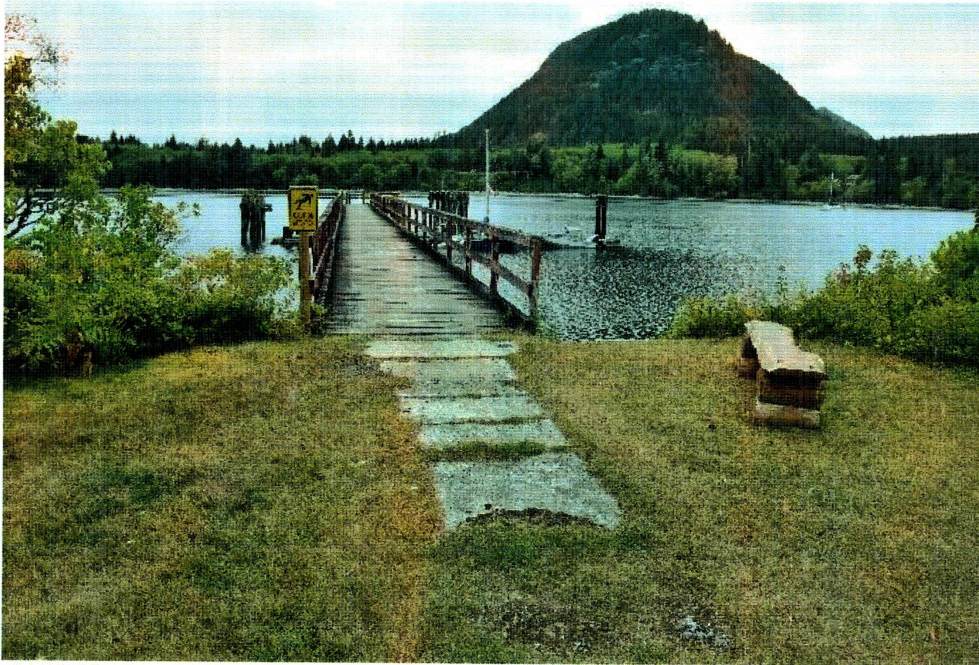
Photo 1 – Pier Approach Area

The pier approach is in generally good condition (Photos 1). There are no signs of settlement in this area, and the slope around the pier abutment appears stable. No load rating sign has been posted.

Repairs are not considered necessary at this time; however ongoing monitoring of the pier approach is recommended. Consideration should also be given to posting a load rating sign and extending safety barriers to the approach area.

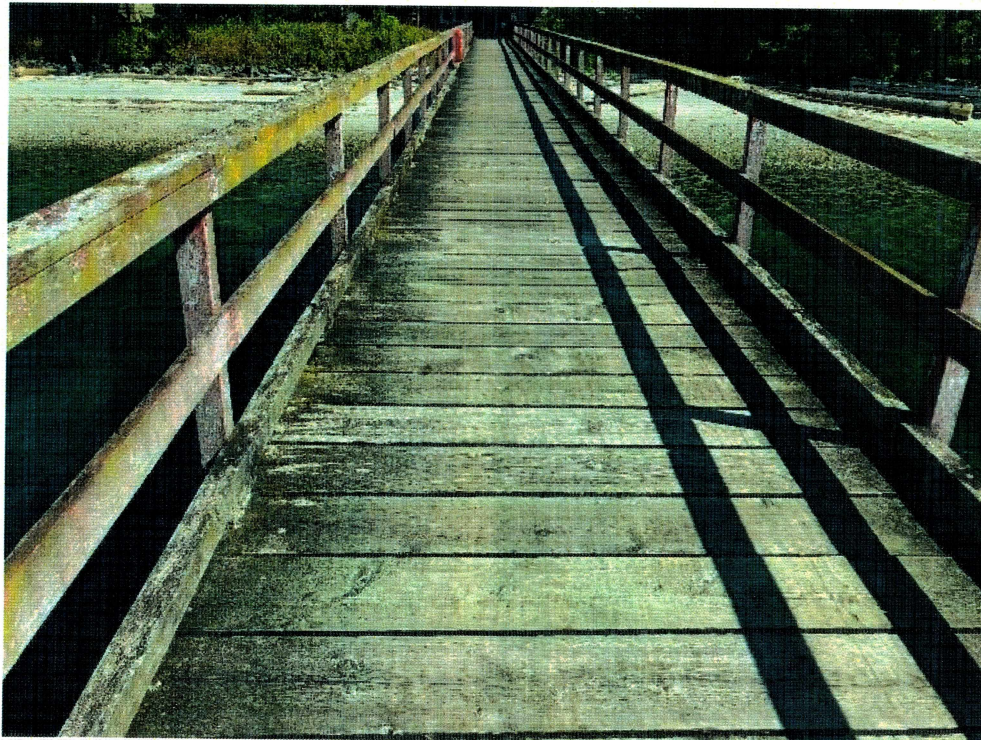
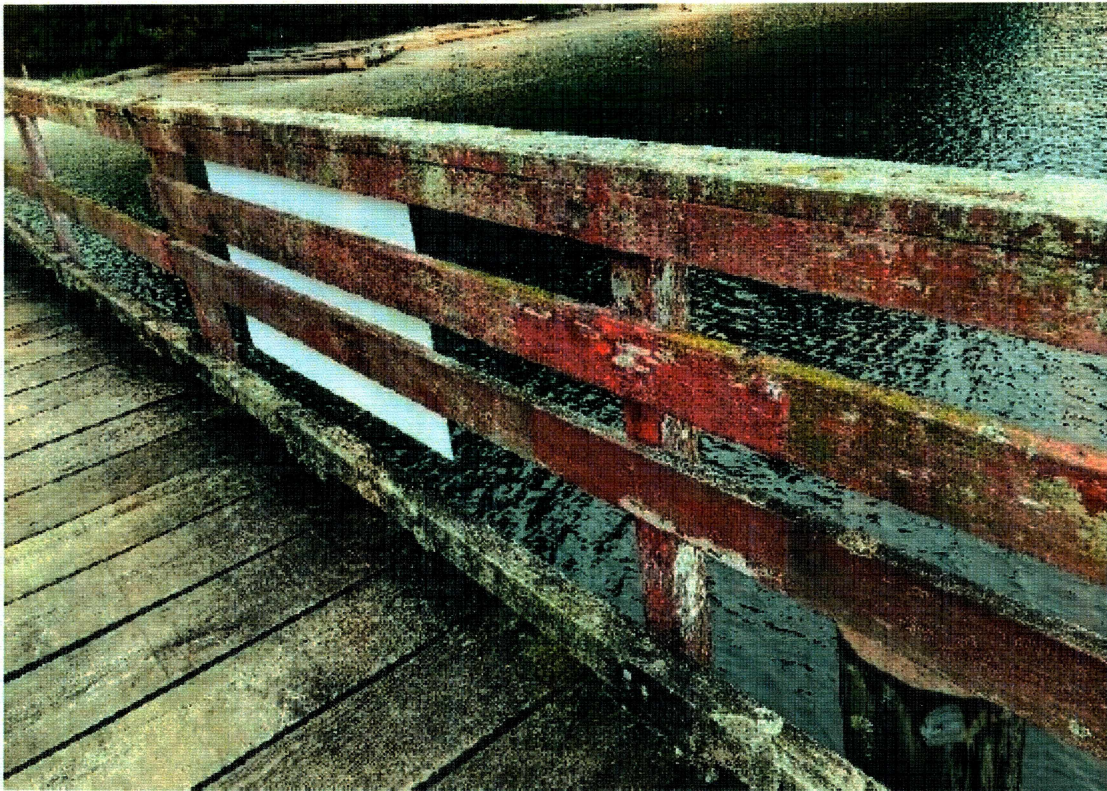
The pier topsides are generally in poor to fair condition with widespread weathering and fungal decay (Photos 2 & 3). Inspection findings are as follows:

Photo 2 – Pier Structure Topsides

Photo 3 – Pier Structure Handrails

- Between piles 12A and 13A (Photo 9)
- Identified during the second inspection on December 7th, 2021, the top rail connection directly above pile 14B has deteriorated and is only connected on one end (Photo 10). *It is recommended that the bull rails and handrail posts be fully replaced and secured in places with deterioration and/or missing bolts. Consideration should be given to painting the handrails to extend the service life of the existing timber. Consideration should also be given to a full phased replacement of the topsides over the next 2-4 years.*

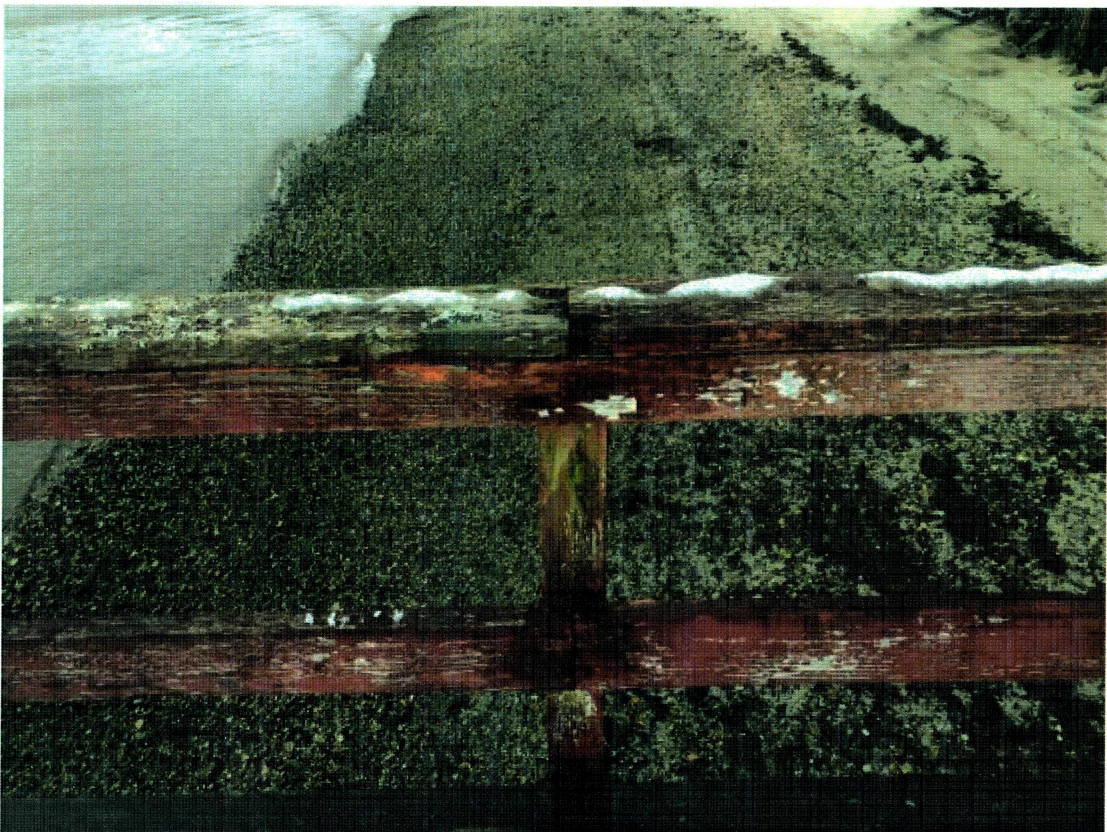
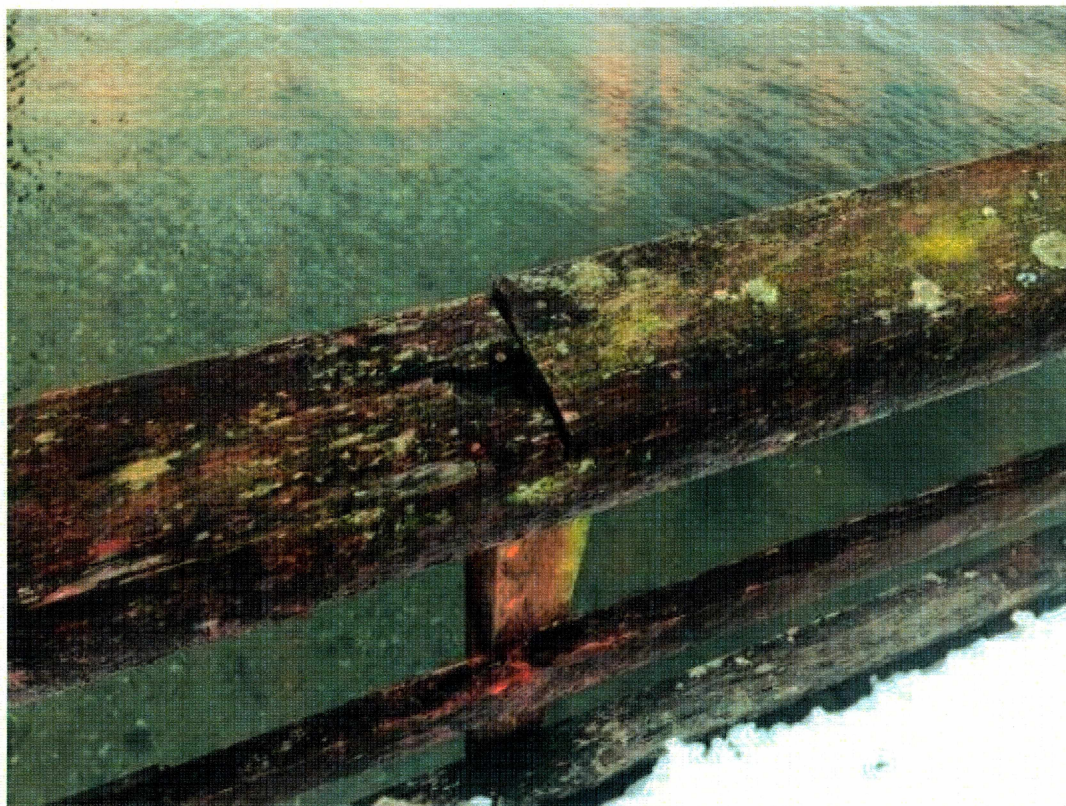
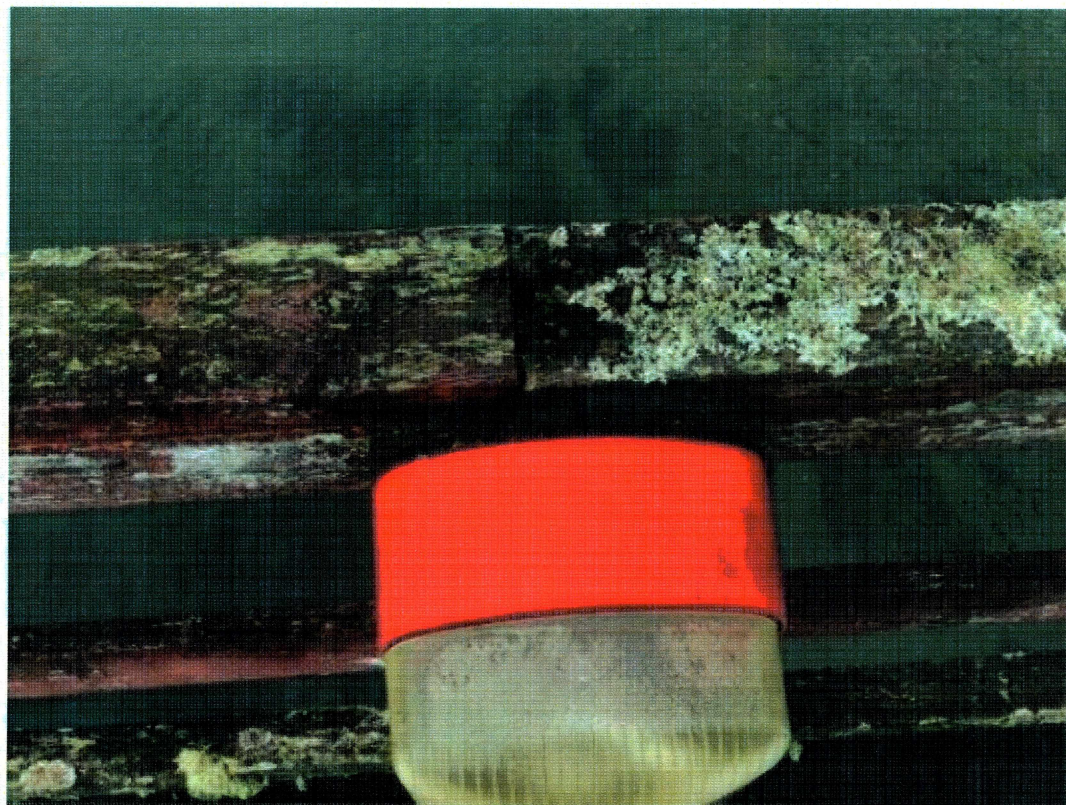
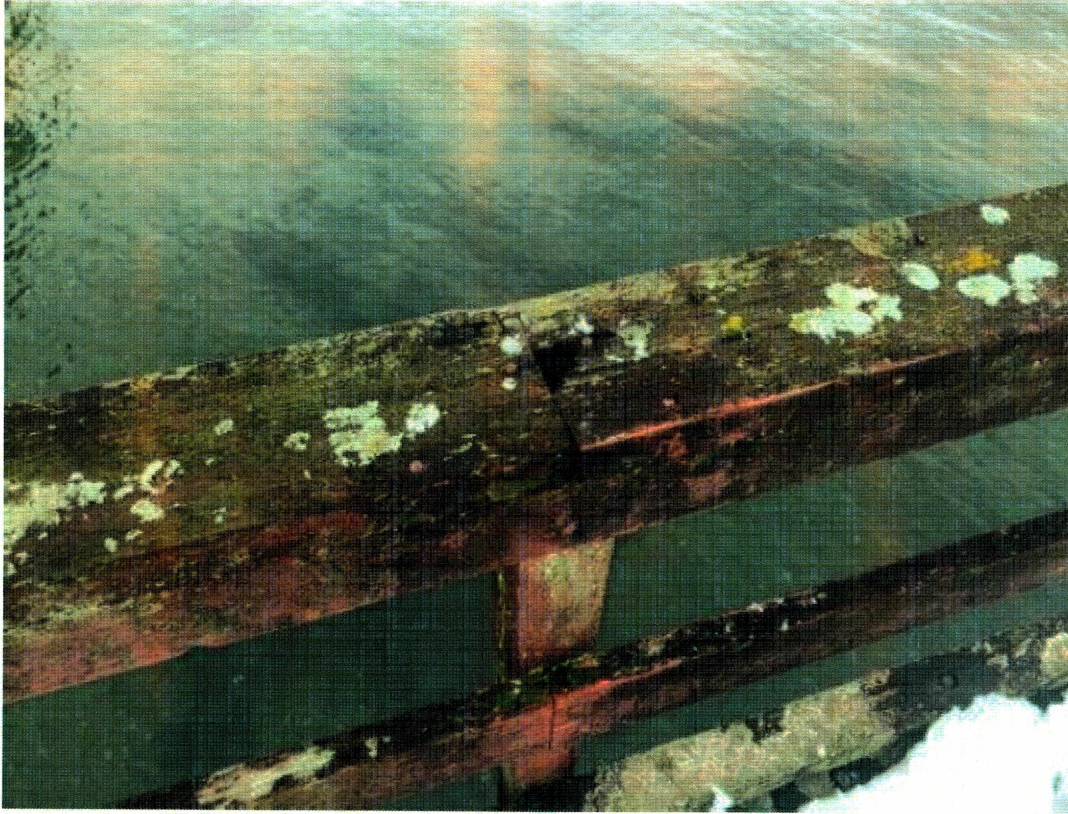
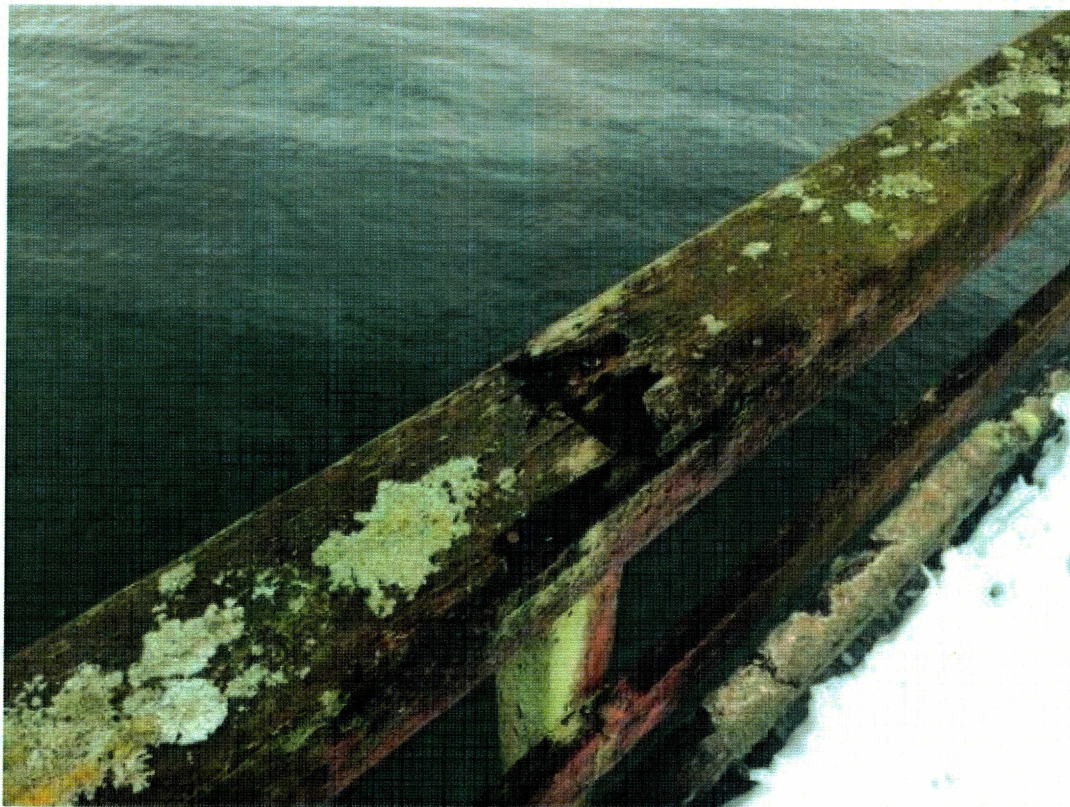
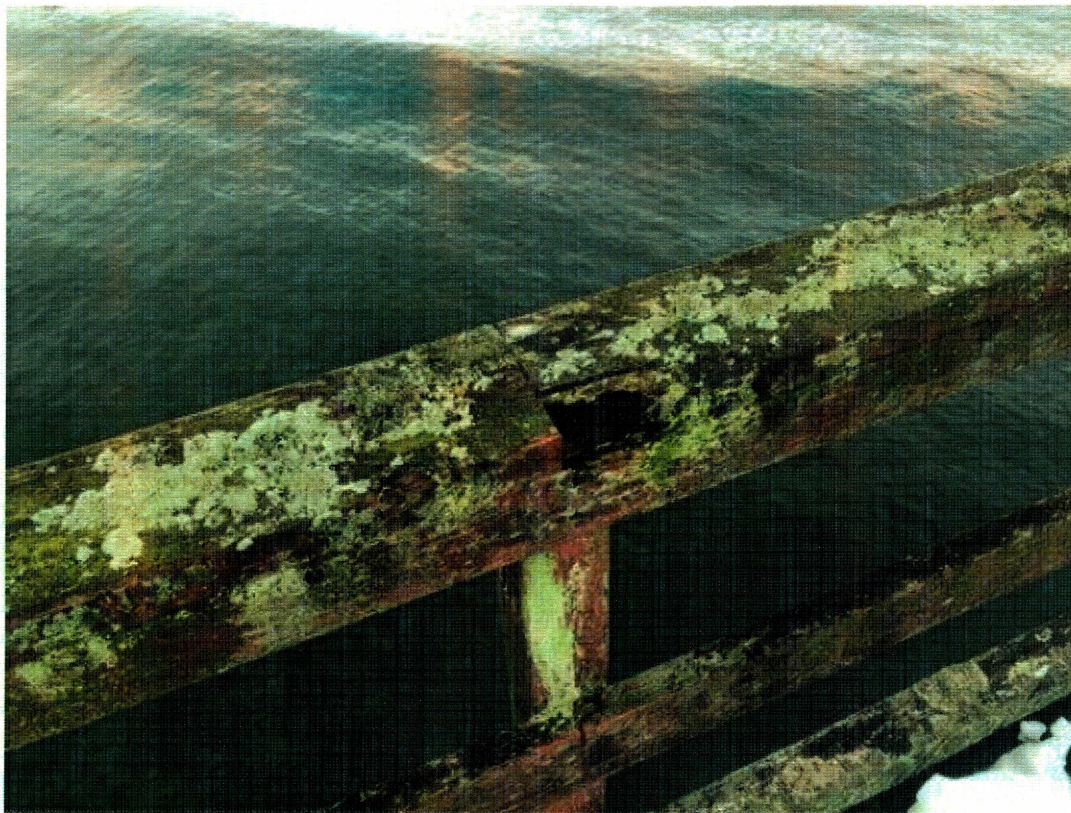
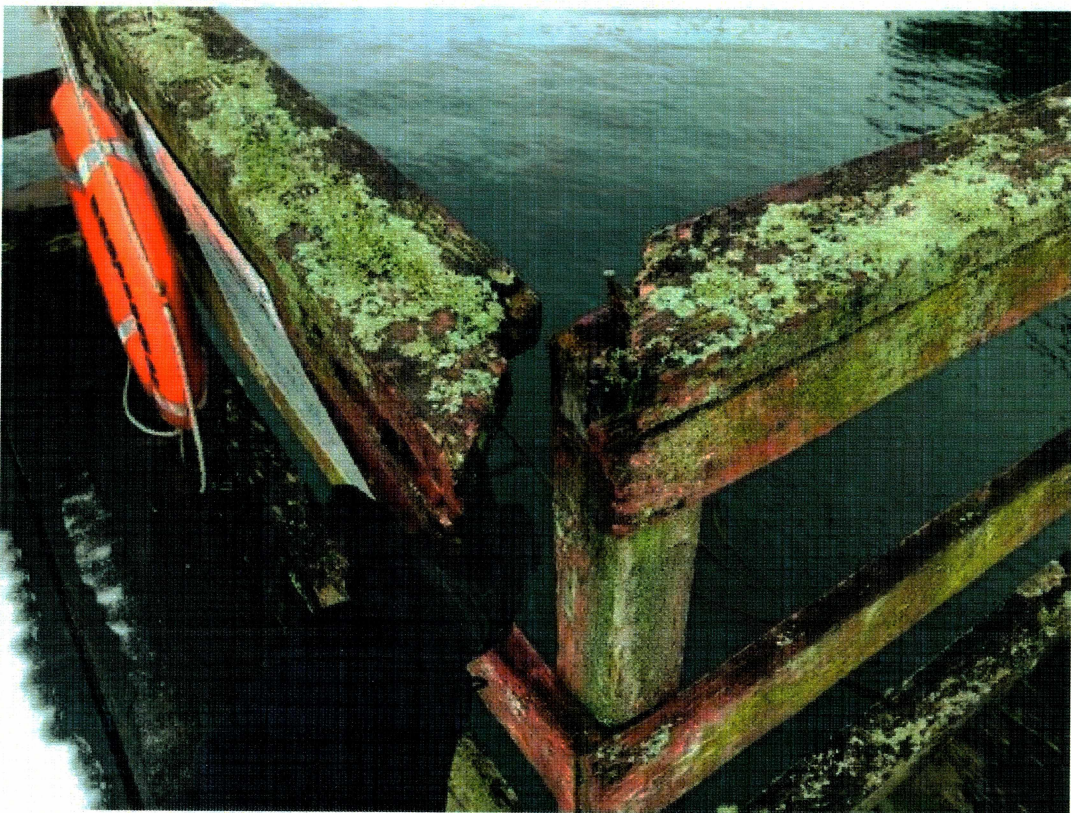
- The handrails appear generally well secured. The handrail posts are connected to the pier structure with two bolts, one through the outer stringer, and one through the bull rail. In some locations, the bull rails are deteriorated or not fully secured, and the handrail posts can shift, however they are still well secured to the stringer. There is significant deterioration to multiple other top rail connections, the approximate locations are directly above the following piles:

Photo 4 – Handrail deterioration between piles 4B and 5B

Photo 5 – Handrail deterioration between piles 7A and 8A

Photo 6 – Handrail deterioration between piles 8B and 9B

Photo 7 – Handrail deterioration between piles 9A and 10A

Photo 8 – Handrail deterioration between piles 11A and 12A

Photo 9 – Handrail deterioration between piles 12A and 13A

Photo 10 – Handrail deterioration between piles 14B and 14C

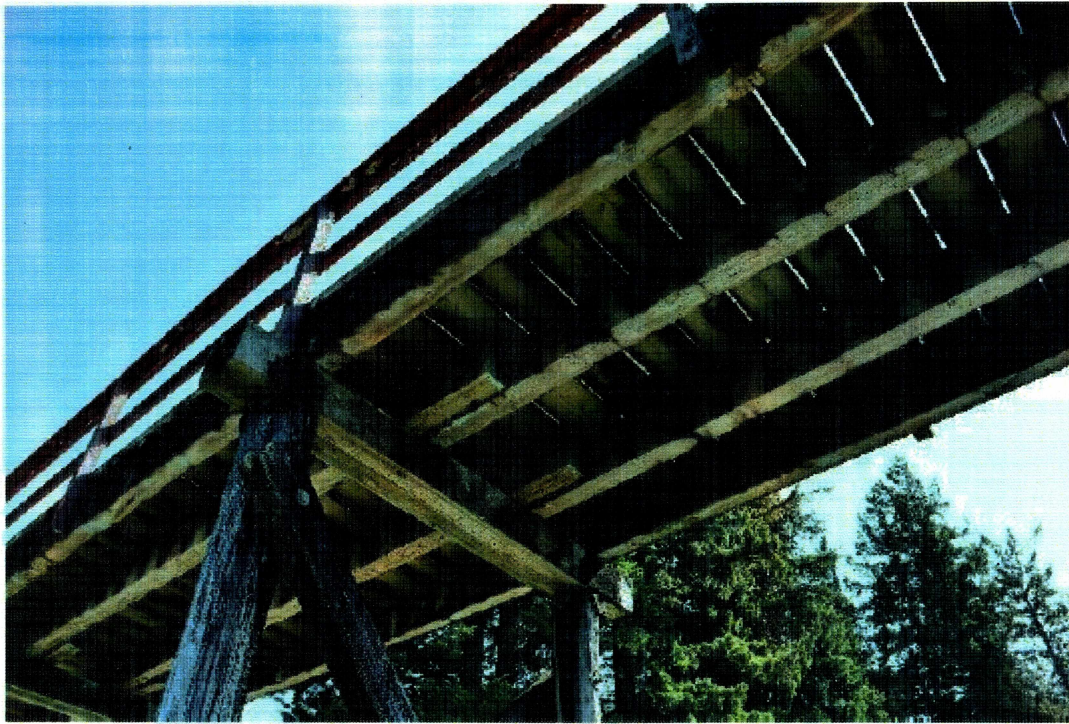
Photo 11 – Typical View of Timber Stringers

The treated timber stringers are generally in good condition (Photo 11). The stringers appear well secured between the decking and the pile caps, and there are no signs of significant splitting or structural deterioration. The ends of the stringers, where the end grain is present, does not show significant evidence of moisture or fungal decay. No cross-sectional loss was found in the stringers during the timber coring inspection.

Repairs are not considered necessary at this time; however ongoing monitoring of the stringers is recommended.

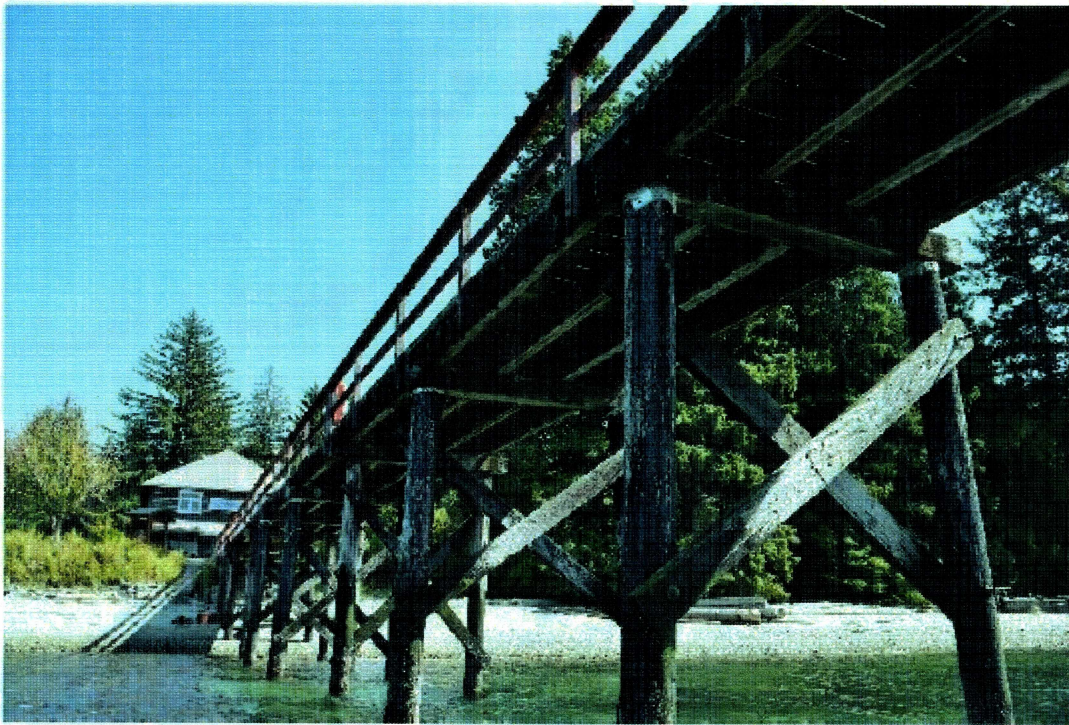
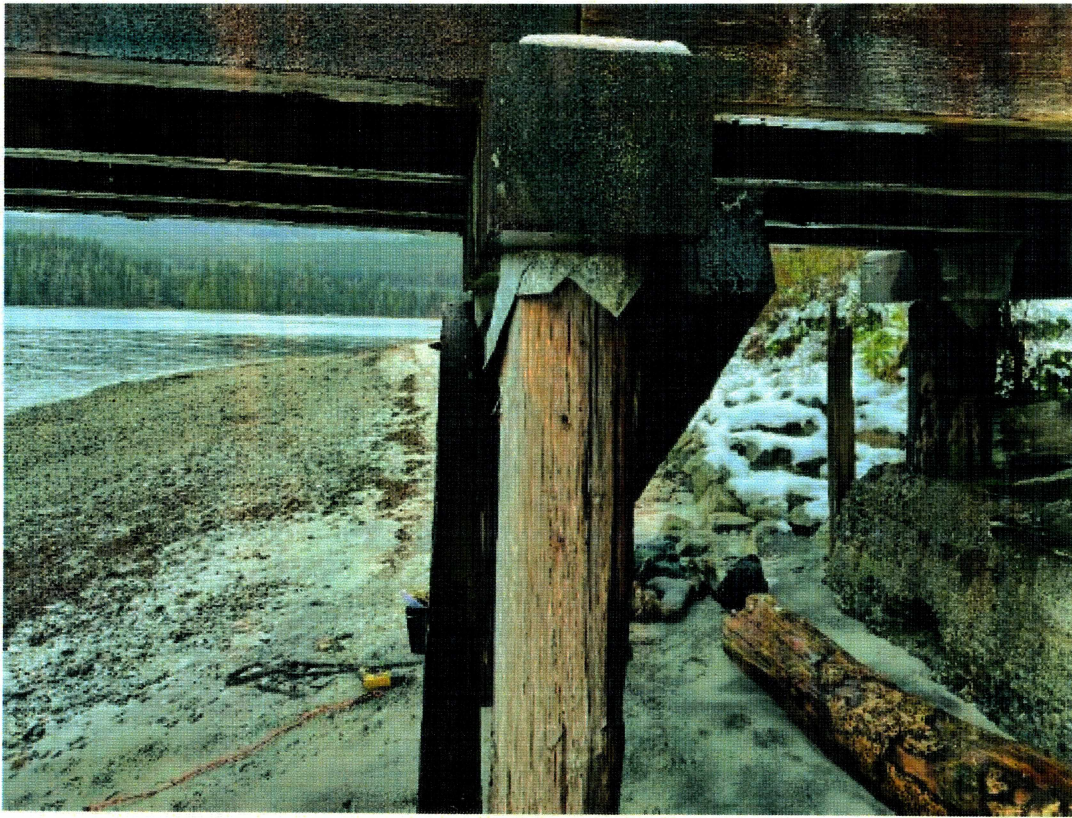
The treated timber pile caps are generally in fair to good condition (Photo 12 & 13). The pile caps appear well secured, and there are no signs of significant splitting or structural deterioration. The pile caps are typically aligned well over the piles, with no evidence of shifting or displacement. There is minor weathering and deterioration to the end grains of the pile caps, notably at Bent 12 (Photo 14). No cross-sectional loss was found in the pile caps during the timber coring inspection.

Photo 12 – General View of Timber Pile Cap Bents

Photo 13 – Typical Timber Pile Cap End Grain

Repairs are not considered necessary at this time, however ongoing monitoring of the pile caps and of the deterioration at the end grains is recommended.

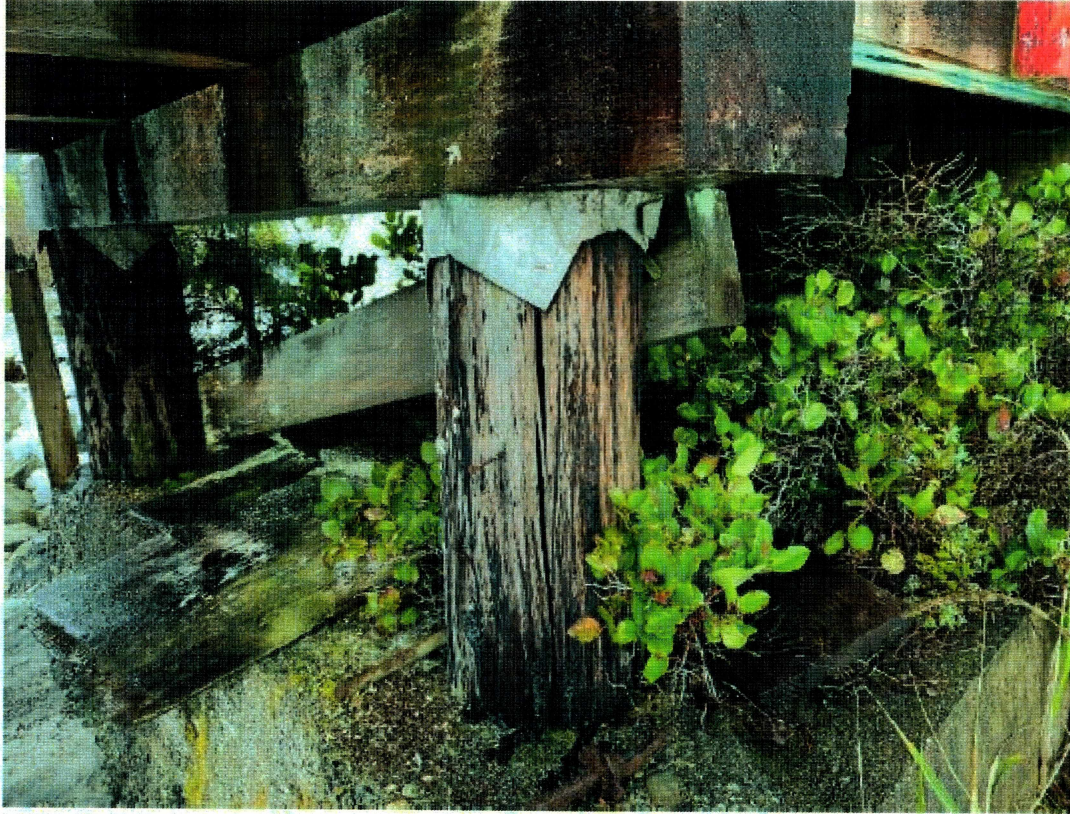
Location	Description	Recommendation
Pile 2A	Large split at the top of the pile. (Photo 15) 50% CSL due to internal fungal decay in the top 0.6m.	Replace timber pile.
Pile 2B	25% CSL due to internal fungal decay in the top 0.3m.	Monitor.
Pile 3A	25% CSL due to internal fungal decay in the top 0.3m.	Monitor.
Pile 3B	Moderate splitting at the top of the pile. (Photo 16) 25% to 75% CSL due to internal fungal decay in the top 0.9 m.	Replace timber pile.
Pile 4B	25% CSL due to internal fungal decay in the top 0.3m with wet fibres. Concrete footing is exposed, with signs of undermining and spalling of the concrete. (Photo 17)	Monitor.
Pile 5A	Moderate splitting at the base of the pile. (Photo 18)	Monitor.
Pile 5B	25-50% CSL due to internal fungal decay in the top 0.3m with wet fibres.	Replace timber pile.
Pile 7A	Pile is slightly misaligned. (Photo 19)	Monitor.

Photo 15 – Split in Pile 2A

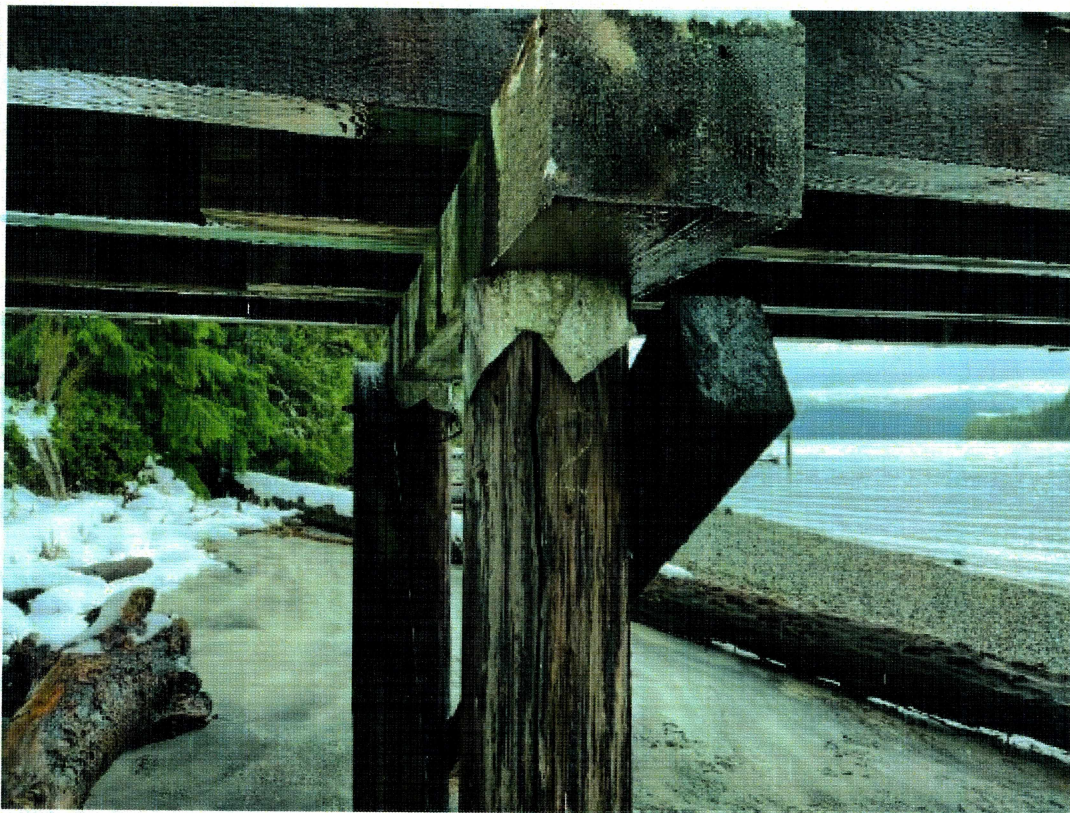
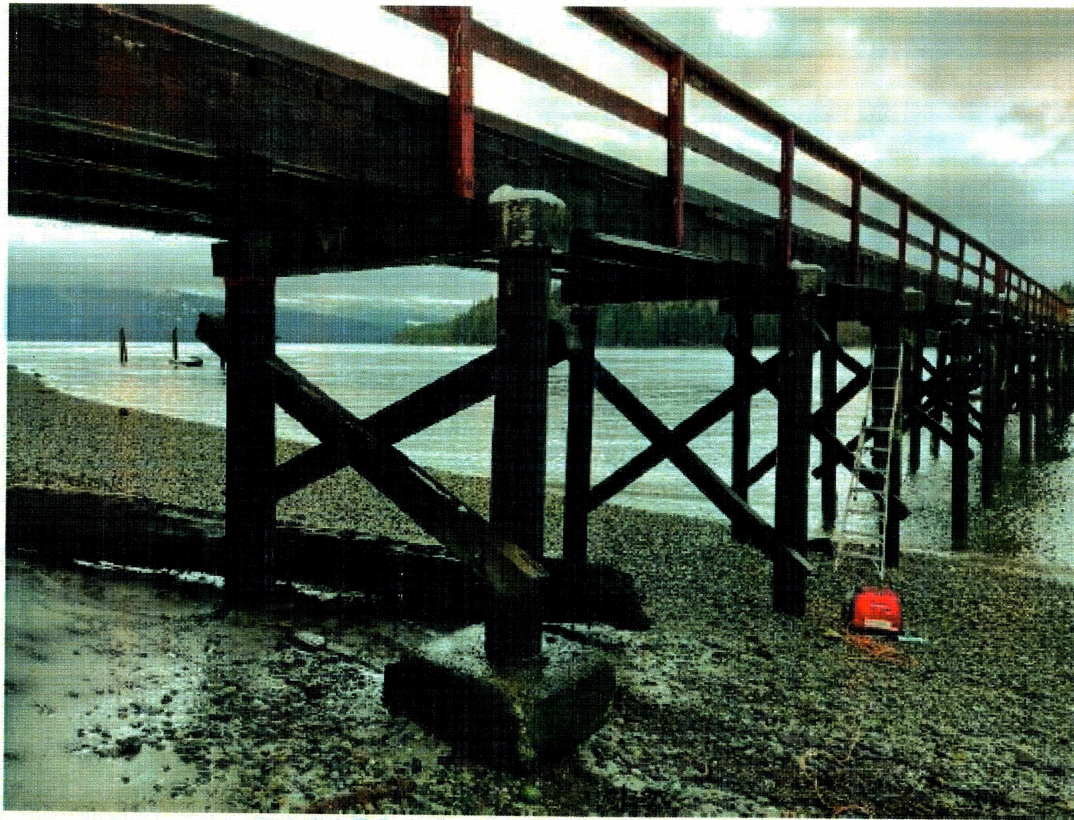
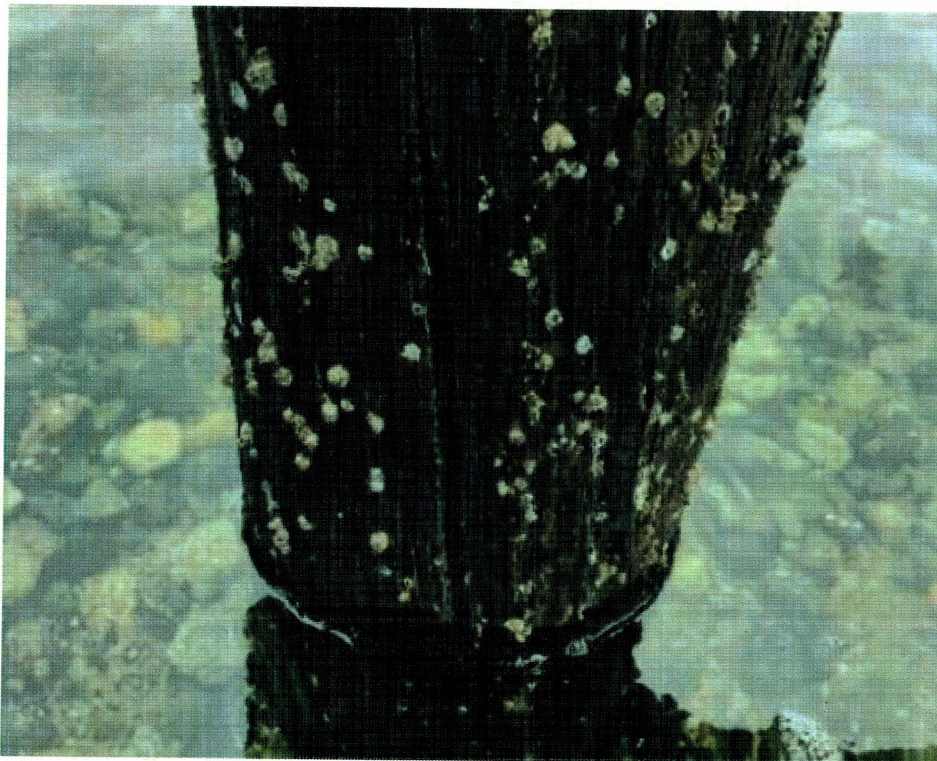
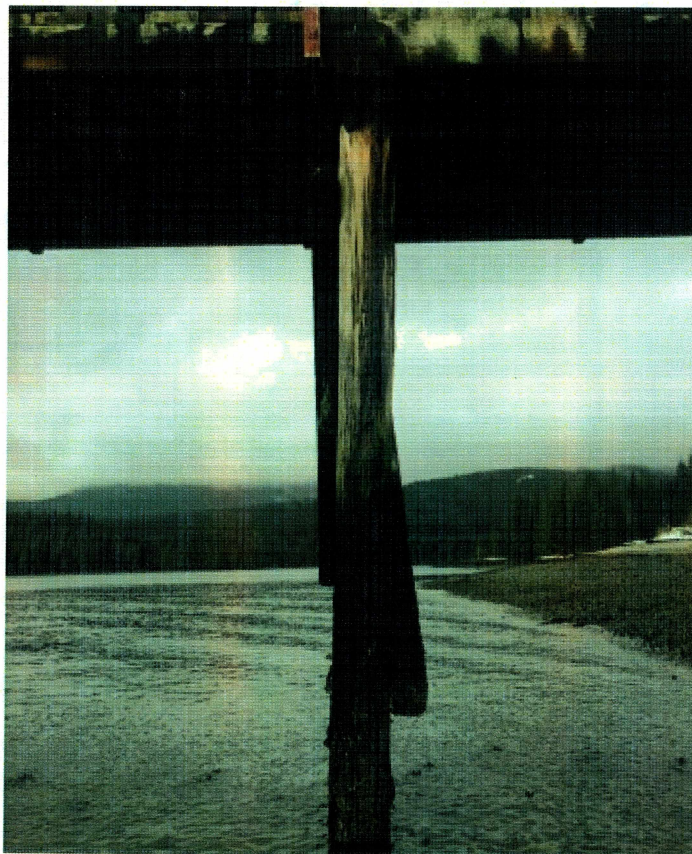
Photo 16 – Split in Pile 3B

Photo 17 – Pile 4B concrete footing

Photo 18 – Split in Pile 5A

Photo 19 – Pile 7A

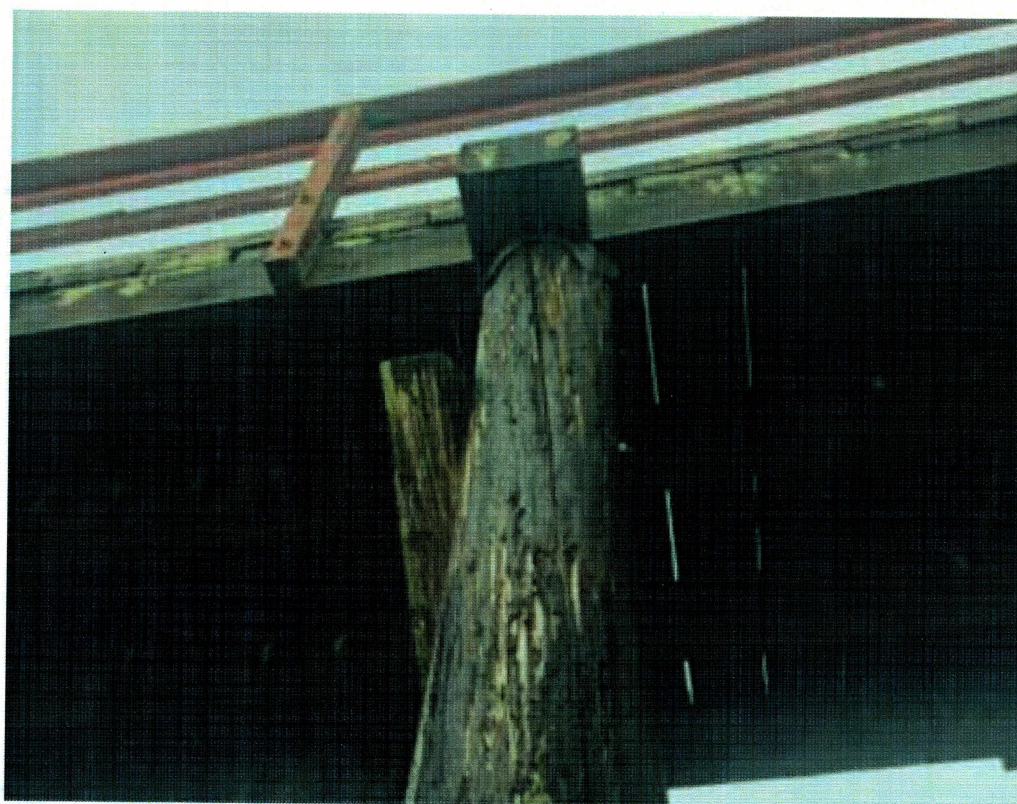
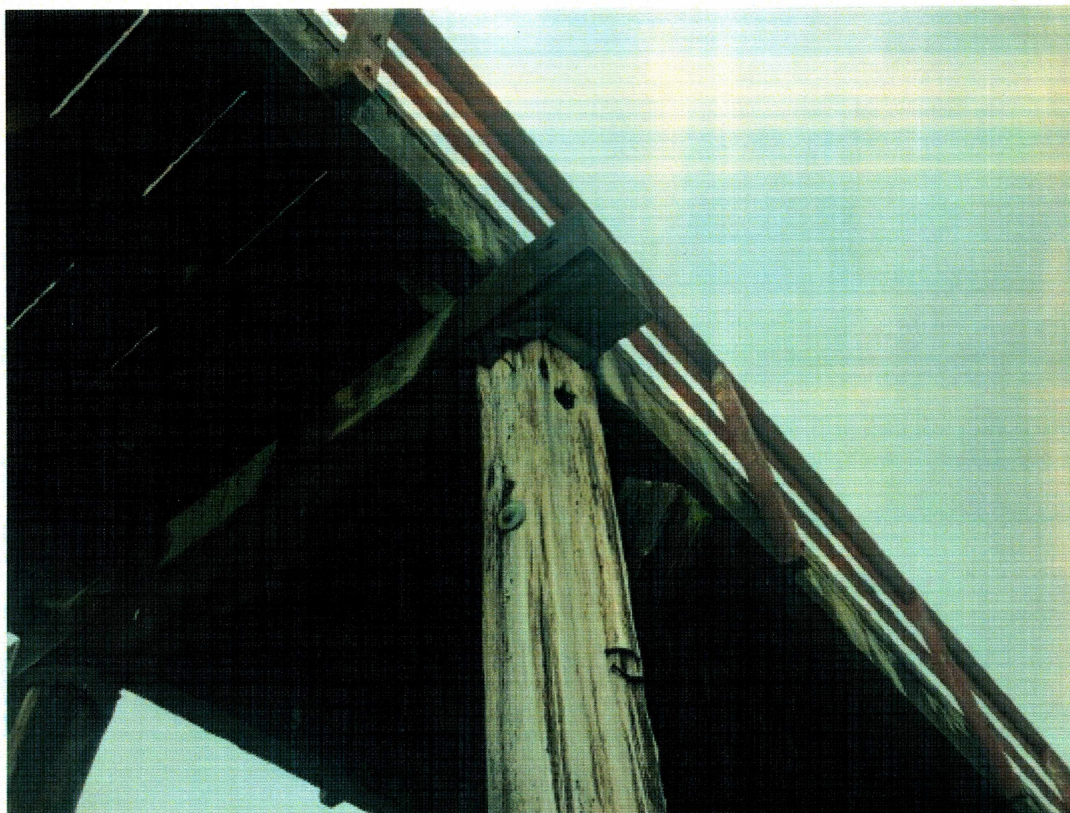
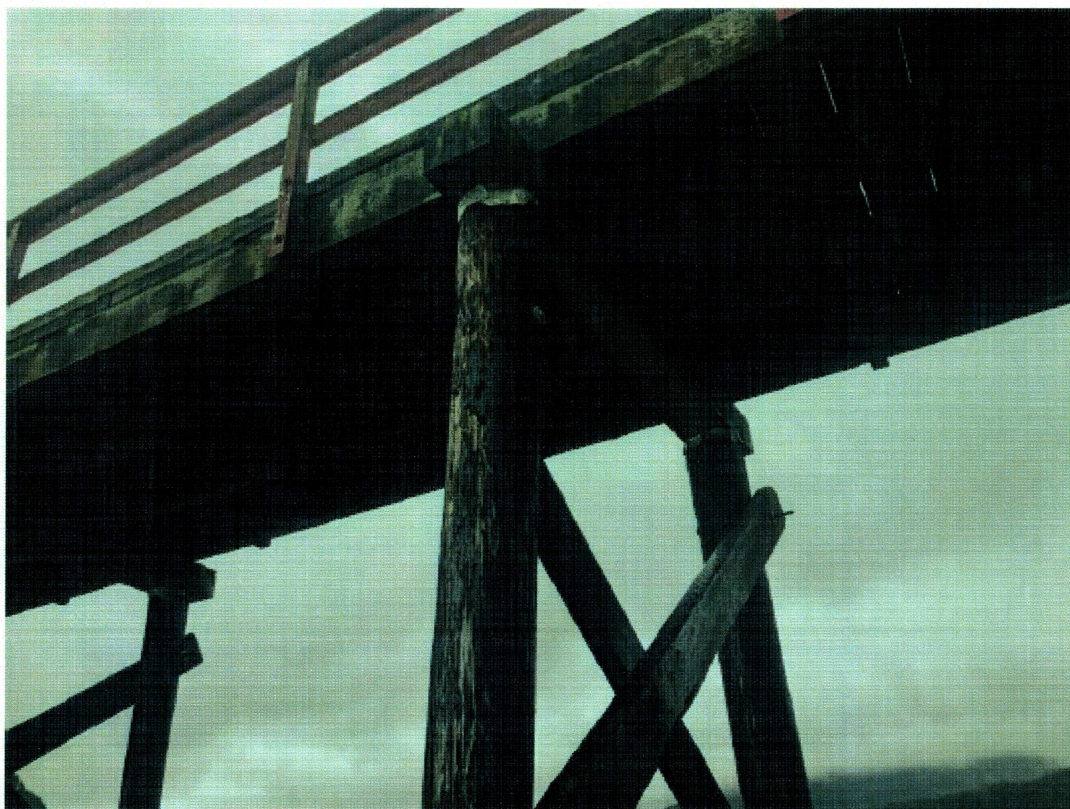
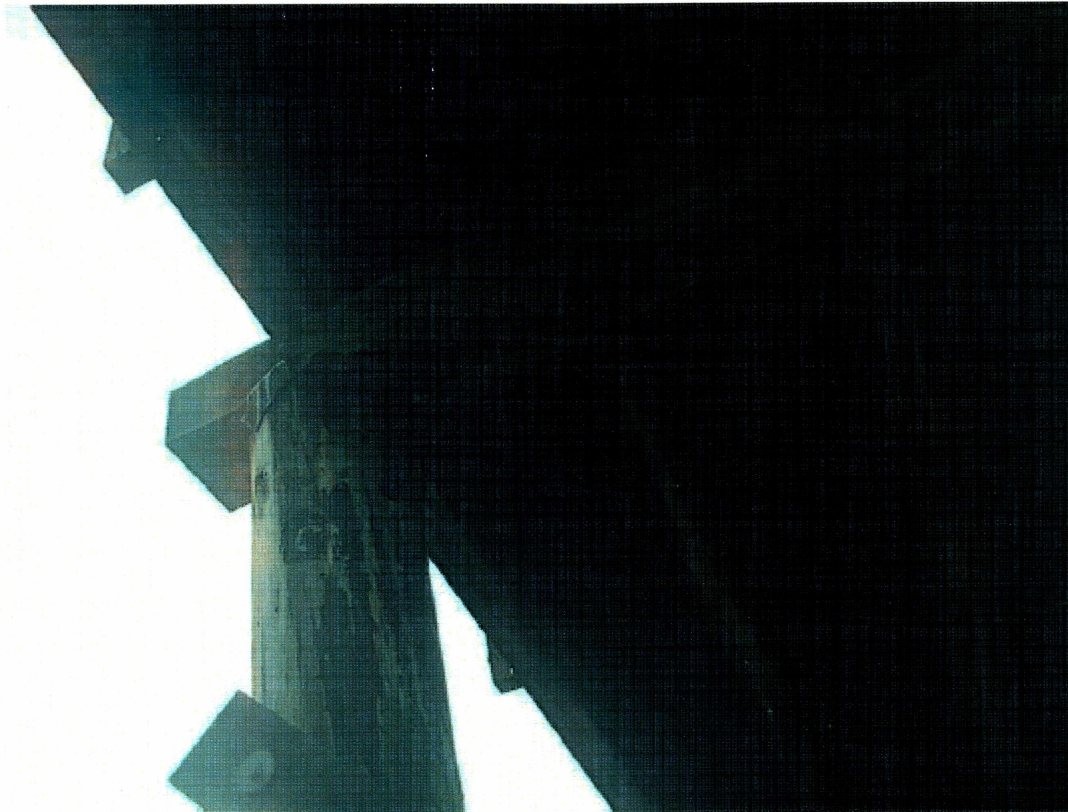
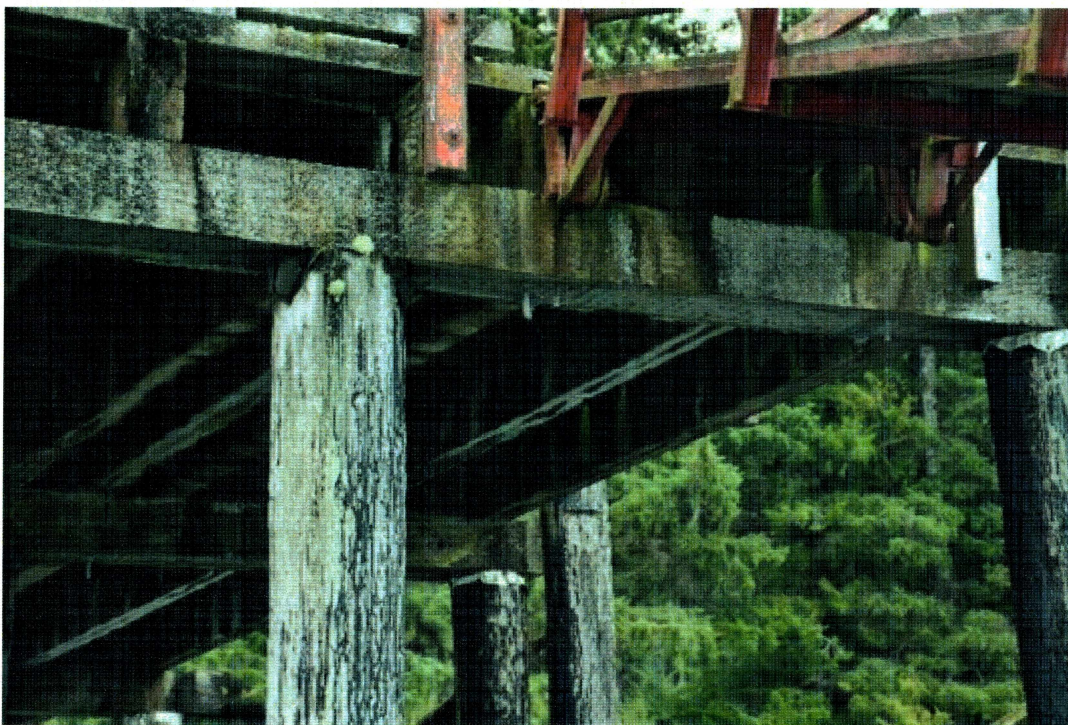
Pile 8A	Moderate splitting at the top of the pile. (Photo 20)	Monitor.
Pile 9A	Large open bolt hole at the top of the pile, likely from a previous cross-brace bolted connection. (Photo 21)	Monitor.
Pile 10A	Moderate splitting at the top of the pile. (Photo 22)	Monitor.
Pile 12A	Large open bolt hole at the top of the pile, likely from a previous cross-brace bolted connection. (Photo 23)	Monitor.
Pile 15B	Moss growing out of the top, indicating that there is fungal decay in the interior of the pile in this location. (Photo 24)	Monitor.

Photo 20 – Split in Pile 8A

Photo 21 – Hole in Pile 9A

Photo 22 – Small split in Pile 10A

Photo 23 – Hole in Pile 12A

Photo 24 – Moss growth in Pile 15B

Repairs are not considered necessary at this time; however ongoing monitoring of the piles and areas of damage is recommended. It is anticipated that the piles identified with splitting and open holes will have established internal fungal decay in the next 5-10 years and should be considered for replacement.
