A BYLAW TO AUTHORIZE THE DISPOSITION OF THE PORT NEVILLE WHARF FACILITY

January 20, 2022 | Revision A

Marine Facility Condition Assessment of the Port Neville Wharf

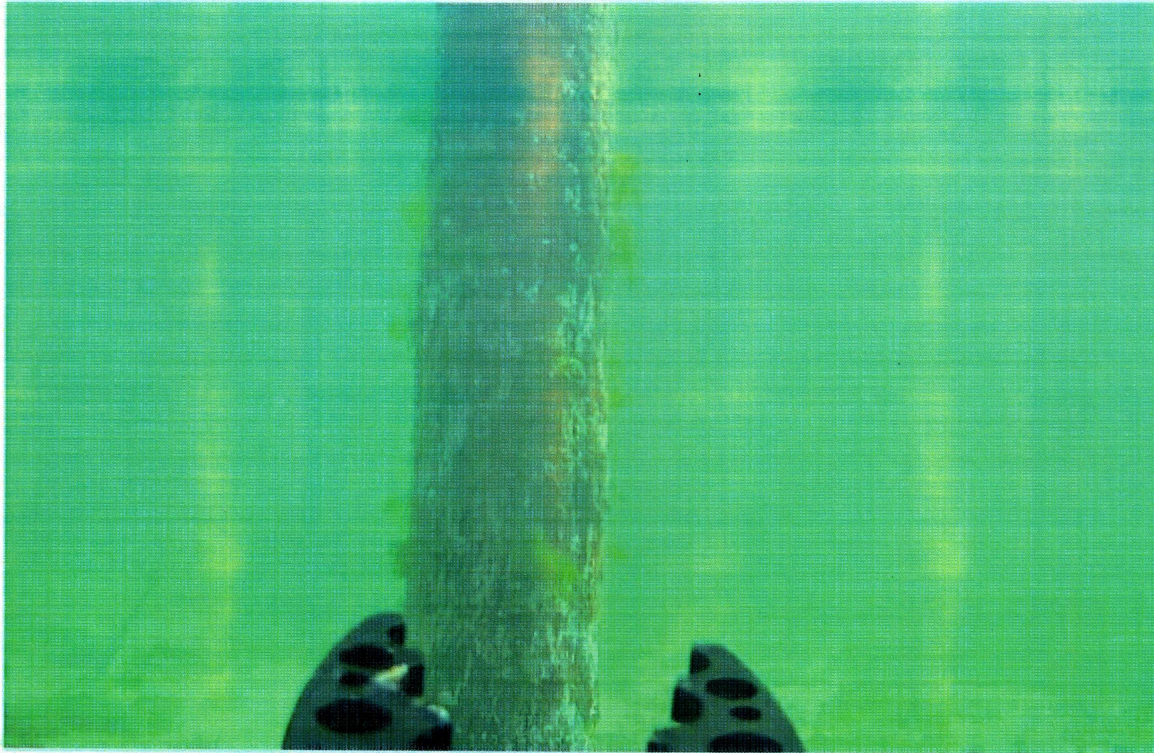
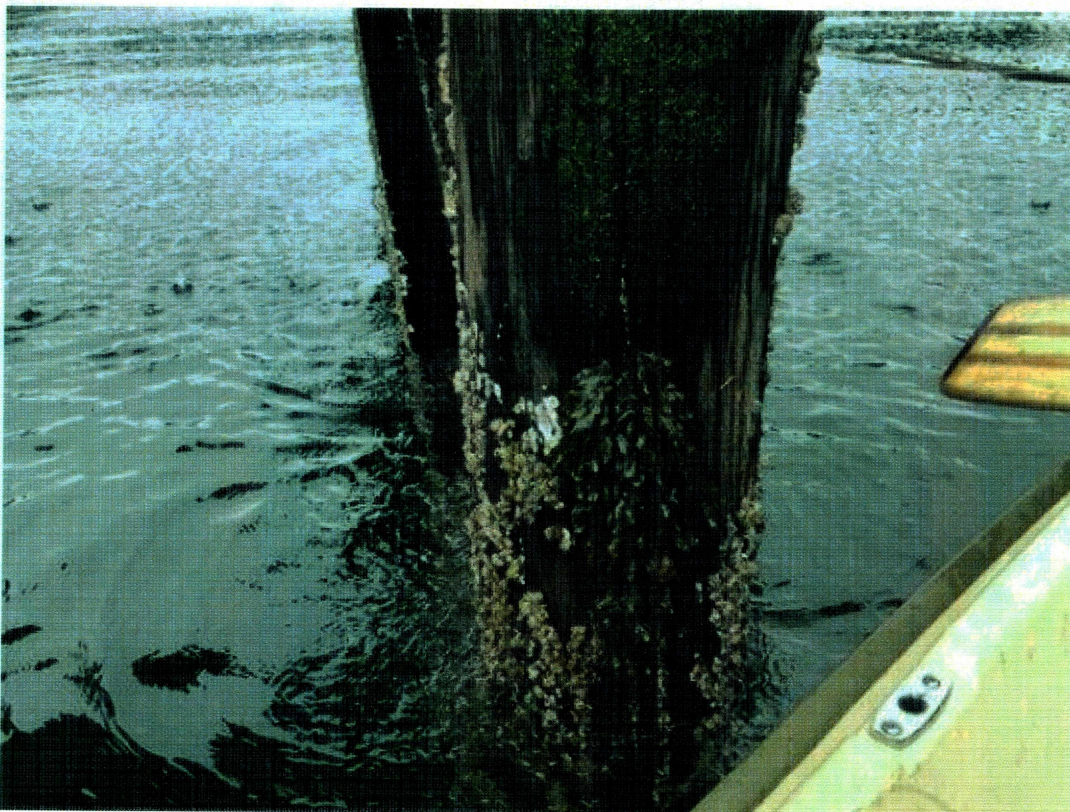
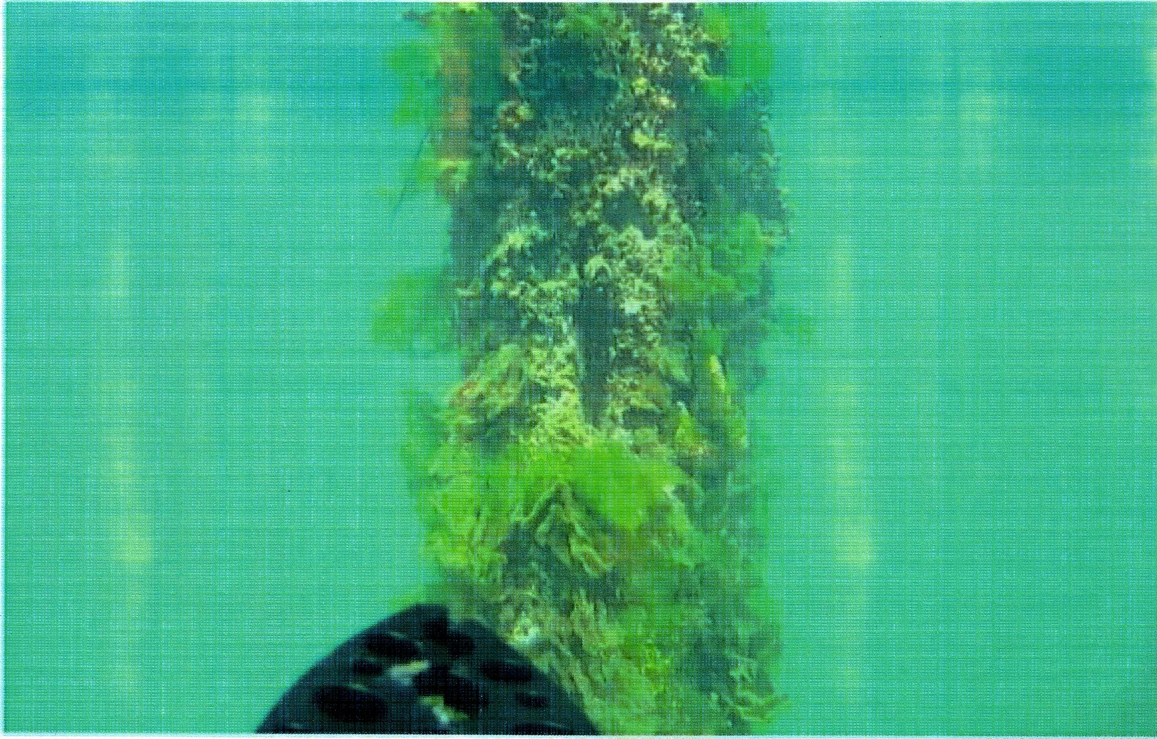
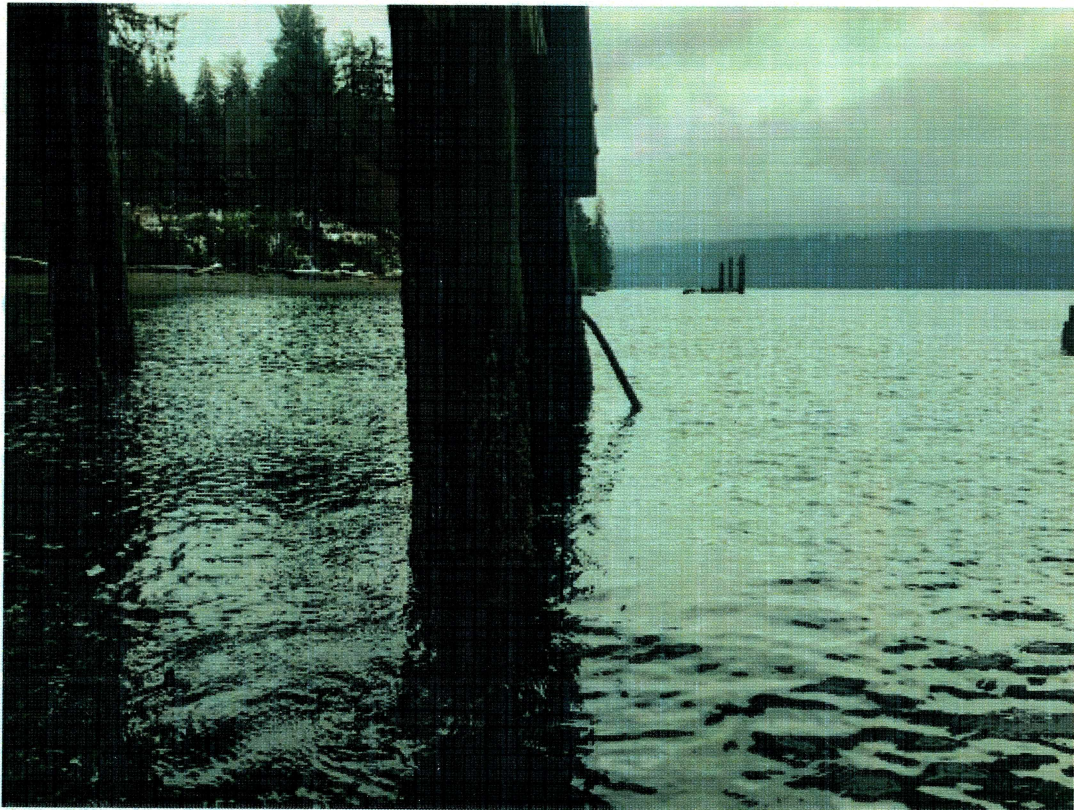
- Fender Pile 10B has a marine borer cavity in the lower intertidal zone with 25% cross-sectional loss (CSL) (Photo 25).
- Fender pile 14A has a large marine borer cavity with 50% CSL, and likely severe cross section loss due to fungal decay (Photos 26 & 27). Marine growth appears to be coming out of the pile.
- Fender pile 15C has a large marine borer cavity with 50% CSL, and likely severe cross section loss due to fungal decay (Photo 28).

Photo 25 – Underwater image of damage to fender Pile 10B

Photo 26 – Fender Pile 14A

Photo 27 – Underwater image of marine borer cavity of fender pile 14A

Photo 28 – Fender Pile 15C

McElhanney understands that the fender piles are not longer used for vessel moorage and repairs are not considered necessary at this time as the fender piles are not structurally important to the pier.

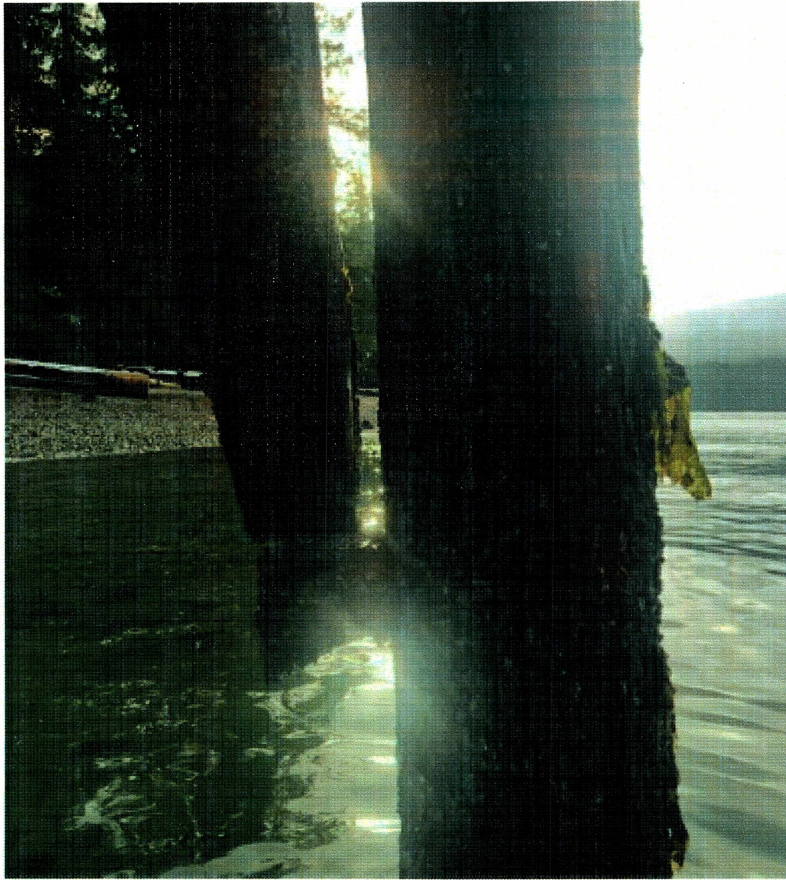
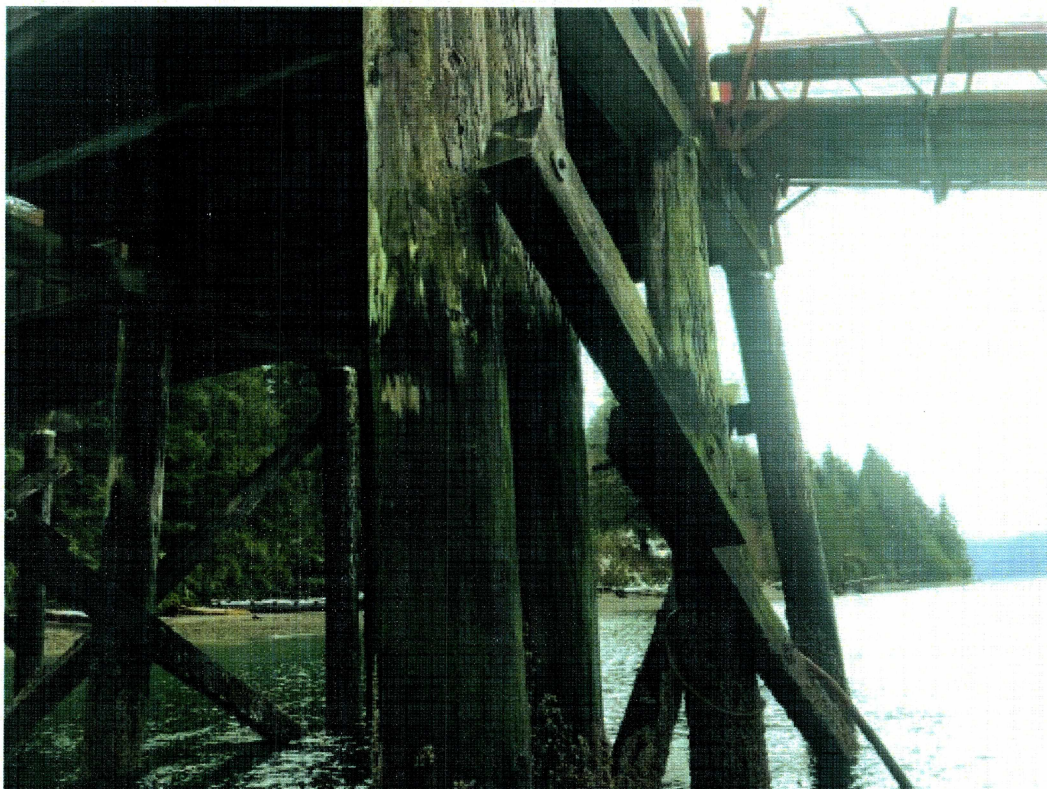
- There is widespread weathering, and minor fungal decay to the end grains of the members, however all cross braces appear well secured to the piles, apart from two locations.
- The cross bracing at Bent 8 appears to not be connected to pile 8A and is only resting on a timber block secured to the pile. (Photo 29)
- The cross bracing at Bent 15 is connected to the fender pile 15C, which has signs of significant cross-section loss. (Photo 30)

Photo 29 – Cross Bracing at Bent 8

Photo 30 – Cross Bracing at Bent 15

It is recommended that the cross braces at Bents 8 and 15 are re-secured. Ongoing monitoring of the cross bracing is recommended.

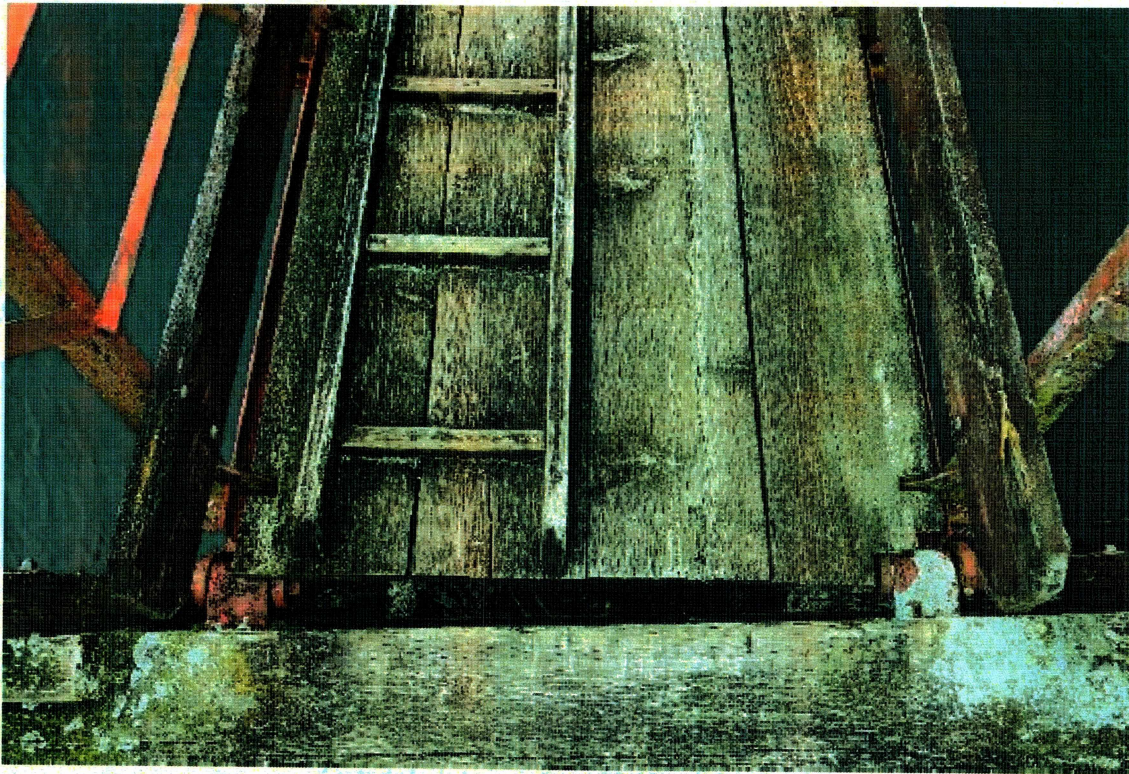
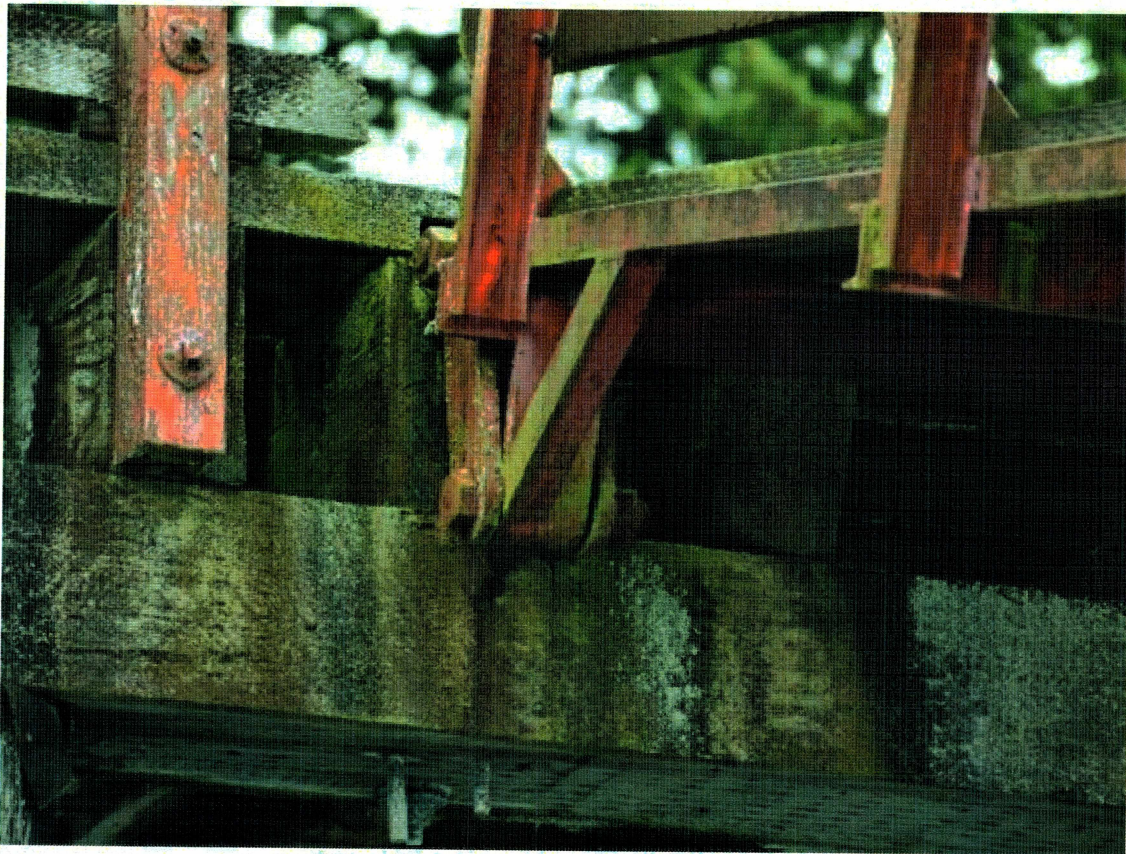
- The upper hinge connection is slightly misaligned (Photos 31 and 32) which is likely to result in advanced wearing of the pinned connection.
- The timber gangway slider plate is in good condition with minor wearing and is well aligned with the gangway roller (Photo 33)
- The deck planks and anti-slip surface have moderate wearing (Photo 34).
- The steel truss members have typical minor to moderate coating failures and corrosion. No significant deterioration of the welded connections was noted (Photo 35).

Photo 31 – Gangway Upper Hinge Connection

Photo 32 – Gangway Upper Hinge Connection

McElhanney recommends that the access gangway be replaced in conjunction with future replacement of the floating docks.

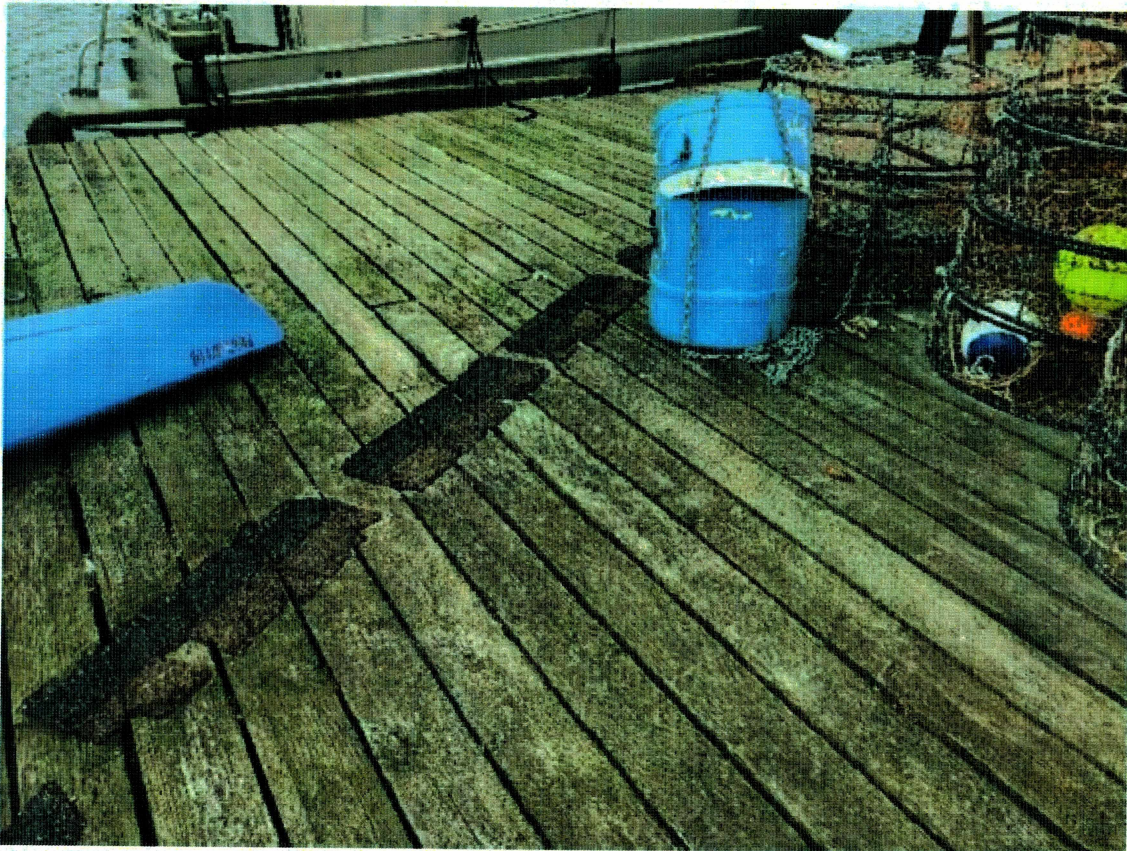
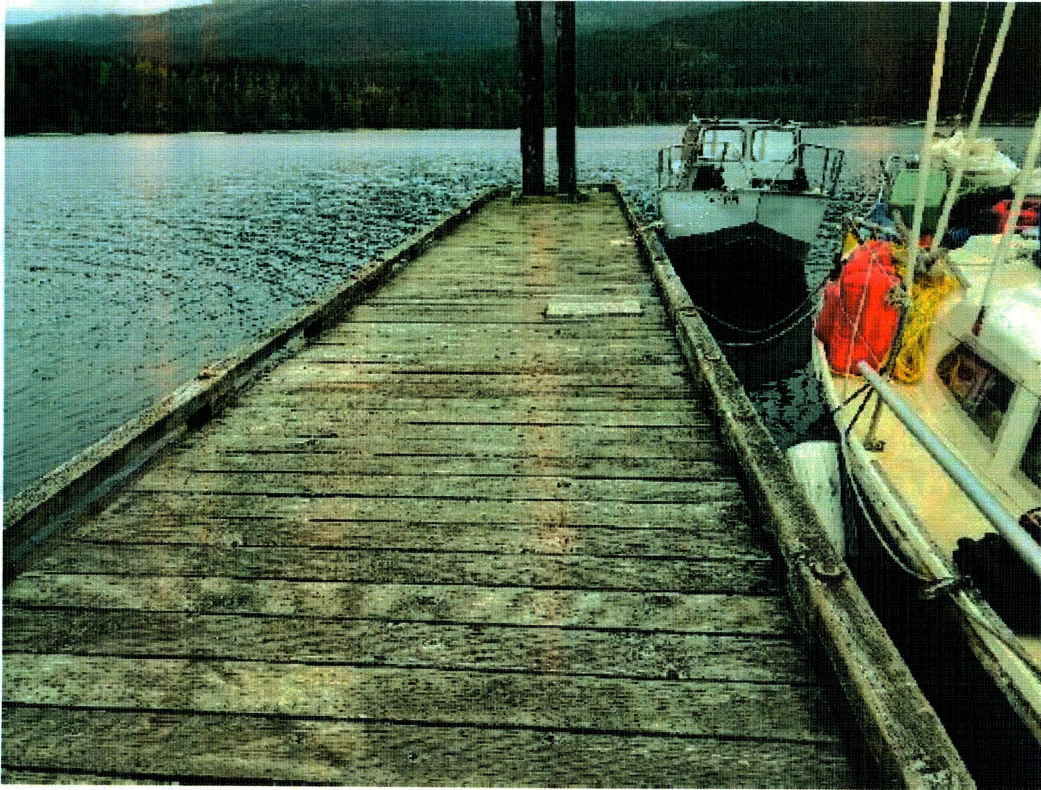
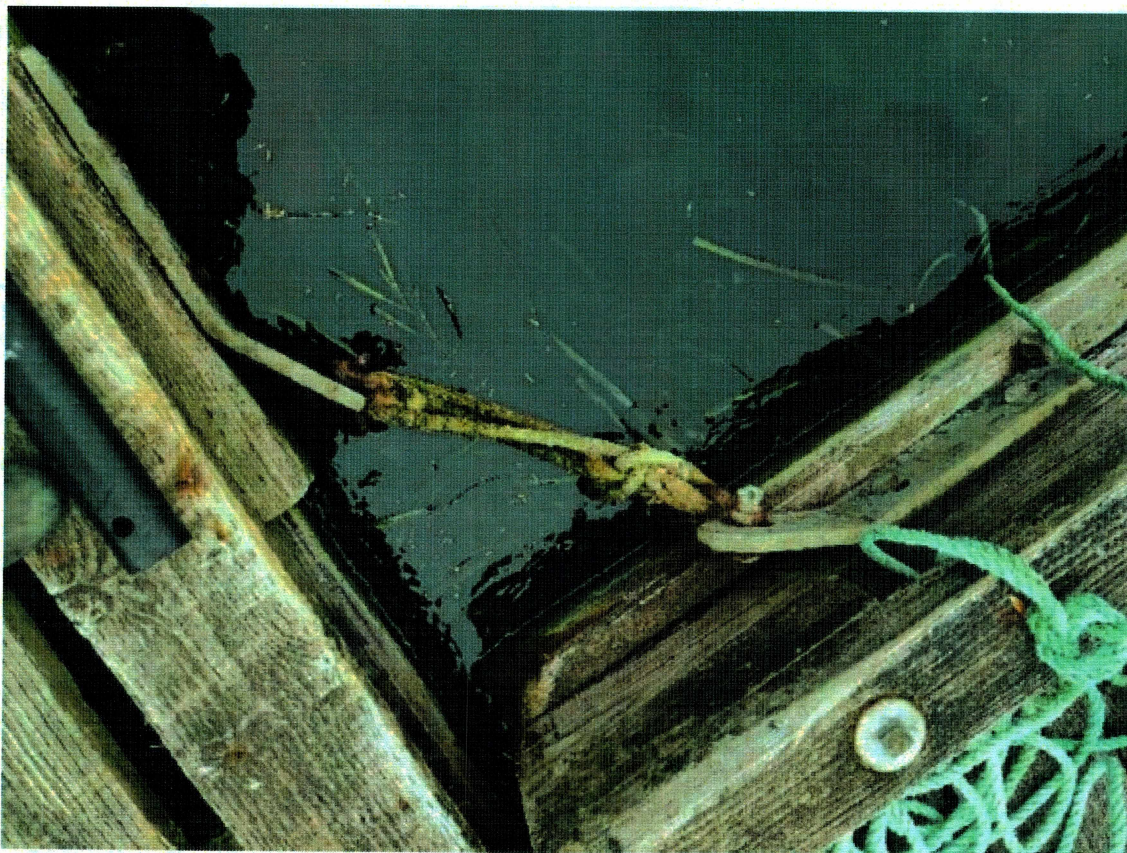
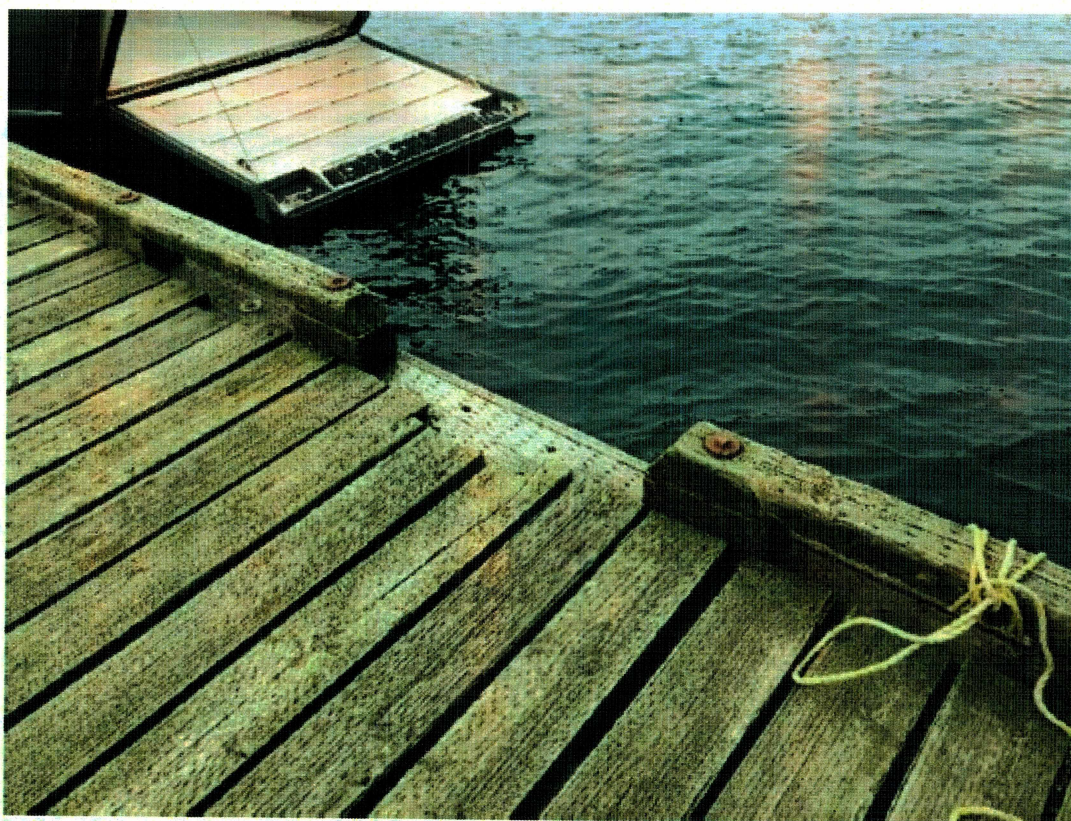
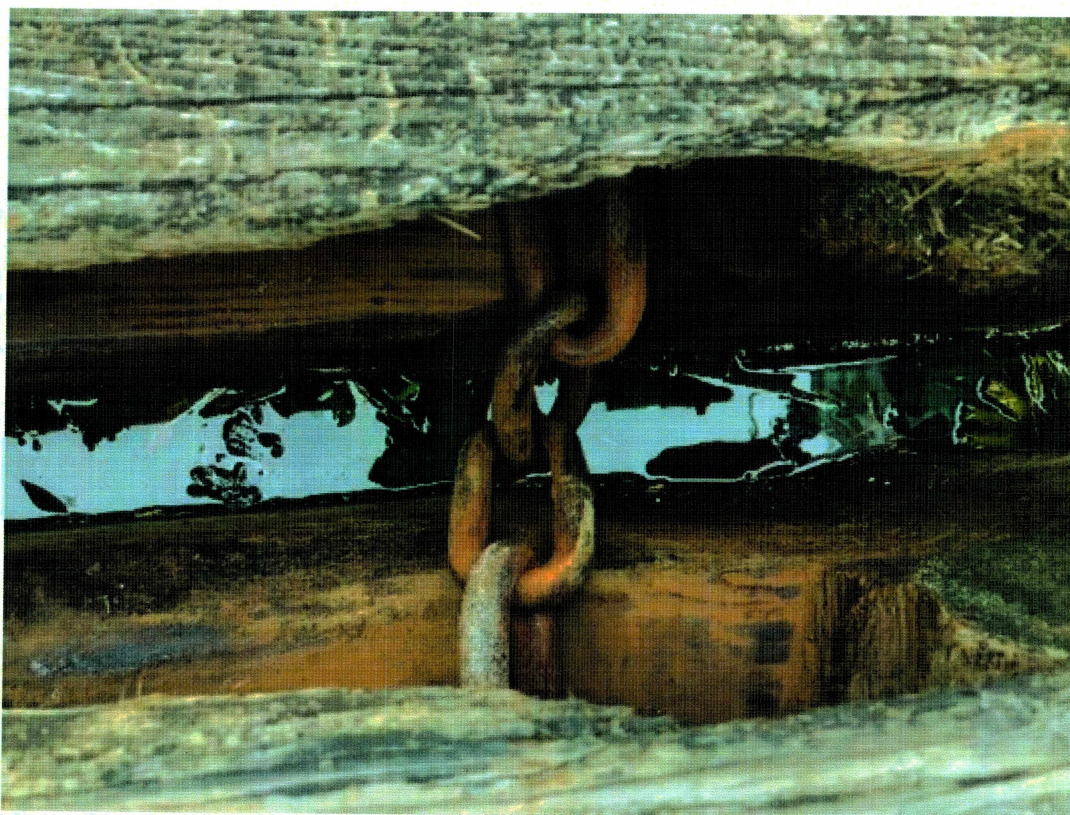
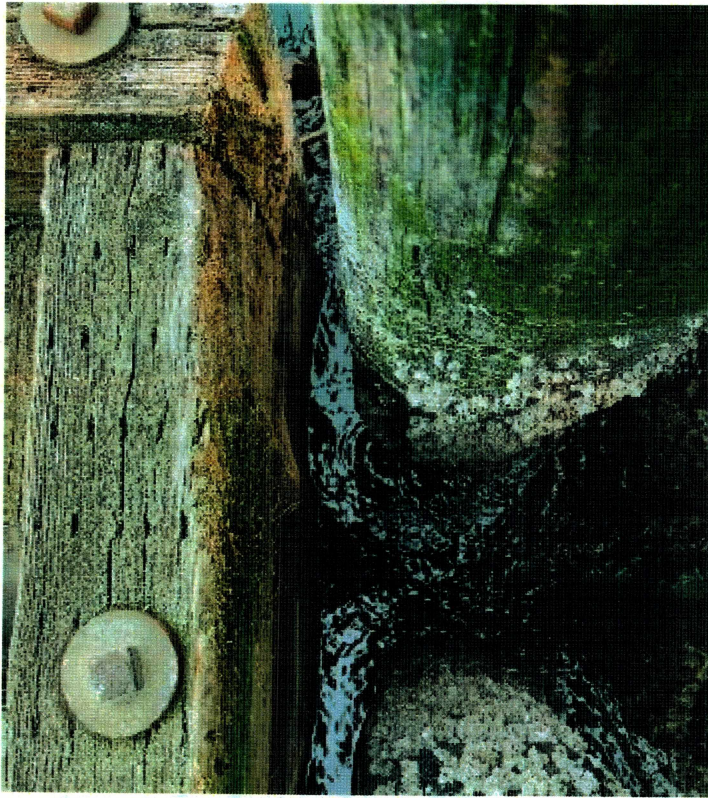
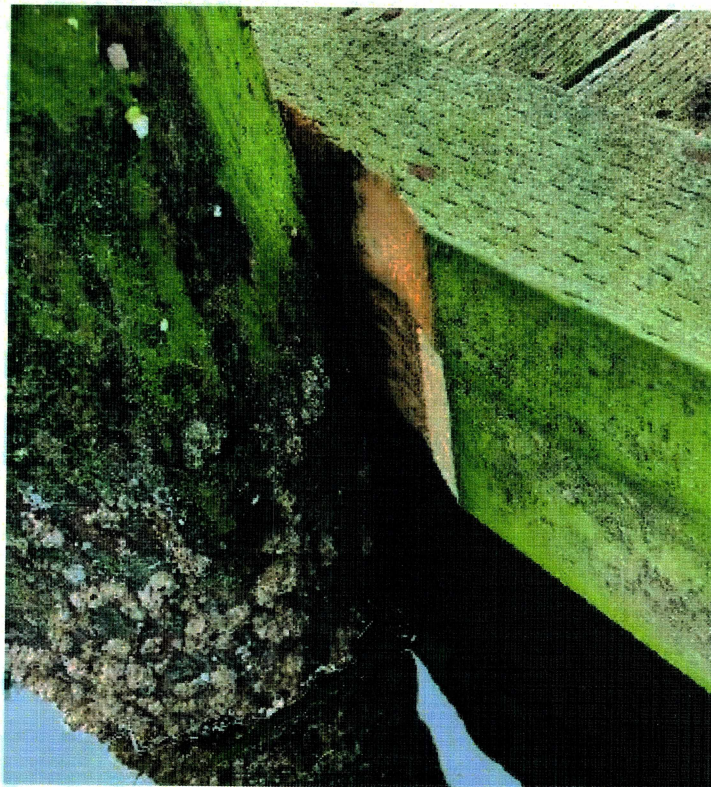
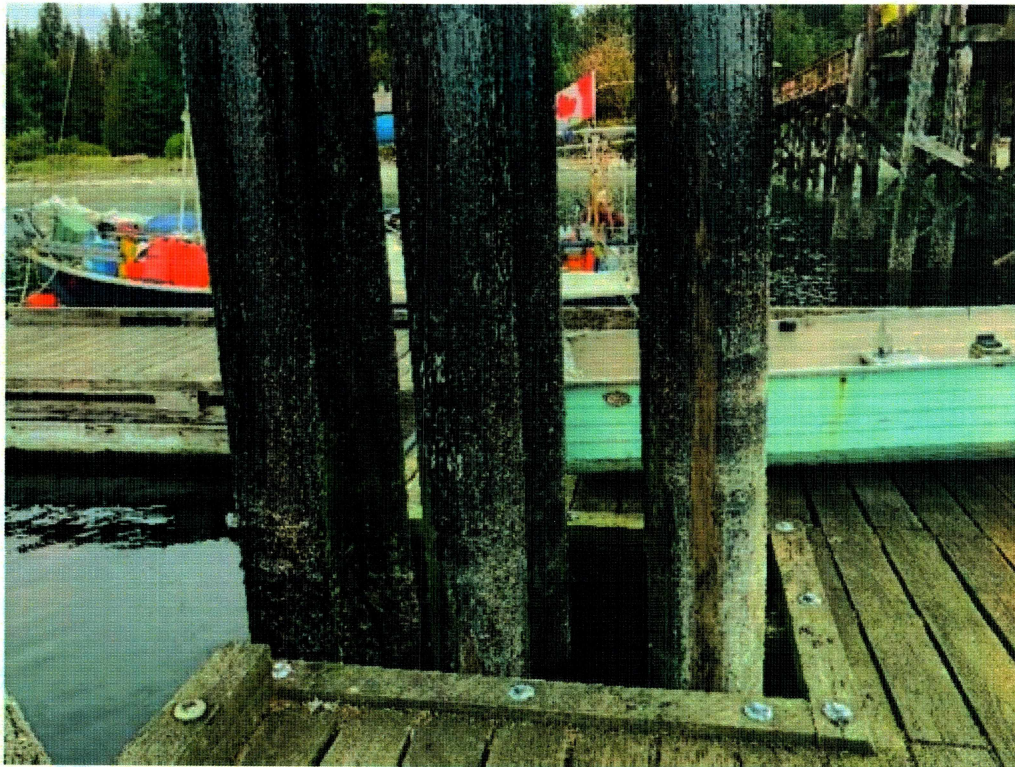
Float A is in poor to fair condition with minor deterioration to the topsides (Photo 36). Inspection findings are as follows:

- The timber deck planks have widespread moderate weathering and fungal decay, with localized deterioration. There is one location on Float B with plywood repair to the decking which is a tripping hazard (Photo 37)
- The floatation elements appear in fair condition.
- The west connection between Float A and Float B is rope (Photo 38). This is currently functioning properly, however this may be subject to rapid wearing and should be replaced with a steel chain in the future.
- The bull rails and fascia boards have widespread mechanical damage (Photo 39). The bull rail is missing in two locations.
- The east connection between Float A and Float B is chain which is causing moderate wearing to the floats (Photo 40).
- The mooring piles and mooring dolphins have moderate abrasion with the dock structures (Photo 41 to 33).

Photo 36 – General view of Float A

Photo 37 – General view of Float B

Photo 38 – Rope connection to Float B

Photo 39 – Missing Bull rail on Float A

Photo 40 – Chain Connection to Float B

Photo 41 – Wearing to Float A from North Mooring Dolphin

Photo 42 – Wearing to Float A from South Mooring Piles

Photo 43 – Float A North Mooring Piles

Consideration should be given to replacing Floats A and B along with the mooring system rather than continue regular minor maintenance/repairs.

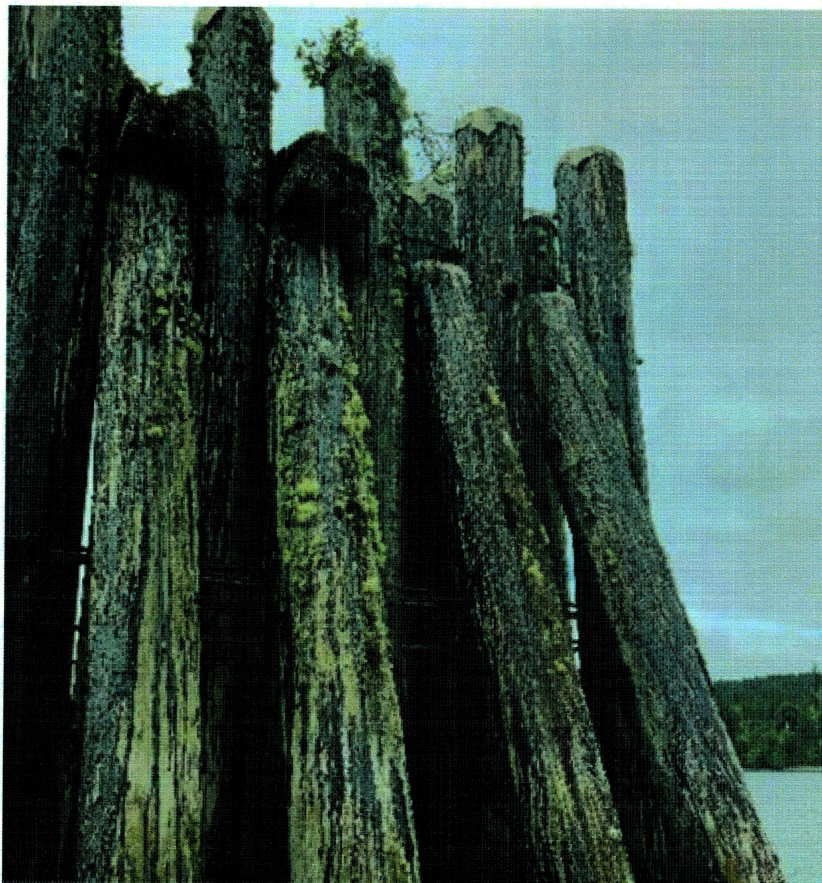
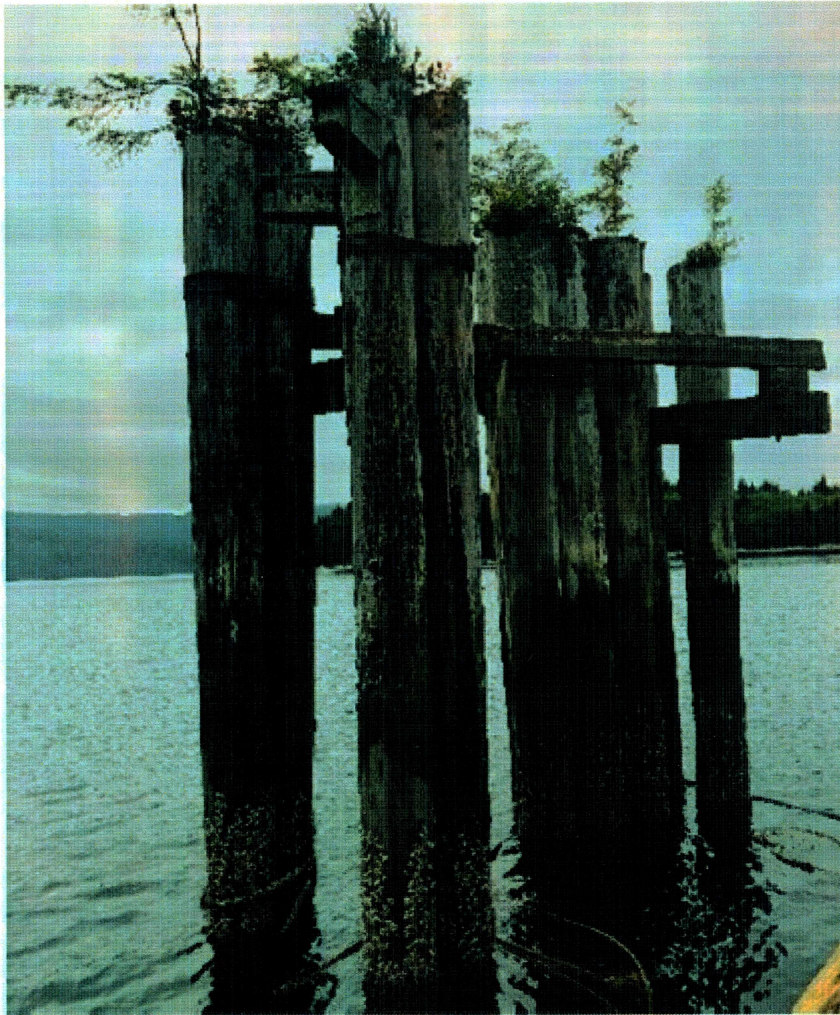
- The north dolphin has vegetation growth near the tops of some of the piles. The timber blocking near the tops of the piles is deteriorating, and the cable wraps are loose (Photo 44)
- The south dolphin has significant vegetation growth near the tops of the piles. There is also severe cross section loss due to internal fungal decay and marine borer cavity in the intertidal zone, specifically on the front facing piles. The timber blocking is in poor condition, and the cable wraps are loose, but remain in place (Photo 45).

Photo 44 – North Mooring Dolphin

Photo 45 – South Mooring Dolphin

McElhanney understands that the mooring dolphins are no longer in service. To mitigate the risk of timber members contacting the dock, it is recommended that the timber dolphins be entirely removed and disposed of.
