**Notes of Levels Survey; Audet 2018**

**Level Survey – Dam Crest to Discharge at Creek**

**Riparian Areas Regulation: Assessment Report; Cynthia Hannah, 2007**

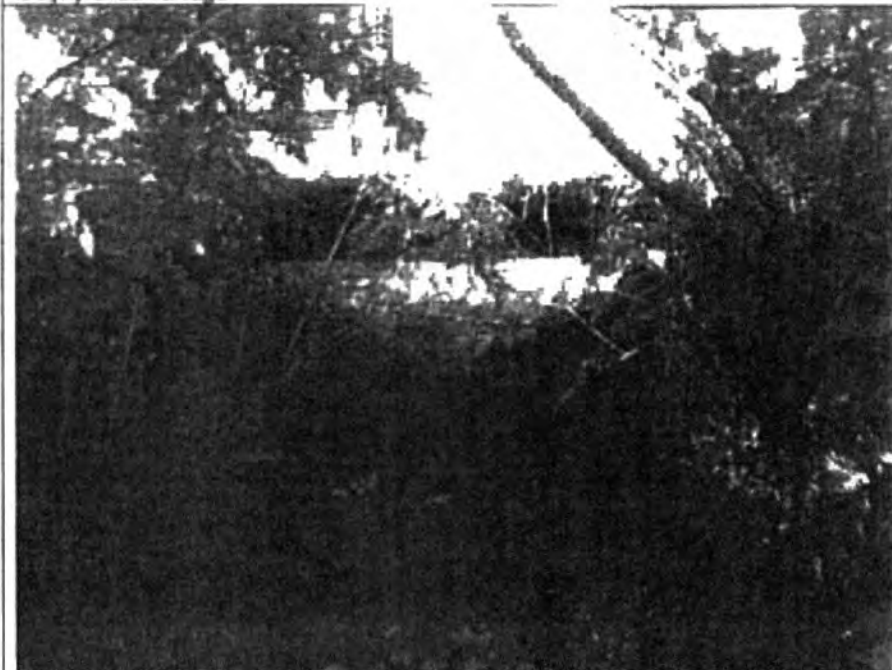
Label

Mayfly Creek bridge

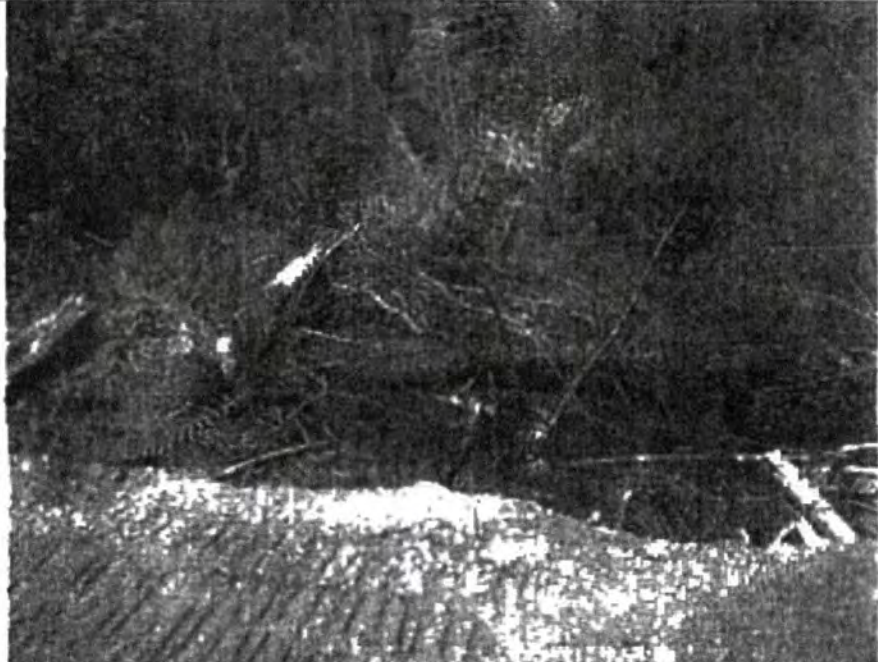
Label

The built road is located adjacent to the beaver pond on Stonefly wetland. The pond edges are vegetated with hardhack, sedges, and a few trees.

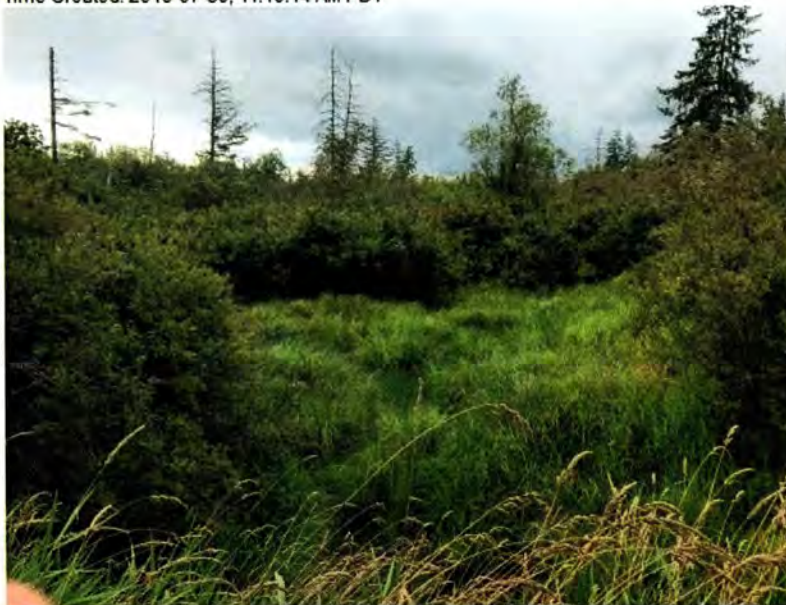
Typical wetland conditions.

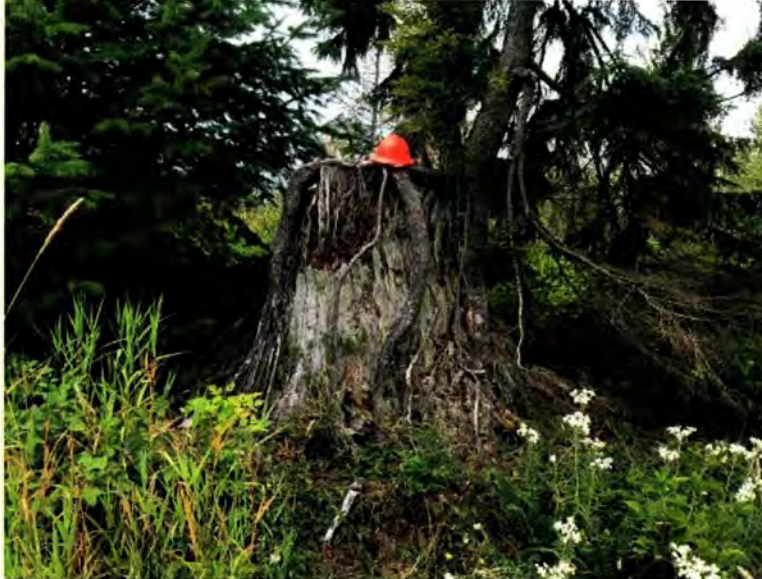
## Photograph 2

Large, saw cut, stump. Notice the sizeable tree growing from the rotten stump.  
Such ground conditions are characteristic of conventional old growth harvesting operations.

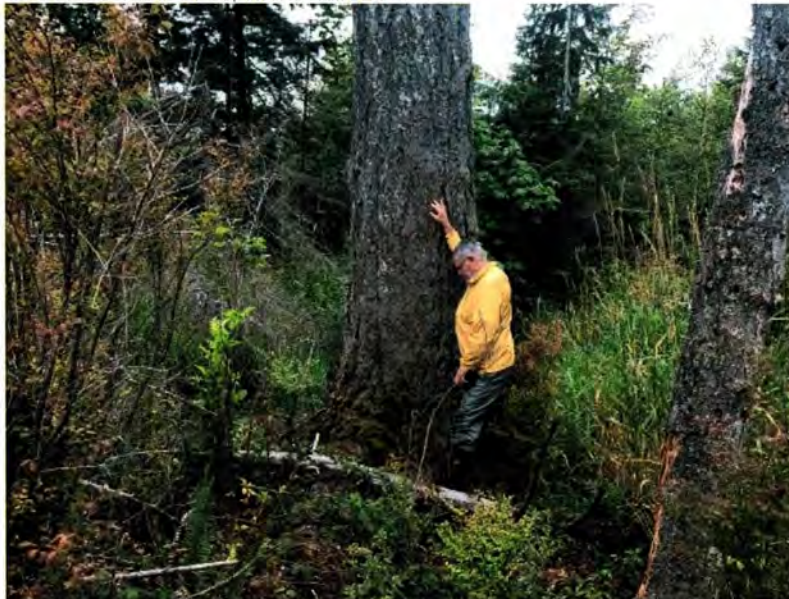
## Photograph 3

Tree cored to approximate the age of the surrounding forest and old growth stumps.

We increment bored the Douglas fir illustrated in photograph 3. We measured the circumference of the tree to be 3.1 metres for a radius of 49 cm. Assuming the tree had a four centimetre thick layer of bark points towards a debarked radius of 45 cm. We sampled the tree with a short (40 centrimetre) and long (66 centrimetre) increment bore. Both cores missed the pith of tree. The:

1. Short increment bore yielded 31 cm of stem for a tree ring count of 83. Adjusting for the unsampled core of the tree suggests a probable age of 120 years (actual tree count of 83 divided by 31 cm length of recovered core multiplied by the estimated 45 cm true radius of the stem).
2. Long increment bore recovered 55 cm of stem but 17 cm of the recovered core where from the opposite side of the tree. The tree ring count upon the near side of the tree was 78. Adjusting for the missing core of the stem suggests an age of at least 92 years (raw count of 78 divided by 38 cm of targeted stem multiplied by estimated 45 cm true radius of the stem).

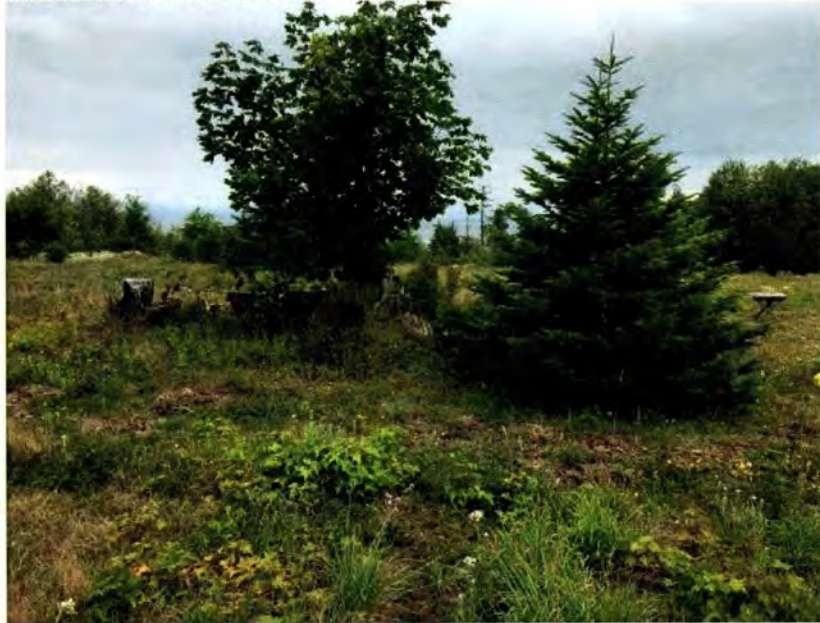
Island of original forest floor surrounded by a clearing.  
The clearing is characteristic of forested lands stripped to mineral soil.

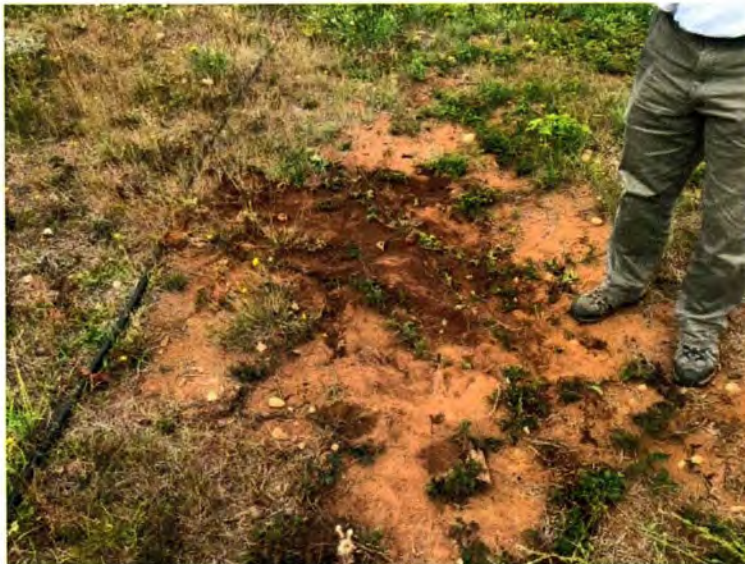
## Photograph 5

Shallow test pit near the site of photograph 4.  
Notice the absence of tree roots and top soil.  
Loose sand found to full (0.5 metre) depth of test pit.

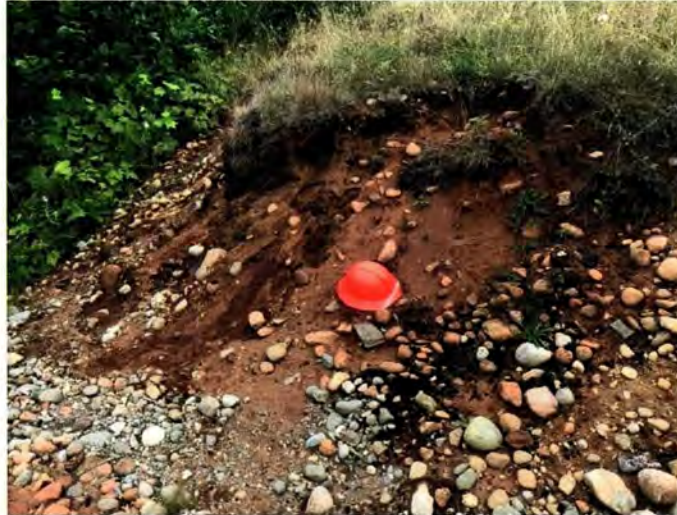
## Photograph 6

Typical sandy soil found along access road upon Mister Audet's property.

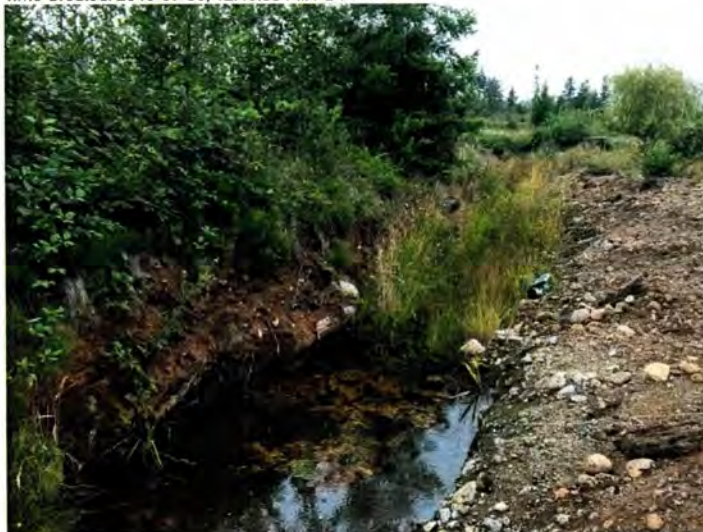
## Photograph 7

The ground conditions at the south end of Mister Audet's property are consistent his and historical FishFor reports. The thin collapsing soil crust, abundance of groundwater seepage and evidence of buried wood are consistent with Mister Audet's and FishFor's site descriptions.

Soil atop buried wood and abundant ground water seepage at the south end of Mister Audet's property.
