Marine Facility Condition Assessment of the Owen Bay Wharf

August 24th, 2022 | Revision 0

Submitted to: Strathcona Regional District (SRD)
Prepared by McElhanney Ltd.

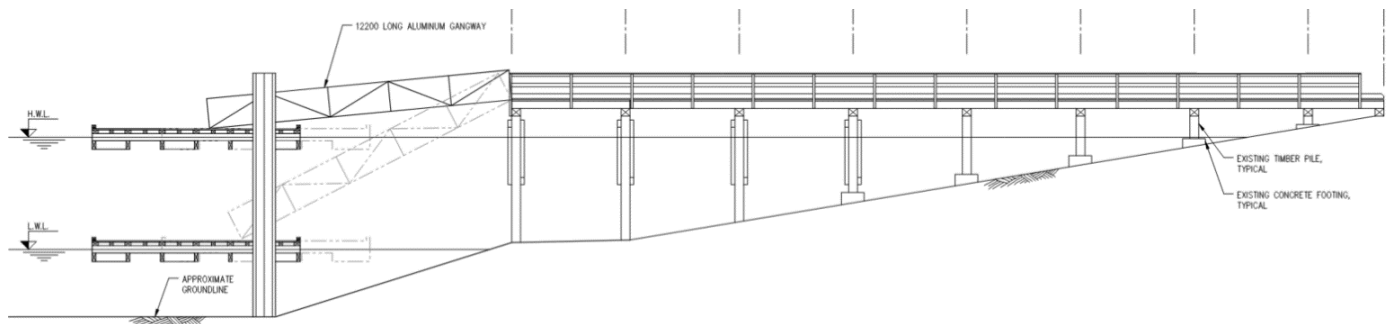
Figure 3 – Wharf Structure Elevation

Figure 3 provides a reference sketch of the timber wharf structure. Inspection photographs can be found in Appendix A.
