STAFF REPORT

RE: **BYLAW NO. 625 - OYSTER RIVERBANK PROTECTION SERVICE**

**RE: STRATHCONA REGIONAL DISTRICT
Oyster River Riverbank Inspection
Inspection Findings, Remediation Recommendations and Management Plan
Our File 3436.005-300**

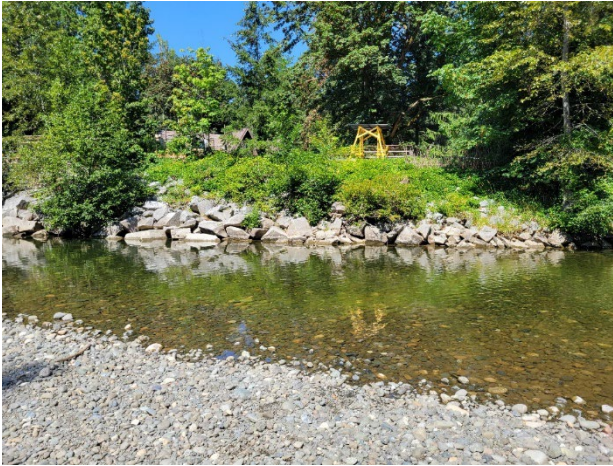
ID	Location	Observations
B1	Oyster River (19a) Bridge to Regent Road Bridge (Lat: 49.86881 Lon: -125.129584)	Approximately 300 m of riprap bank armouring spanning nearly the full distance between bridges. Rock is well interlocked at an approximately 2:1 slope with a median diameter (D50) estimated at 750 to 1000 mm. Several trees and Himalayan Blackberry have established within the rock apron especially at the upstream end (Photo 1). A small amount of rock loss at the toe was observed at the downstream end of the riffle.
B2	Downstream of Lorna Lane to approximately 100 m upstream of Oyster River (19a) Bridge (Lat: 49.869783 Lon: -125.139307)	Riprap bank armouring approximately 600 m long varying in diameter from 300 mm to 1,200 mm with much larger rock placed along the toe. Slope varies from 1:1 to 3:1 with full bank coverage that thins at its upper slope. Riprap is weathered, with condition generally fair and some undermined areas showing exposed bank (Photo 2). The furthest upstream section appears to be newer rock, however significant trees and vegetation have established in the interstitial spaces of the rock.

Photo 1: Established Trees and Vegetation, Especially Himalayan Blackberry, in the Riprap Apron Between Hwy 19a Bridge and Regent Road Bridge (August 7, 2024)

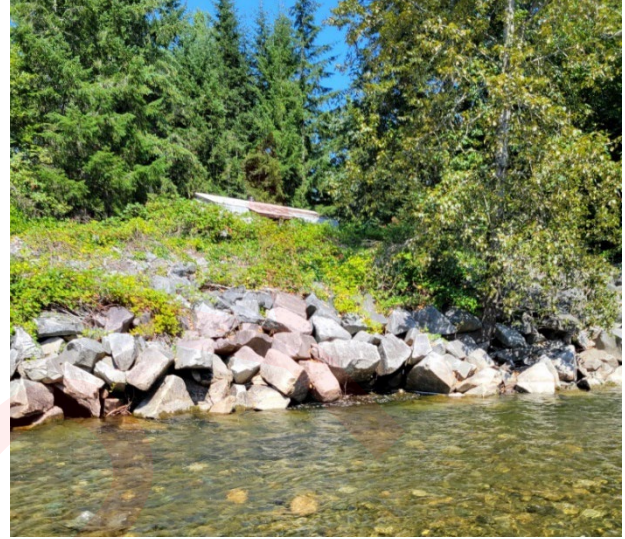
Photo 2: Some Minor Riprap Loss at the Toe of Slope Upstream of Hwy 19a Bridge (August 7, 2024)

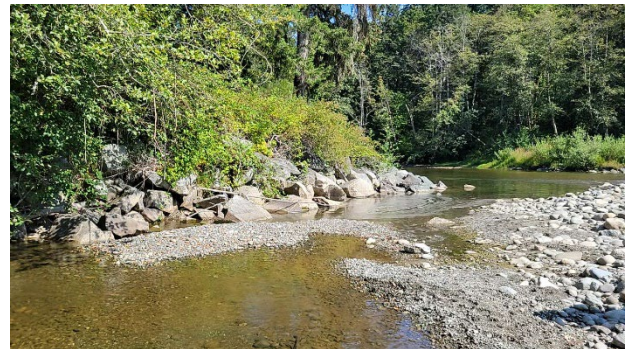
B3	Upstream limit of assessment area to Lorna Lane (Lat: 49.868942 Lon: -125.14218)	Approximately 200 m long riprap bank armouring with a D50 of 800 mm at a slope ranging from 2:1 to 1:1. The rock appears to be newer however some local loss was observed along the toe. Some vegetation has established in the bank and the instream base is founded on bedrock (Photo 3).
B4	Side channel and tie-in to Glenmore Dike (Lat: 49.868829 Lon: -125.143257)	Steep riprap placed at a 1:1 slope along the corner of the confluence of the side channel and river main stem. The full bank is covered with riprap with a diameter of 700 mm and greater. The riprap extends up the side channel an unknown distance towards the Glenmore Dike and into heavy vegetation (Photo 4).

Photo 4: Riprap Extending up a Side Channel Towards the Glenmore Dike and into Heavy Vegetation (August 7, 2024)

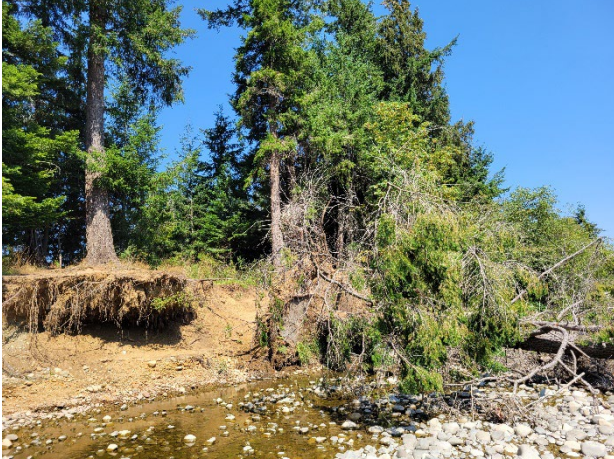
Photo 5: Actively eroding Bank Undercutting Several Mature Trees (August 7, 2024)

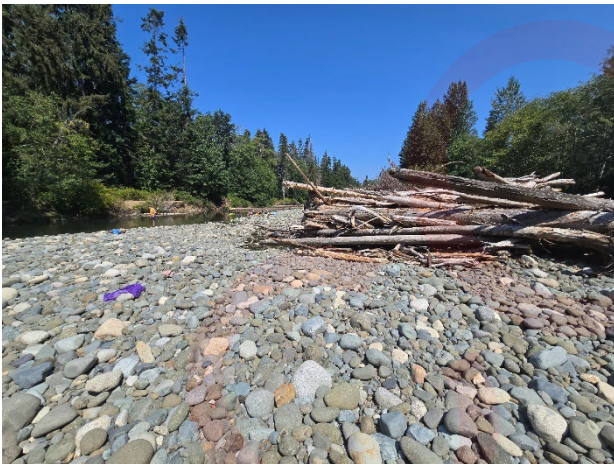
Photo 7: Log Jam on a Gravel Bar at Oyster River Nature Park (August 7, 2024)

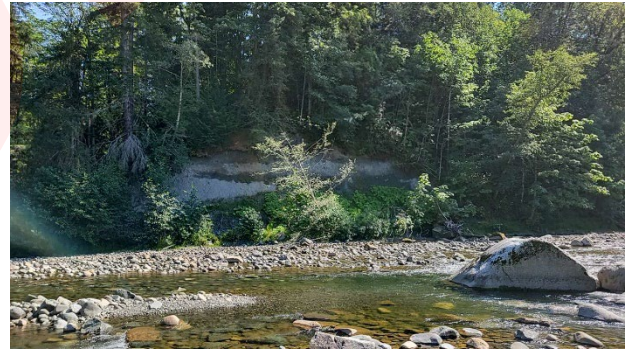
G5	Right bank (CVRD) at Lorna Lane (Lat: 49.869401 Lon: -125.140776)	A large silt bluff is actively eroding and likely acting as a sediment input source to the river (Photo 8).
G6	Upstream limit of assessment area to Lorna Lane (Lat: 49.868942 Lon: -125.14218)	The river runs over an outcropping of exposed bedrock which results in effectively no risk of scour or undercutting of bank armouring (Photo 9).

Photo 8: Eroding Silt Bluff on the Right Bank at Lorna Lane (August 7, 2024)

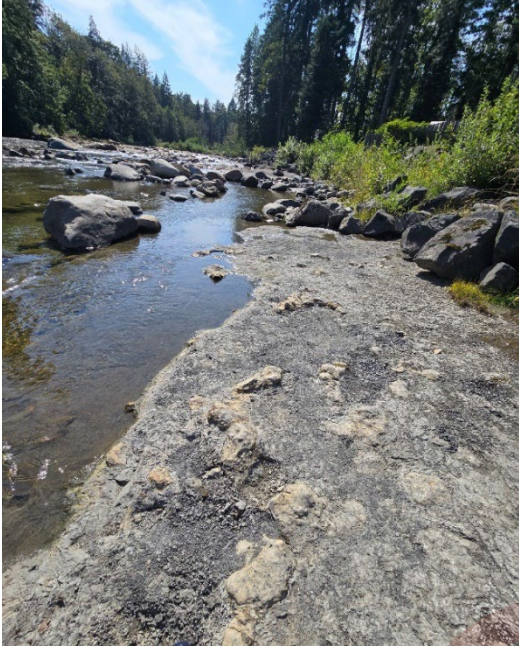
Photo 9: The River Runs Over Exposed Bedrock at the Upper Limit of the Assessment Reach (August 7, 2024)

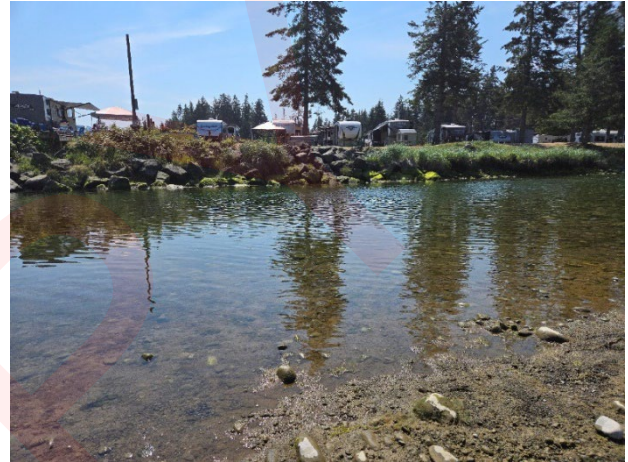
ID	Location	Observations
O1	Oyster River Estuary south (right) bank (Lat: 49.871636 Lon: -125.118946)	This section of bank is significantly lower than the left bank (0.25 to 1 m) and a clear preferential path for overland flooding. Some weathered, blocky bank armouring exists and is generally in poor condition (Photo 10).
O2	Oyster River Nature Park (Lat: 49.870112 Lon: -125.123316)	A berm has been constructed slightly set back from the left bank composed of poorly sorted rock with some tethered logs assumed to be a woody debris structure. Trees are growing through the berm in several sections, and its presumed function is to protect a wellhead in the parkland nearby. While not a bank armouring measure, it is presumed to provide some river training function during high river flows, despite its likely permeability (Photo 11).
O3	Regent Road Bridge, right bank (Lat: 49.868795 Lon: -125.124885)	Overly steep riprap of varied size on the right bridge abutment showing some material loss (Photo 12). A tributary enters the main channel upstream of the bridge which potentially increases erosion risk to the riprap apron.

Photo 10: Low Right bank at the Estuary with some Rock Armouring (August 7, 2024)

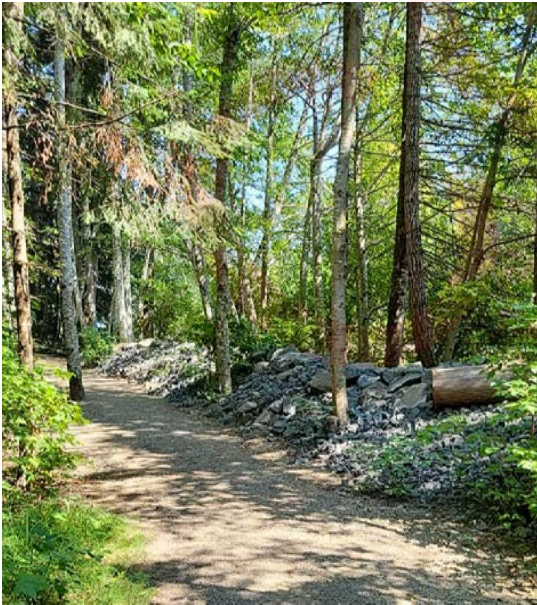
Photo 11: A Windrow Berm in the Left Floodplain to Protect a Wellhead (August 7, 2024)

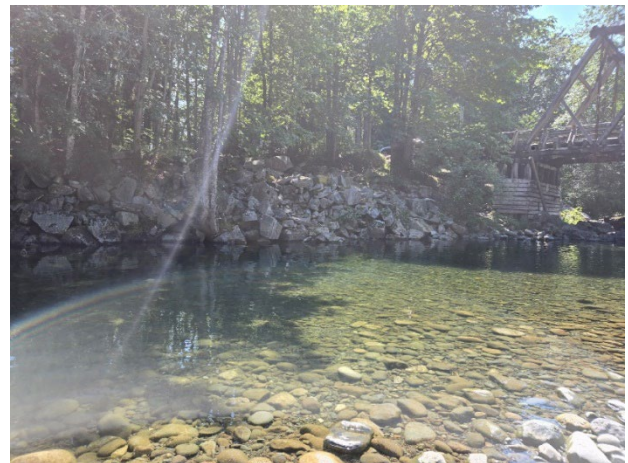
Photo 12: Steep and Varied Riprap Showing Some Material Loss on the Right Abutment of the Regent Road Bridge (August 7, 2024)

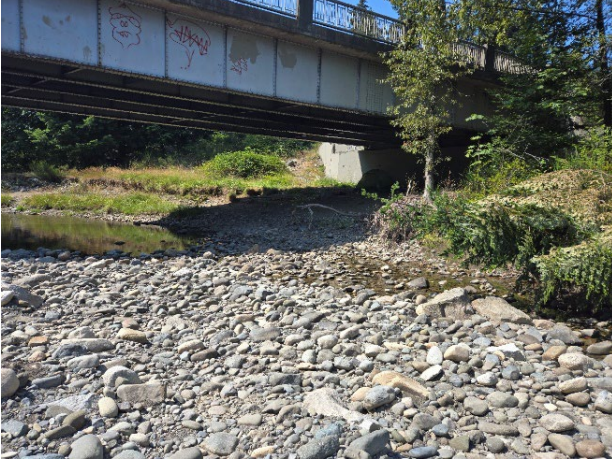
O4	Oyster River Road Bridge (Lat: 49.868257 Lon: -125.130321)	There is no armouring on the left bridge abutment and the unprotected bank shows some minor erosion (Photo 13).

Photo 13: No Bank Armouring and Some Erosion Evident on the Left Abutment of the Hwy 19a Bridge (August 7, 2024)
