RE: BYLAW NO. 487- ELECTORAL AREA C WHARVES SERVICE

FEASIBILITY STUDY

ELECTORAL AREA C WHARVES SERVICE

Marine Facility Condition Assessment of the Surge Narrows Wharf

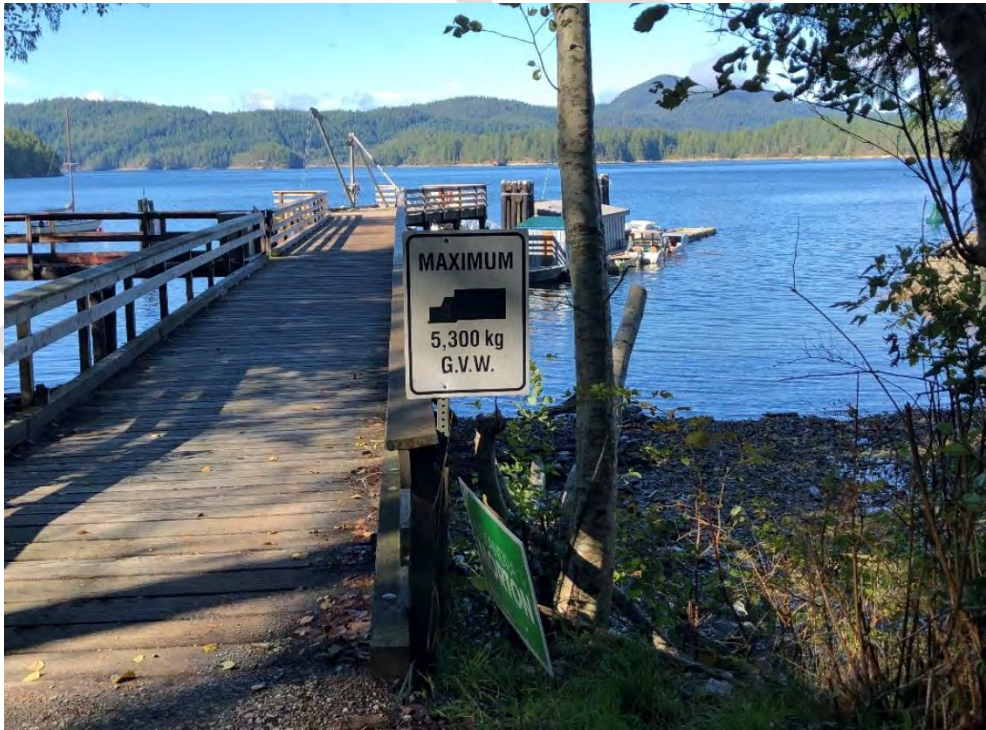
Photo 2 - Load rating sign

The approach is in generally good condition (Photo 1). There are no signs of settlement in this area, and the slope around the abutment appears stable. The load rating sign specifies a maximum gross vehicle weight of 5,300kg (Photo 2).

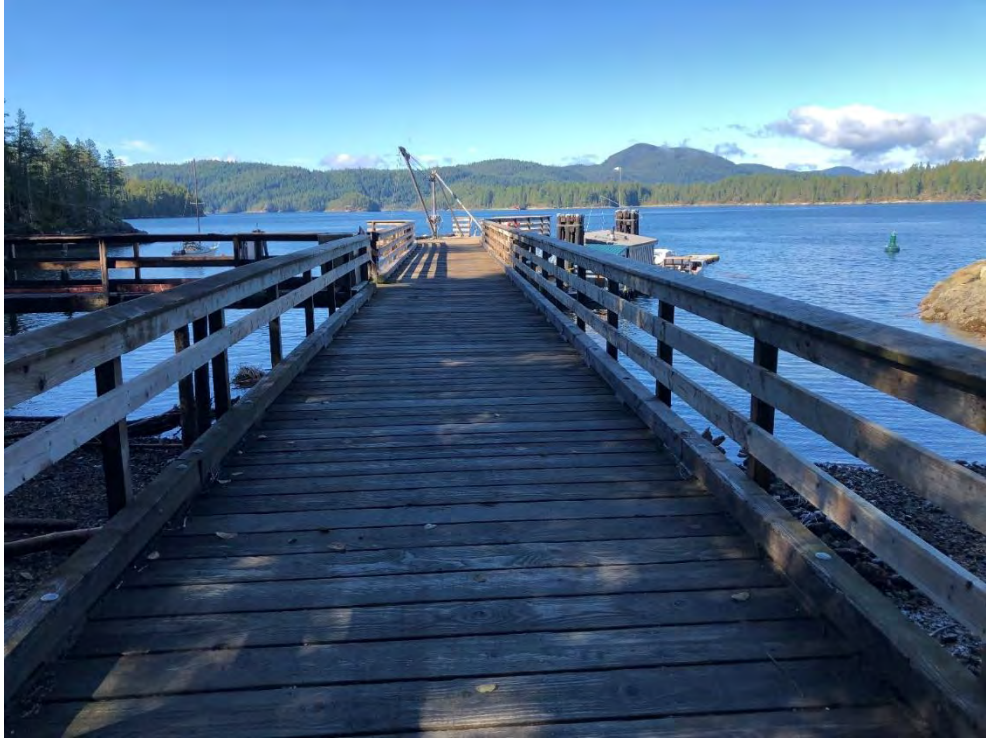
Photo 3 - Wharf Structure Topsides

The topsides are generally in good condition with minor widespread weathering (Photo 3). Inspection findings are as follows:

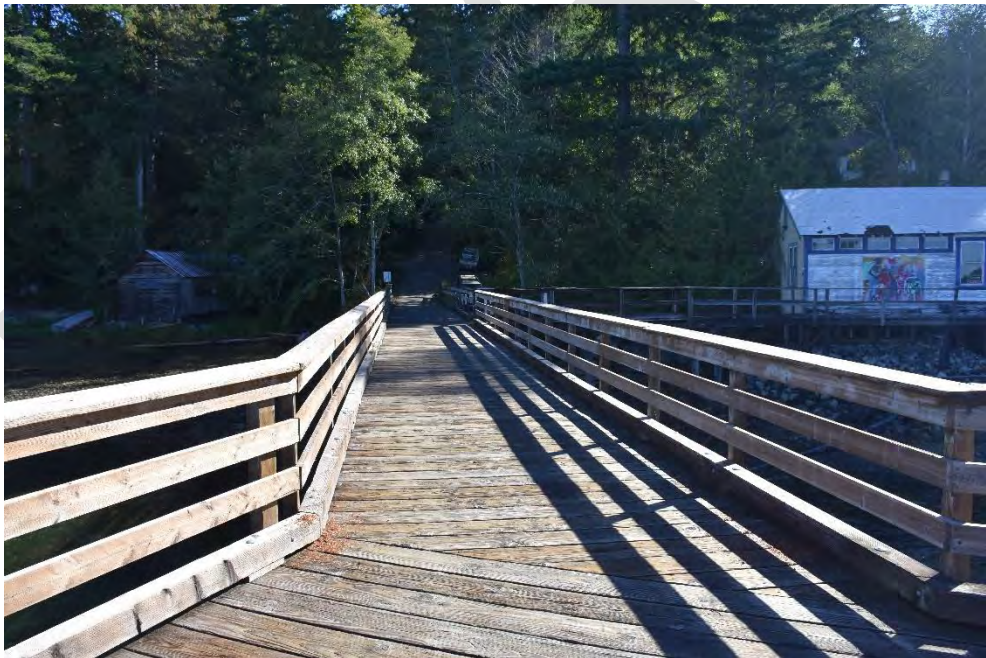
Photo 4 - Wharf Structure Handrails

- The timber handrails are well secured and in good condition (Photo 4). These were replaced in 2013 according to the repair drawings by Herold Engineering. One section of the handrails on the south end is missing the lower mid-rail (Photo 5).
- The timber deck planks are in good condition with widespread minor weathering (Photo 6). All deck planks appear generally well secured. The decking was also replaced in 2013.
- There is one section along the wharf structure which leads to private property. This area is closed off to the general public (Photo 7).

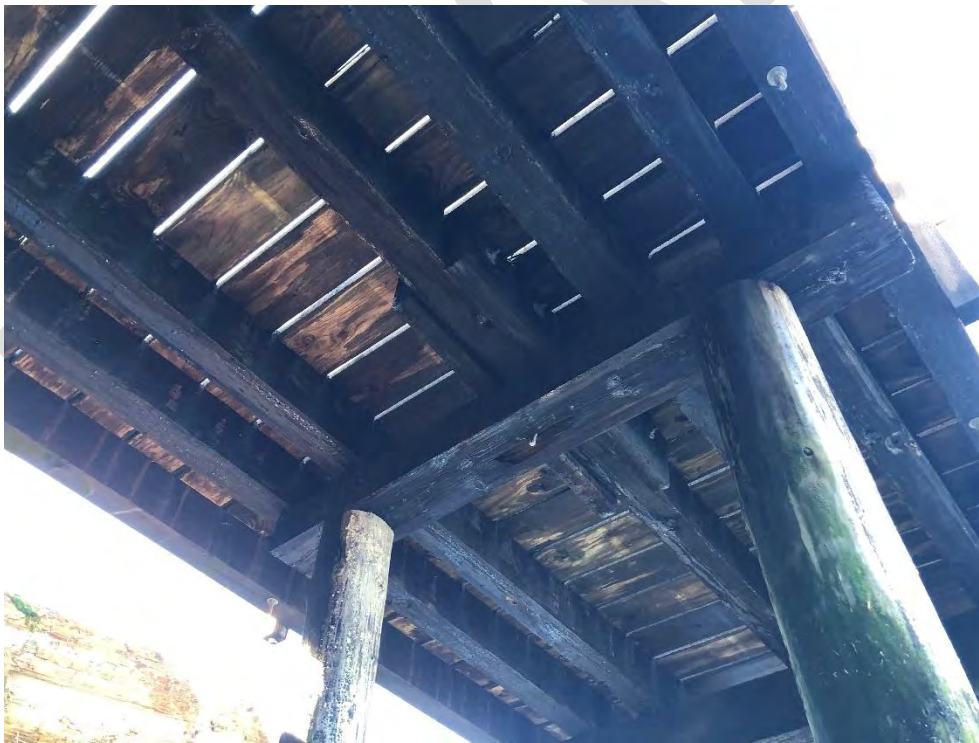
Photo 8 - Typical View of Timber Stringers

The timber stringers are generally in good condition (Photo 8). The stringers appear well secured between the decking and the pile caps, and there are no signs of significant splitting or structural distress.

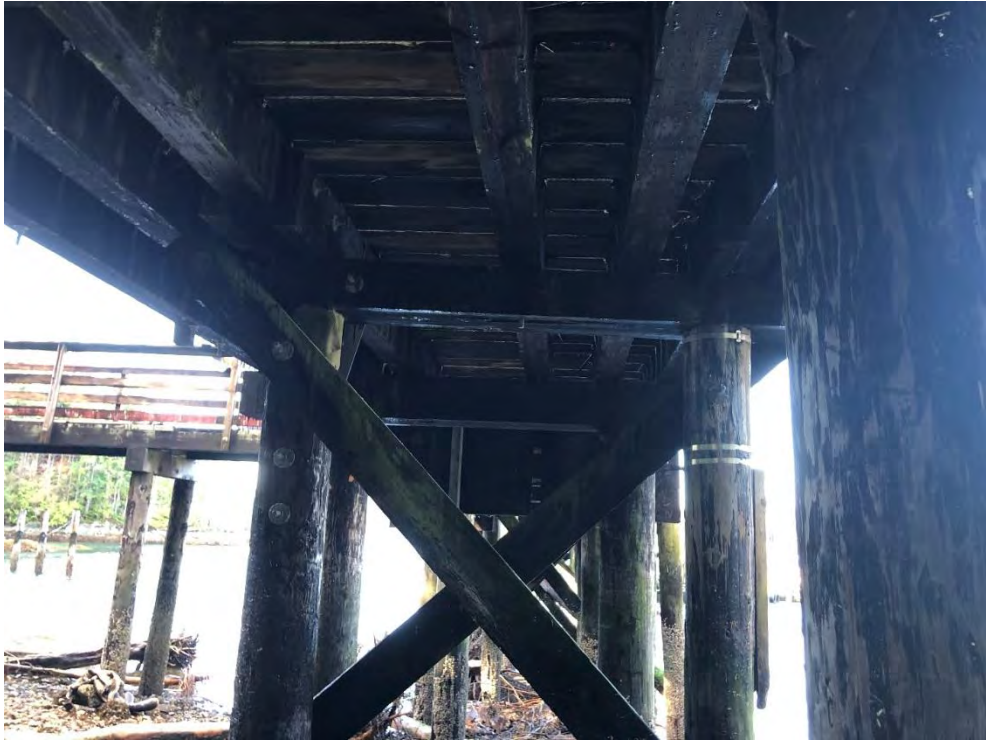
Photo 13 - Pile cap at Bent 4

Location	Description of Findings	Photo
Bent No. 1	The pile cap is split on the north end.	Photo 11
Bent No. 2	The pile cap has a minor split at the south end grain.	Photo 12
Bent No. 4	The pile cap is fractured at the base in the center, and the end of one of the through bolts is exposed.	Photo 13
Bent No. 6	The pile cap is above 2 corbels on each pile. The corbels are in fair condition and secured vertically with a steel angle on one side. The top corbel at the north end is showing signs of splitting.	Photo 14 to Photo 15
Bent No. 7	The pile cap is above 2 corbels on the south pile. The corbels are in fair condition and stabilized vertically with a steel angle on one side. The bottom corbel is showing minor signs of splitting at the end grain.	Photo 16 to Photo 17
Bent No. 10	The pile cap is fractured at the base in the center, and the end of one of the through bolts is exposed.	Photo 18
Bent No. 11	The pile cap is splitting at the north end grain.	Photo 19

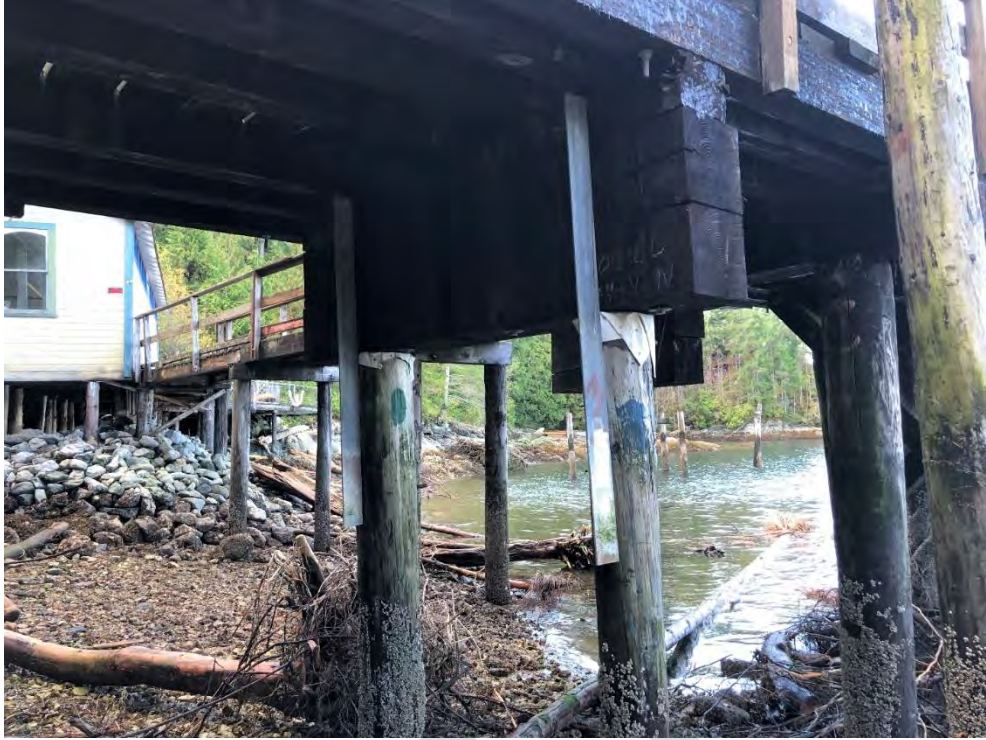
Photo 15 - Split in corbel at Bent 6

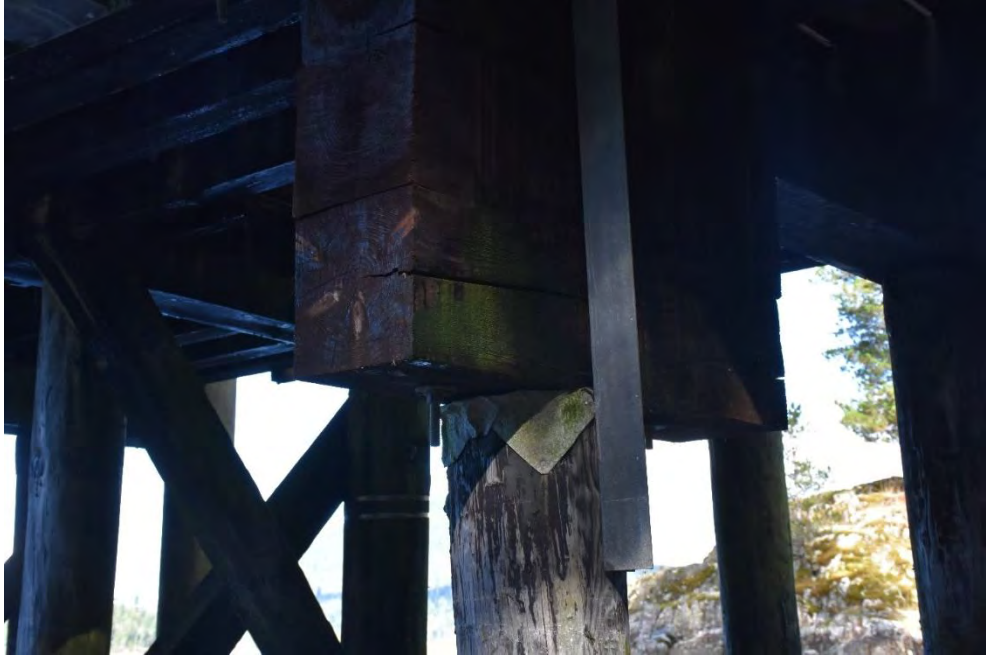
Photo 17 - Split in corbel at Bent 7

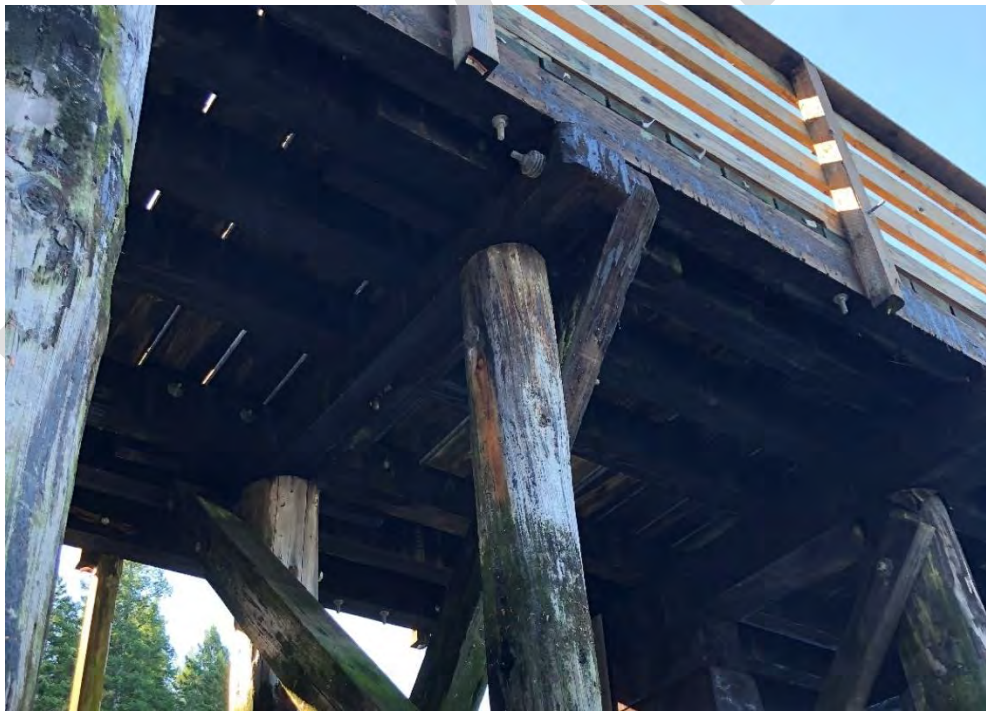
Photo 20 - Pile cap at Bent 12

Bent No. 12	The pile cap is fractured at the base in the center, and the end of one of the through bolts is exposed.	Photo 20
Bent No. 13	The pile cap at is above 2 corbels on the south pile. The corbels are in fair condition and stabilized vertically with a steel angle on one side. The corbel is showing minor signs of splitting at the end grain.	Photo 21
Bent No. 14	The pile cap has some damage at the end grain on the north end.	Photo 22
Bents Nos. 2, 4, 6, 8, 10, 12 and 14	The pile caps do not extend the full length of the deck. The pile caps end approximated one foot before the end stringer on the south end. The end stringers therefore span 2 bents at these locations.

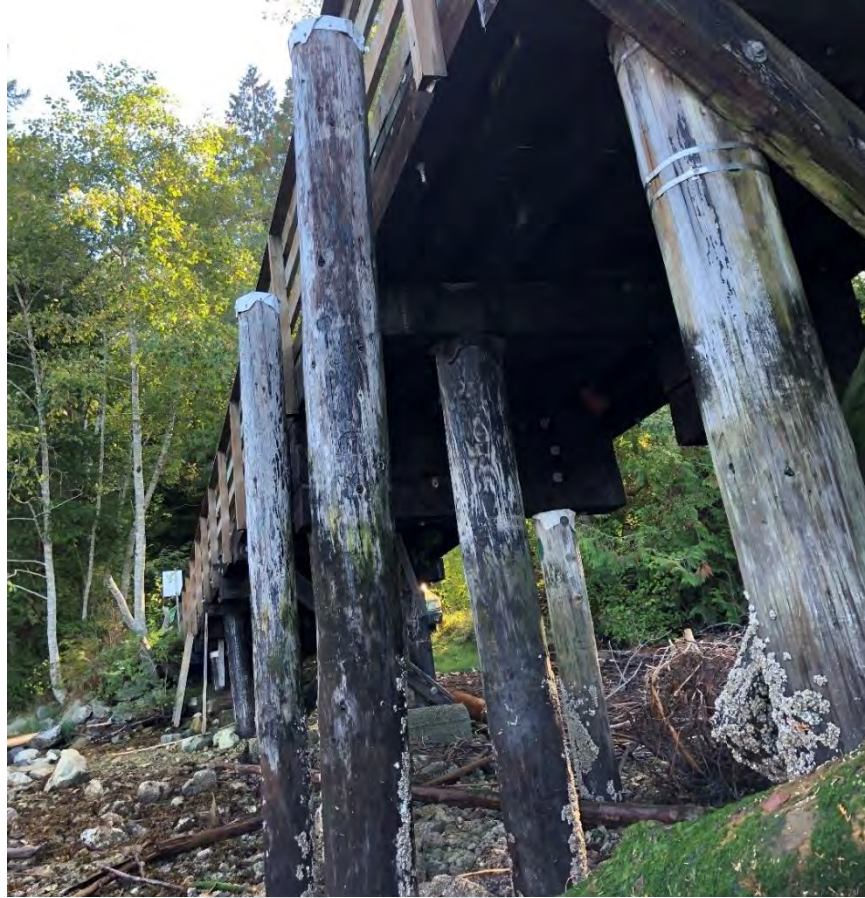
Photo 29 - North end fender piles

The timber fender piles are generally in fair condition, with no signs of significant deterioration or mechanical damage (Photo 29 to Photo 30).

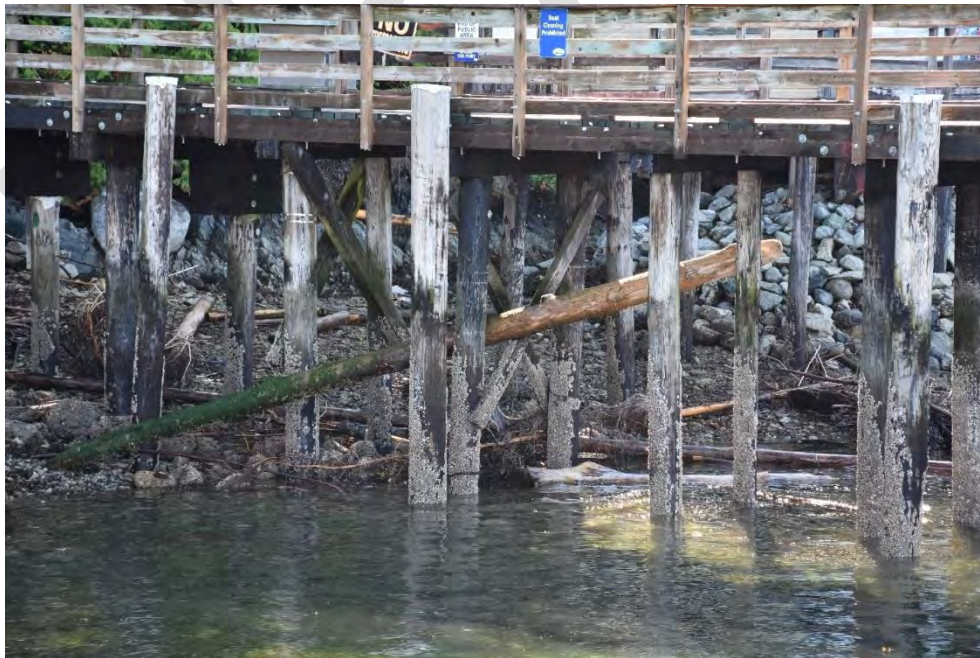
Photo 30 - North end fender piles and log debris

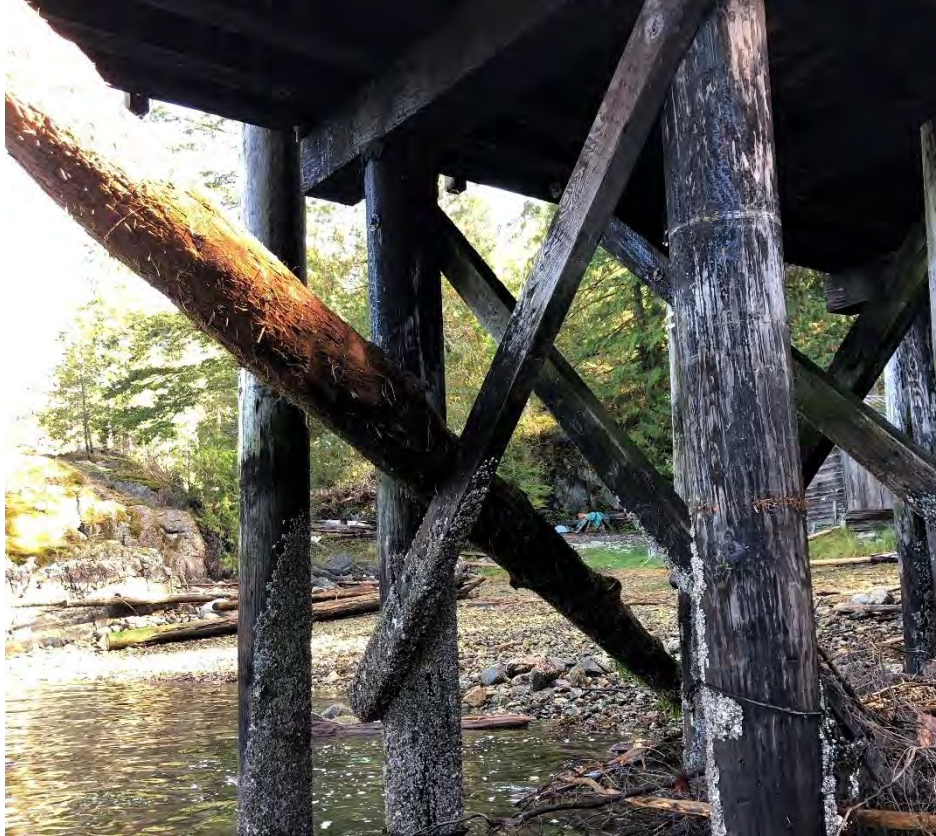
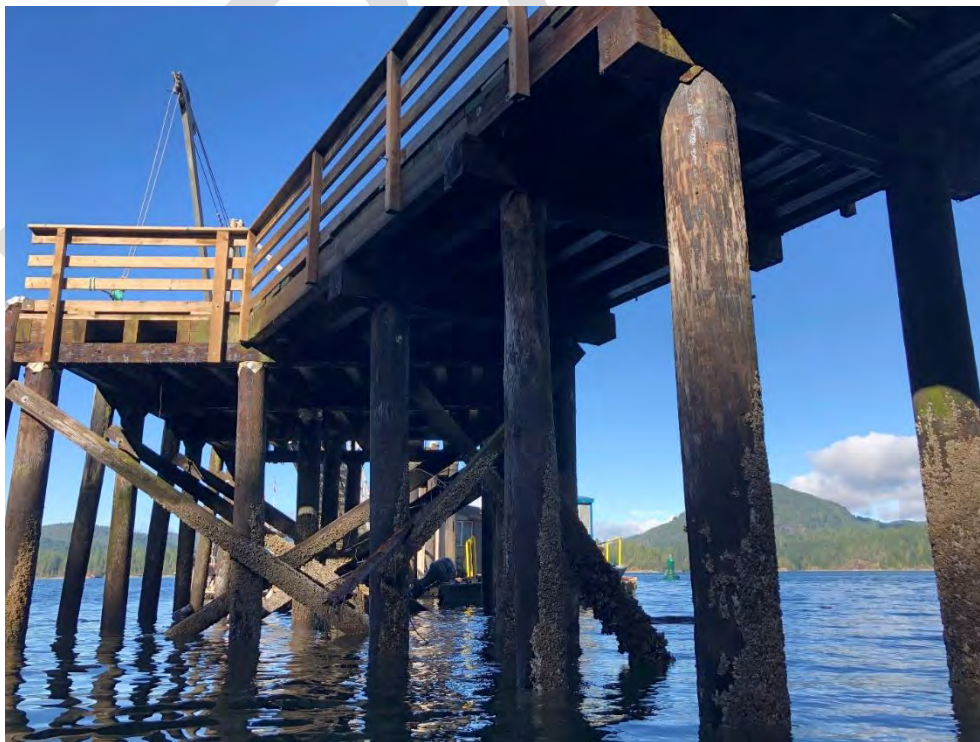
- There is widespread weathering, and minor fungal decay to the end grains of the members, however all cross braces appear well secured to the piles.
- There are two locations where timber log debris is trapped under the wharf structure and is resting on the cross-bracing. (Photo 33 to Photo 34).
- It appears a timber member was added as a side brace from the deck to pile 11B, however it is no longer secured to the pile and is hanging from the deck (Photo 35).

Photo 33 - Log resting on the Cross Bracing

Photo 34 - Log resting on the Cross Bracing

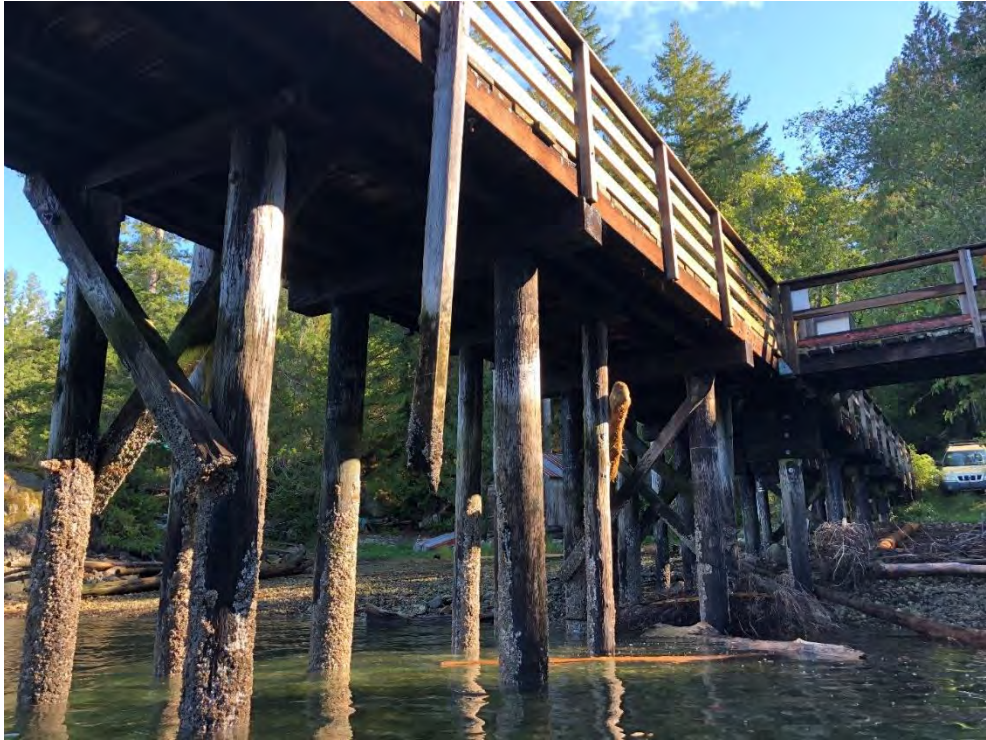
Photo 35 - Hanging side brace at pile 11B

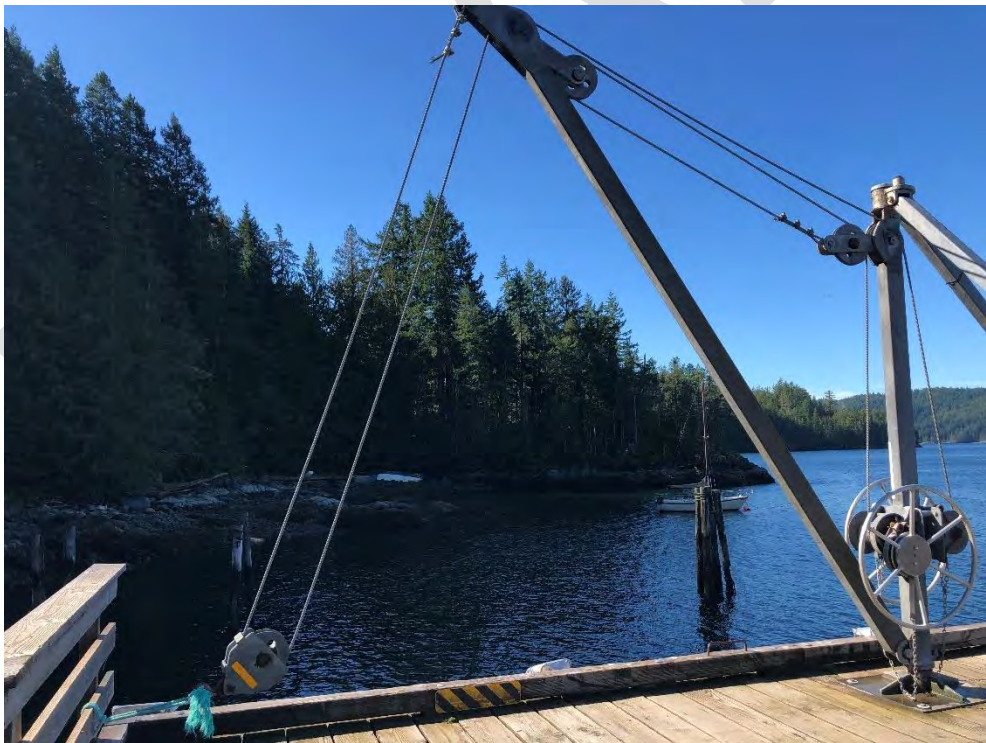
Photo 36 - Derrick Loading Crane

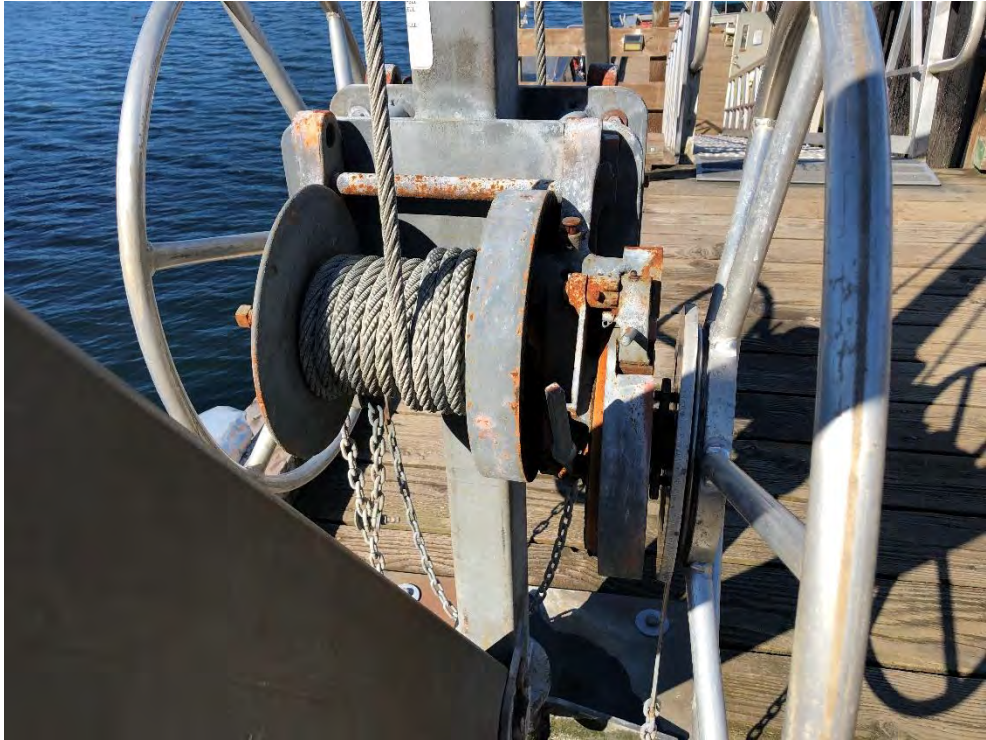
Photo 37 - Derrick Loading Crane

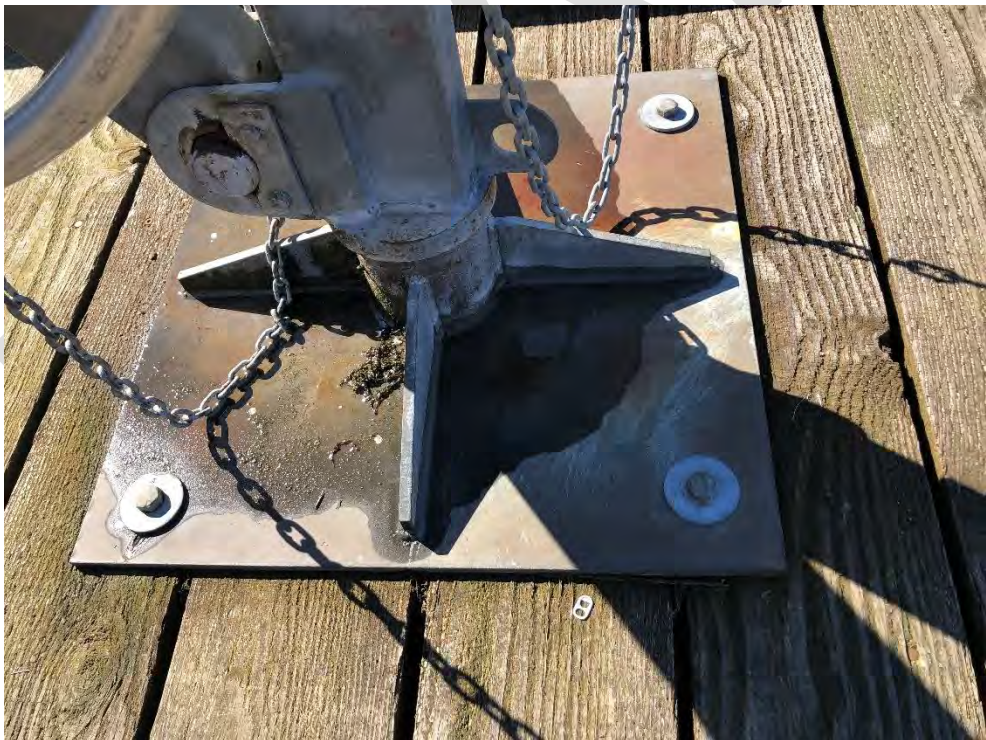
Photo 38 - Derrick Loading Crane

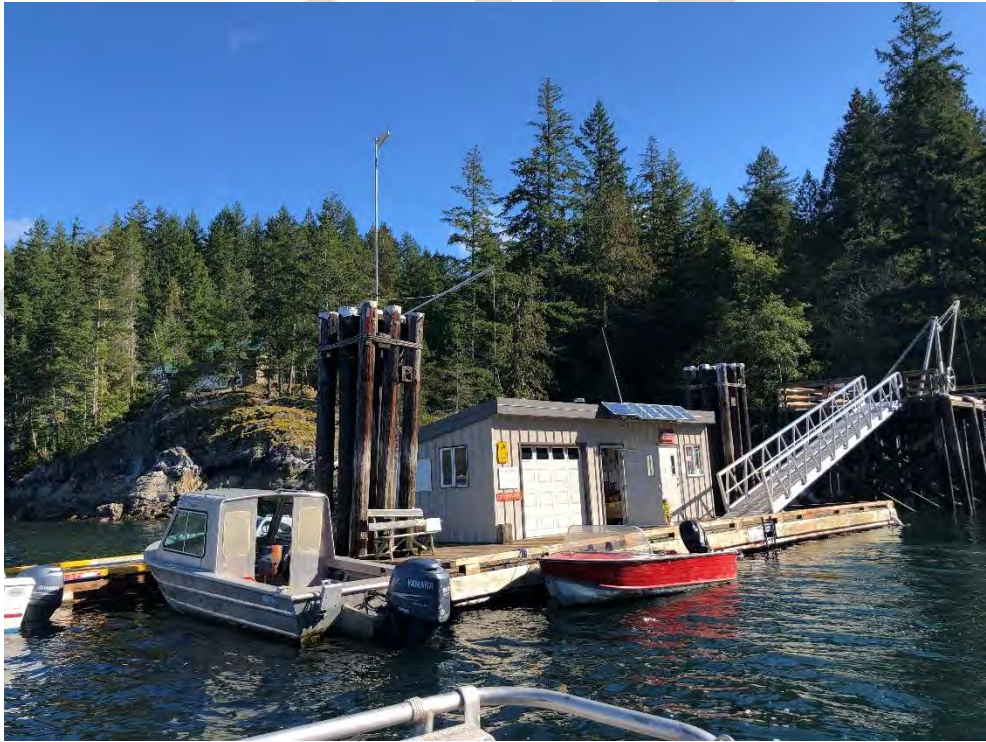
Photo 42 - General View of the Main Float

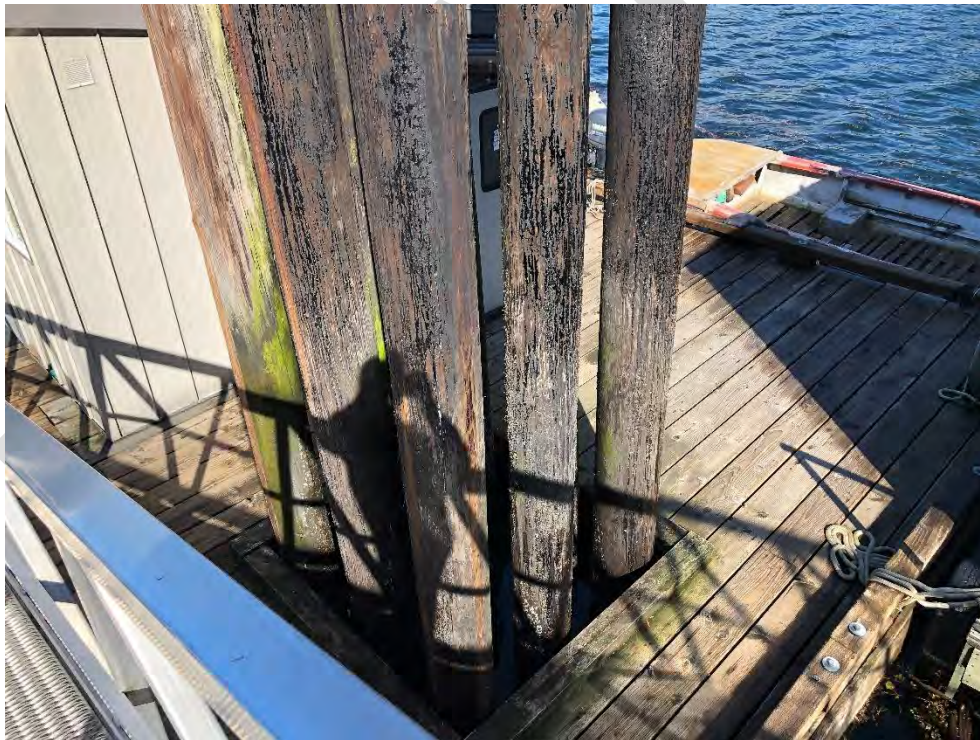
Photo 50 - East end Mooring Piles

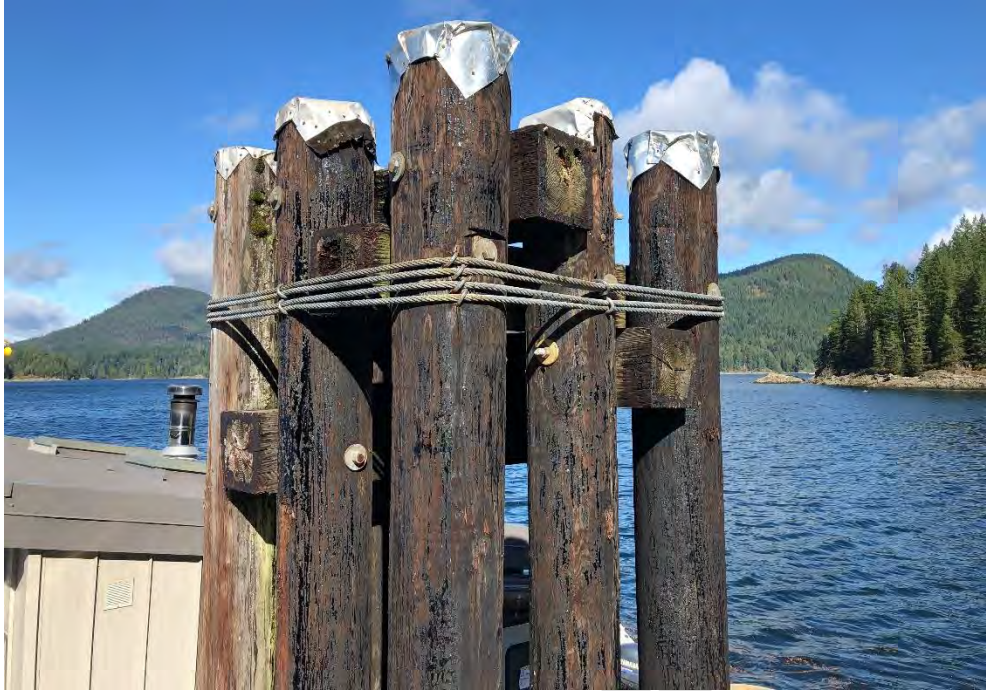
Photo 51 - East end Mooring Piles

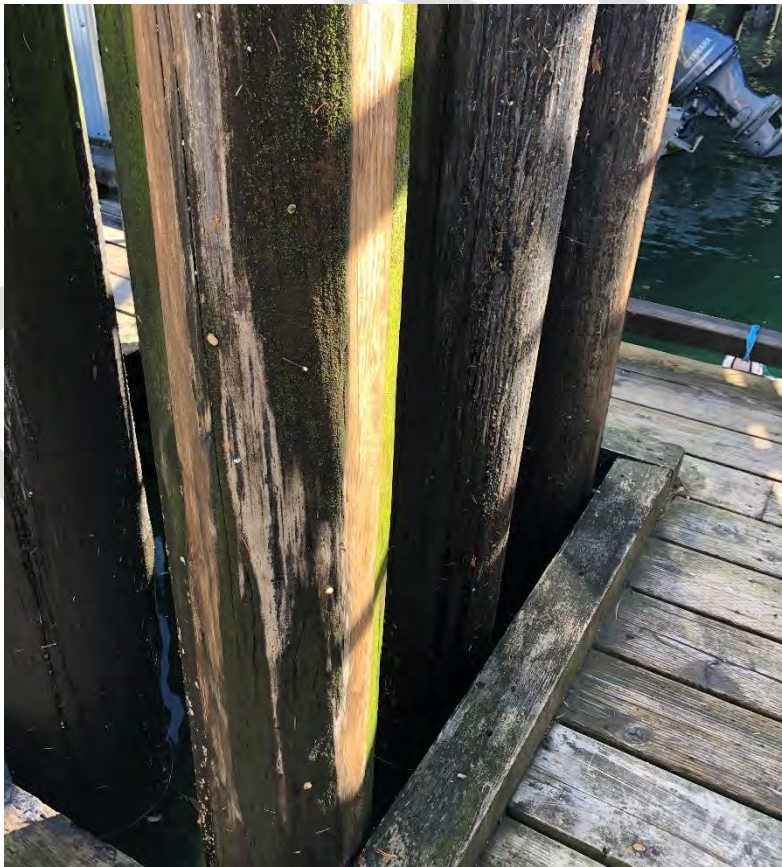
Photo 52 - East end Mooring Piles

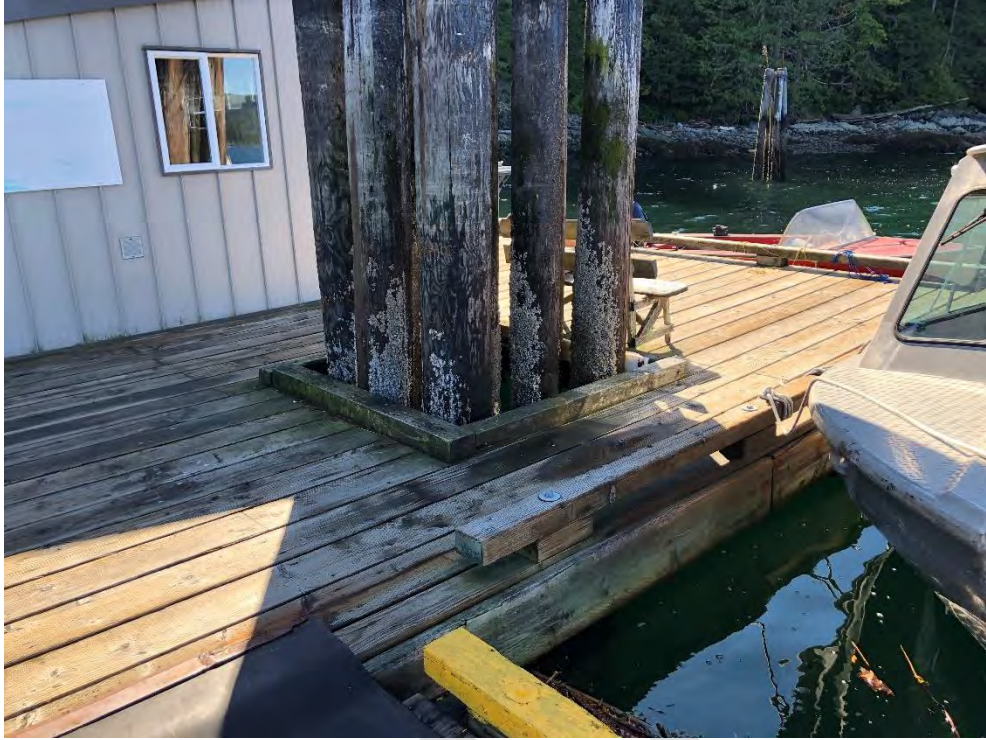
Photo 53 - West end Mooring Piles

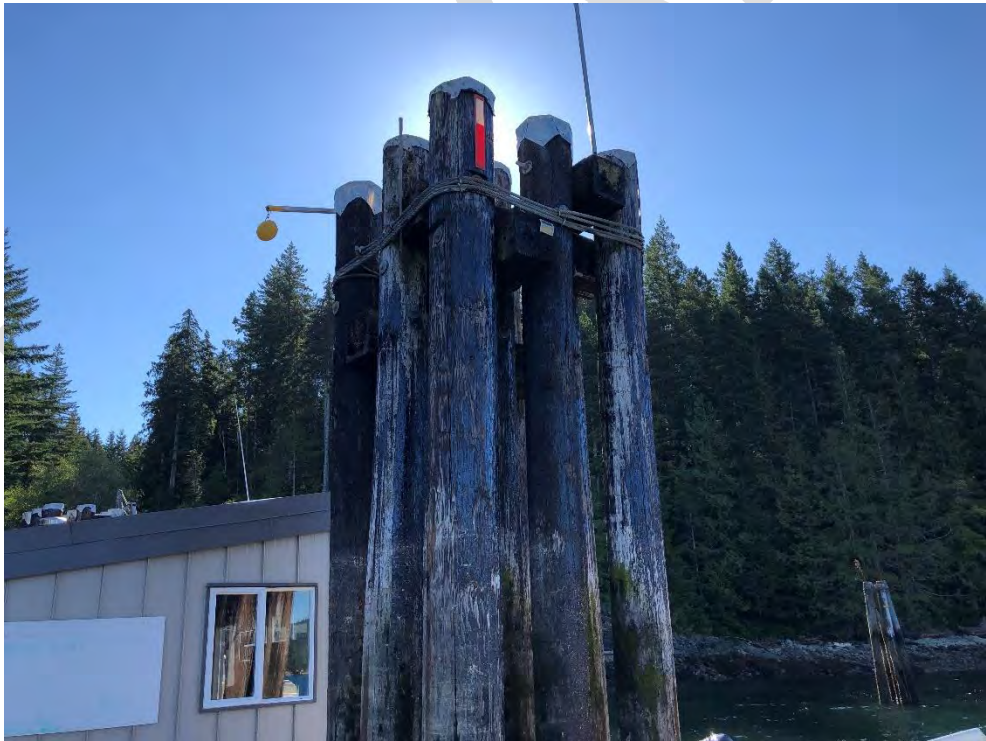
Photo 54 - West end Mooring Piles

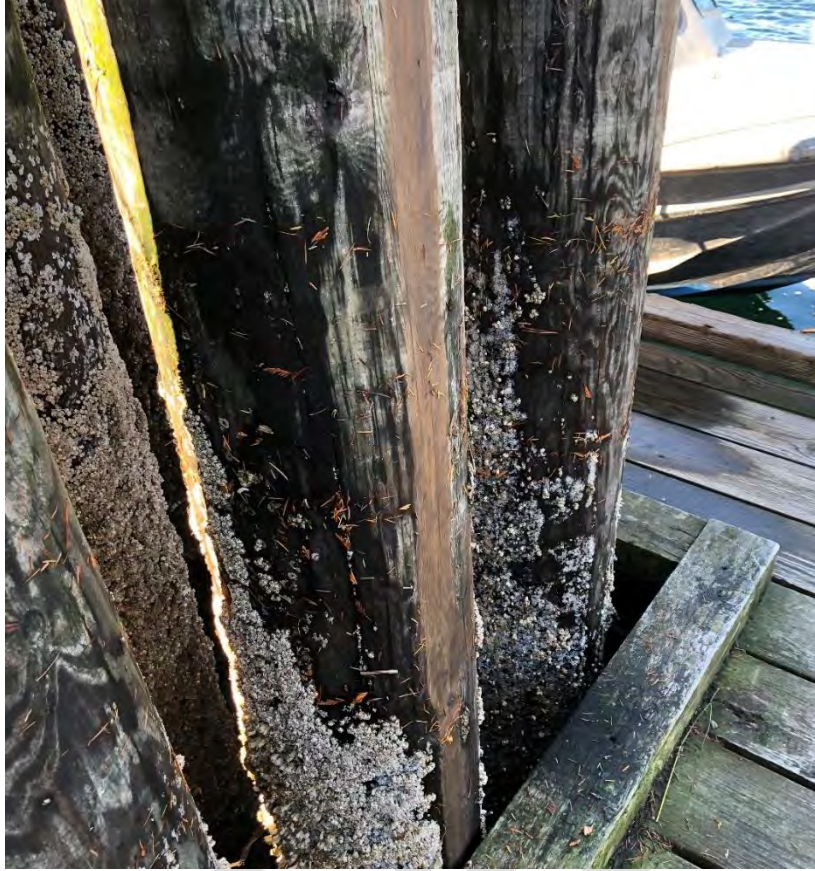
Photo 55 - West end Mooring Piles – up to 10% CSL

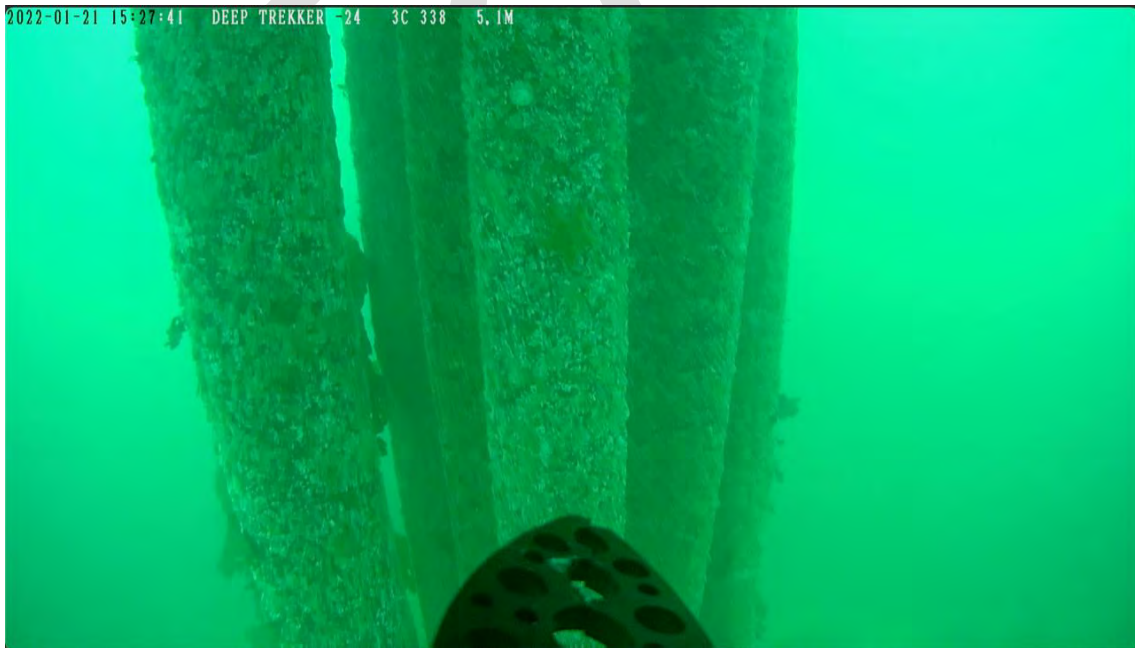
Photo 56 - West end Mooring Piles

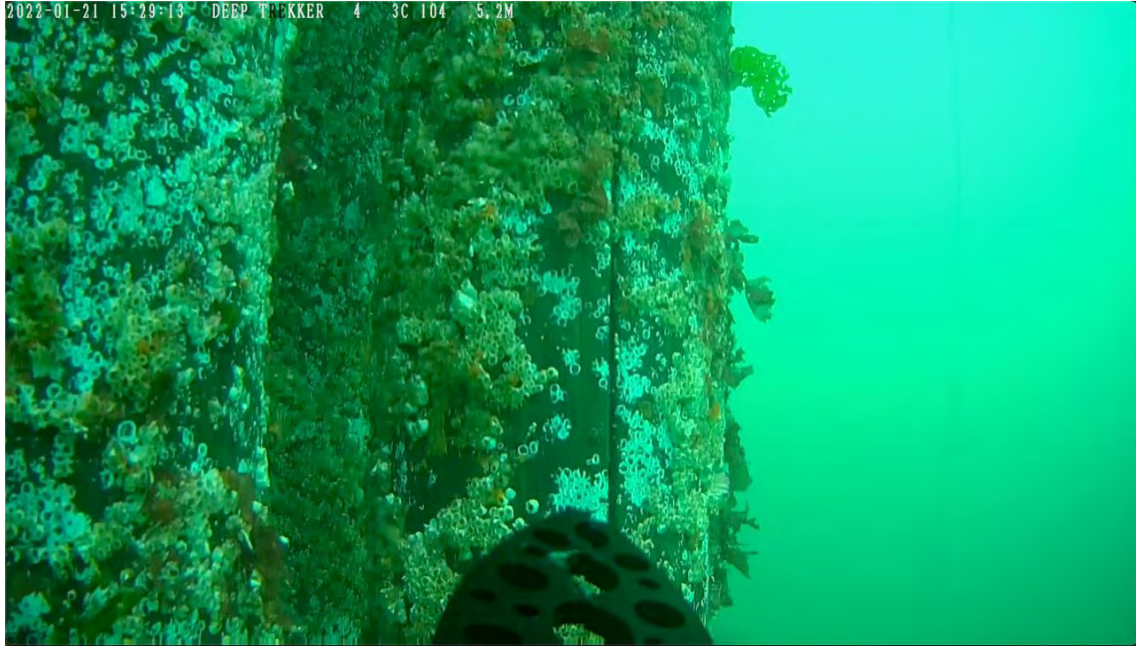
Photo 57 - West end Mooring Piles

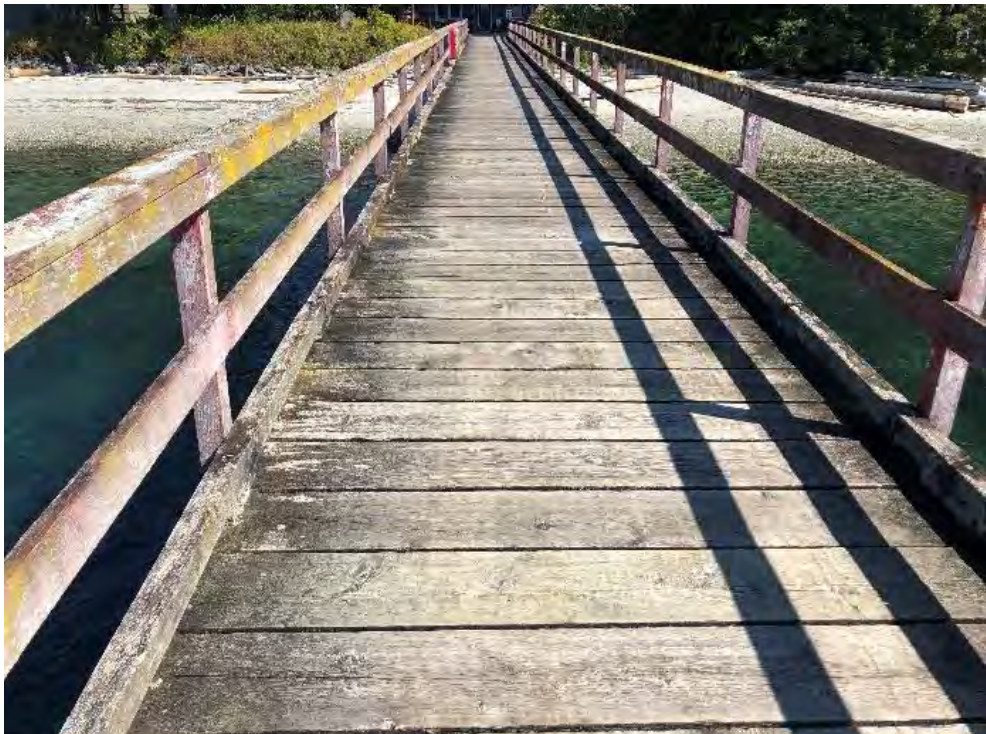
Photo 2 – Pier Structure Topsides

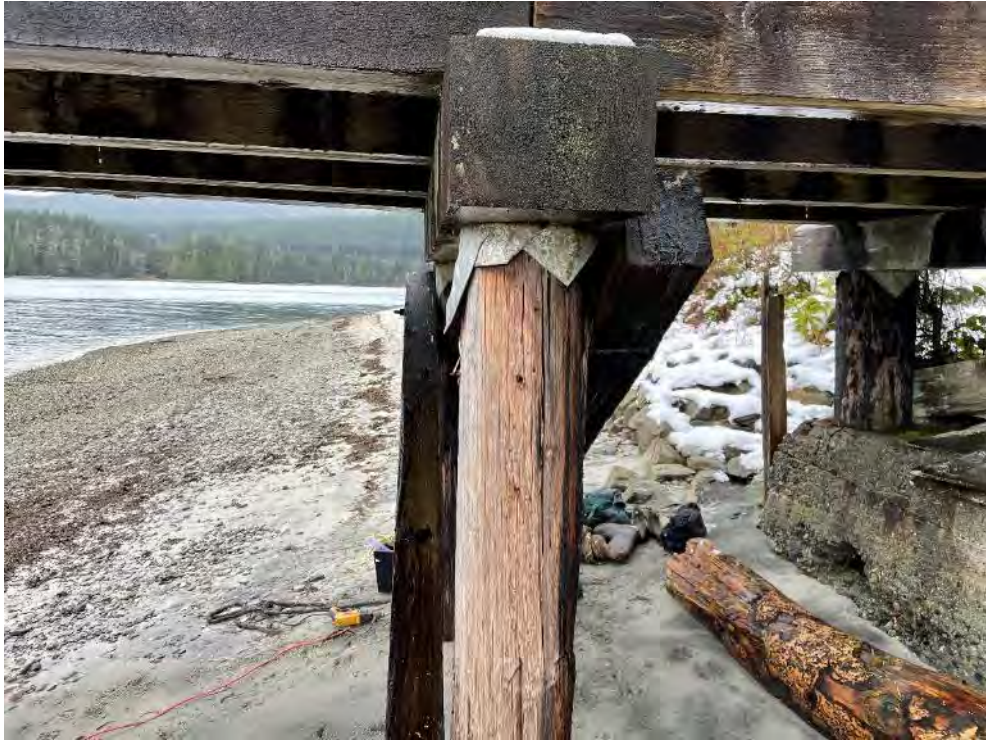
The treated timber pile caps are generally in fair to good condition (Photo 12 & 13). The pile caps appear well secured, and there are no signs of significant splitting or structural deterioration. The pile caps are typically aligned well over the piles, with no evidence of shifting or displacement. There is minor weathering and deterioration to the end grains of the pile caps, notably at Bent 12 (Photo 14). No cross-sectional loss was found in the pile caps during the timber coring inspection.

Photo 13 – Typical Timber Pile Cap End Grain

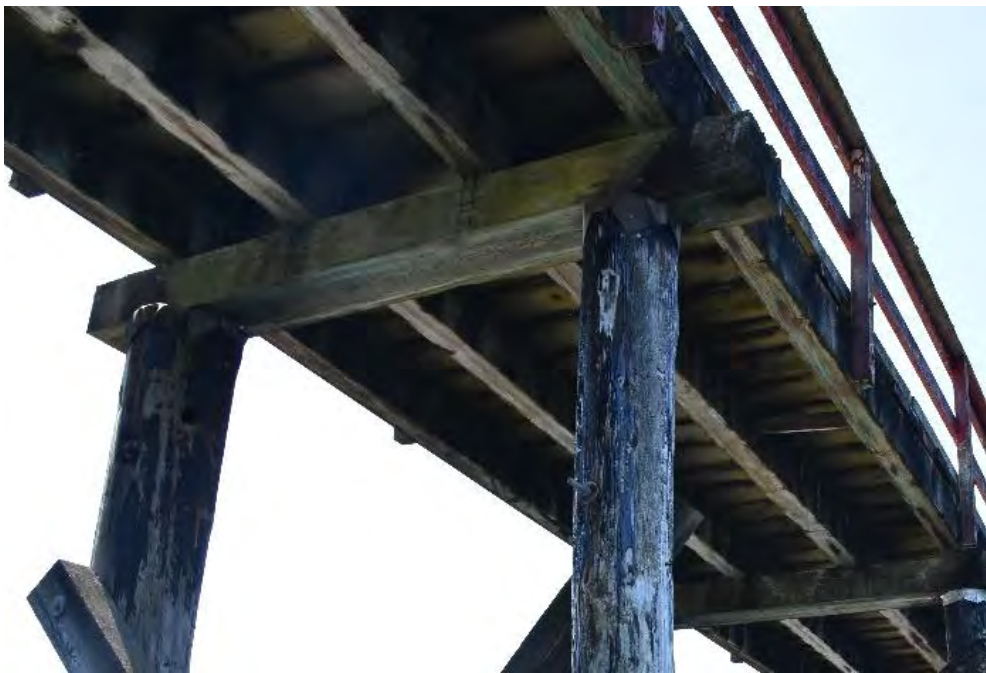
Photo 14 – Timber Pile Cap at Bent 12

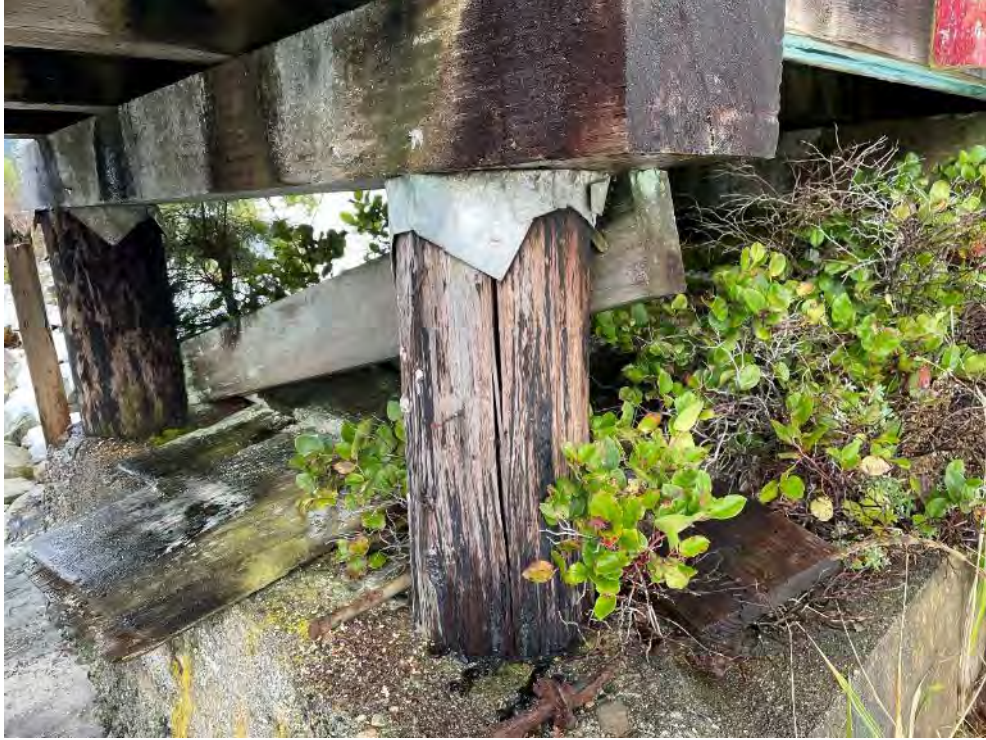
Location	Description	Recommendation
Pile 2A	Large split at the top of the pile. (Photo 15) 50% CSL due to internal fungal decay in the top 0.6m.	Replace timber pile.
Pile 2B	25% CSL due to internal fungal decay in the top 0.3m.	Monitor.
Pile 3A	25% CSL due to internal fungal decay in the top 0.3m.	Monitor.
Pile 3B	Moderate splitting at the top of the pile. (Photo 16) 25% to 75% CSL due to internal fungal decay in the top 0.9 m.	Replace timber pile.
Pile 4B	25% CSL due to internal fungal decay in the top 0.3m with wet fibres. Concrete footing is exposed, with signs of undermining and spalling of the concrete. (Photo 17)	Monitor.
Pile 5A	Moderate splitting at the base of the pile. (Photo 18)	Monitor.
Pile 5B	25-50% CSL due to internal fungal decay in the top 0.3m with wet fibres.	Replace timber pile.
Pile 7A	Pile is slightly misaligned. (Photo 19)	Monitor.

Photo 15 – Split in Pile 2A

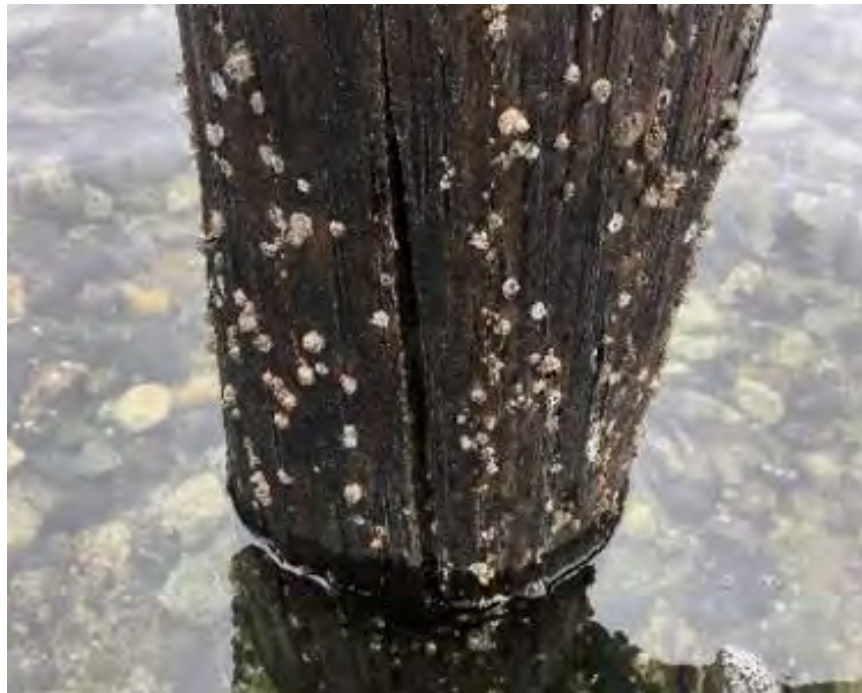
Photo 18 – Split in Pile 5A
