RE: BYLAW NO. 487- ELECTORAL AREA C WHARVES SERVICE

FEASIBILITY STUDY

ELECTORAL AREA C WHARVES SERVICE

Marine Facility Condition Assessment of the Surge Narrows Wharf

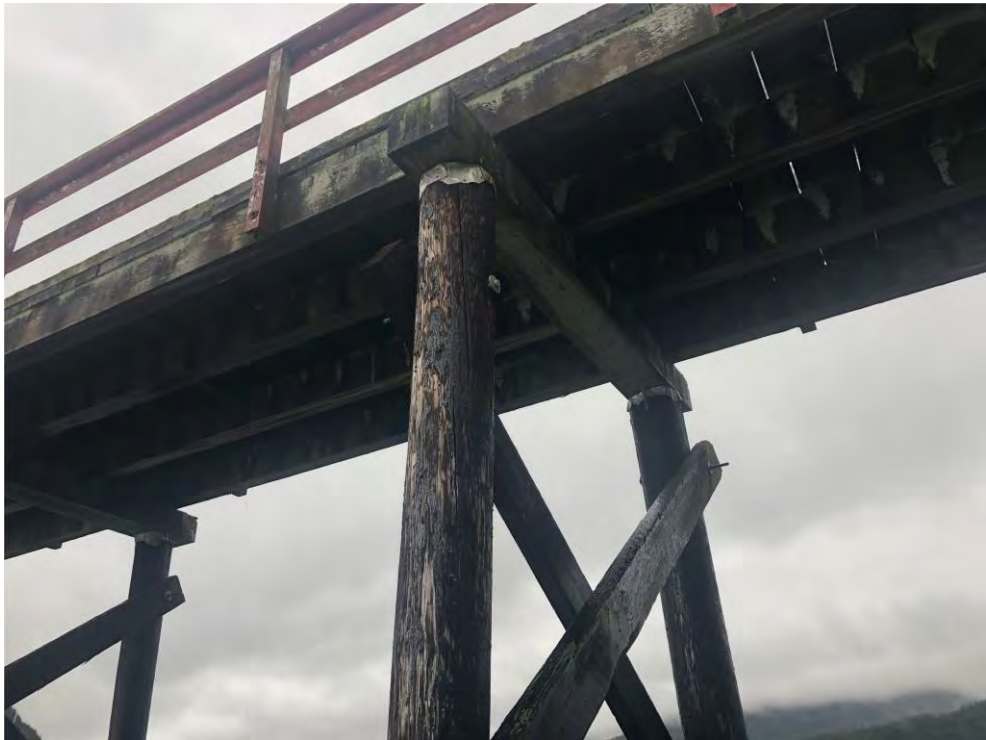
Pile 8A	Moderate splitting at the top of the pile. (Photo 20)	Monitor.
Pile 9A	Large open bolt hole at the top of the pile, likely from a previous cross-brace bolted connection. (Photo 21)	Monitor.
Pile 10A	Moderate splitting at the top of the pile. (Photo 22)	Monitor.
Pile 12A	Large open bolt hole at the top of the pile, likely from a previous cross-brace bolted connection. (Photo 23)	Monitor.
Pile 15B	Moss growing out of the top, indicating that there is fungal decay in the interior of the pile in this location. (Photo 24)	Monitor.

Photo 22 – Small split in Pile 10A

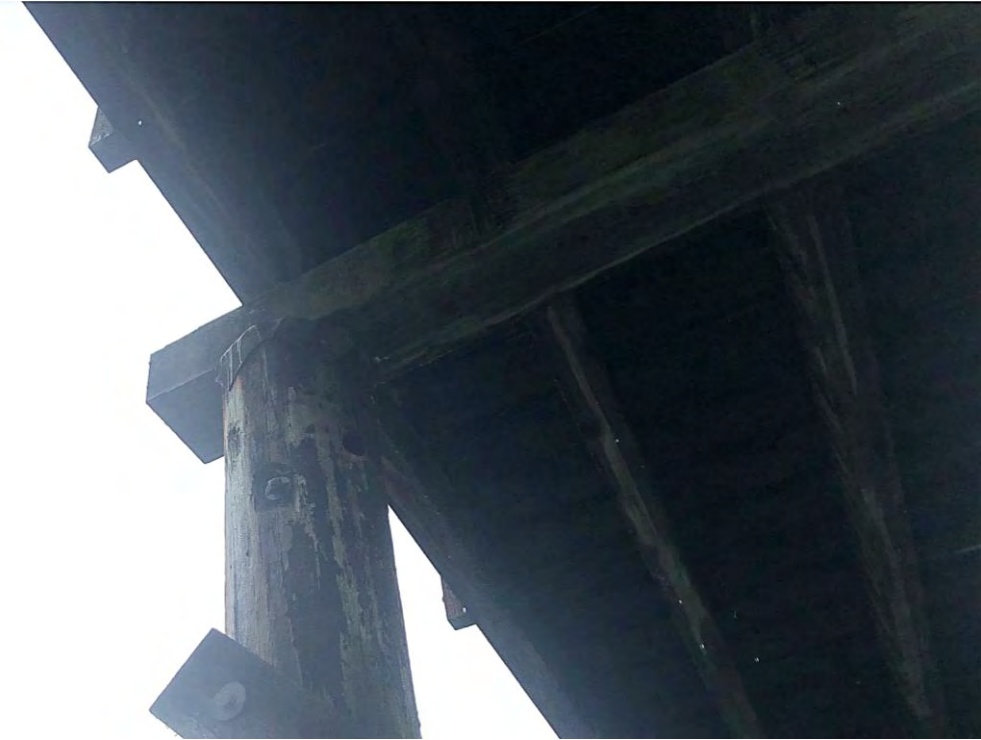
Photo 23 – Hole in Pile 12A

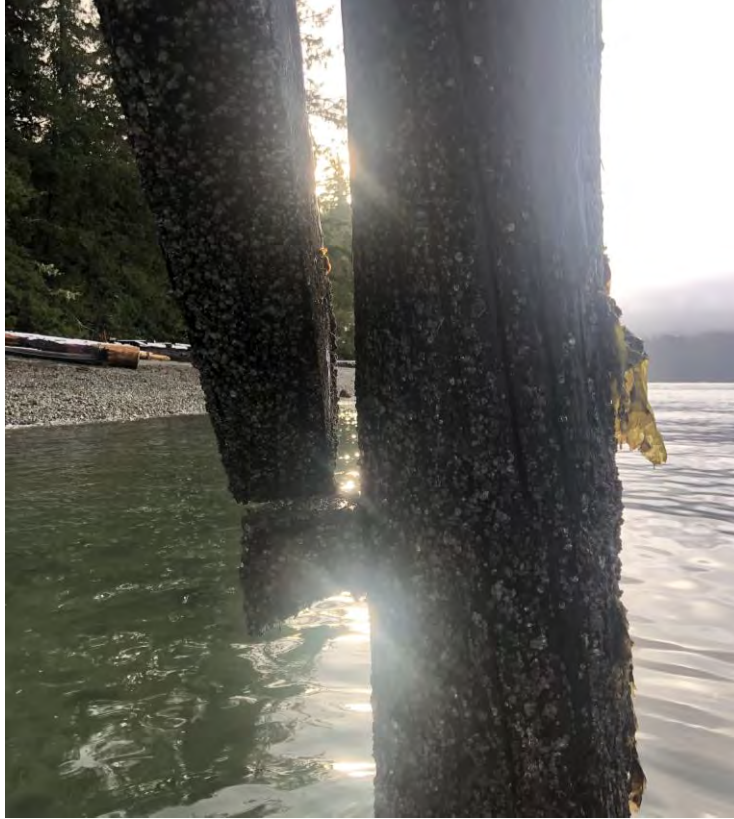
- There is widespread weathering, and minor fungal decay to the end grains of the members, however all cross braces appear well secured to the piles, apart from two locations.
- The cross bracing at Bent 8 appears to not be connected to pile 8A and is only resting on a timber block secured to the pile. (Photo 29)
- The cross bracing at Bent 15 is connected to the fender pile 15C, which has signs of significant cross-section loss. (Photo 30)

Photo 29 – Cross Bracing at Bent 8

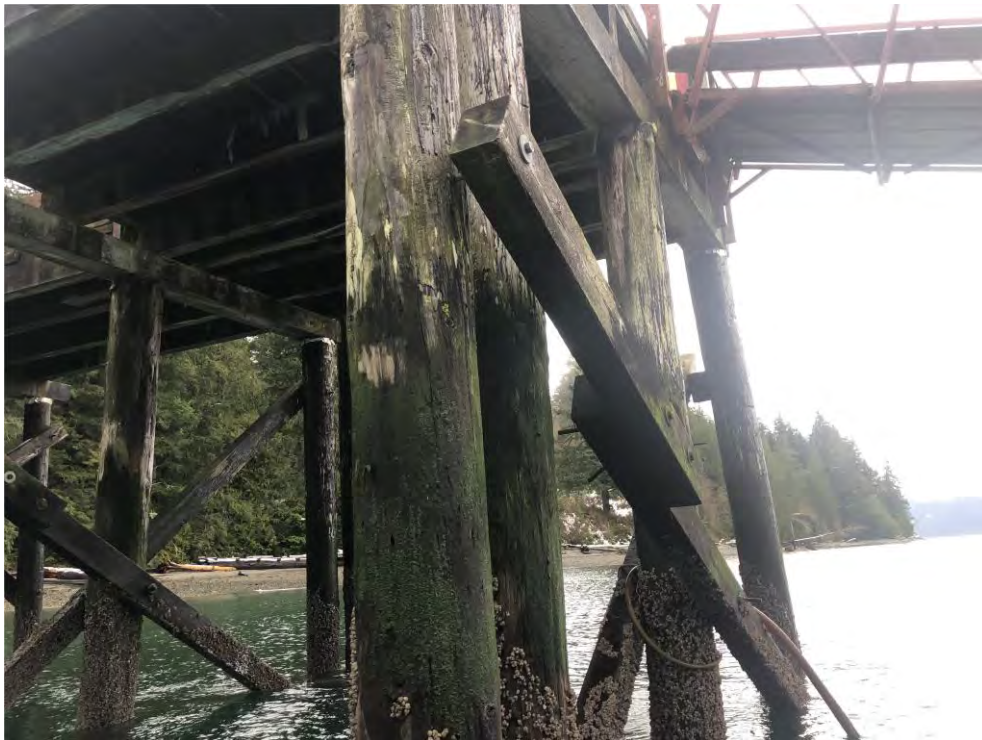
Photo 30 – Cross Bracing at Bent 15

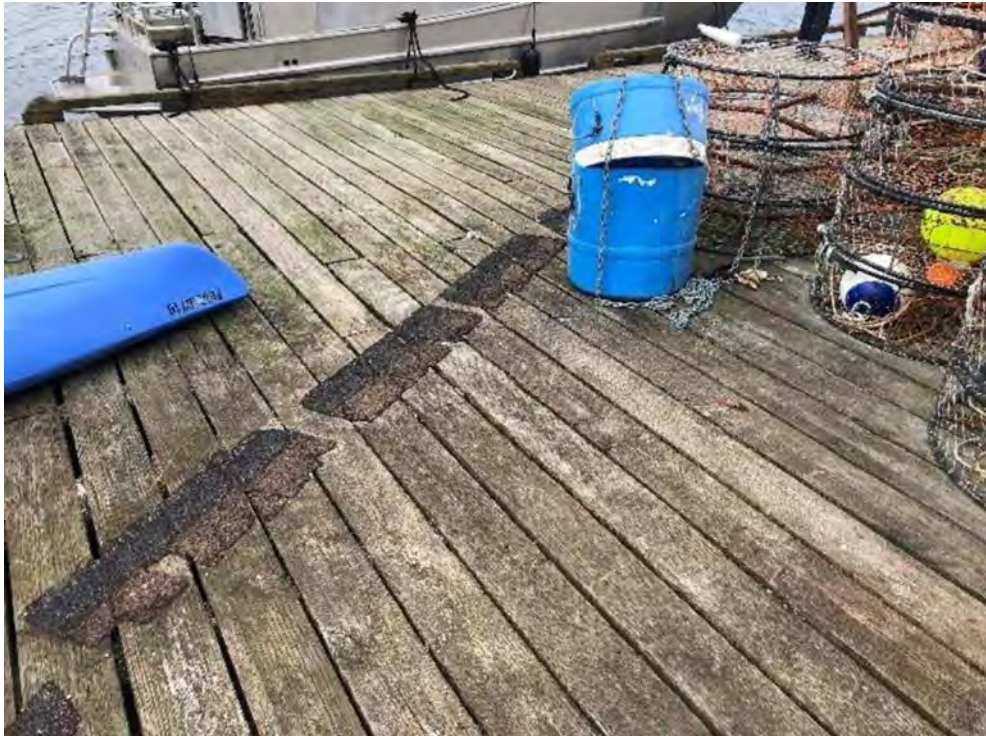
Float A is in poor to fair condition with minor deterioration to the topsides (Photo 36). Inspection findings are as follows:

Photo 36 – General view of Float A

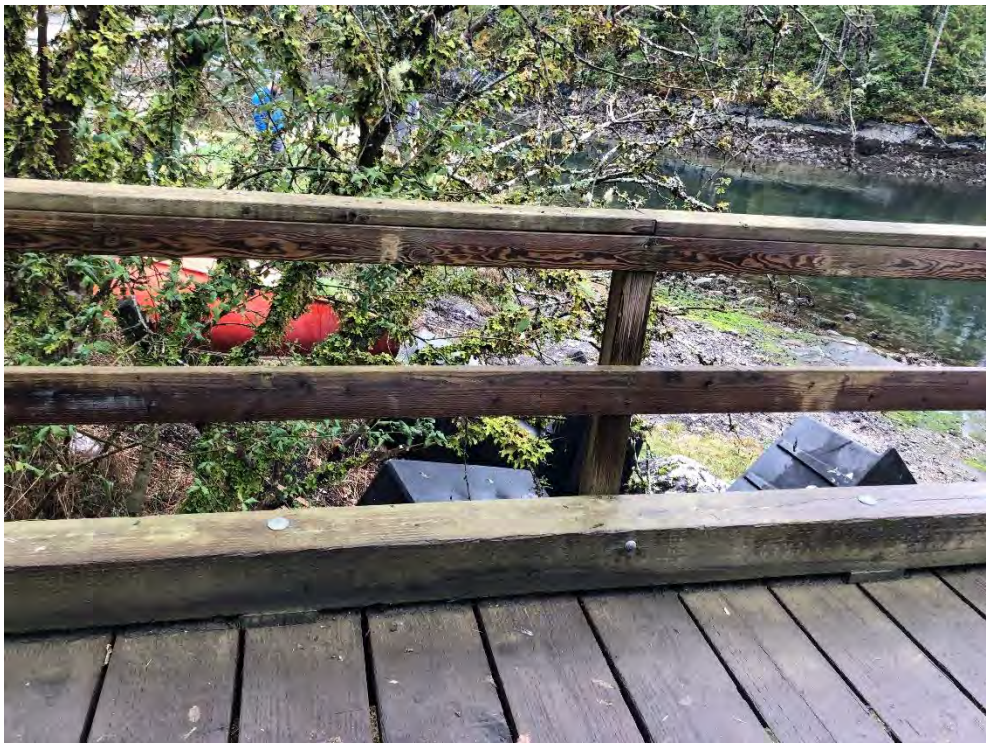
Photo 4 - General View of the Handrails

The topsides are generally in fair to good condition with moderate widespread weathering and fungal decay (Photo 3 and Photo 4). Inspection findings are as follows:

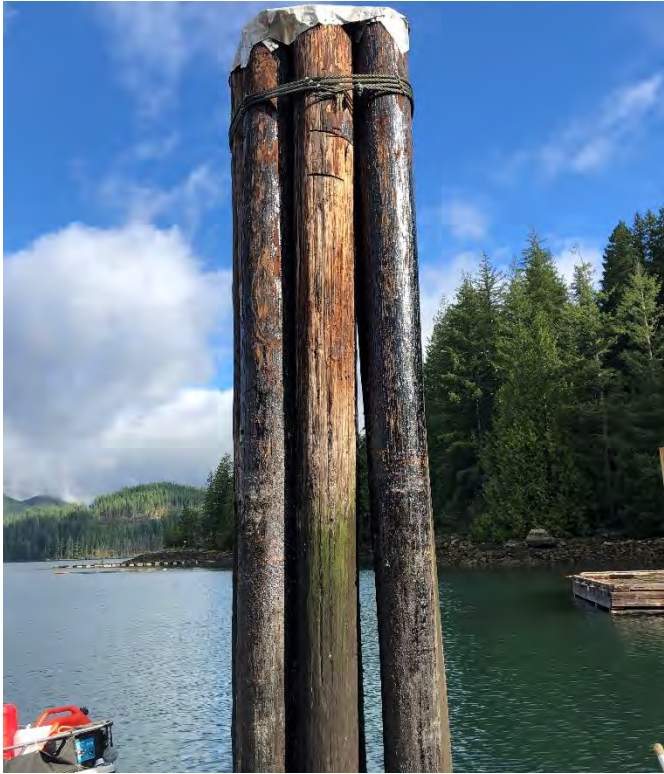
Photo 28 - North Mooring Piles

- The timber mooring piles are in fair to good condition, with widespread minor fungal decay and weathering. There are no significant signs of abrasion from the floats to the pile faces. The connections at the top of the mooring piles are in good condition, and the wire rope lashing is secure (Photo 27 to Photo 31).
