A BYLAW TO AUTHORIZE THE DISPOSITION OF THE PORT NEVILLE WHARF FACILITY

January 20, 2022 | Revision A

Marine Facility Condition Assessment of the Port Neville Wharf

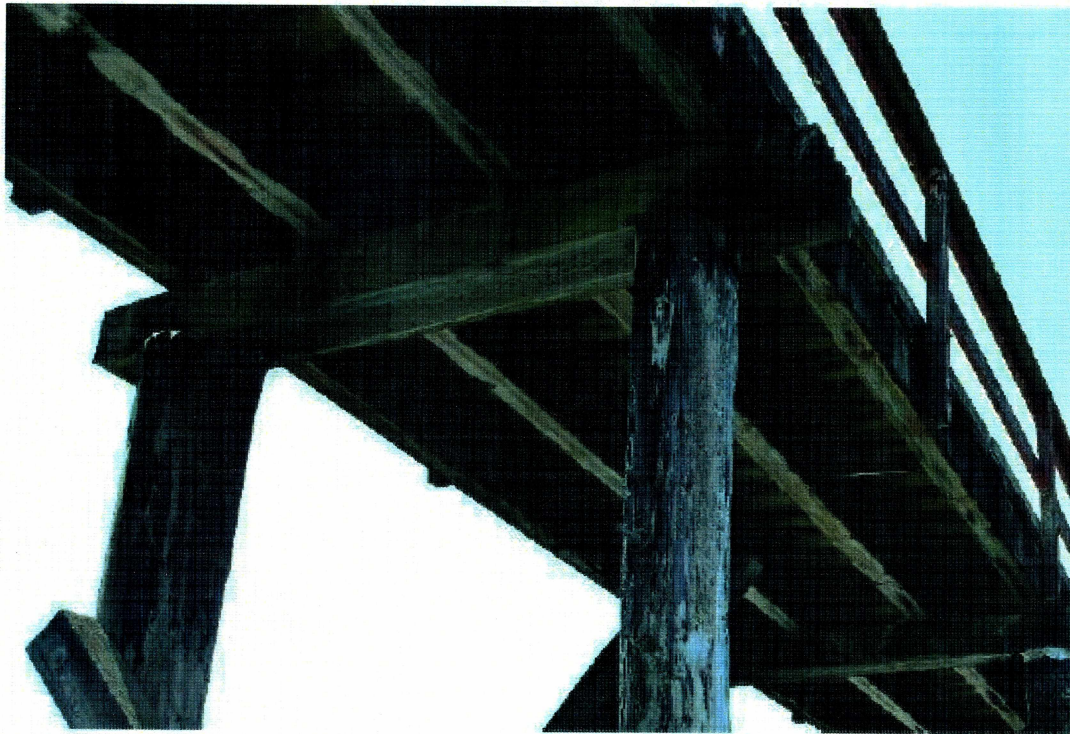
The treated timber pile caps are generally in fair to good condition (Photo 12 & 13). The pile caps appear well secured, and there are no signs of significant splitting or structural deterioration. The pile caps are typically aligned well over the piles, with no evidence of shifting or displacement. There is minor weathering and deterioration to the end grains of the pile caps, notably at Bent 12 (Photo 14). No cross-sectional loss was found in the pile caps during the timber coring inspection.

Photo 14 – Timber Pile Cap at Bent 12

Repairs are not considered necessary at this time, however ongoing monitoring of the pile caps and of the deterioration at the end grains is recommended.

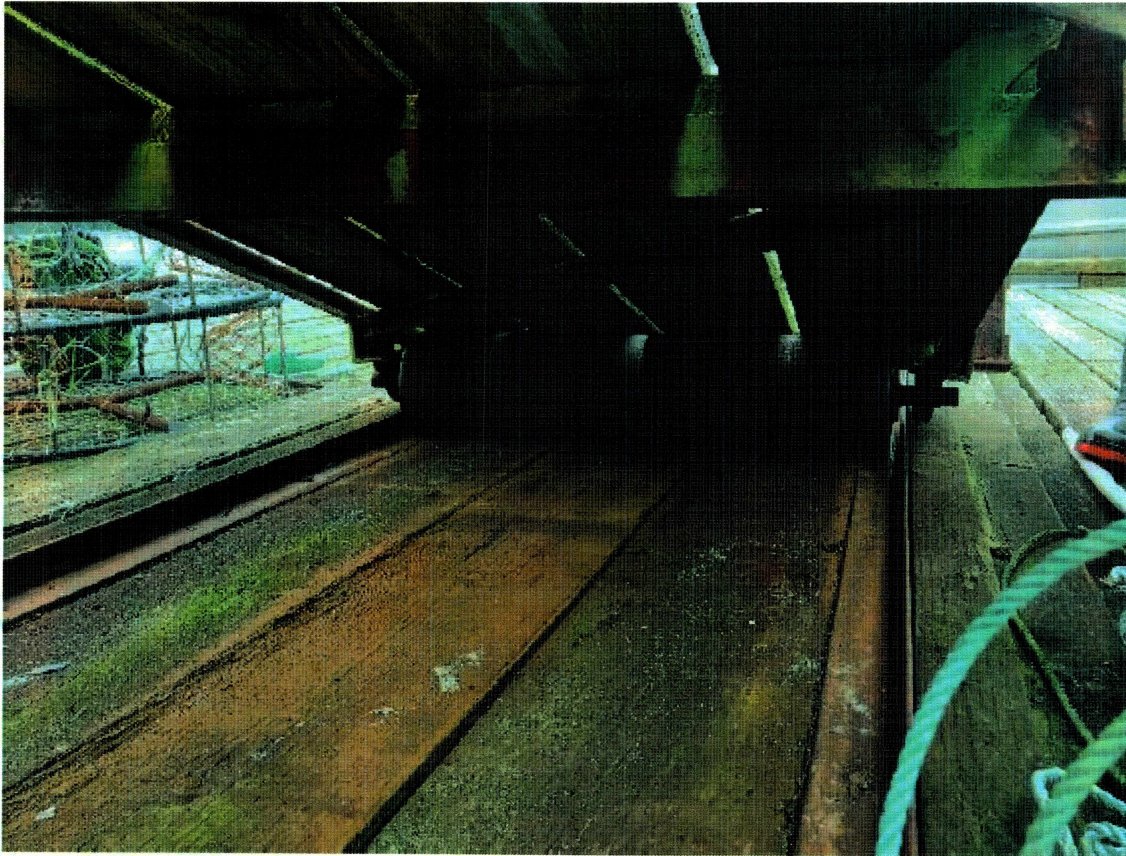
- The upper hinge connection is slightly misaligned (Photos 31 and 32) which is likely to result in advanced wearing of the pinned connection.
- The timber gangway slider plate is in good condition with minor wearing and is well aligned with the gangway roller (Photo 33)
- The deck planks and anti-slip surface have moderate wearing (Photo 34).
- The steel truss members have typical minor to moderate coating failures and corrosion. No significant deterioration of the welded connections was noted (Photo 35).

Photo 33 – Gangway Timber Slider Plate and Roller

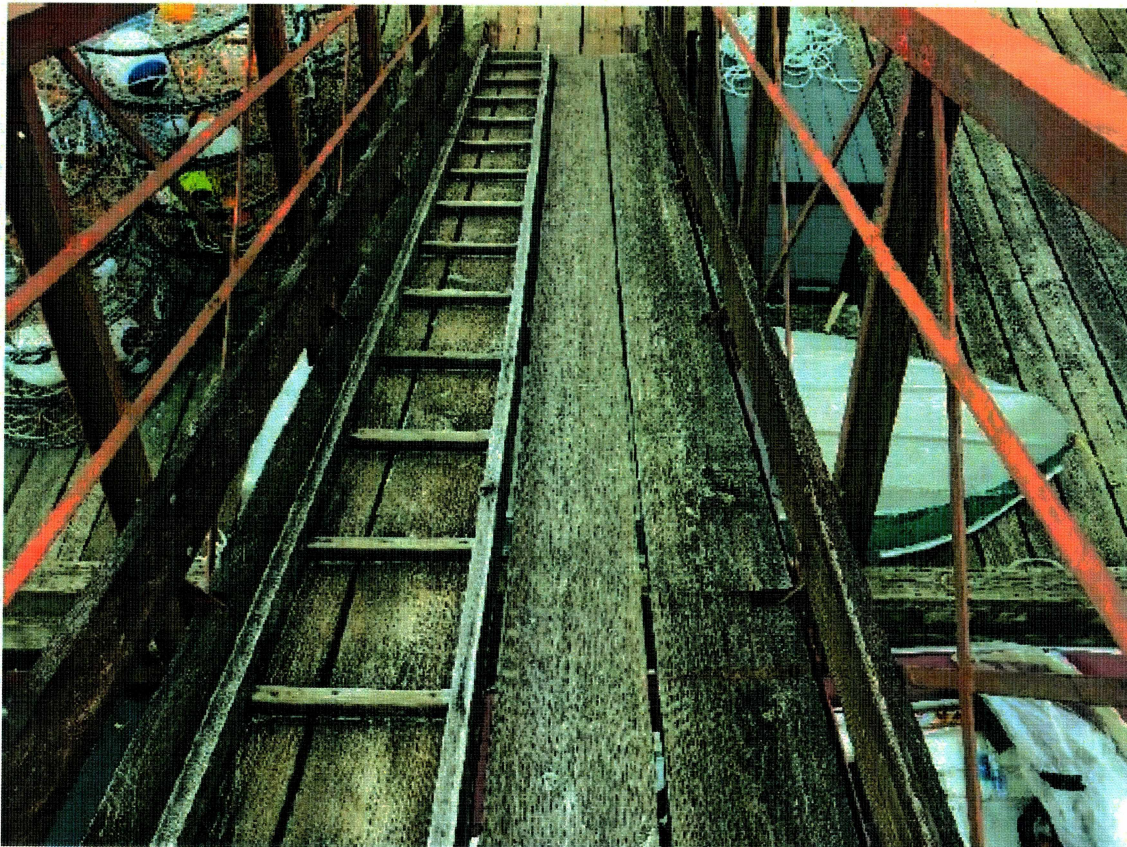
Photo 34 – Gangway Timber Deck Planks

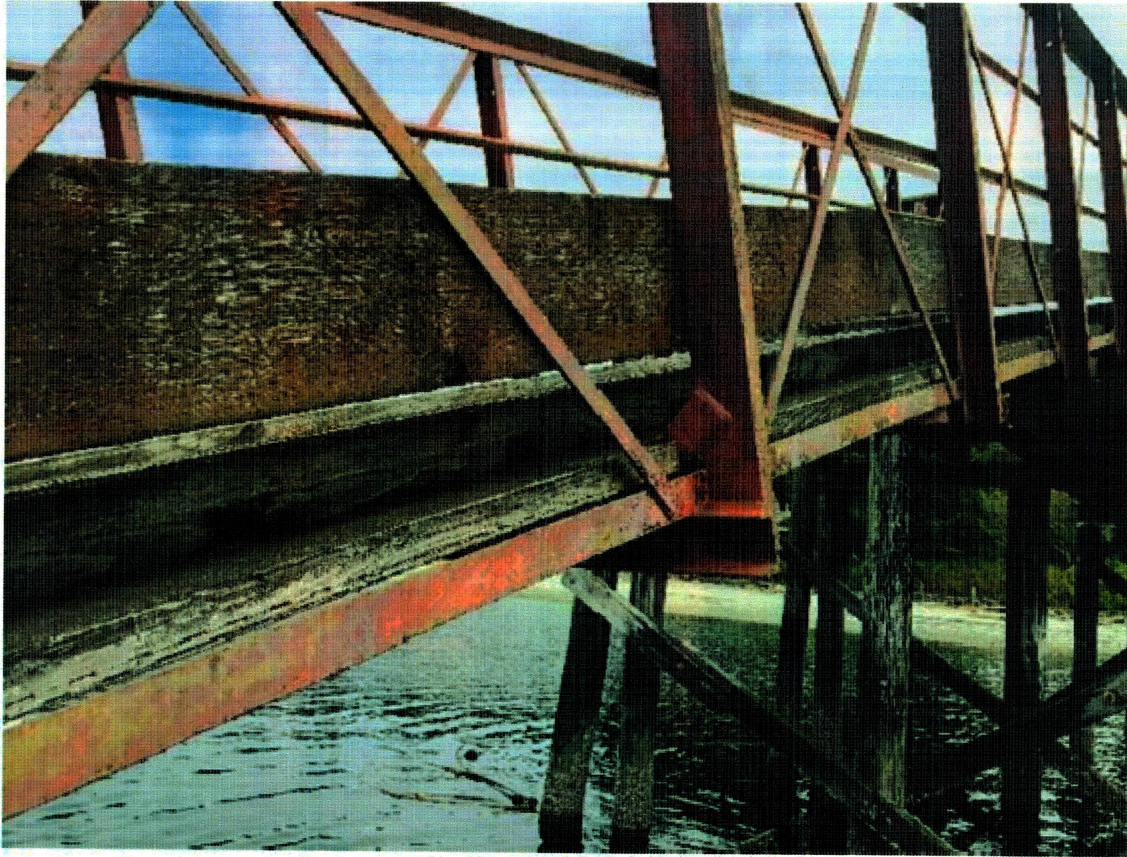
Photo 35 – Steel Gangway

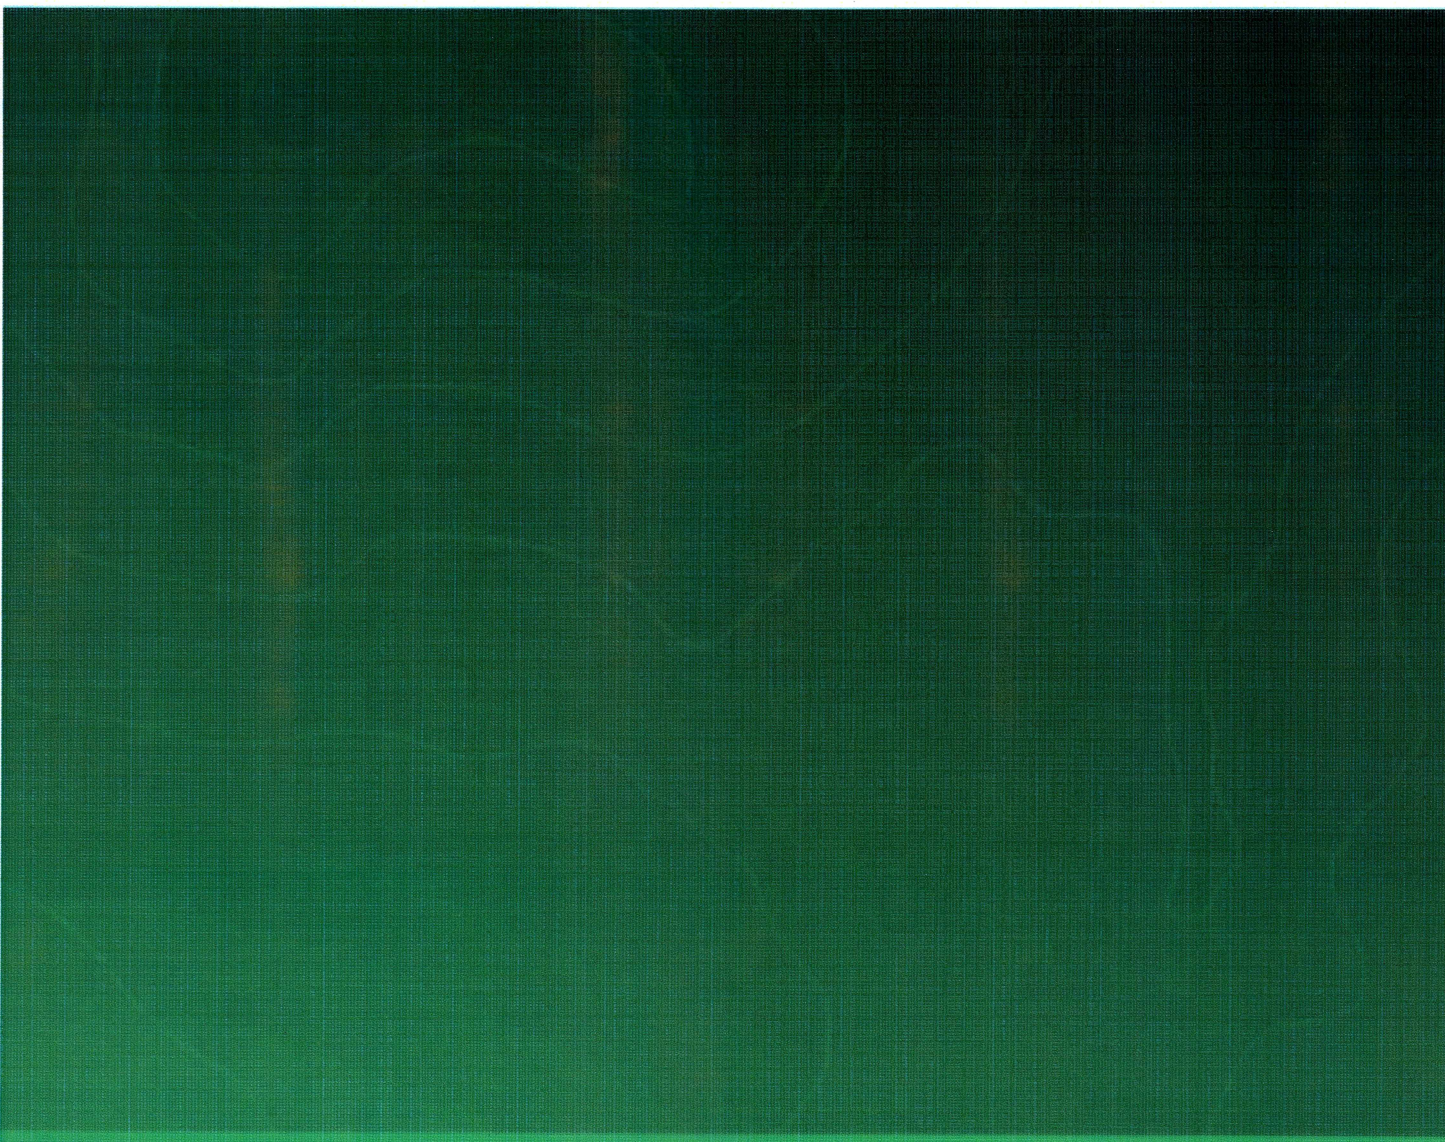
- The north dolphin has vegetation growth near the tops of some of the piles. The timber blocking near the tops of the piles is deteriorating, and the cable wraps are loose (Photo 44)
- The south dolphin has significant vegetation growth near the tops of the piles. There is also severe cross section loss due to internal fungal decay and marine borer cavity in the intertidal zone, specifically on the front facing piles. The timber blocking is in poor condition, and the cable wraps are loose, but remain in place (Photo 45).

Photo 45 – South Mooring Dolphin
