STAFF REPORT

RE: **BYLAW NO. 625 - OYSTER RIVERBANK PROTECTION SERVICE**

**RE: STRATHCONA REGIONAL DISTRICT
Oyster River Riverbank Inspection
Inspection Findings, Remediation Recommendations and Management Plan
Our File 3436.005-300**

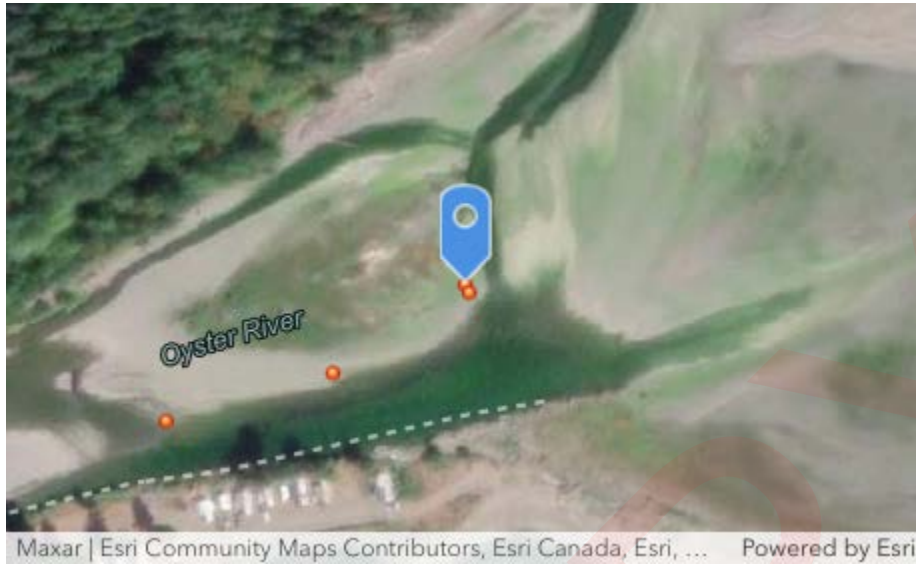
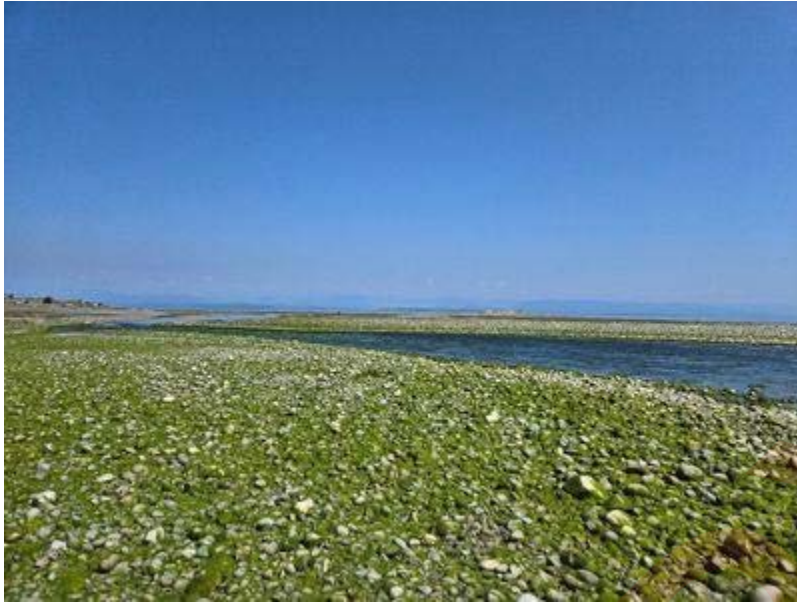
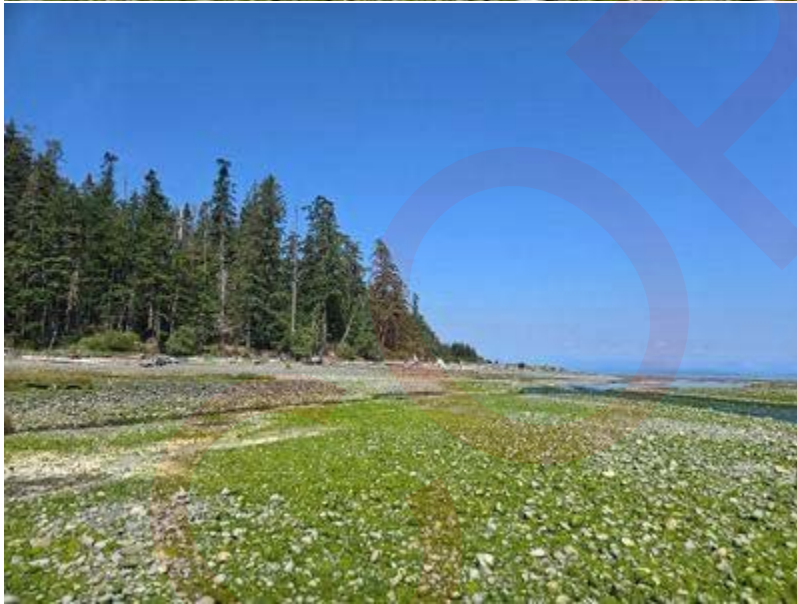
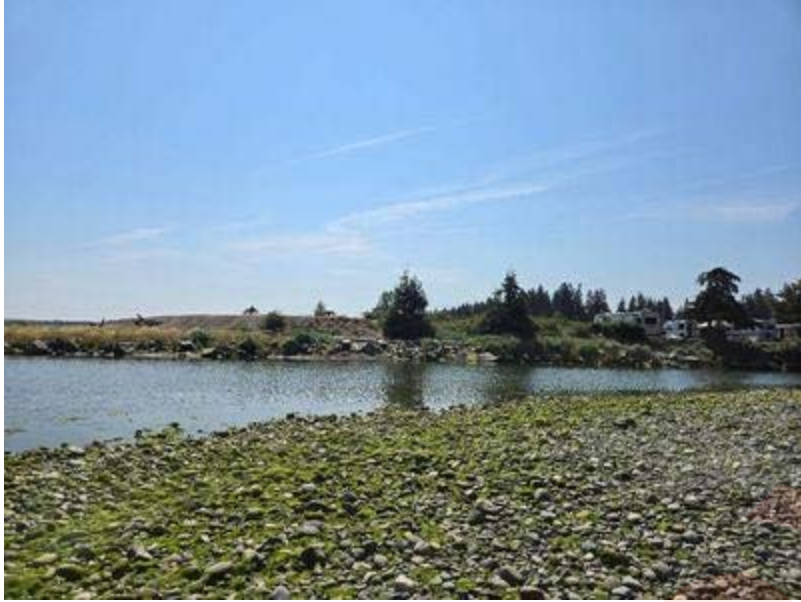
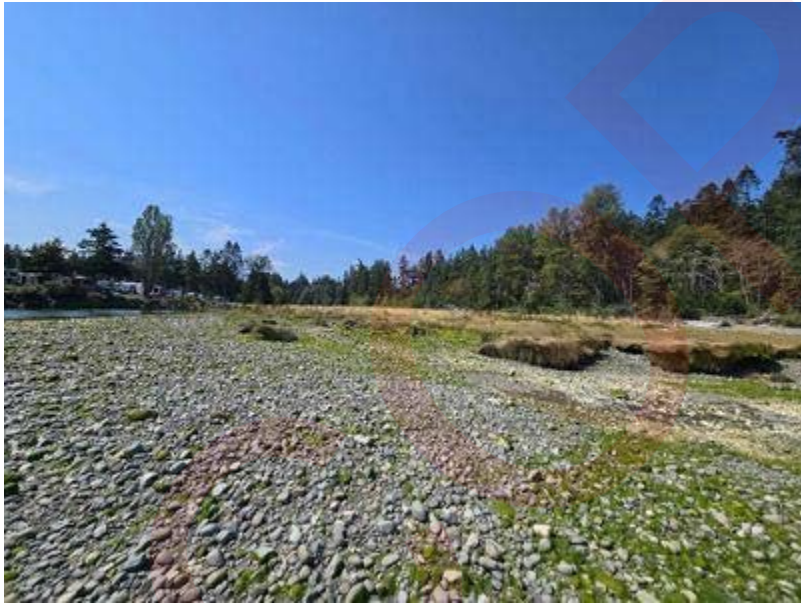
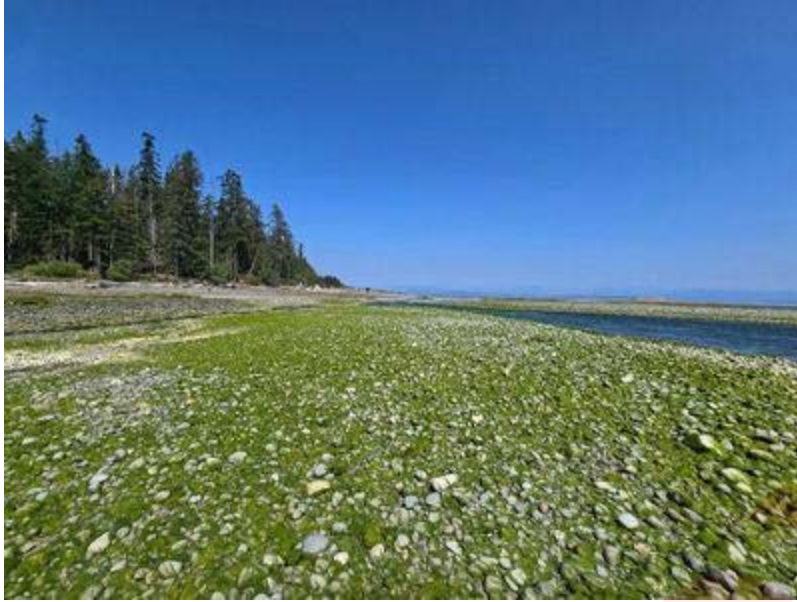
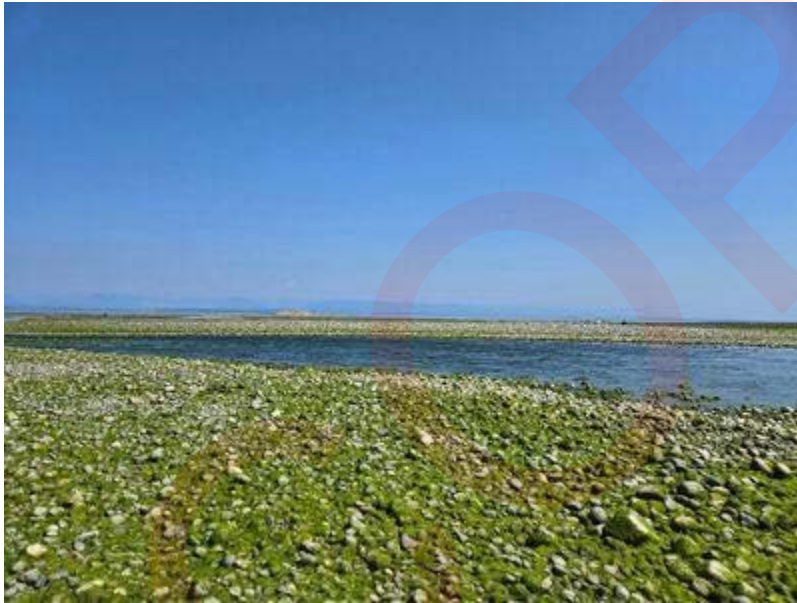
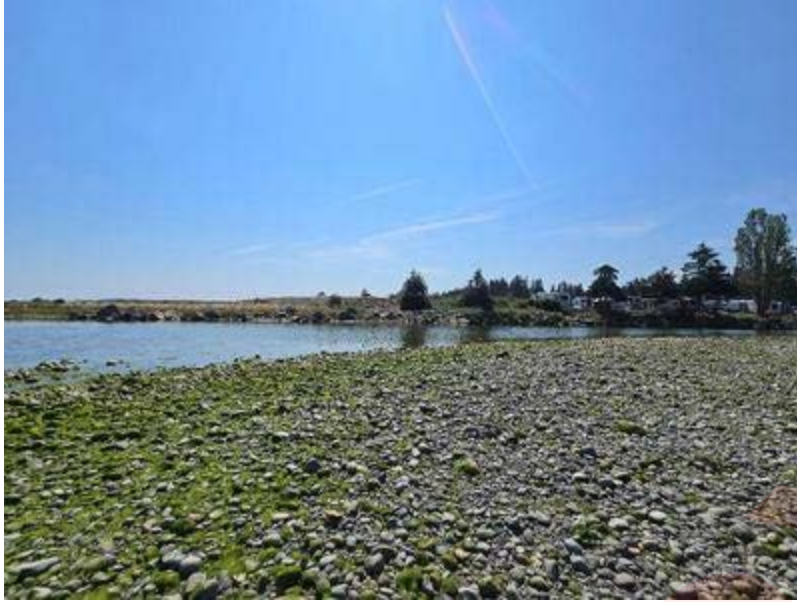
start of assessment. small riprap on right bank. largely ineffective

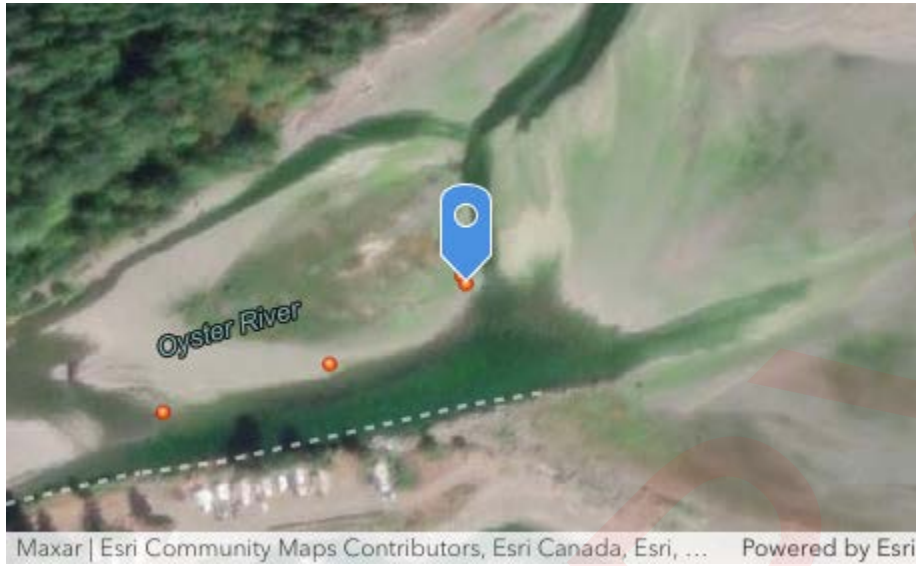
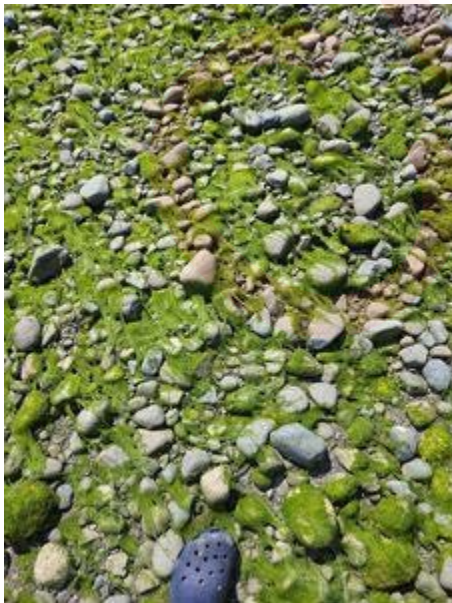
sediment appears to be building up here

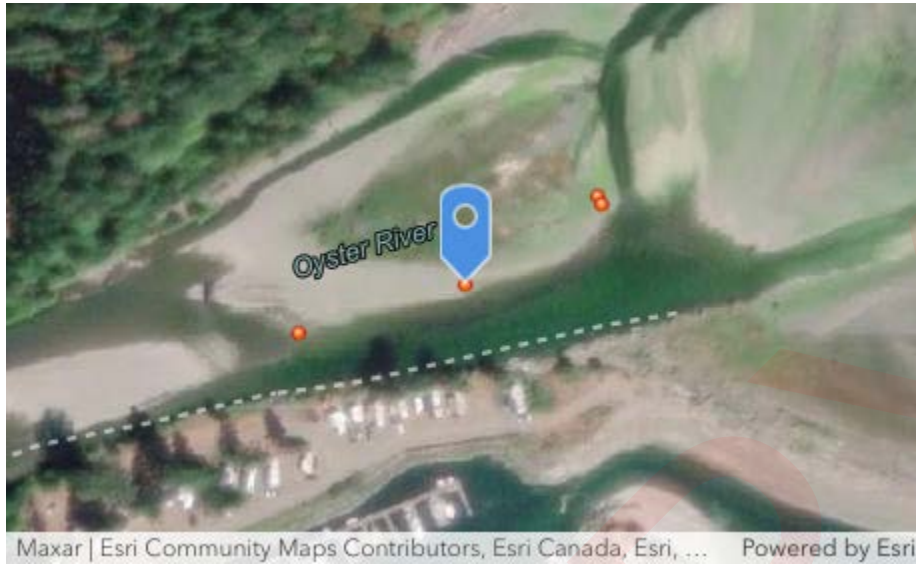
25 m section of riprap with concrete blocks, near vertical and failing

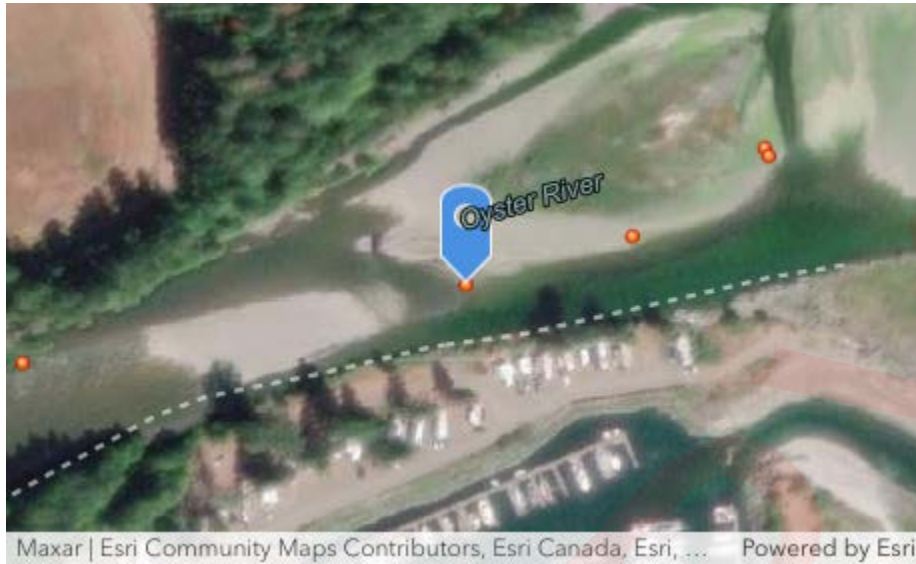
upstream end of riprap in ok condition

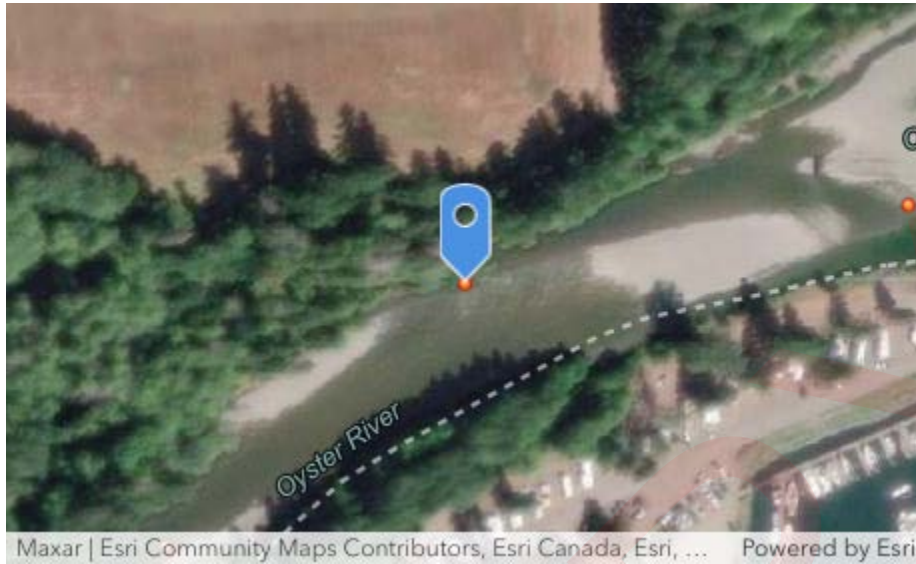
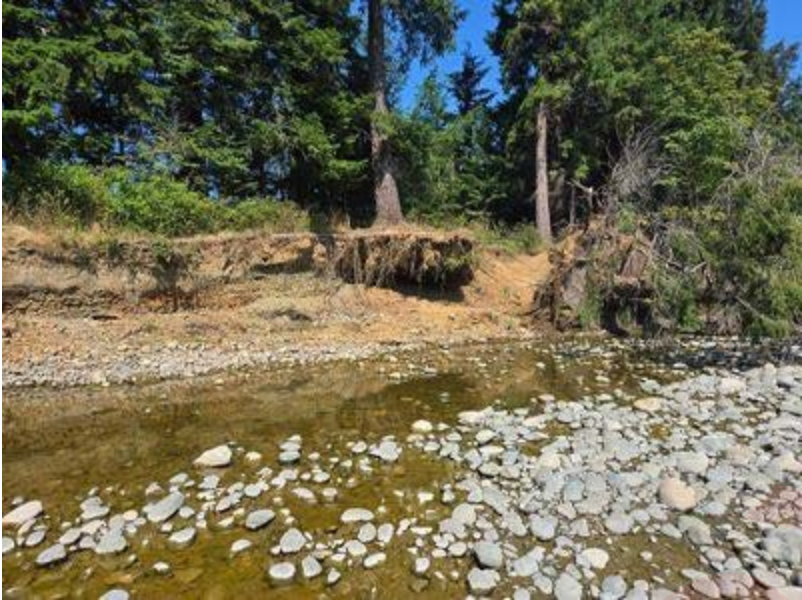
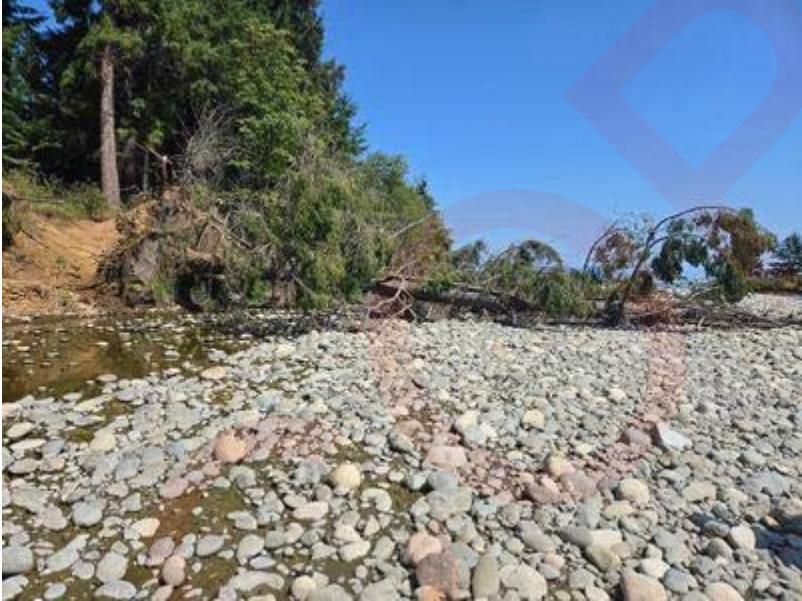
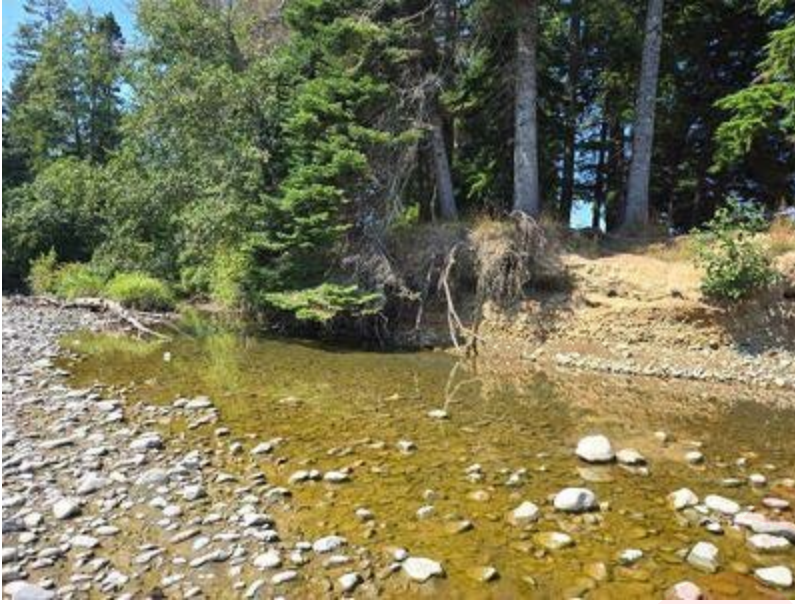
left bank erosion, 3m tall bank of gravel. mature tree recent fallen, 2 others at risk. trails on bank appears to have eroded

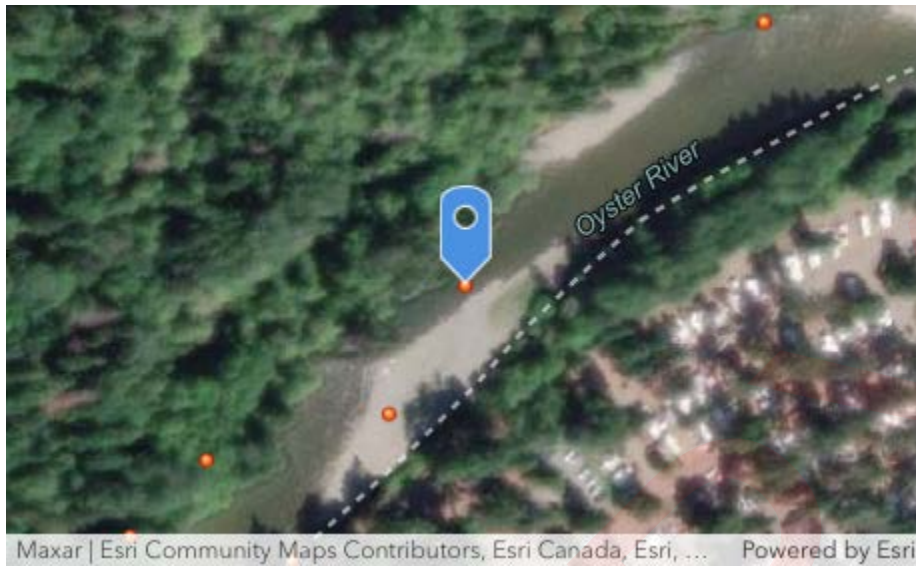
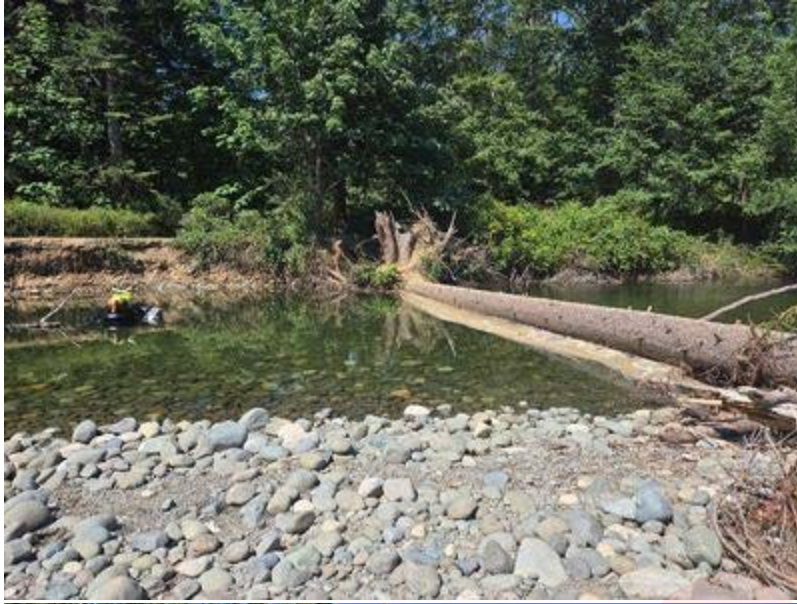
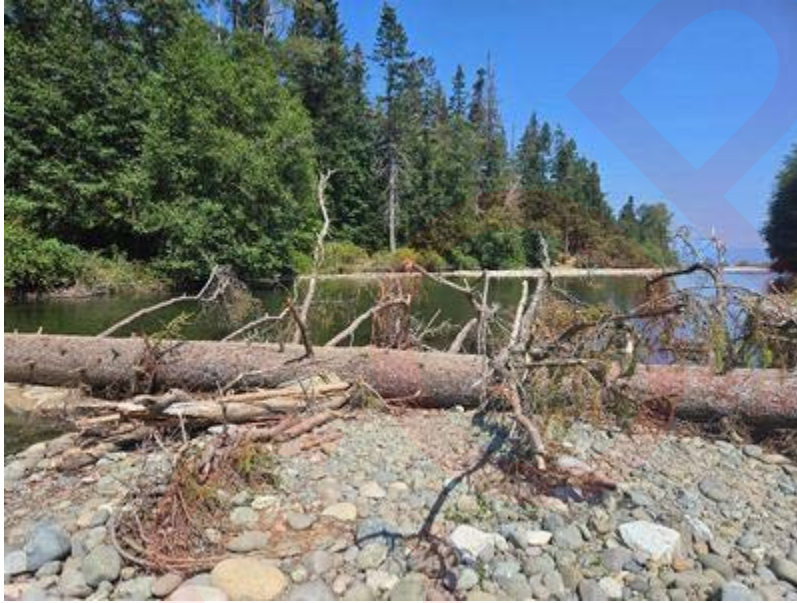
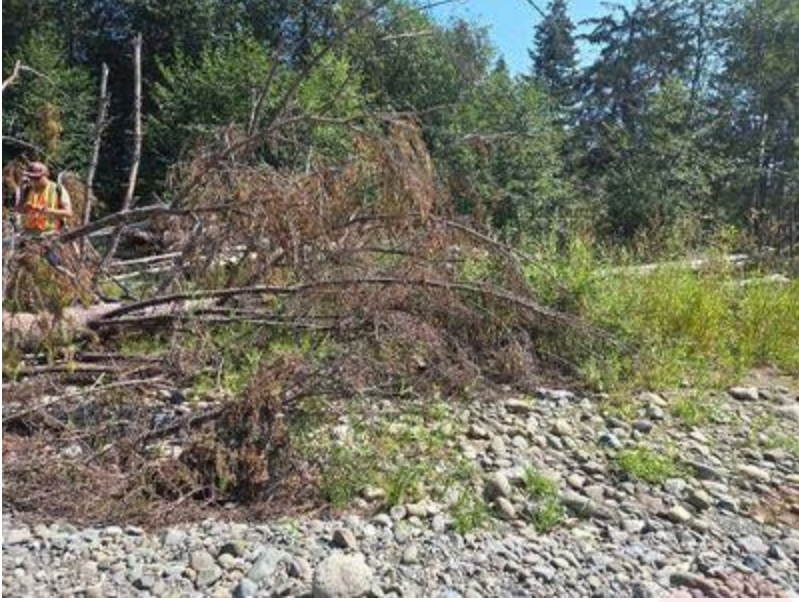
50 cm Dia tree spanning entire channel. concern it will further trap debris. ledt bank erosion

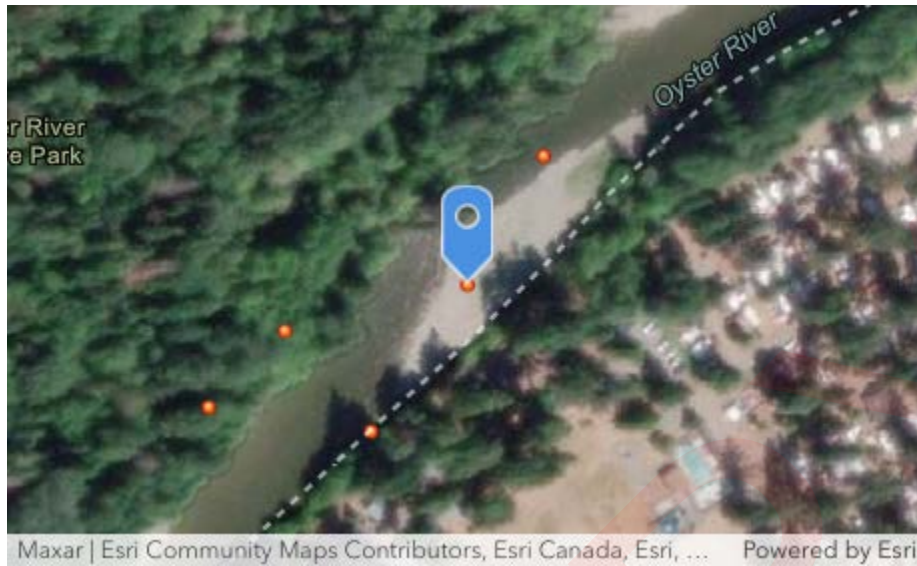
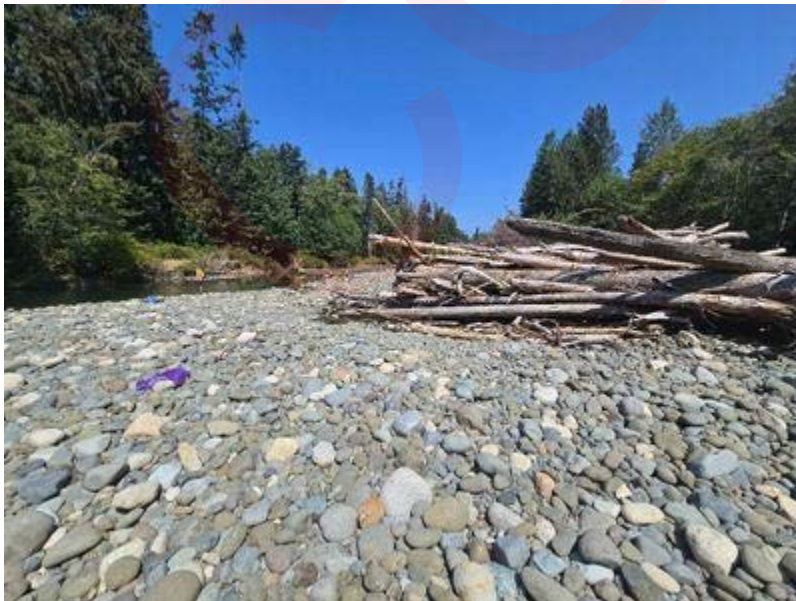
log jam 50 m upstream of fallen tree. very low bank on right (0.25 to 1 m in height) risk of flooding on right bank

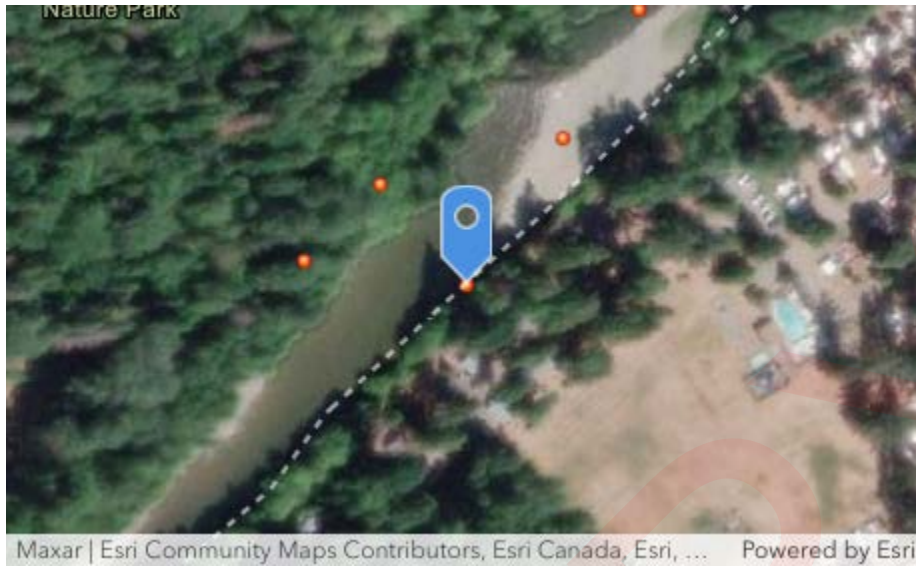
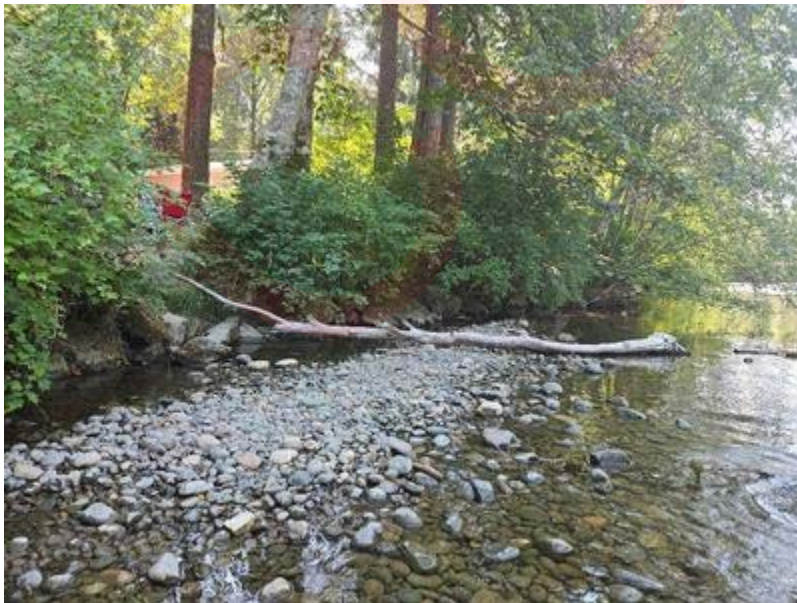
old riprap from railway bridge. downstream extent on right bank

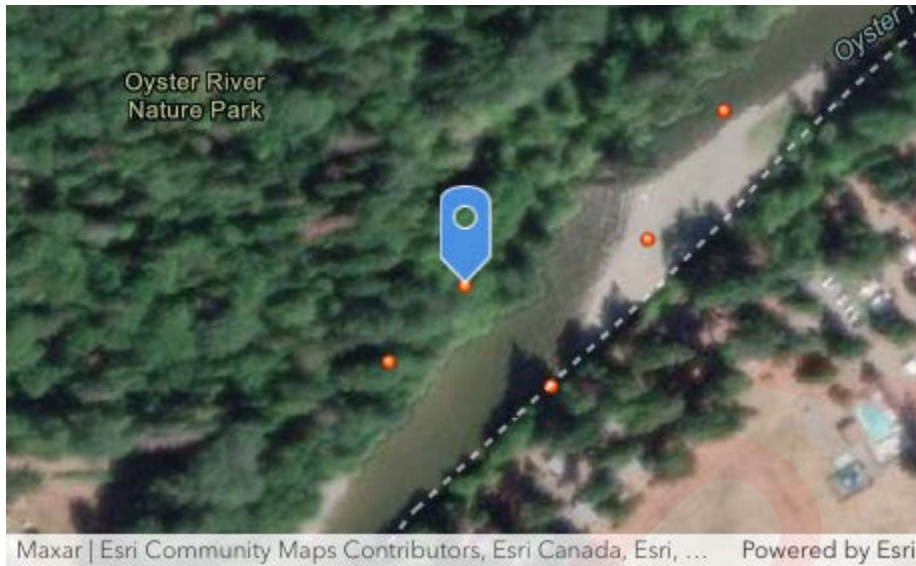
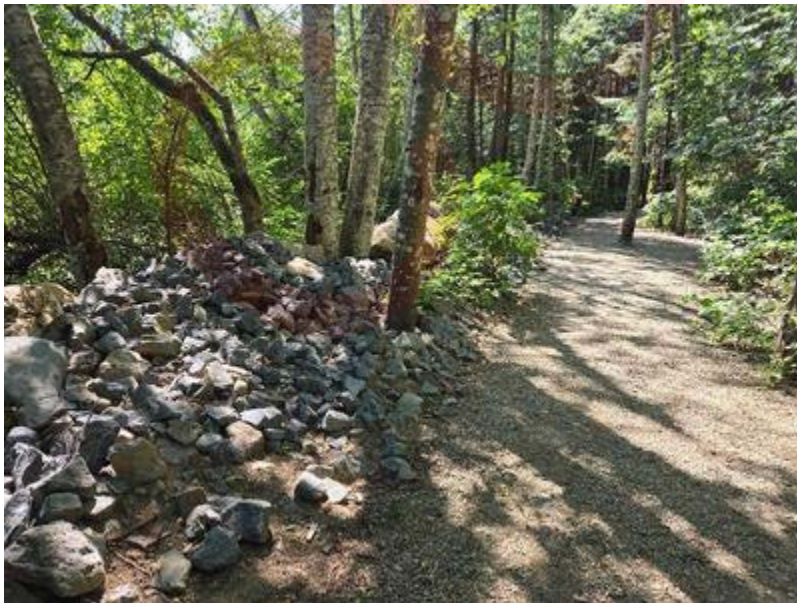
newly built rock berm, wood debris cabled into bank

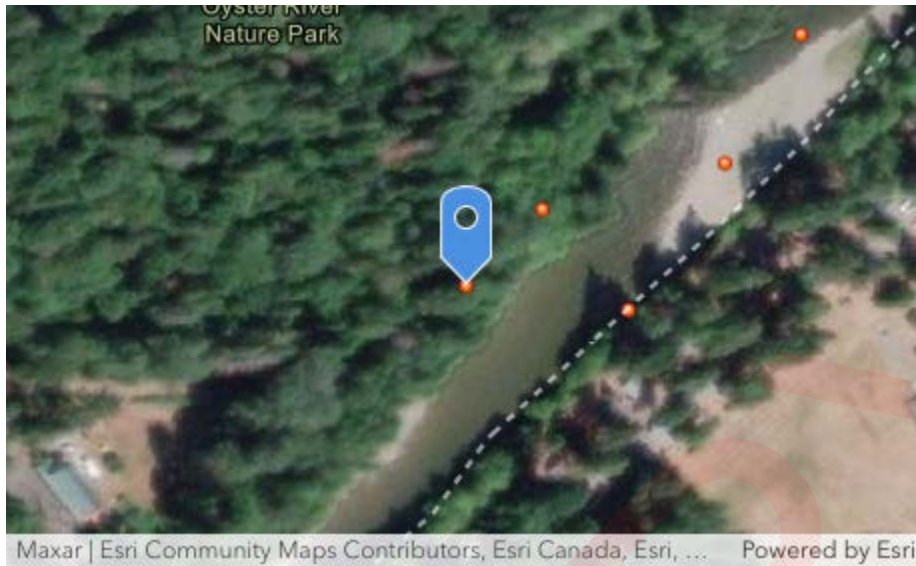
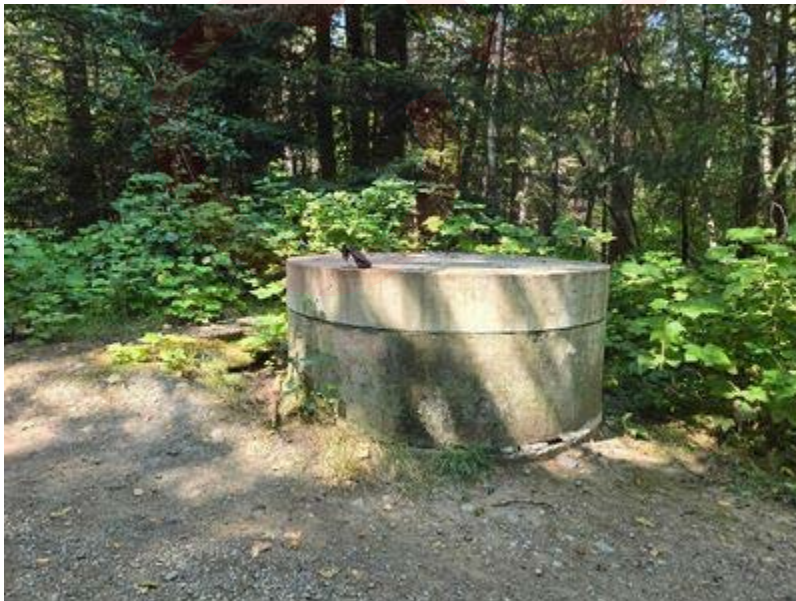
upstream berm transitions to old berm structure. appears to protect well head or sewer infrastructure located here

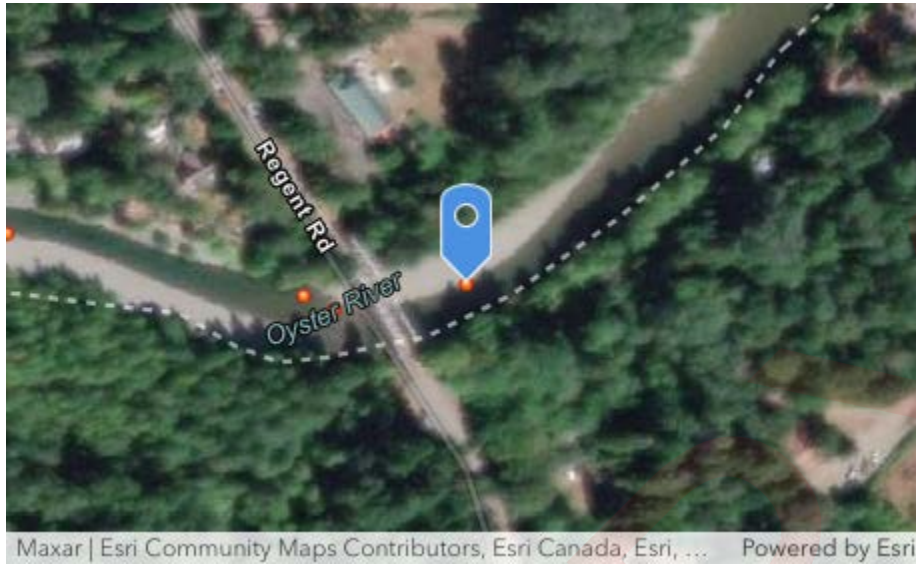
very steep blocky riprap on right bank downstream of railway bridge. OK condition

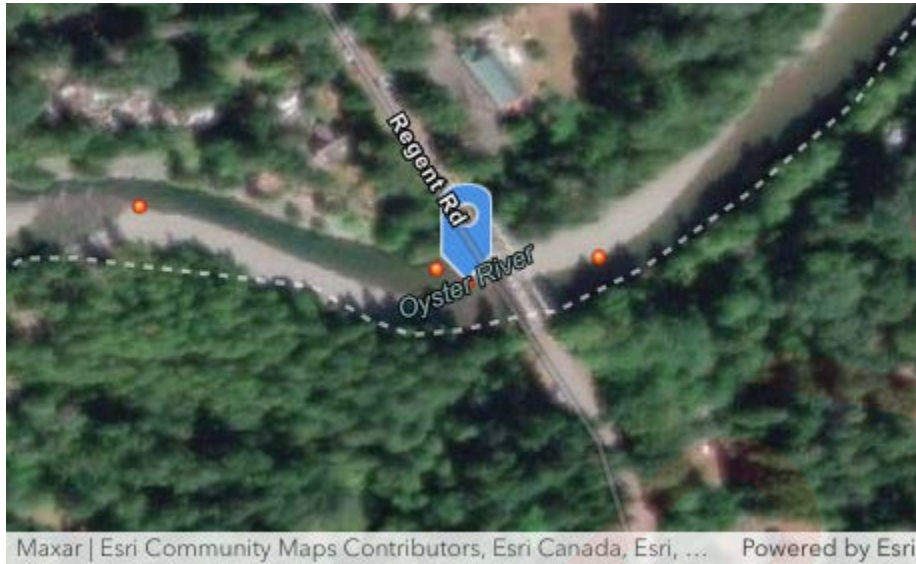
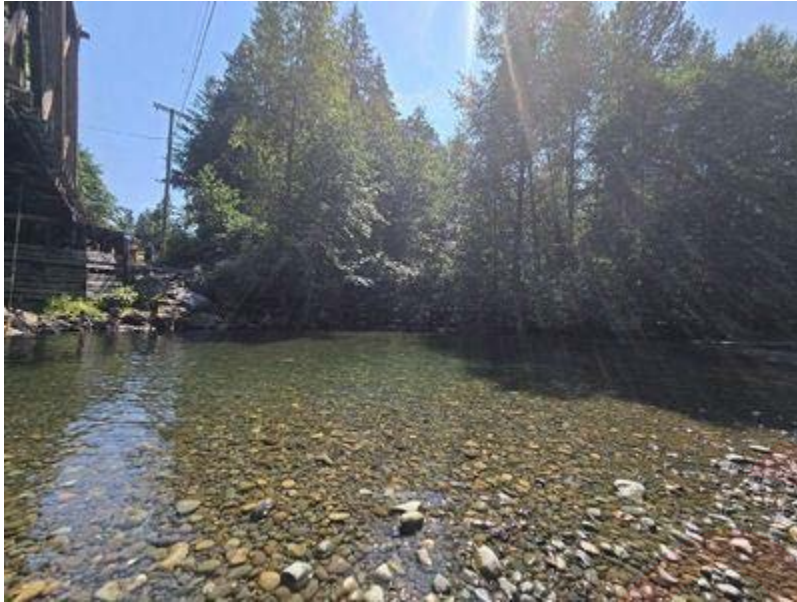
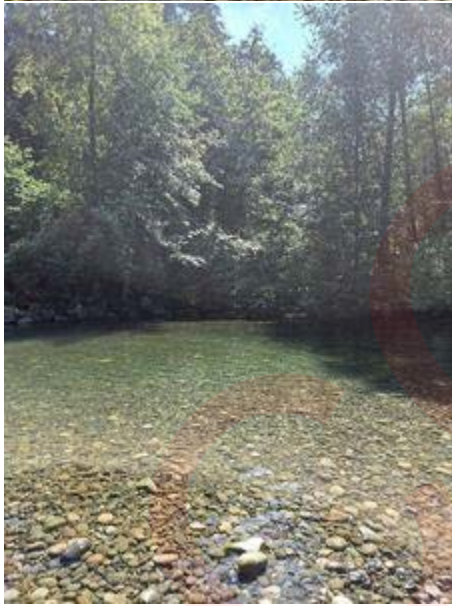
small tributary upstream of bridge on right bank. riprap along abutment is poor shape but still offers some protection. surprised that bank on right is not worse given channel alignment

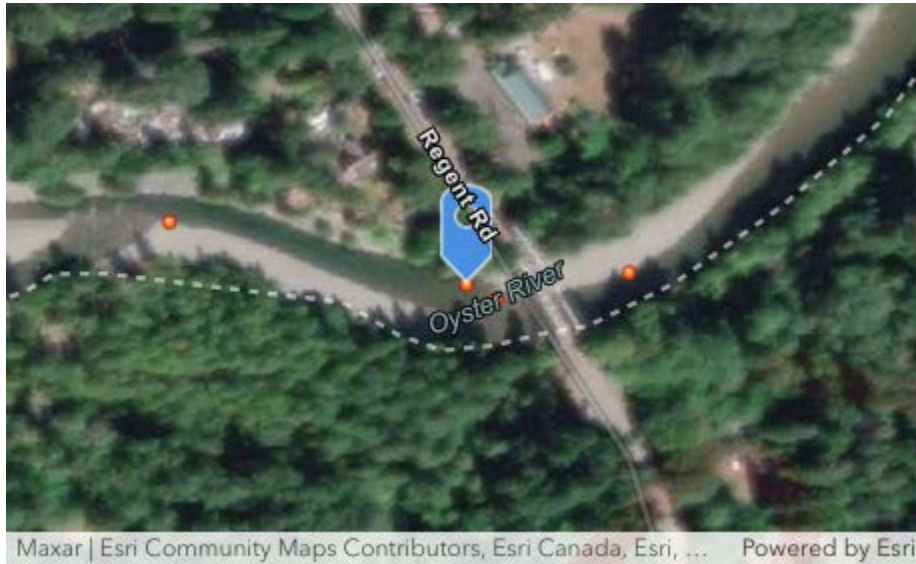
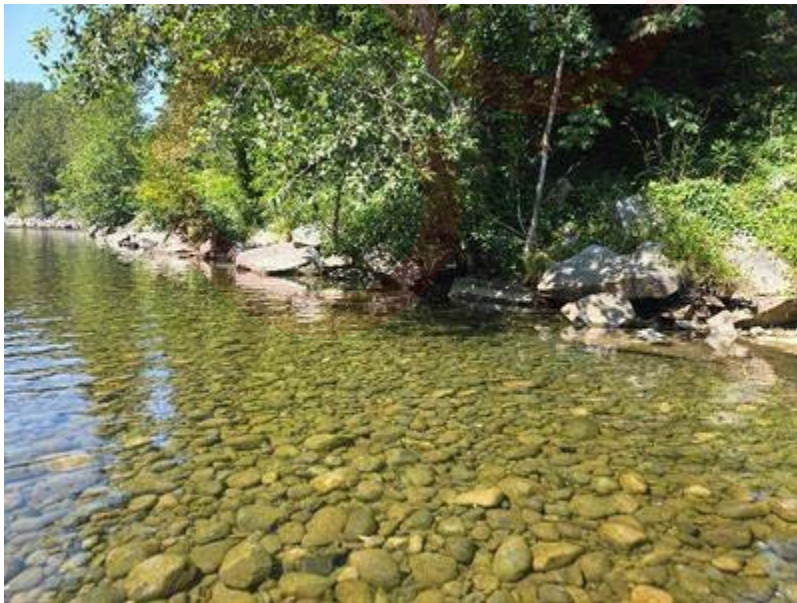
start of riprap downstream edge on left bank

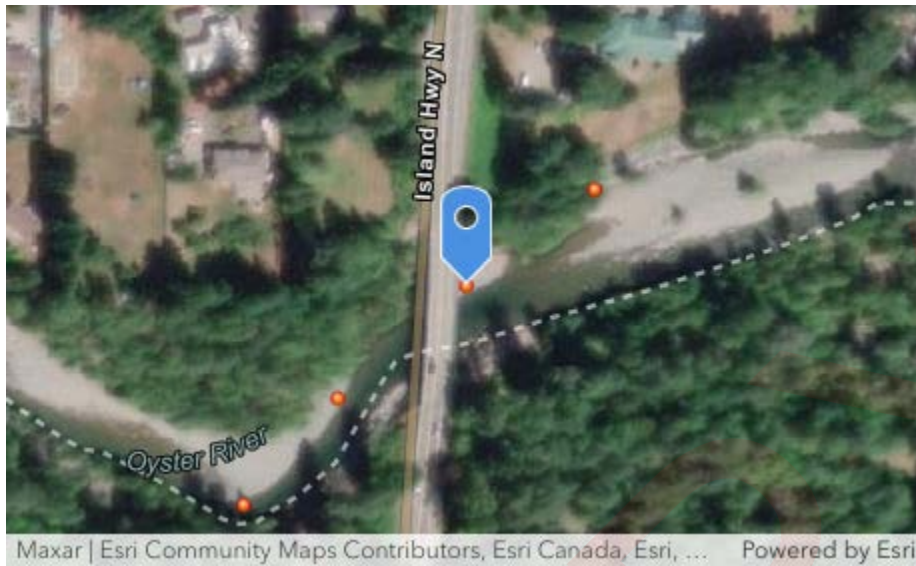
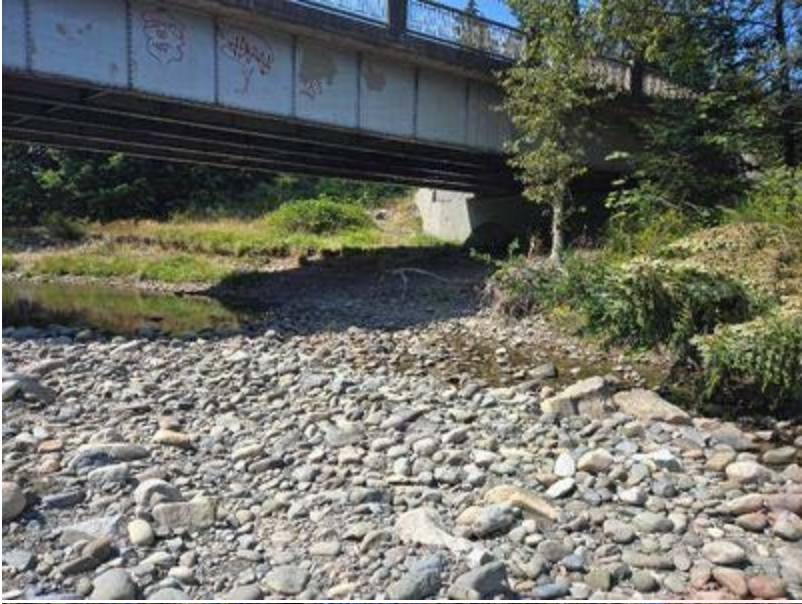
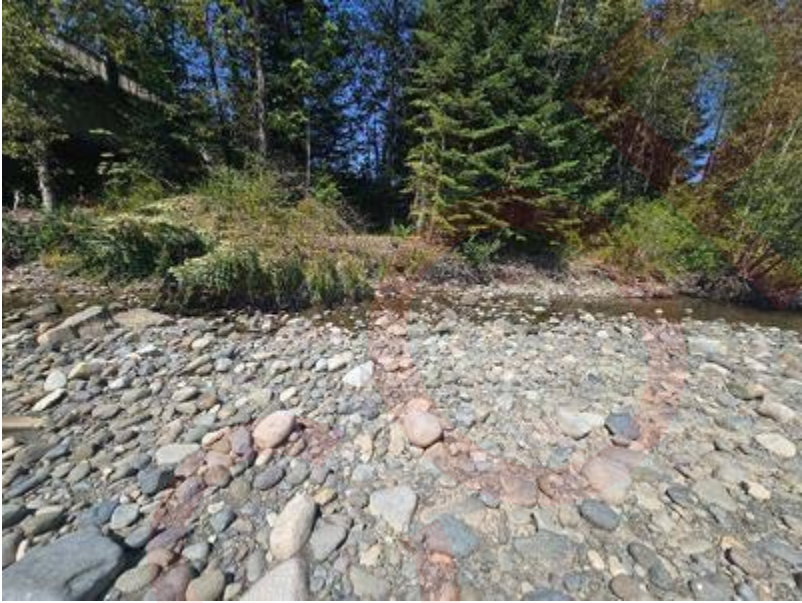
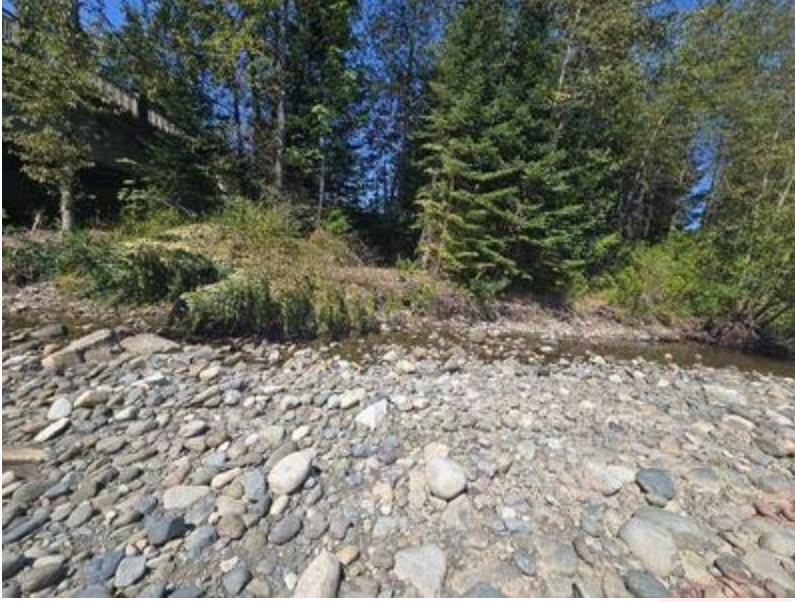
minor bank erosion along unprotected left bank at bridge

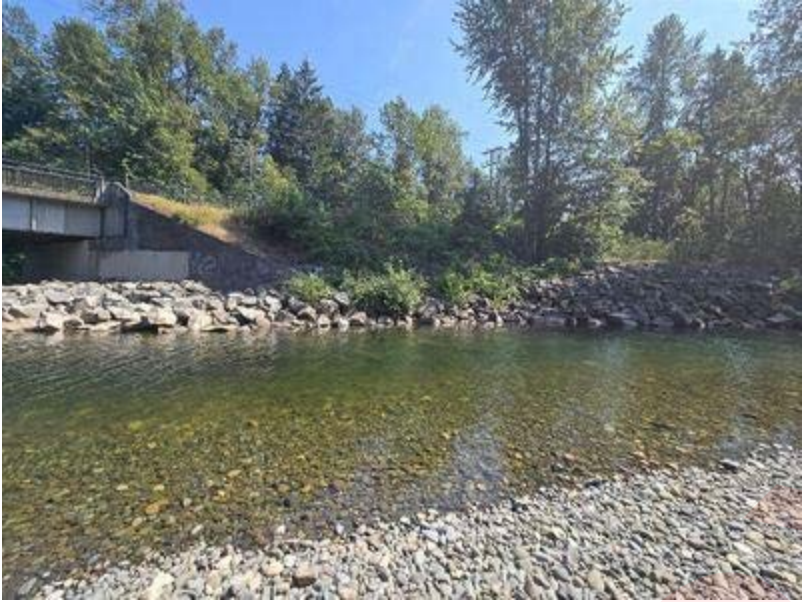
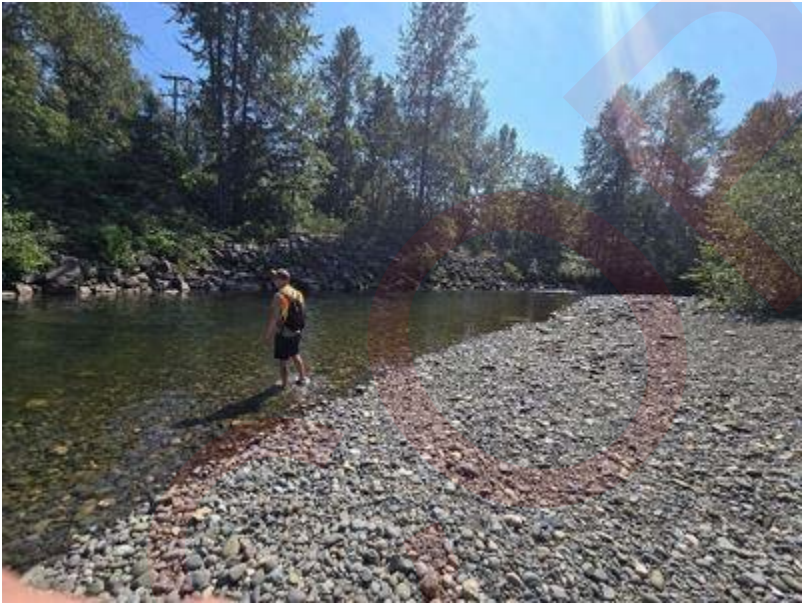
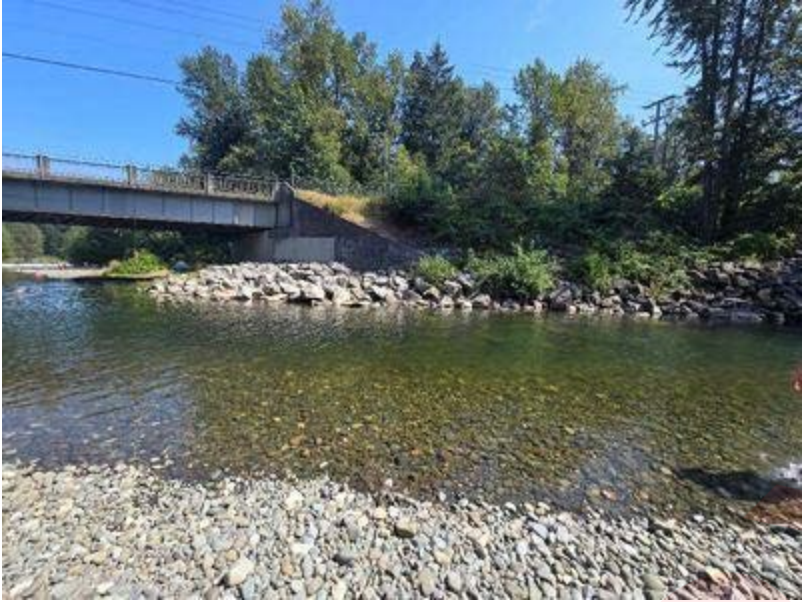
right bank riprap blends into bank riprap upstream. steep ok condition

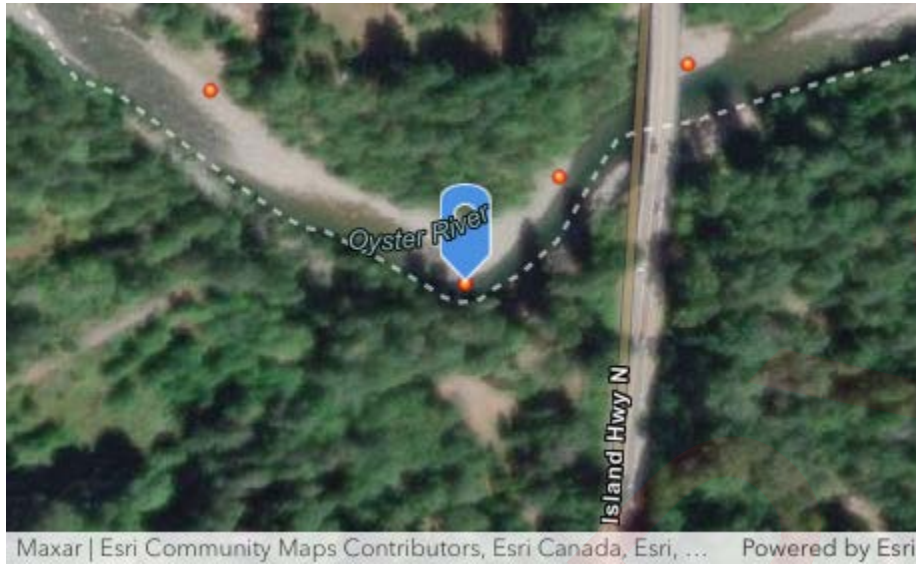
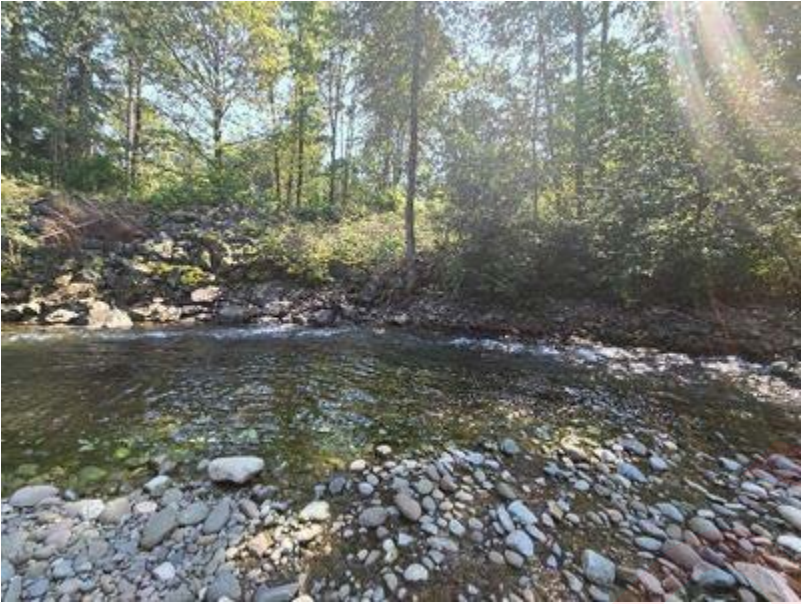
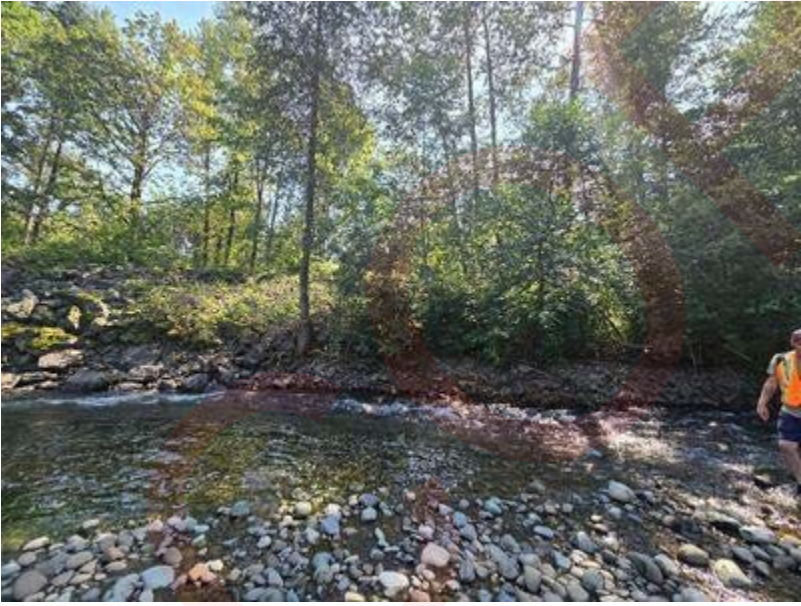
right bank riprap goes into forest.

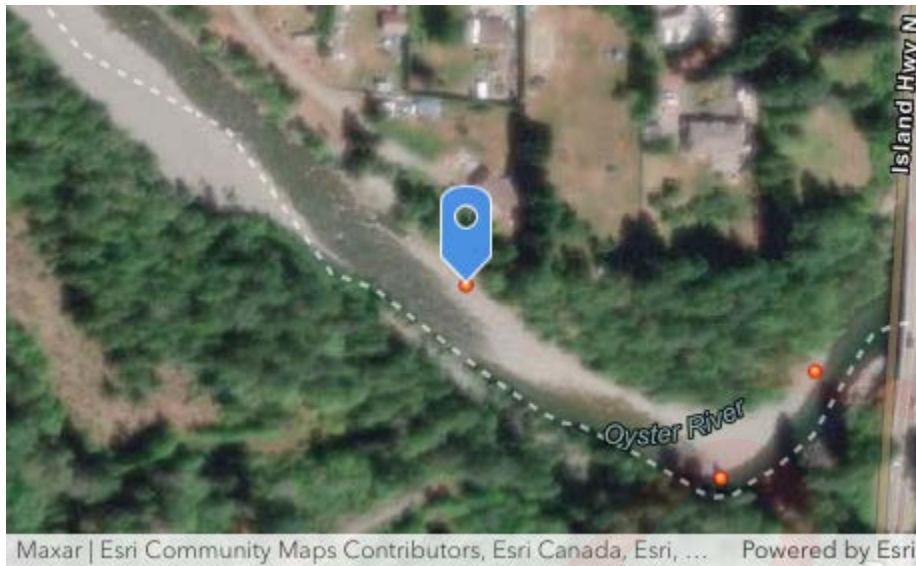
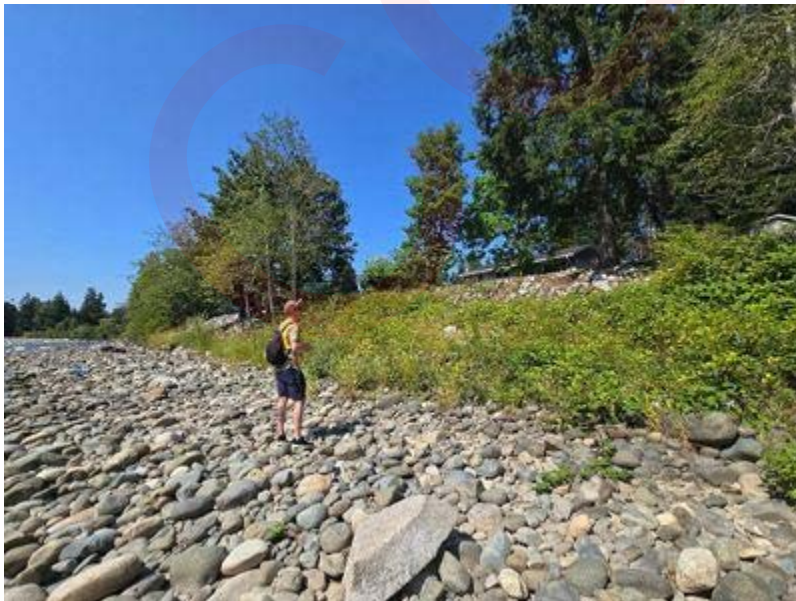
downstream extent of riprap on left bank. smallish
