STAFF REPORT

RE: **BYLAW NO. 625 - OYSTER RIVERBANK PROTECTION SERVICE**

**RE: STRATHCONA REGIONAL DISTRICT
Oyster River Riverbank Inspection
Inspection Findings, Remediation Recommendations and Management Plan
Our File 3436.005-300**

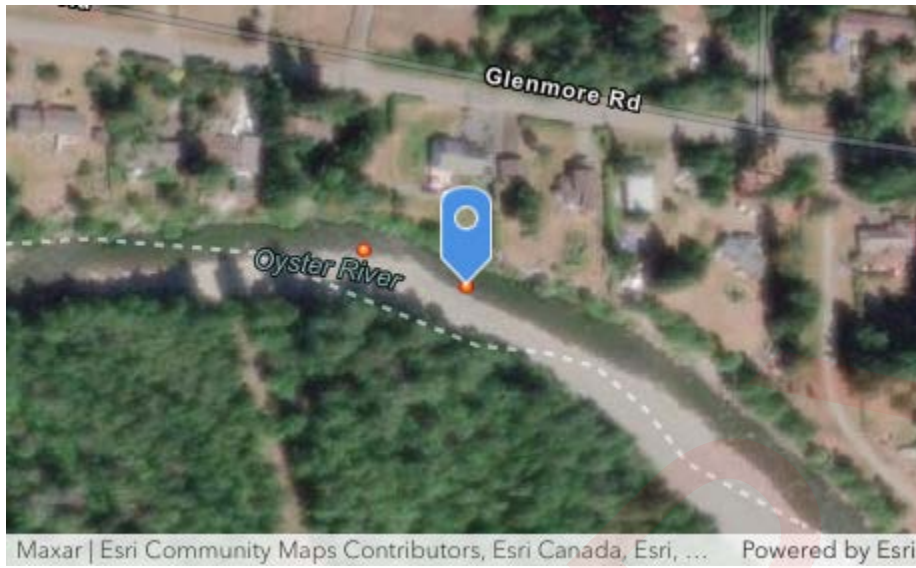
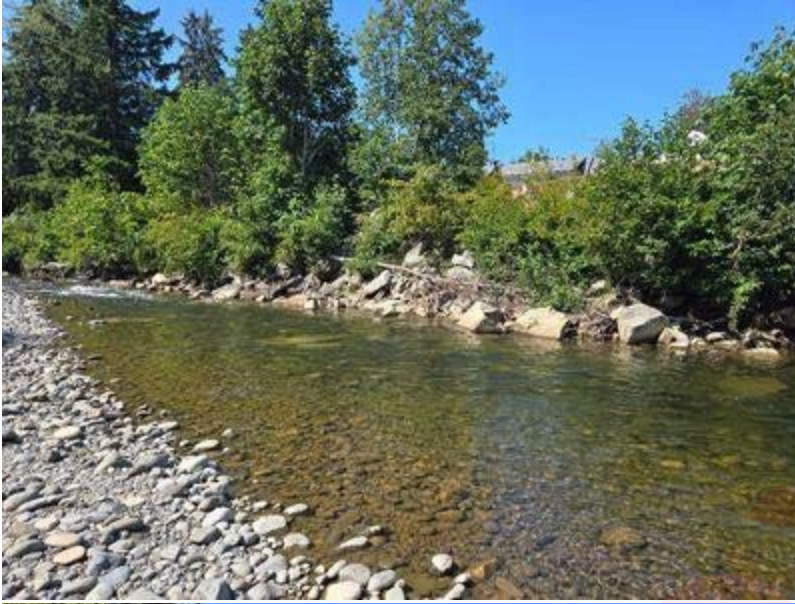
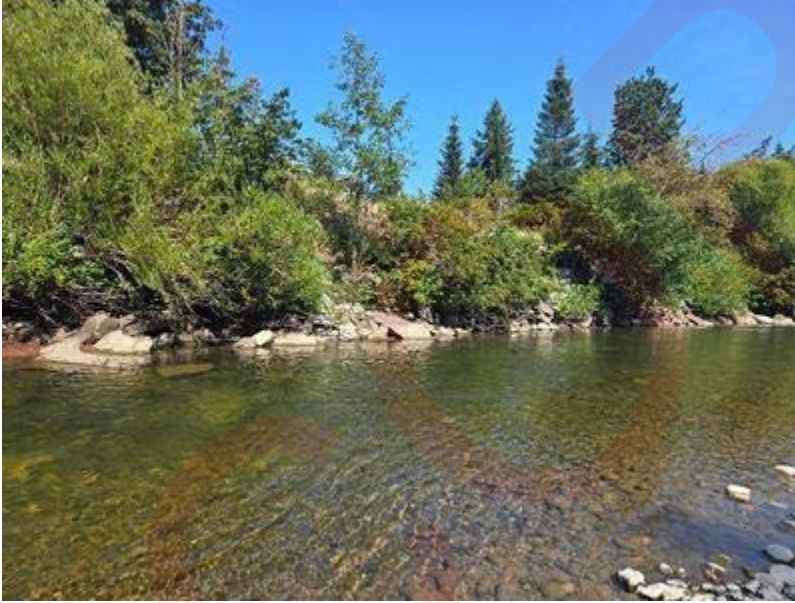
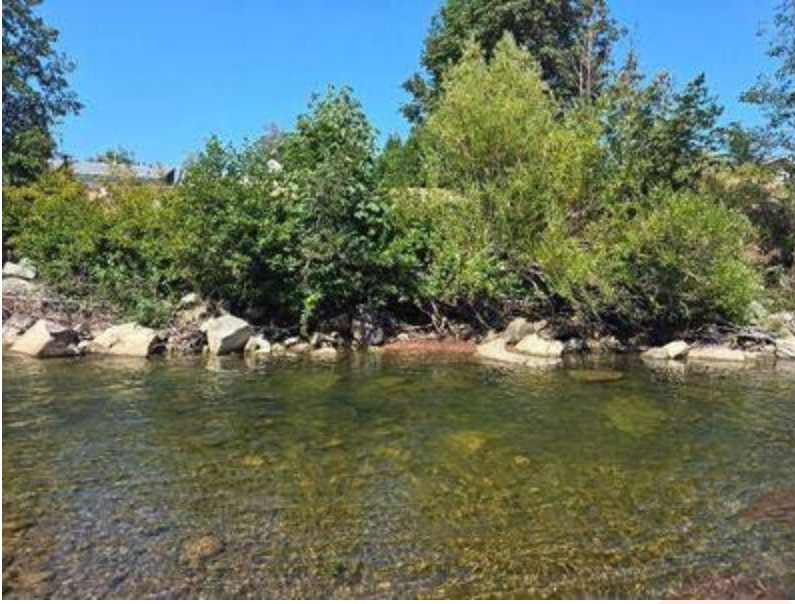
small failure of riprap, bank exposed

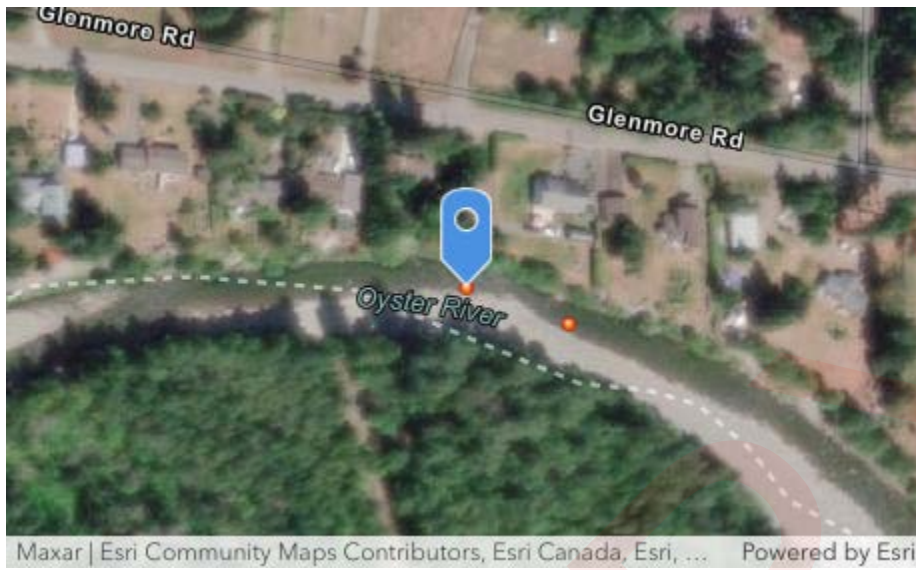
small riprap failure, bank exposed

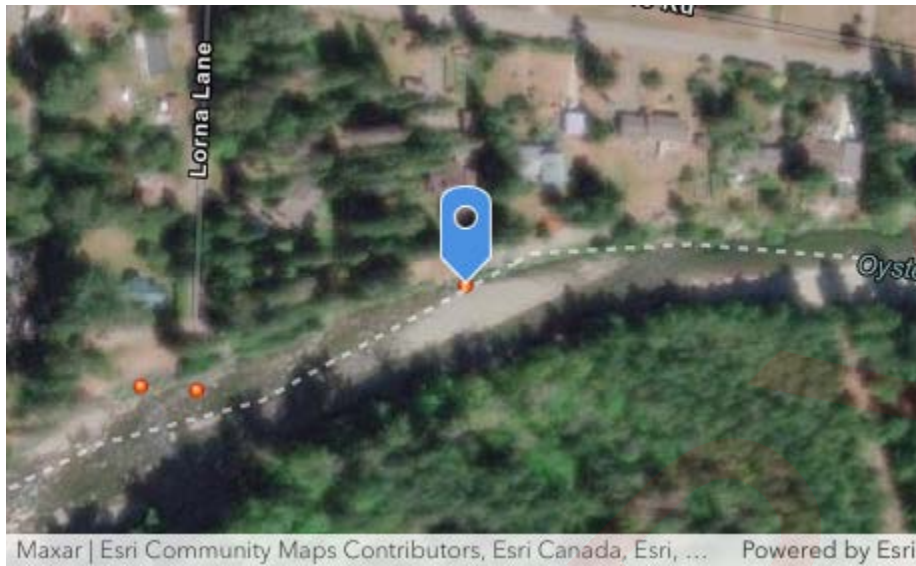
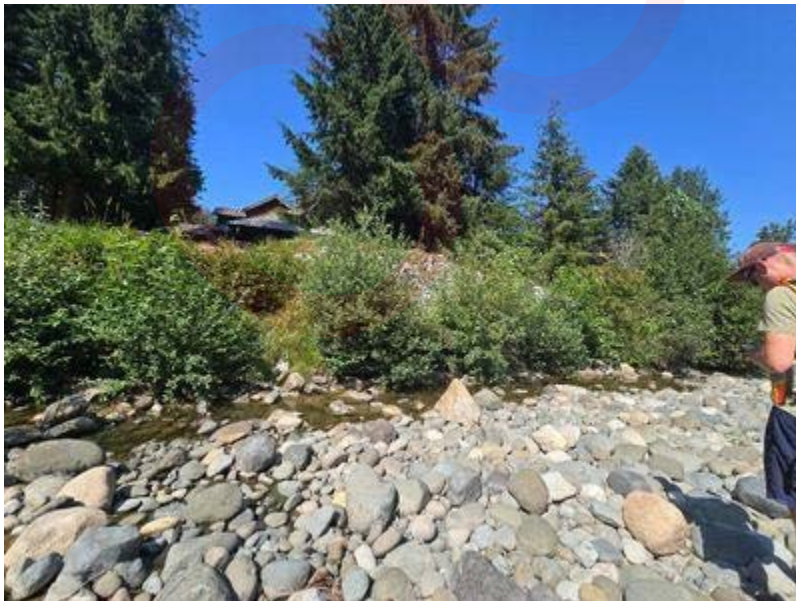
riprap on left bank appears to transition to lower elevation riprap (1 m lower)

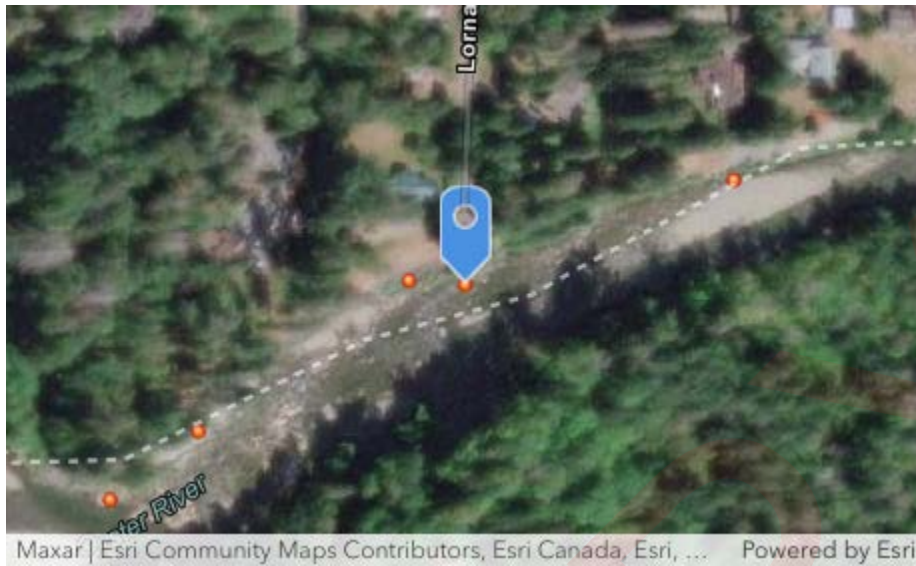
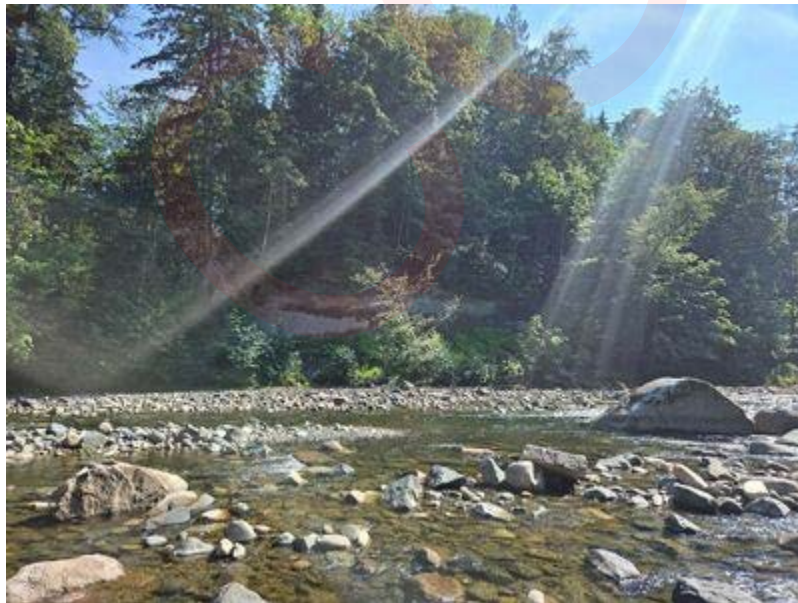
large silt bluff on right bank, actively eroding

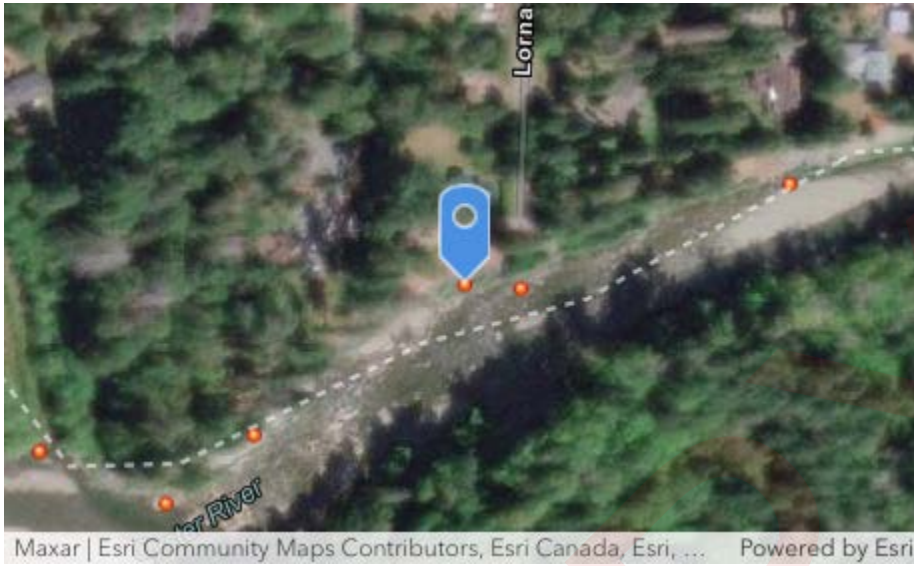
bedrock outcrop

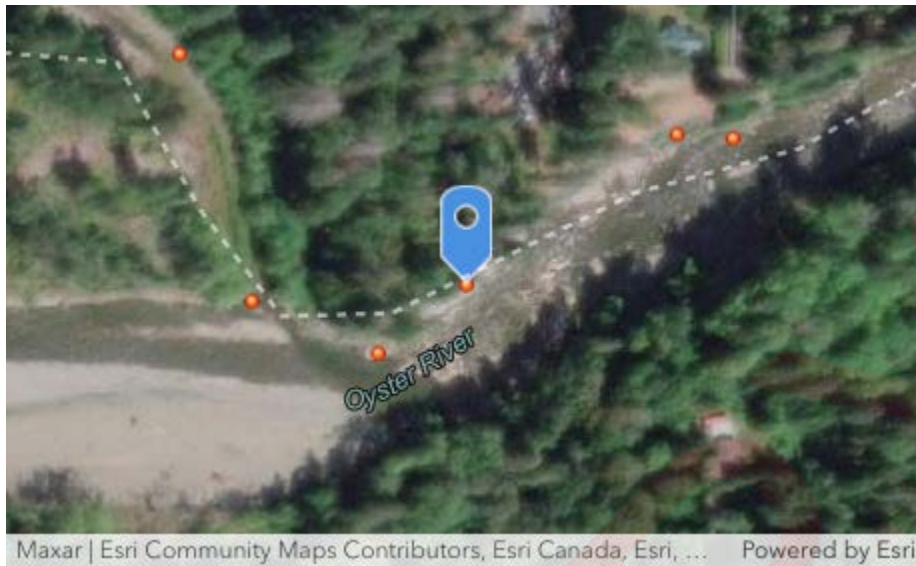
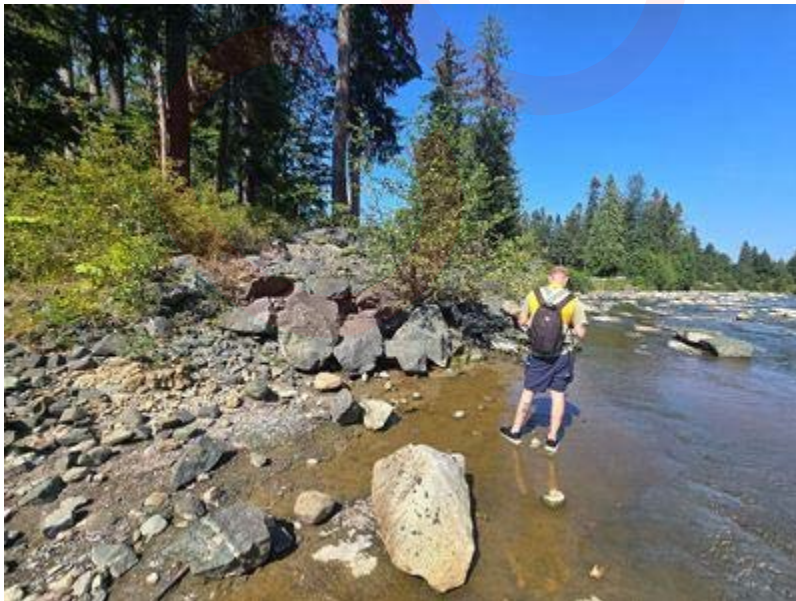
upstream end of riprap on left bank, bedrock present across channel

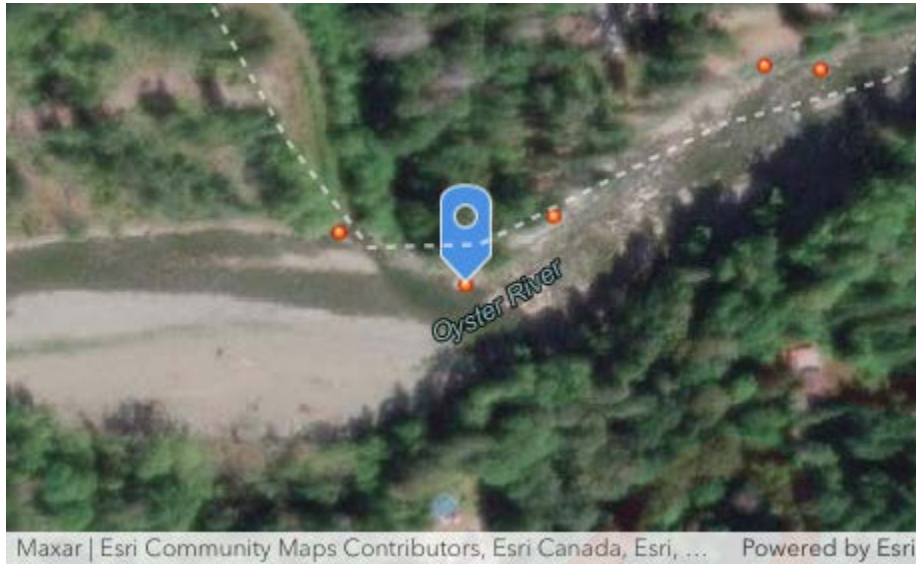
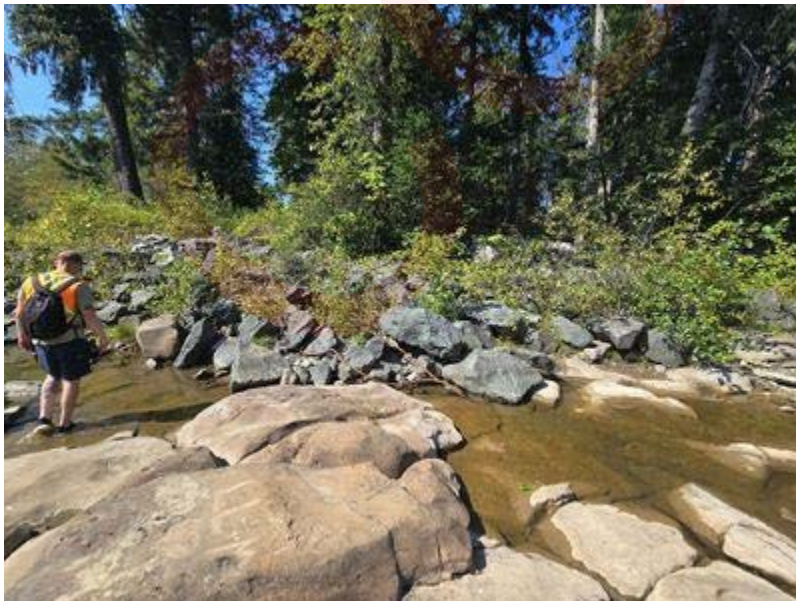
riprap section on point downstream of old channel outlet on left bank

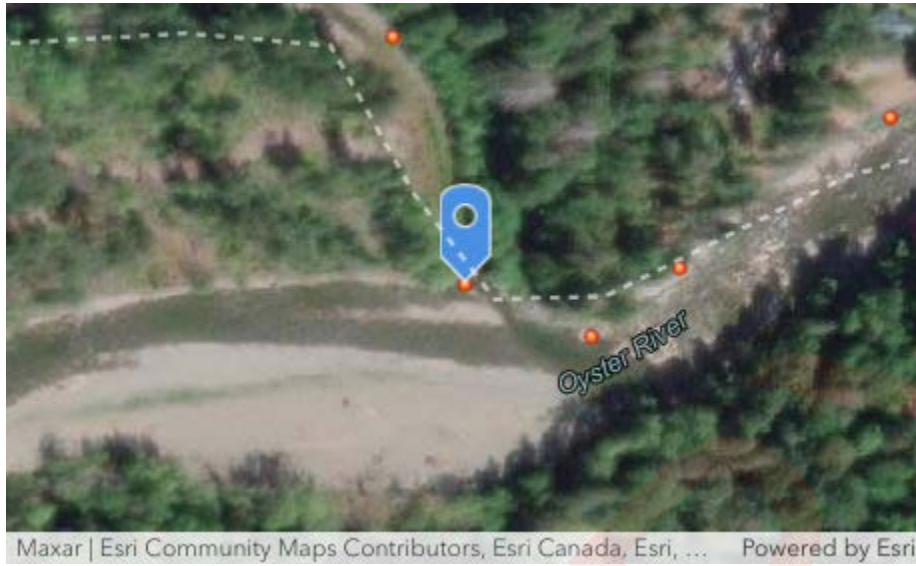
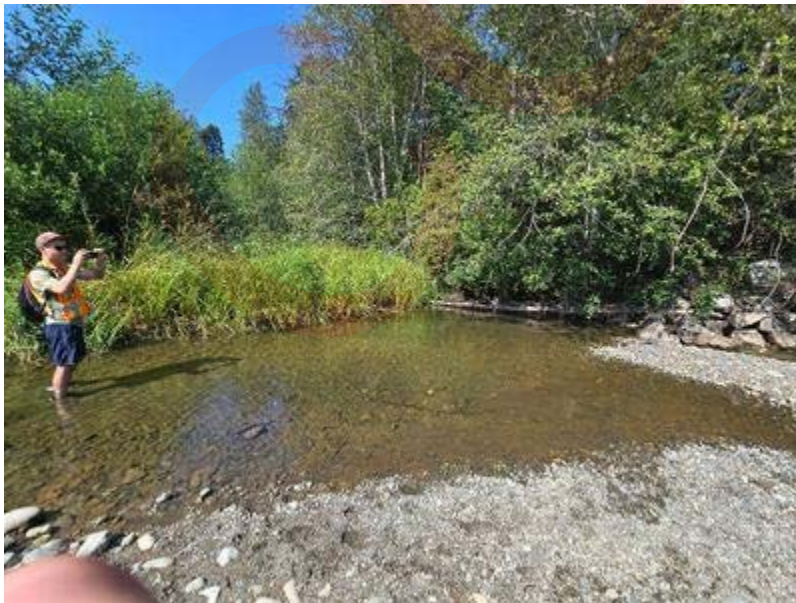
exit of old channel

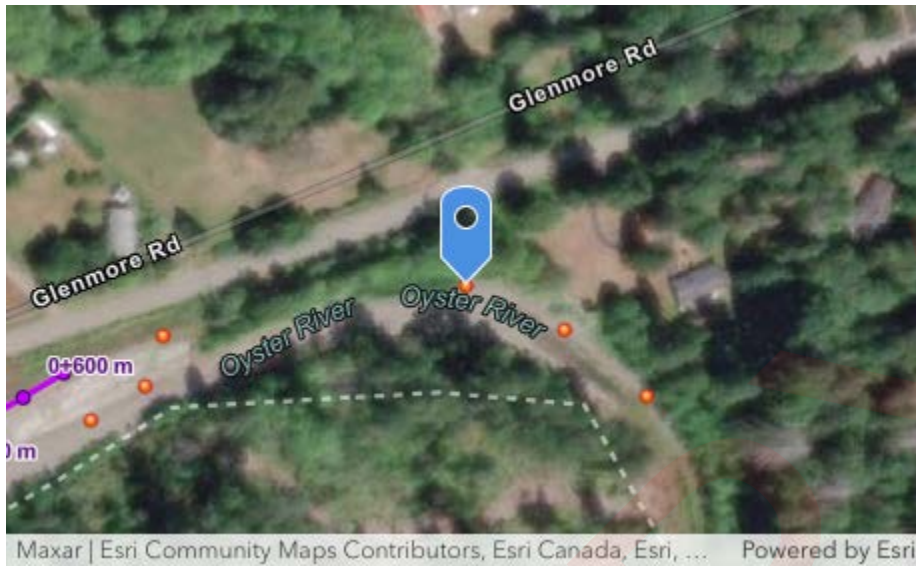
riprap is good condition

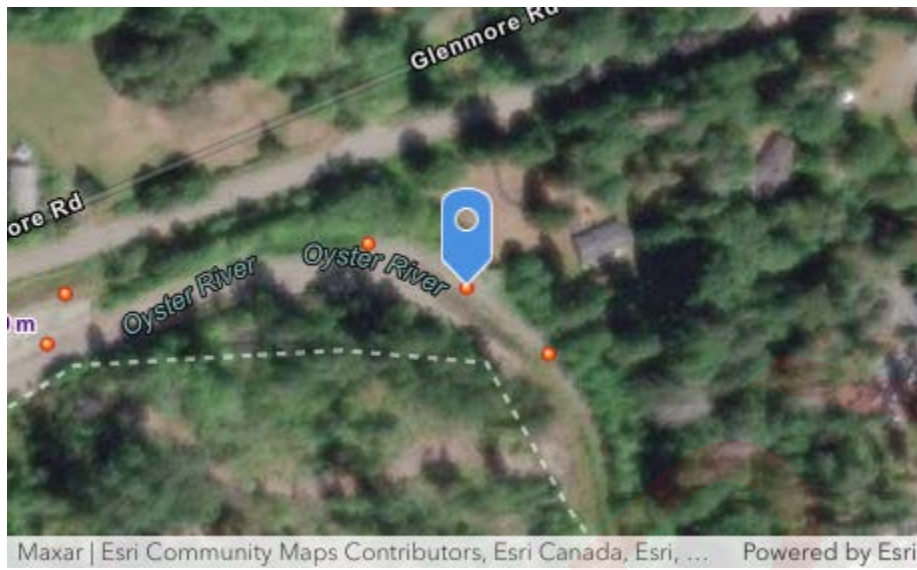
large riprap in good condition

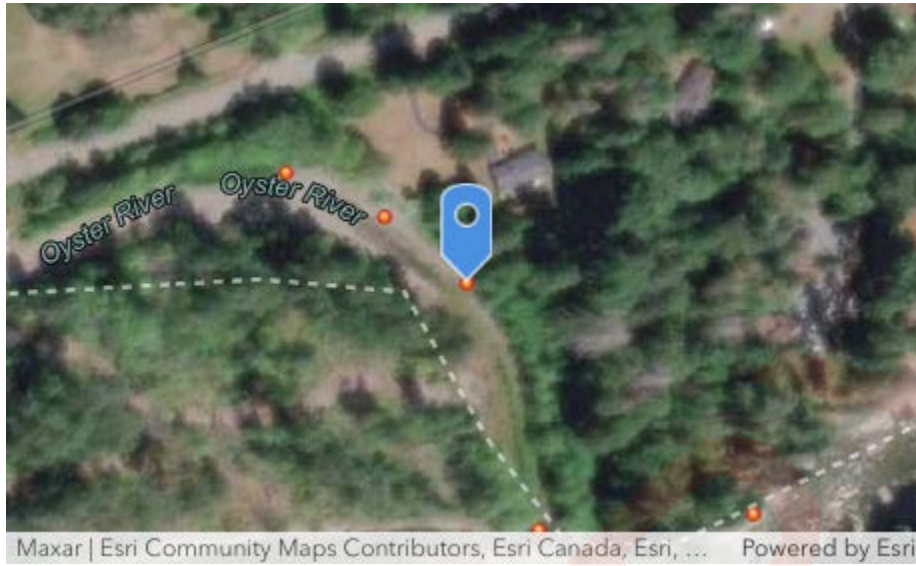
rirap in good condition

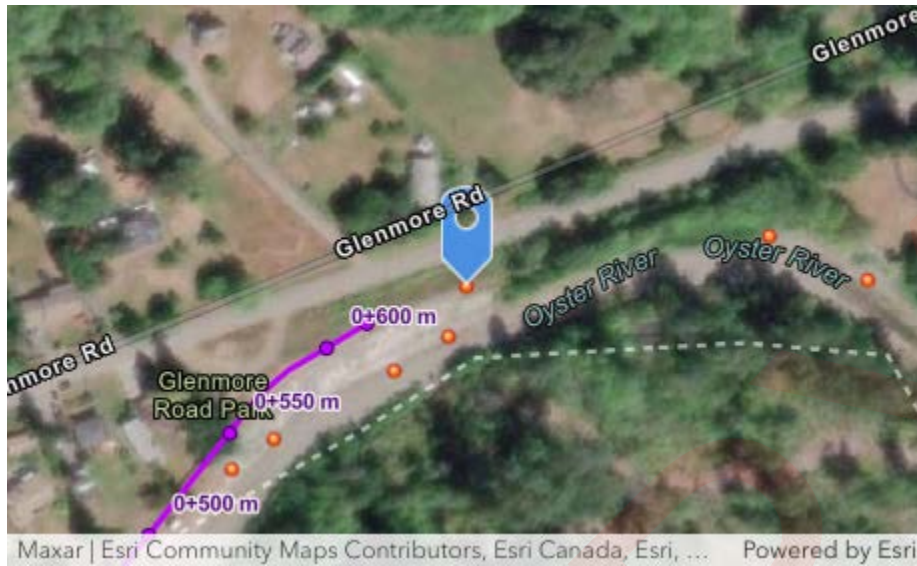
removal of shrubs needed. edge of dike ties into river riprap

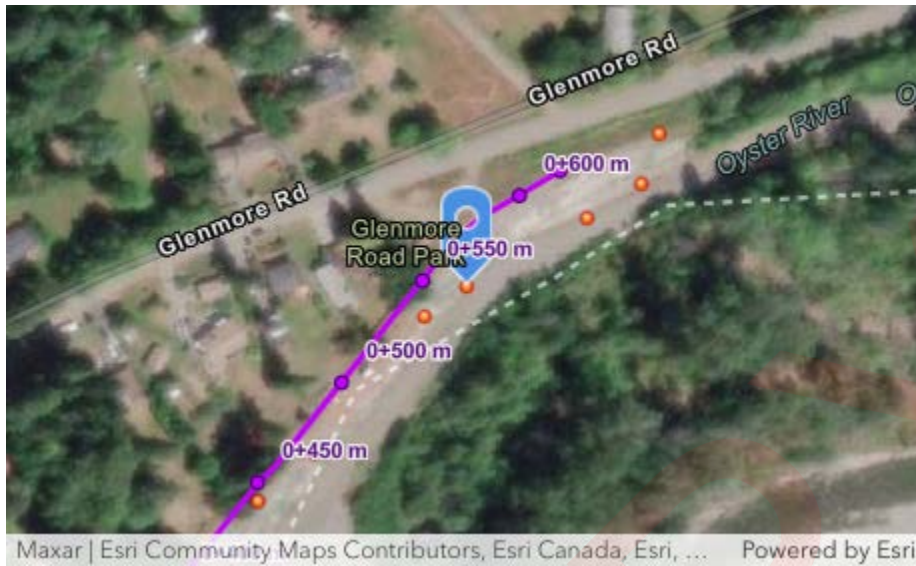
large shrubs small trees along riprap toe.

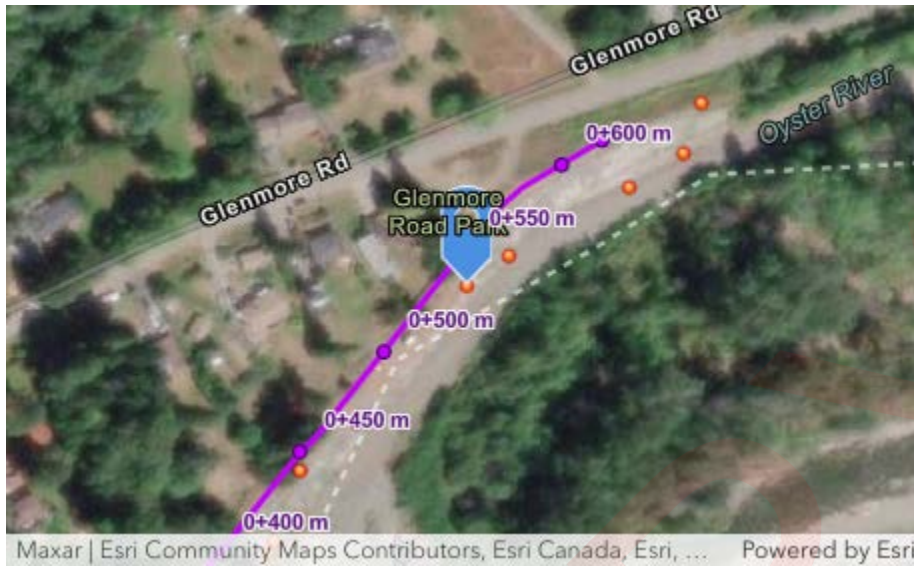
riprap in excellent condition. gate here. trees on land side of dike. possible transition from older installed riprap to newer riprap (downstream)

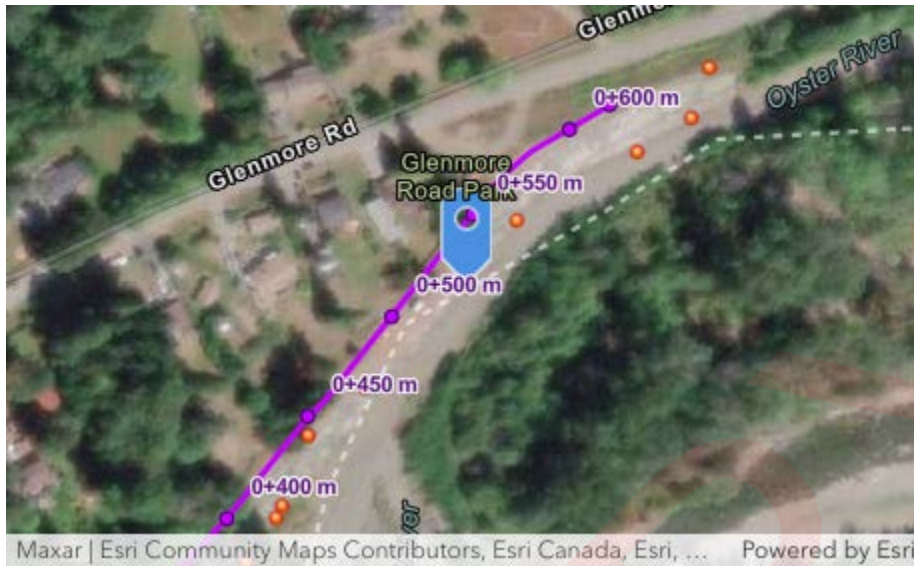
riprap in excellent condition. refuse appears to have been dumped on dike (bricks, concrete, mortar). upper portion of dike had soil layer with established grass cover

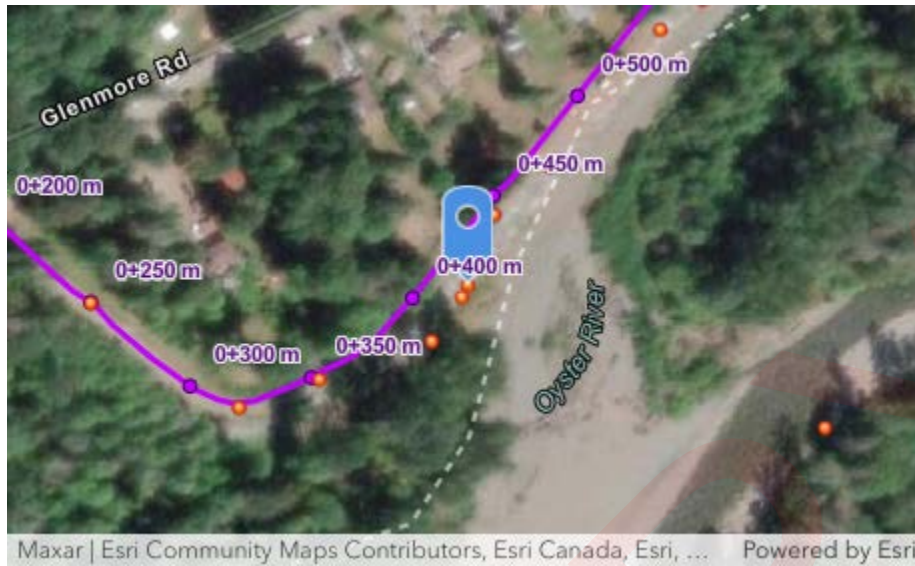
toe in excellent condition

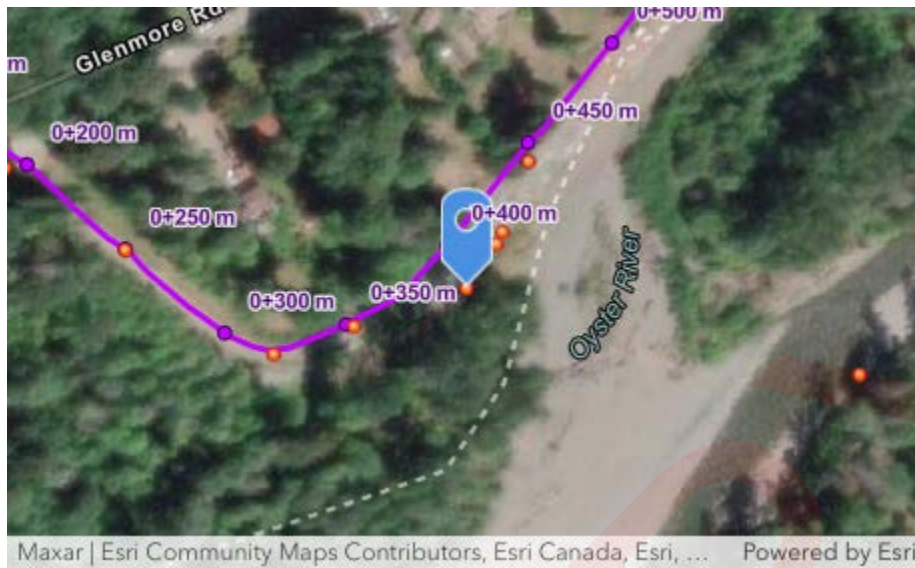
18 inch valve outlet on riverside of dike. riprap in excellent condition

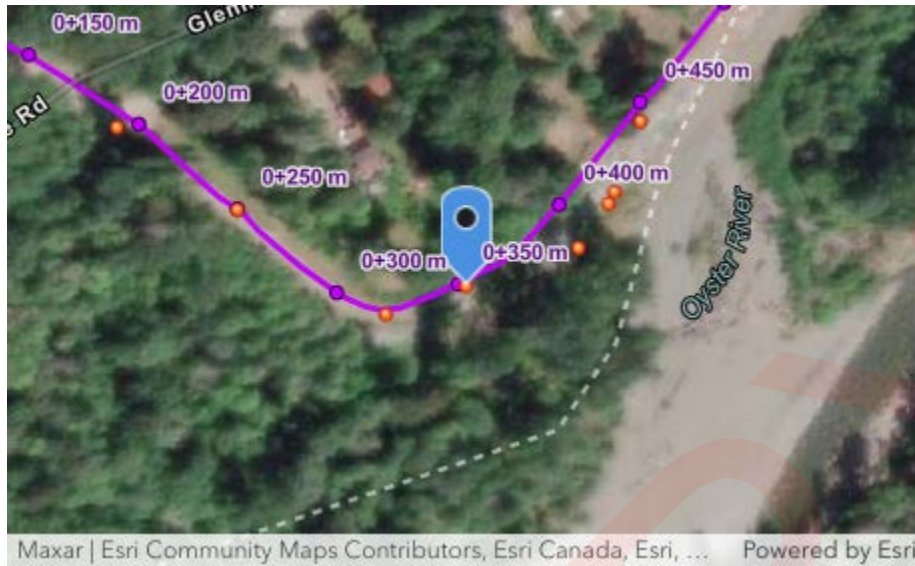
dike almost completely cover with vegetation. no evidence of erosion via water

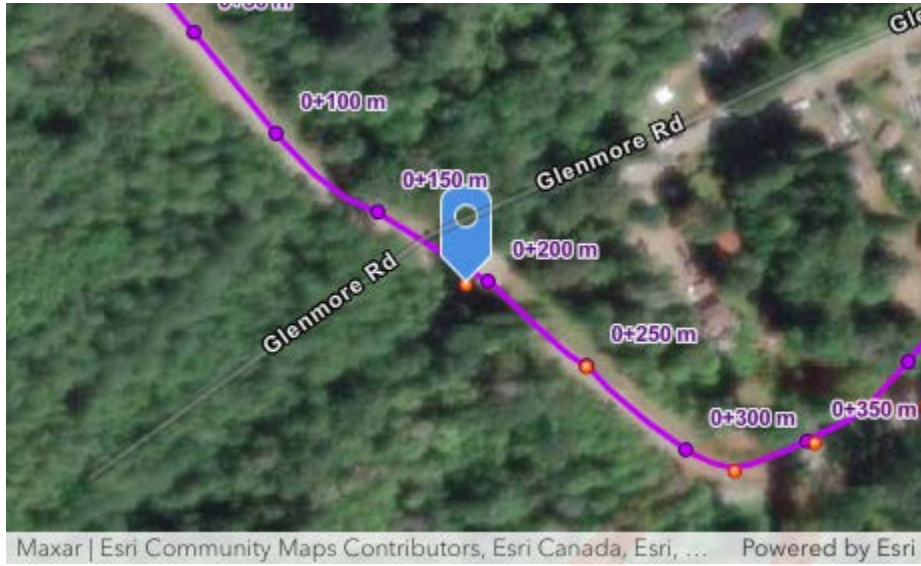
dike turns into road

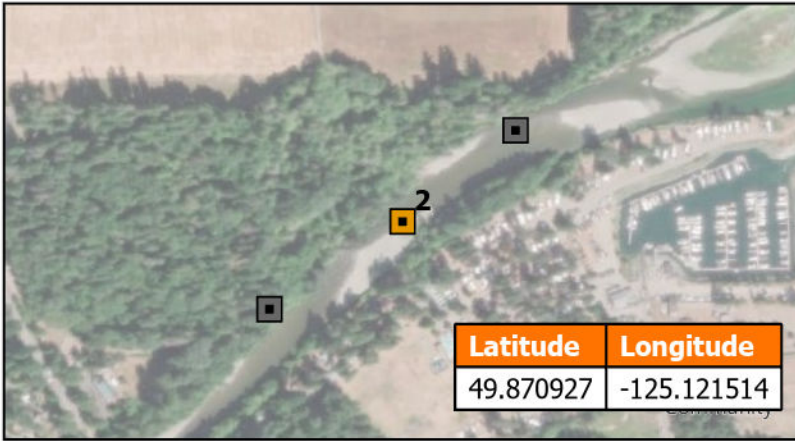
Observation Type	Please provide a description	Material	Dimensions	Crest Elevation	Filter Layer	Please provide a description	Condition Comments
Other	Down tree spanning entire creek, dia +0.6 m. Bank eroding and undercut

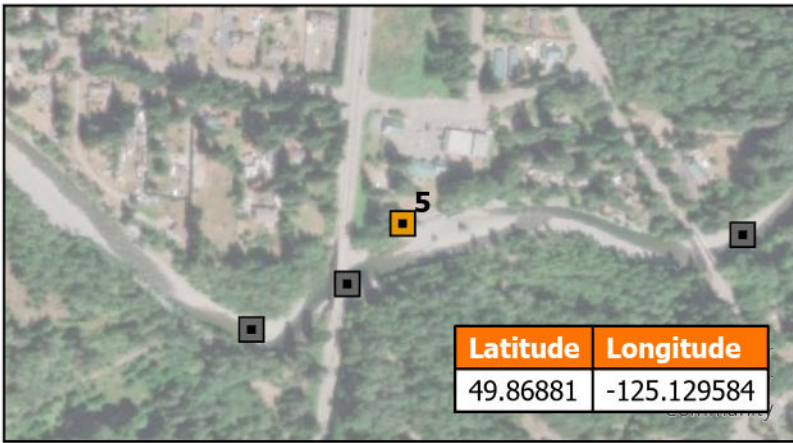
Observation Type	Please provide a description	Material	Dimensions	Crest Elevation	Filter Layer	Please provide a description	Condition Comments
Bank Protection		Rock riprap	Approx 275m length (bridge to bridge nearly), generally 2:1 slope, interlocked well, 750 to 1000 mm d50, smaller at top of slope	Full bank, good coverage	Unknown		90+, generally good condition

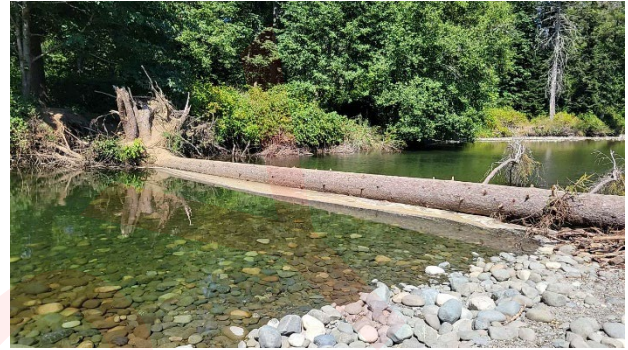
Photo 6: Large Fallen tree Spanning the Full Channel Width Removed September 25, 2024 (August 7, 2024)
