RE: BYLAW NO. 487- ELECTORAL AREA C WHARVES SERVICE

FEASIBILITY STUDY

ELECTORAL AREA C WHARVES SERVICE

Marine Facility Condition Assessment of the Surge Narrows Wharf

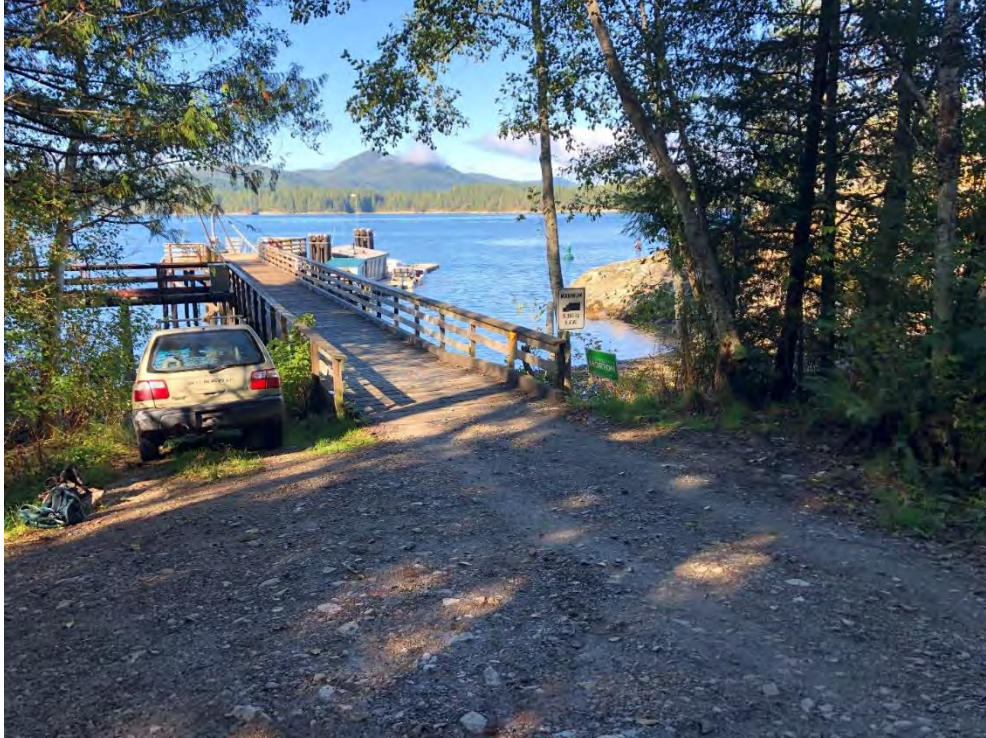
Photo 1 - Approach area

The approach is in generally good condition (Photo 1). There are no signs of settlement in this area, and the slope around the abutment appears stable. The load rating sign specifies a maximum gross vehicle weight of 5,300kg (Photo 2).

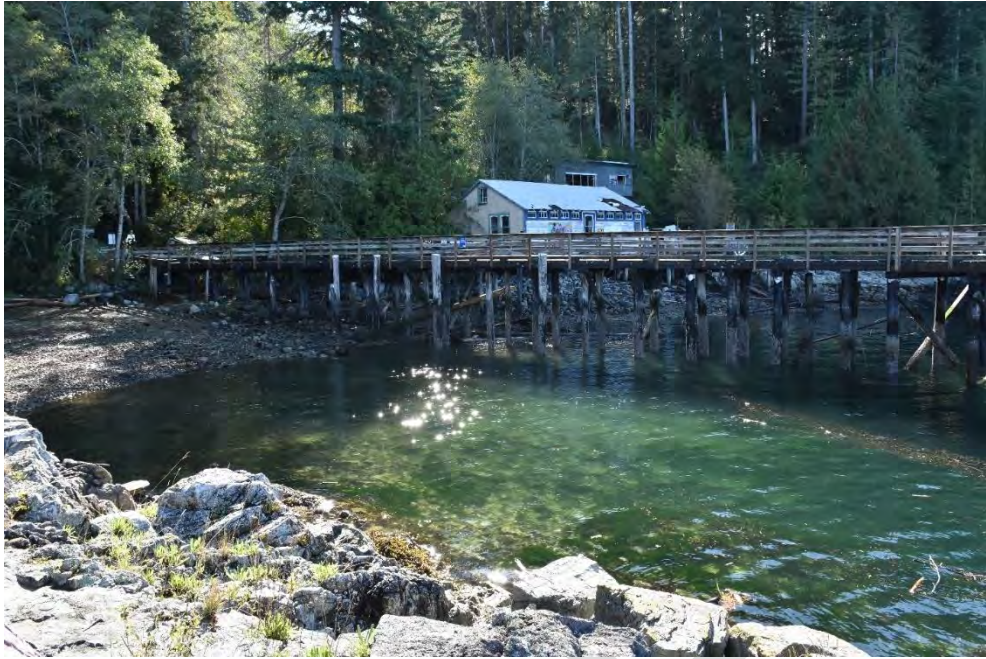
Photo 9 - General View facing south of the timber pile caps

The treated timber pile caps are generally in fair condition, with widespread weathering and green algae growth, and damage to isolated members (Photo 9 to Photo 10). The pile caps appear well secured, and are typically aligned well over the piles, with no signs of shifting. Inspection findings are as follows in Table 1 below:

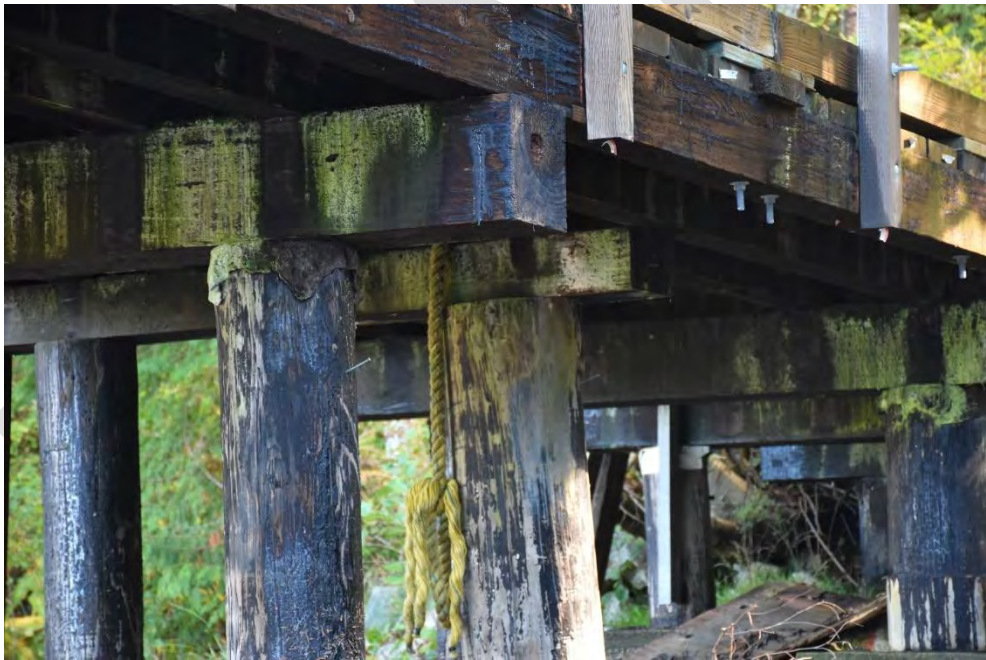
Photo 10 - Weathering and green algae growth on pile caps

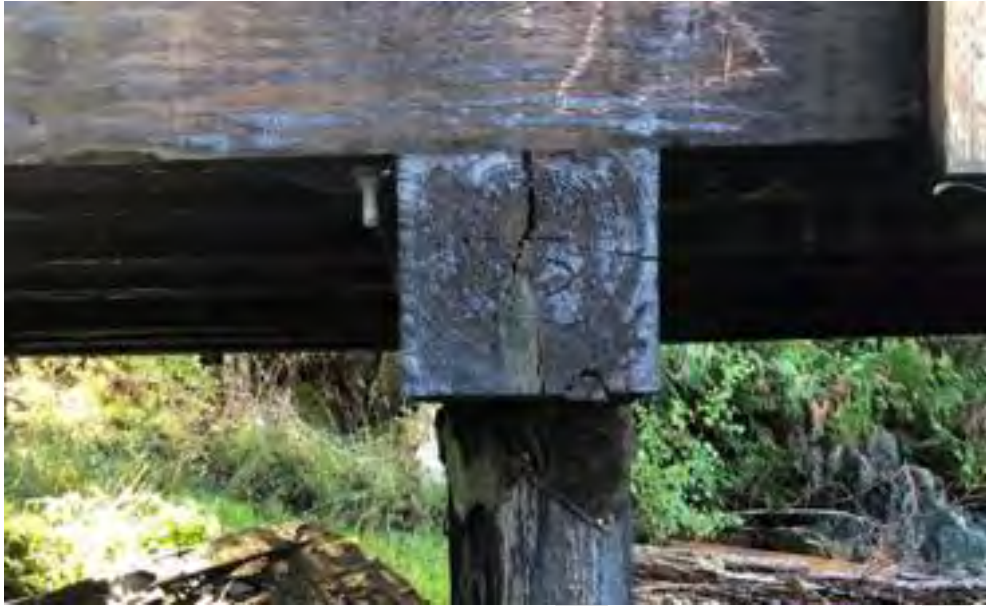
Location	Description of Findings	Photo
Bent No. 1	The pile cap is split on the north end.	Photo 11
Bent No. 2	The pile cap has a minor split at the south end grain.	Photo 12
Bent No. 4	The pile cap is fractured at the base in the center, and the end of one of the through bolts is exposed.	Photo 13
Bent No. 6	The pile cap is above 2 corbels on each pile. The corbels are in fair condition and secured vertically with a steel angle on one side. The top corbel at the north end is showing signs of splitting.	Photo 14 to Photo 15
Bent No. 7	The pile cap is above 2 corbels on the south pile. The corbels are in fair condition and stabilized vertically with a steel angle on one side. The bottom corbel is showing minor signs of splitting at the end grain.	Photo 16 to Photo 17
Bent No. 10	The pile cap is fractured at the base in the center, and the end of one of the through bolts is exposed.	Photo 18
Bent No. 11	The pile cap is splitting at the north end grain.	Photo 19

Photo 11 - Split at the north end of the pile cap at Bent 1

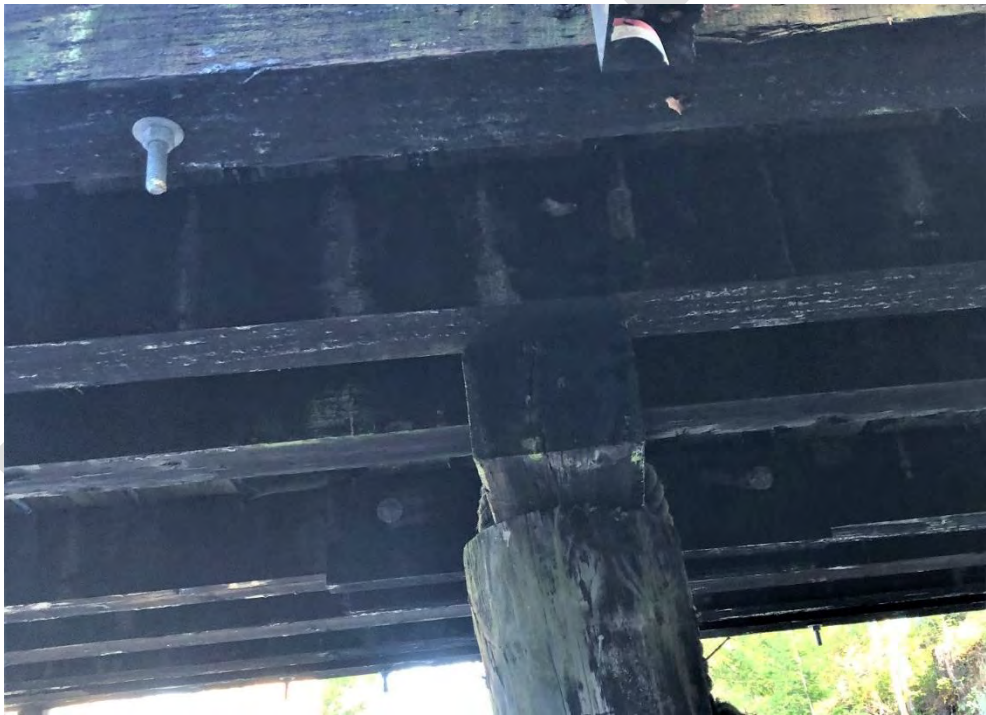
Photo 12 - Minor splitting of the pile cap at Bent 2

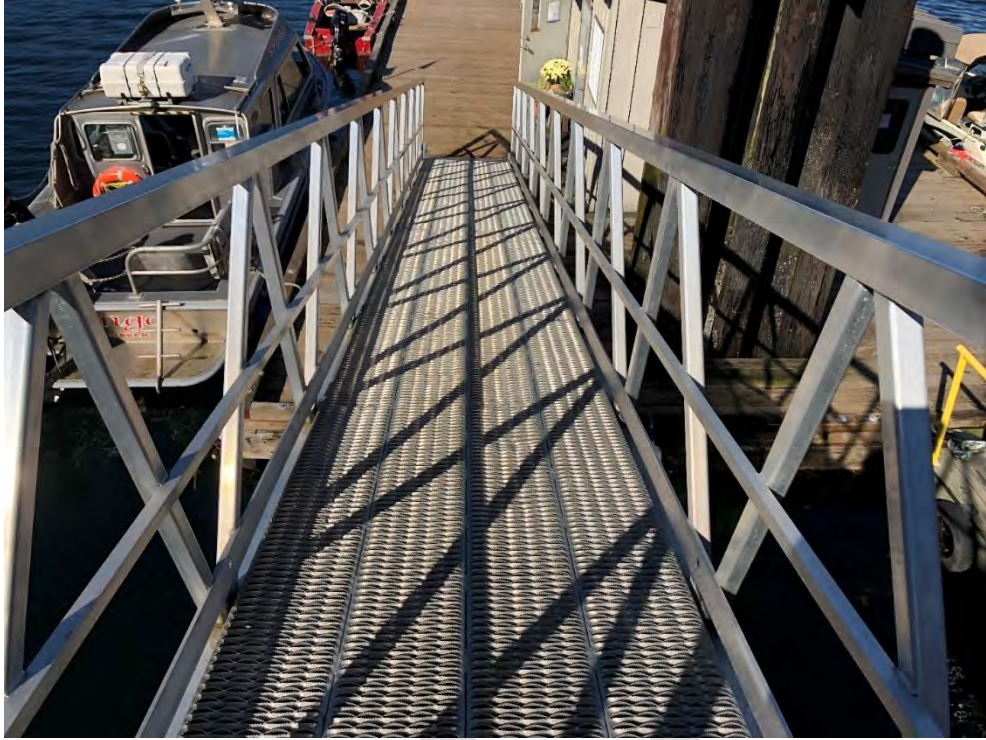
Photo 39 - General View of Aluminum Gangway

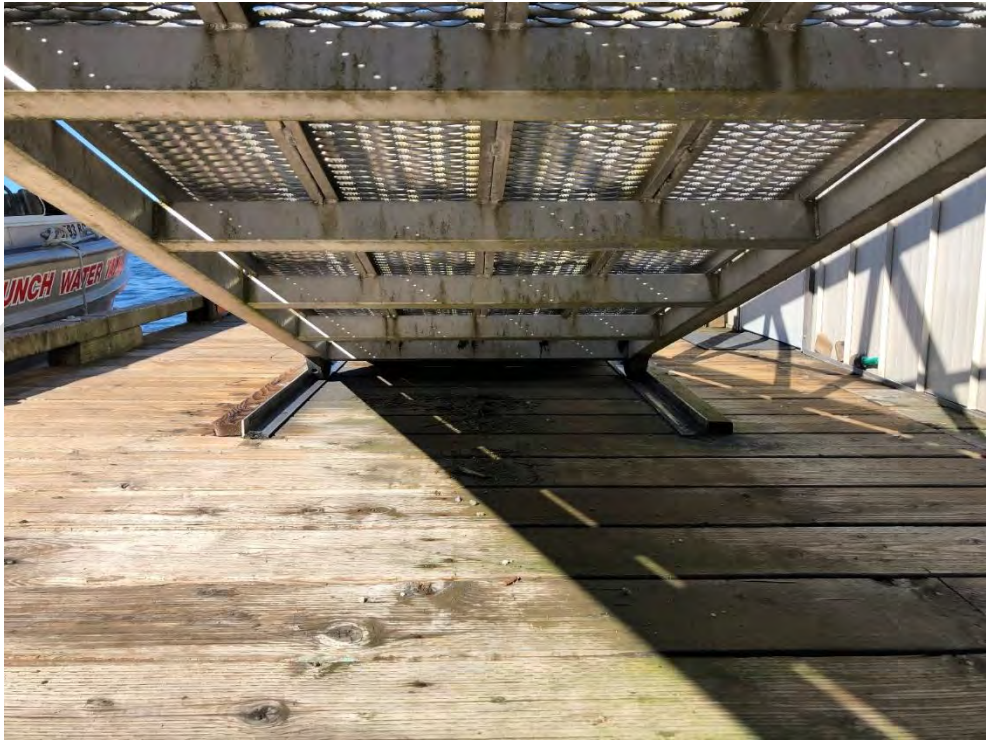
Photo 40 - Gangway slider plate and rollers

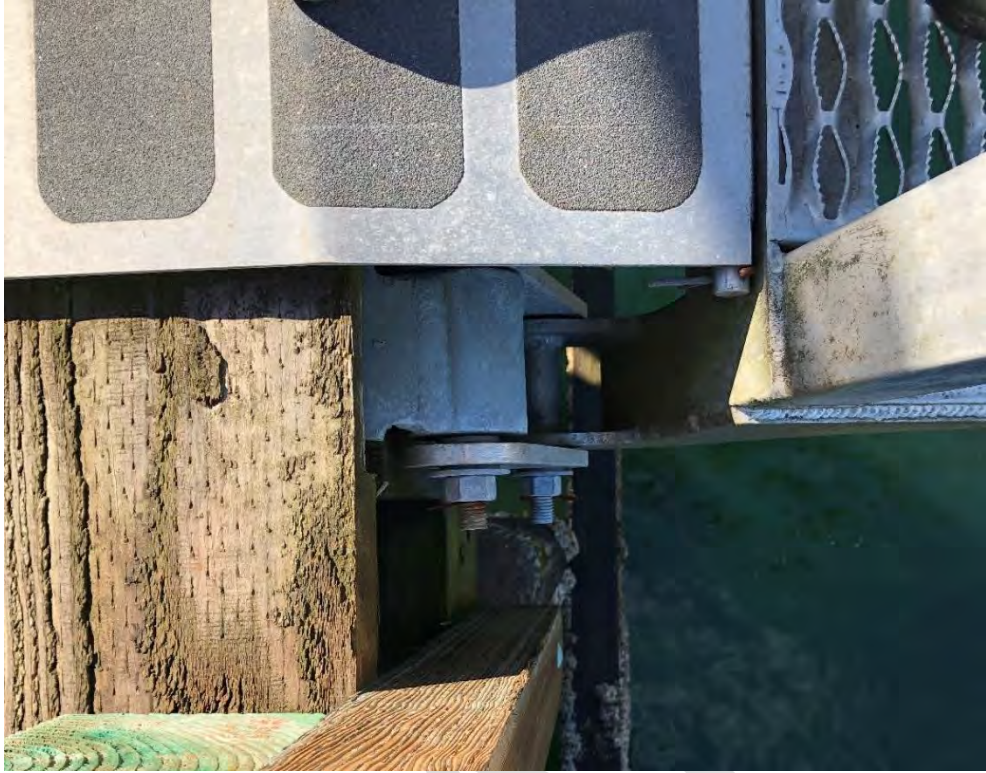
Photo 41 - Gangway Upper Hinge Connection

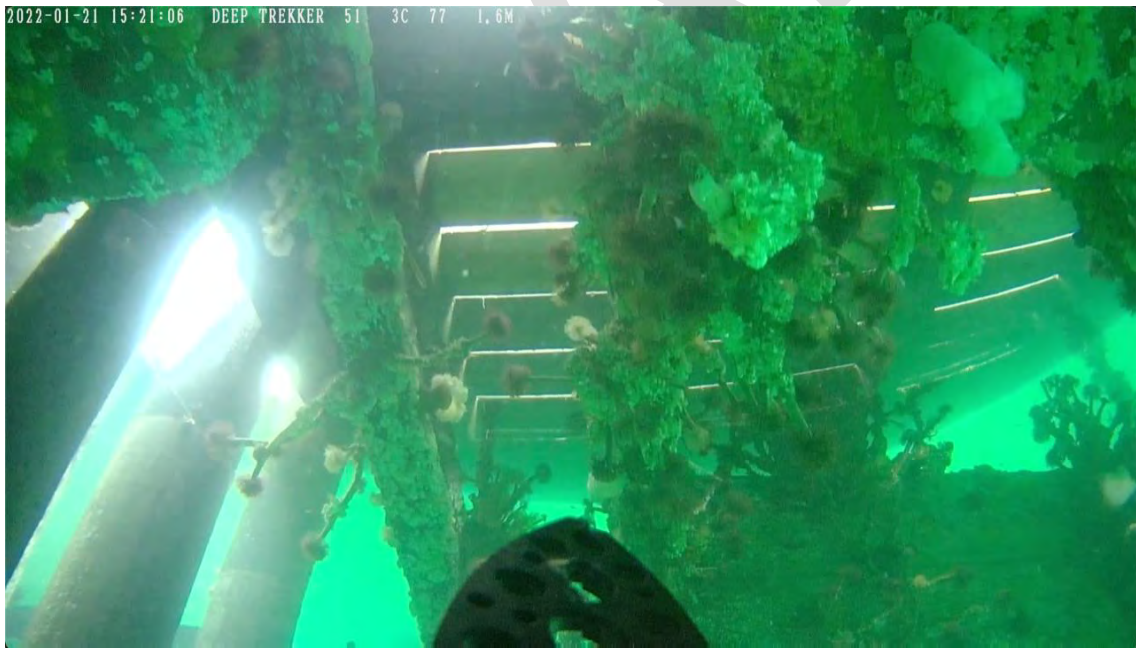
Photo 48 - Main Float on the east end

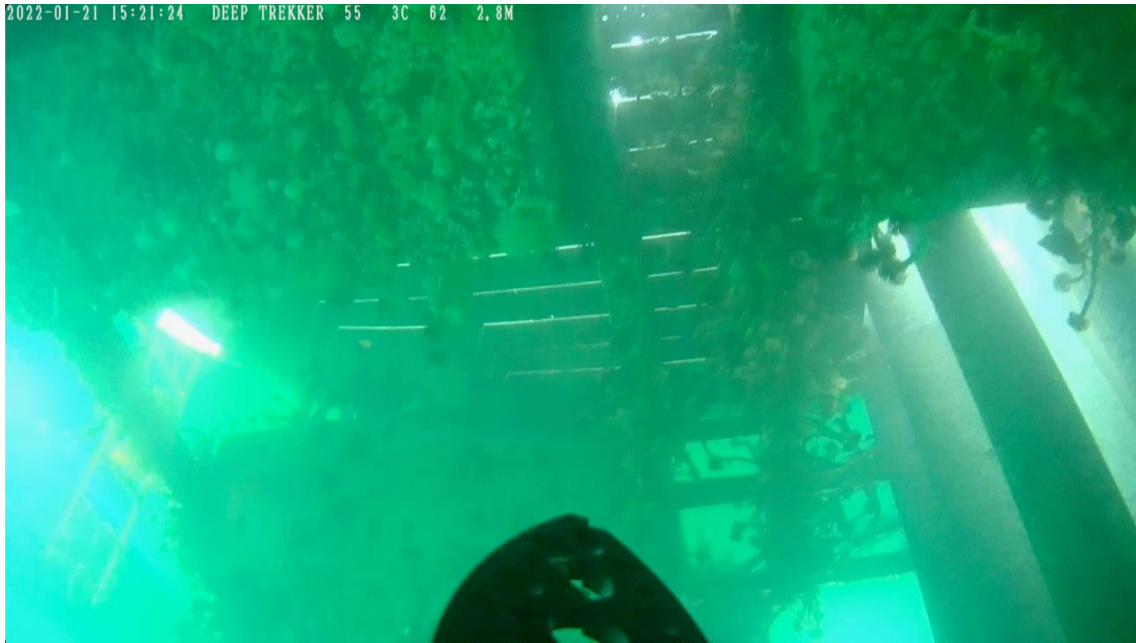
Photo 49 - Main Float on the east end

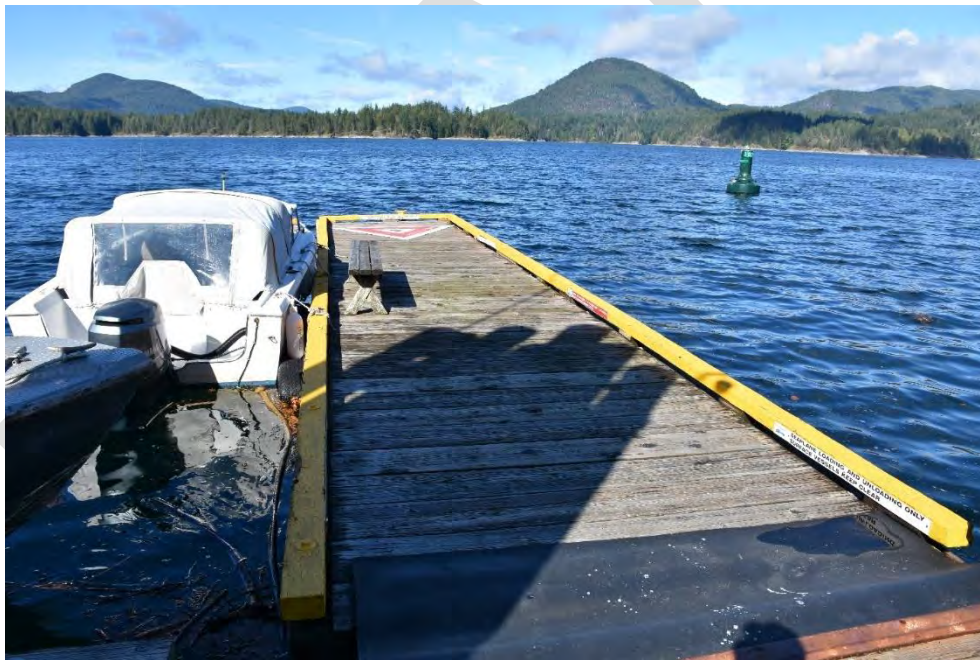
Photo 58 - General view of the Seaplane Float

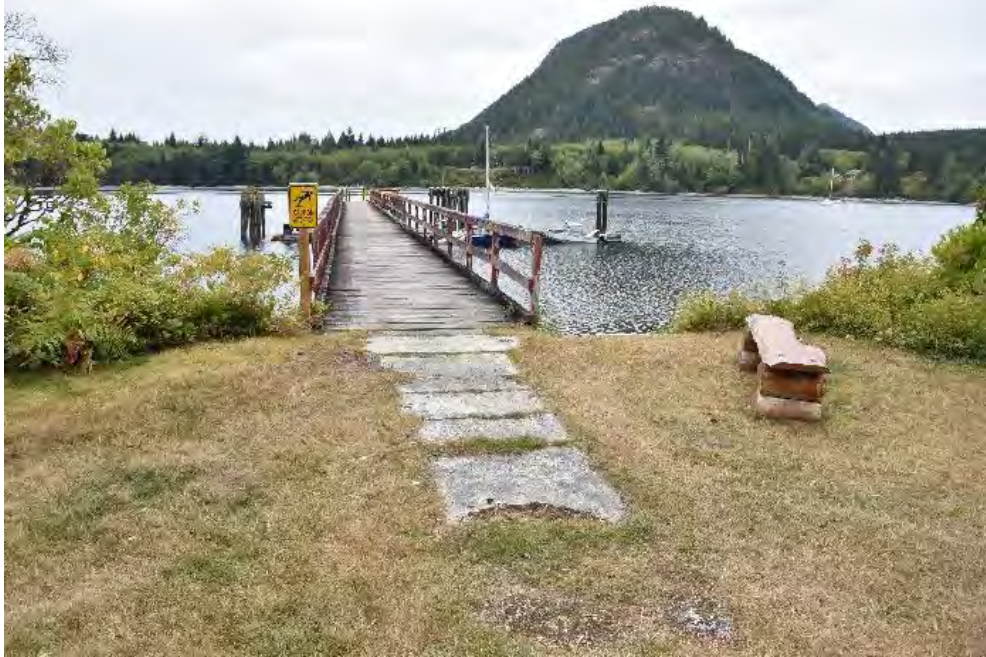
The pier approach is in generally good condition (Photos 1). There are no signs of settlement in this area, and the slope around the pier abutment appears stable. No load rating sign has been posted.

Photo 1 – Pier Approach Area

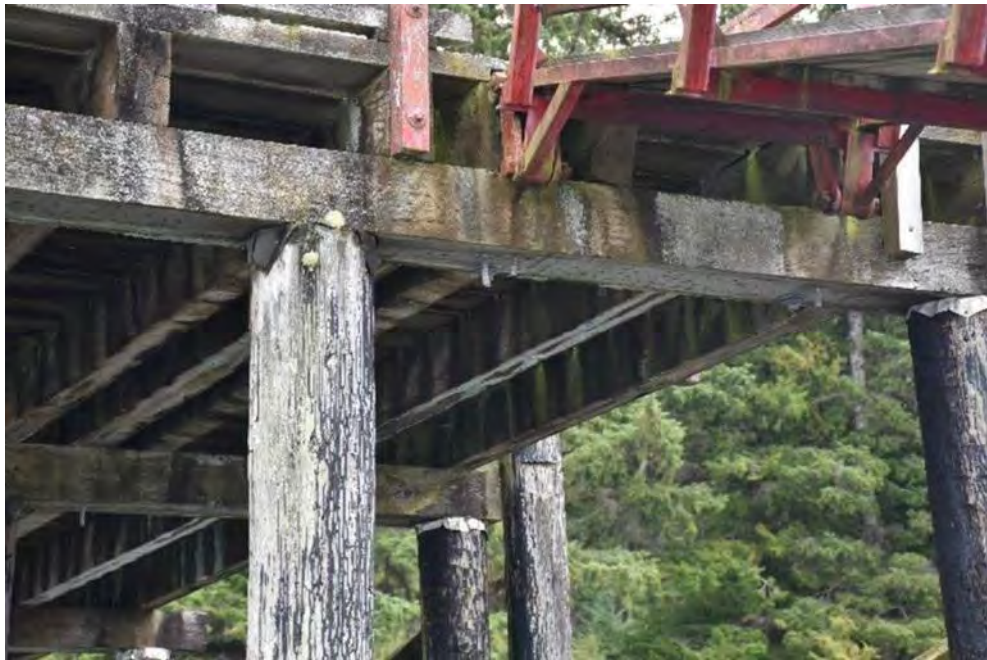
Pile 8A	Moderate splitting at the top of the pile. (Photo 20)	Monitor.
Pile 9A	Large open bolt hole at the top of the pile, likely from a previous cross-brace bolted connection. (Photo 21)	Monitor.
Pile 10A	Moderate splitting at the top of the pile. (Photo 22)	Monitor.
Pile 12A	Large open bolt hole at the top of the pile, likely from a previous cross-brace bolted connection. (Photo 23)	Monitor.
Pile 15B	Moss growing out of the top, indicating that there is fungal decay in the interior of the pile in this location. (Photo 24)	Monitor.

Photo 24 – Moss growth in Pile 15B

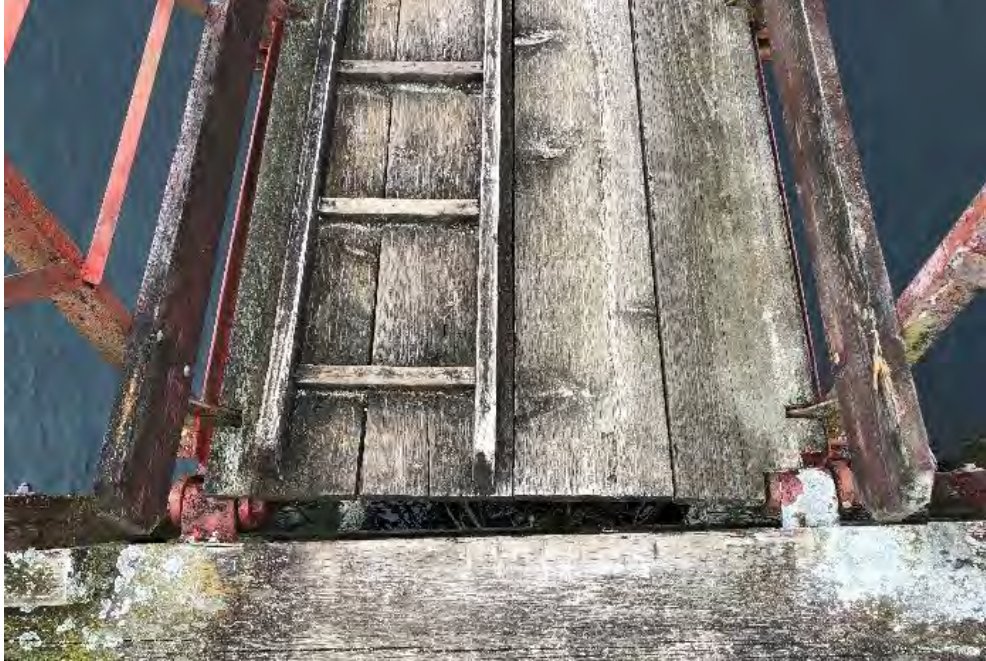
- The upper hinge connection is slightly misaligned (Photos 31 and 32) which is likely to result in advanced wearing of the pinned connection.
- The timber gangway slider plate is in good condition with minor wearing and is well aligned with the gangway roller (Photo 33)
- The deck planks and anti-slip surface have moderate wearing (Photo 34).
- The steel truss members have typical minor to moderate coating failures and corrosion. No significant deterioration of the welded connections was noted (Photo 35).

Photo 31 – Gangway Upper Hinge Connection
